China Earthquake Reconnaissance Report: Performance of Transportation Structures During the May 12, 2008, M7.9 Wenchuan Earthquake

PUBLICATION NO. FHWA-HRT-11-029

OCTOBER 2011

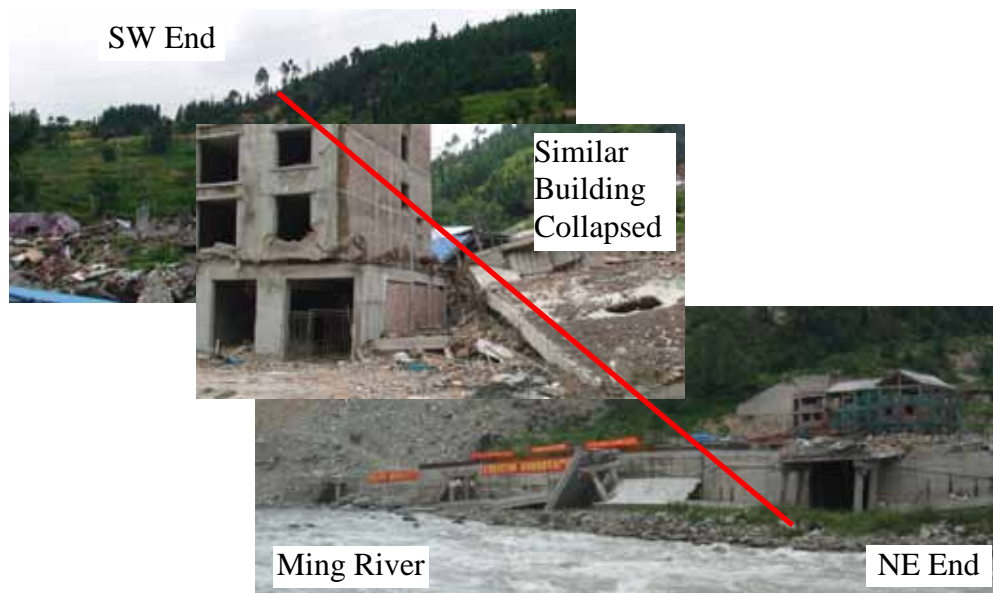
The epicenter of the earthquake was located near Yingxiu in Wenchuan County, Sichuan Province. The surface rupture of the center fault in the Longmen-Shan fault zone was observed in Yingxiu, as illustrated in figure 5. The thrust fault appeared to cross the Ming River at a right angle. The earthquake left behind a distinct dislocation on the river bed at the northeast end of the surface rupture. The northwest side of the fault, on the upstream of the river, moved upward against the southeast side of the fault. The fact that one deck panel along the elevated expressway bridge was still supported by one pier indicated the sudden push by a near-field pulsing effect. The line on figure 5 traces the surface rupture features: a sudden slope change in the mountain, buildings that were damaged next to collapsed buildings, and dislocation across the river bed.

Figure 5. Photo. Surface Rupture of the Earthquake Fault.

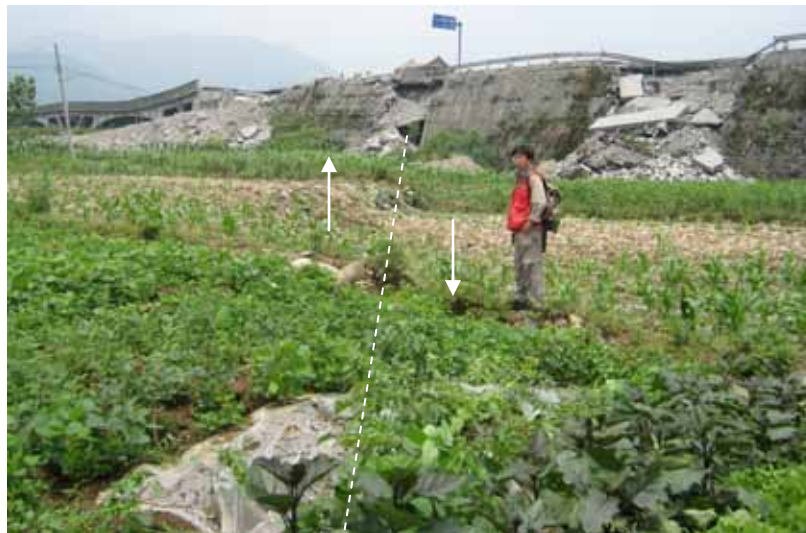
Xiaoyudong Bridge is located at 31.1859 °N, 103.7677 °E between the front and center faults in the Longmen-Shan fault zone. Part of the bridge structure collapsed, and the rest suffered significant damage. According to Xie et al., surface rupture was observed at the bridge site, as shown in figure 7 and figure 8. The vertical offset was more than 3.28 ft (1 m). The highest peak ground acceleration recorded during the Wenchuan earthquake, 0.65 g (6.37 m/s^2), was measured near Xiaoyudong Bridge, at a point to its northeast.

Figure 7. Photo. Surface Rupture Near Xiaoyudong Bridge.

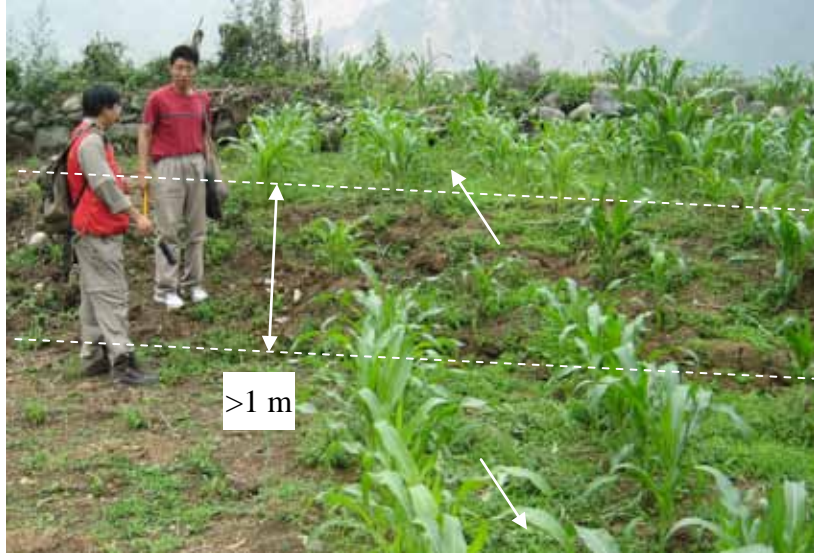
Source: Dr. Zhenming Wang, Kentucky Geological Survey, University of Kentucky
Figure 8. Photo. Surface Rupture Away From Xiaoyudong Bridge.

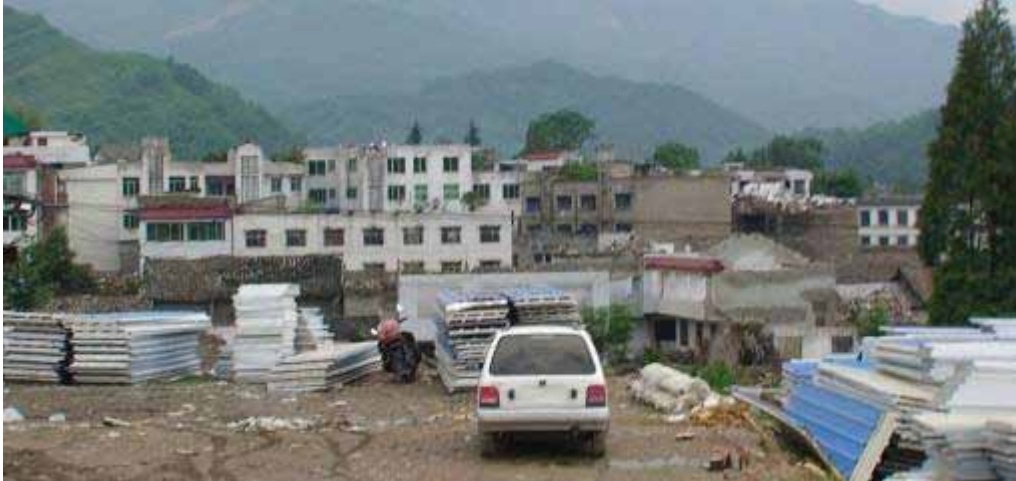
As shown in figure 11, many buildings around the bridge suffered significant damage. There is a village on the other side of the bridge. Near the village were many tents that were most likely provided as shelters for people, as shown in figure 12.

Figure 11. Photo. Building Damage Near Zhima Bridge.

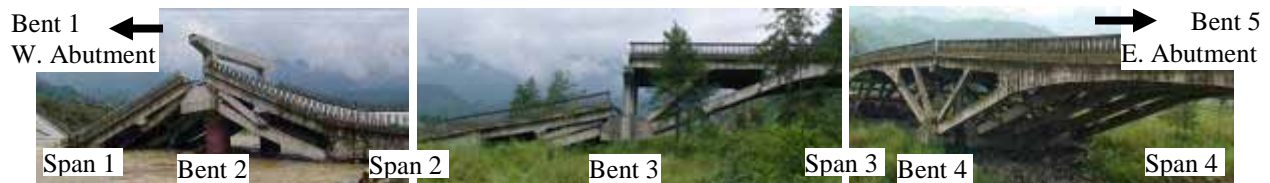
The two spans on the west side of the bridge had collapsed, and the eastern most span was severely damaged, as shown in figure 17. The remaining span suffered little damage. As shown in figure 17, bent 2 is located in the middle of the river, with the longest pile shafts exposed above ground. Bent 2 was significantly tilted while the other intermediate bents appeared to have little rotation. The difference in the stiffness of the various bents most likely contributed to the collapse of the two western spans. Under severe shaking around the bridge site, as indicated by landslides shown in figure 18, bent 2 rotated, resulting in unseating of the two spans. The bent cap was approximately 33.15 inches (850 mm) across, and the seat length of each girder was approximately 11.7 inches (300 mm), which is very limited for strong shaking at the bridge site.

Figure 17. Photo. Overall View of the Remaining Arches.

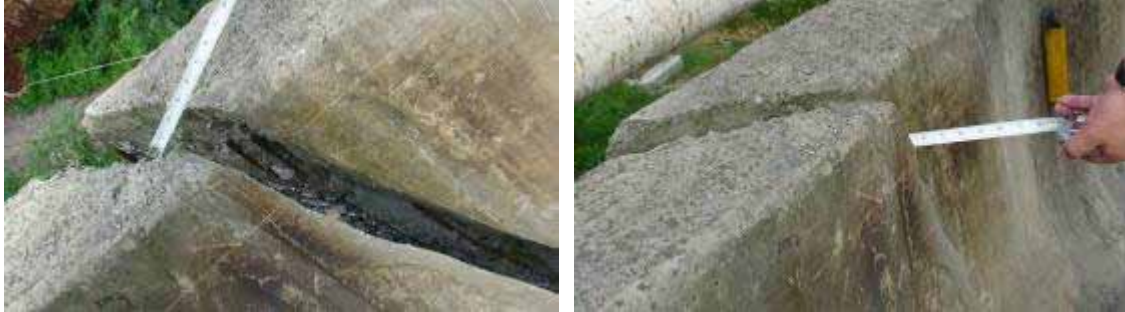
Figure 32. Photo. Measurement of Expansion Joint Offset.

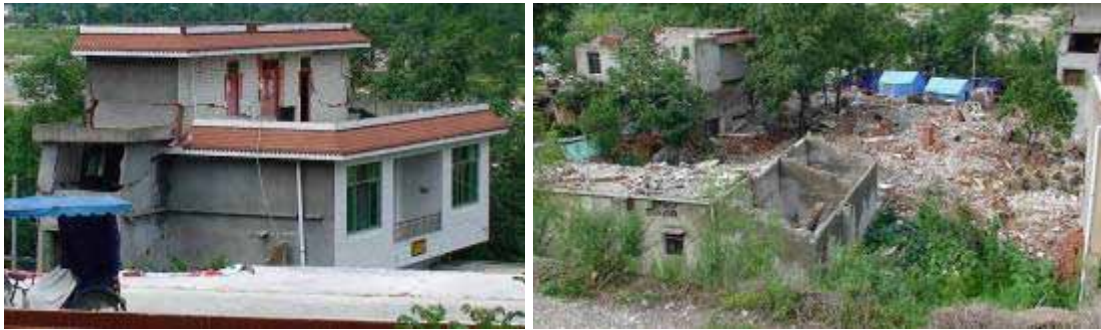
Figure 33. Photo. Building Damage in Nearby Town.

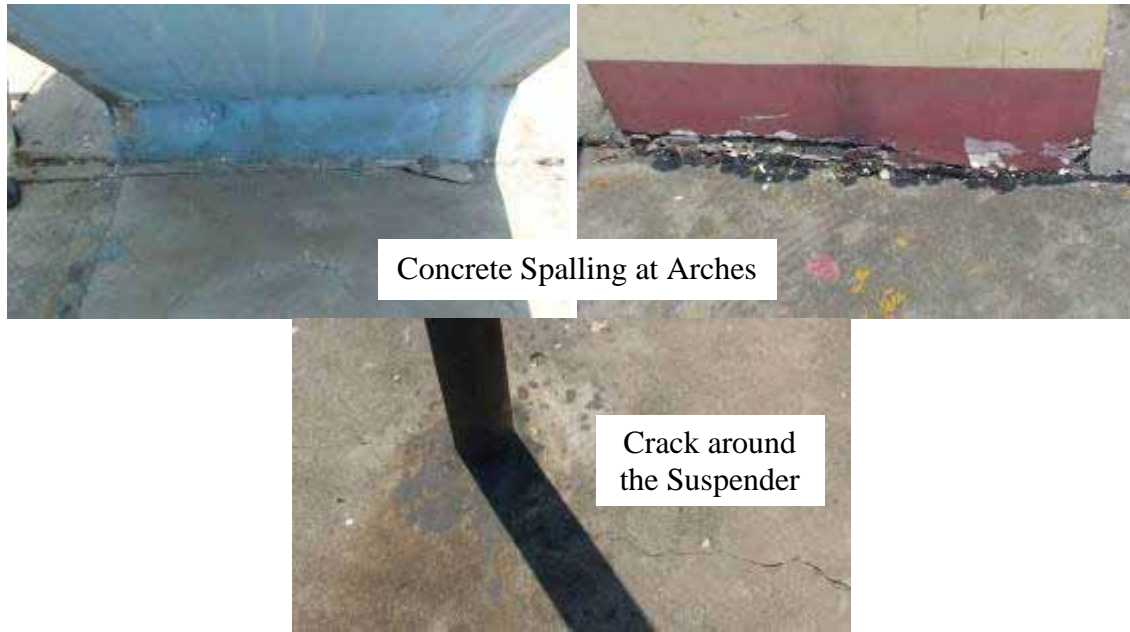
Baiyun Bridge was built in 2001 and spans the Anchuang River in the northwest-southeast direction. It is a three-span simply supported tied-arch structure, as shown in figure 34. As illustrated in figure 35, the three spans of the bridge are 223, 262.4, and 223 ft (68, 80, and 68 m). The height-to-span ratio is approximately 1:5. The arches are supported on four-column bents and seat-type abutments. To protect ties from corrosion, the tendon duct of each tie was filled with oil. Both the tie and the oil duct were embedded in the RC bridge deck. After the earthquake, oil in the tendon ducts began to leak, as shown in figure 36, suggesting that the ducts developed cracks during the earthquake or that the anchorages were damaged. In addition, concrete spalling and cracking were observed on the bridge deck around the arches and cables, as shown in figure 37.

Figure 37. Photo. Concrete Spalling and Cracks on Bridge Deck.

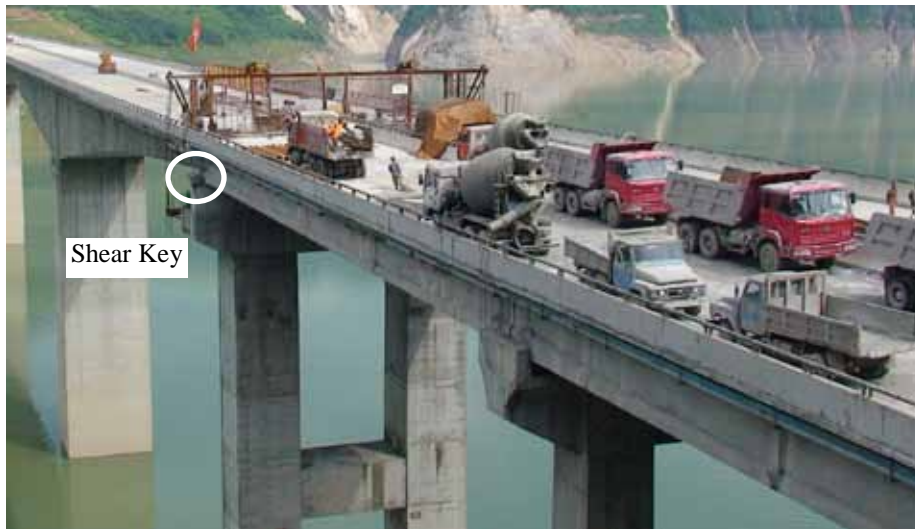
Figure 57. Photo. Shear Key Failure.

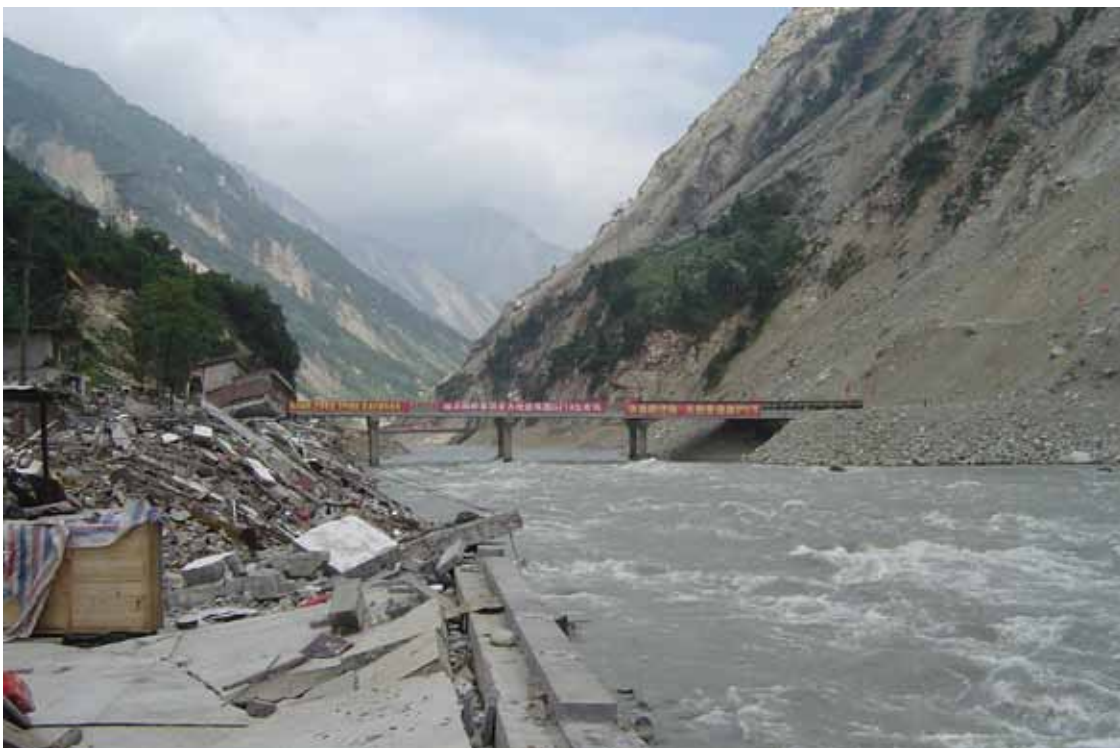
Figure 62. Photo. Mingjiang Bridge and Other Structural Damage in Yingxiu Village.

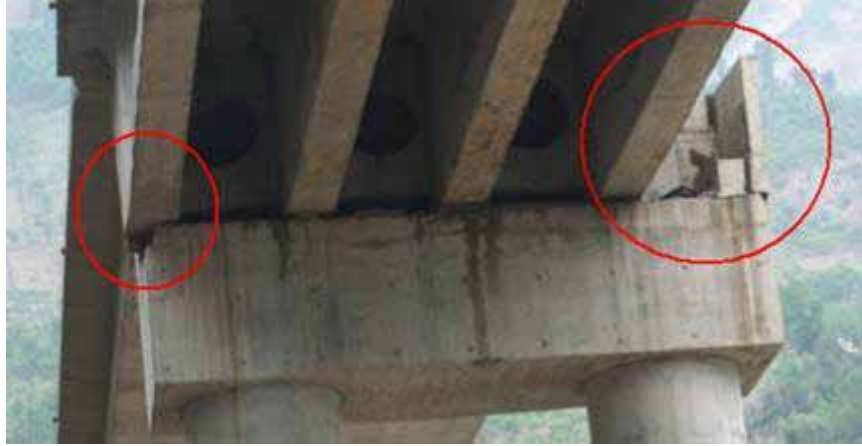
Figure 66. Photo. Damage at Bent 9.

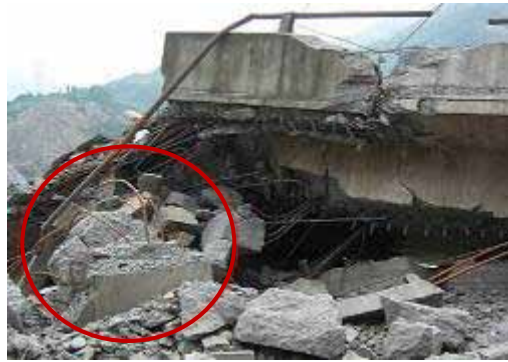
Figure 67. Photo. Column Shear and Flexural Failure at Bent 15.

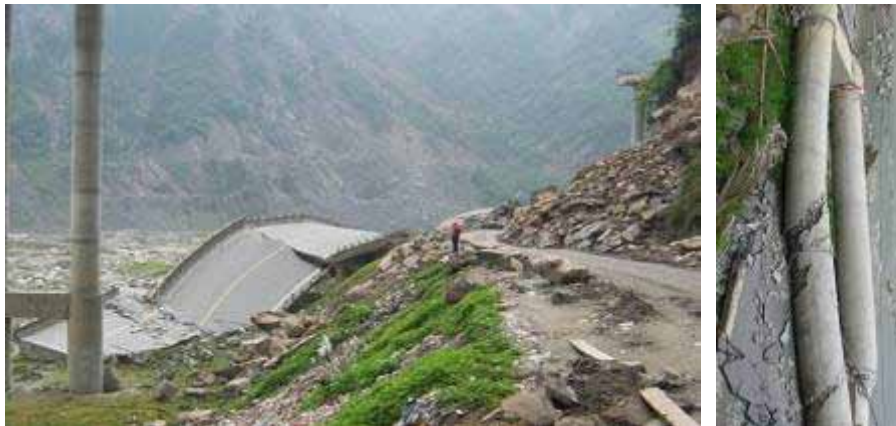
Figure 68. Photo. Column Shear Failure and Section 5 Collapse at Bent 15.
