Subject: **ACTION:** Hoan Bridge Failure  
Investigation

Date: July 10, 2001

# Summary Conclusions of the Forensic Investigation For the Hoan Bridge

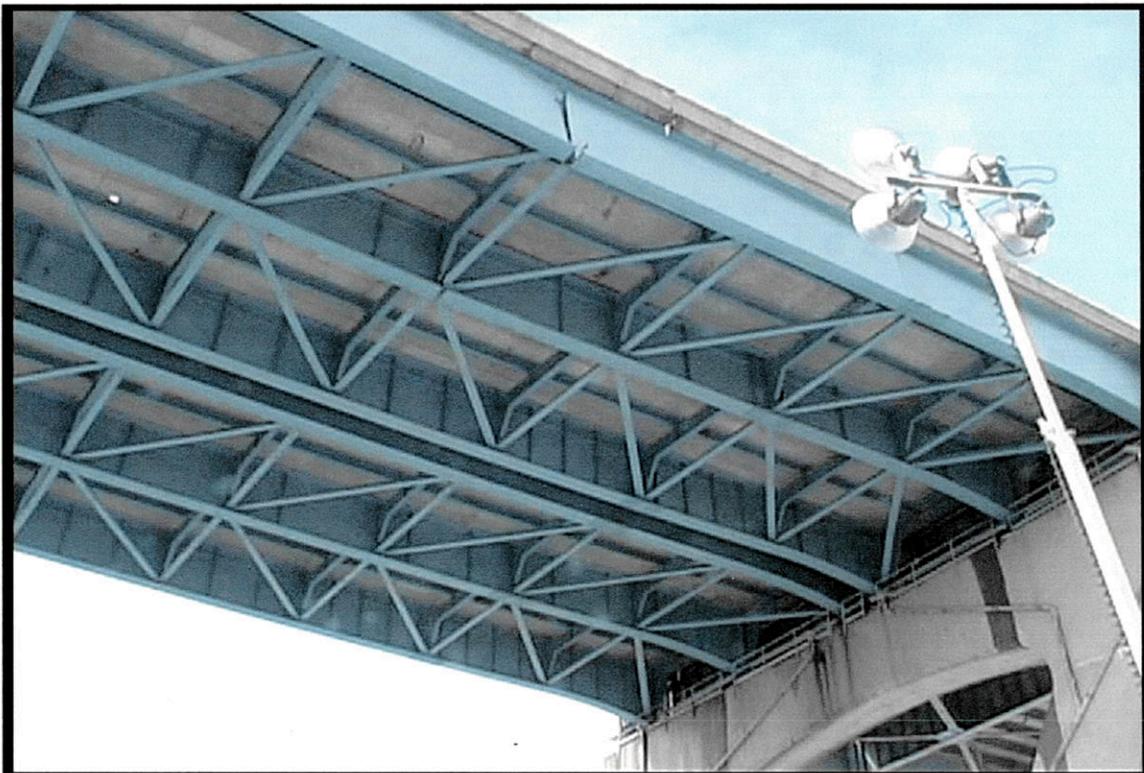
On December 13, 2000, fractures were discovered in all three girders of one of the southern approach spans to the Hoan Bridge carrying Northbound I-794 over the Milwaukee River. Figure 1 shows an underside view of the fractures. The interior and east exterior girders were fractured full depth, and the web had several 3 ft. fractures in the west exterior girder.

Figure 1 Underside of the South Approach Span Showing the Fractured Girders

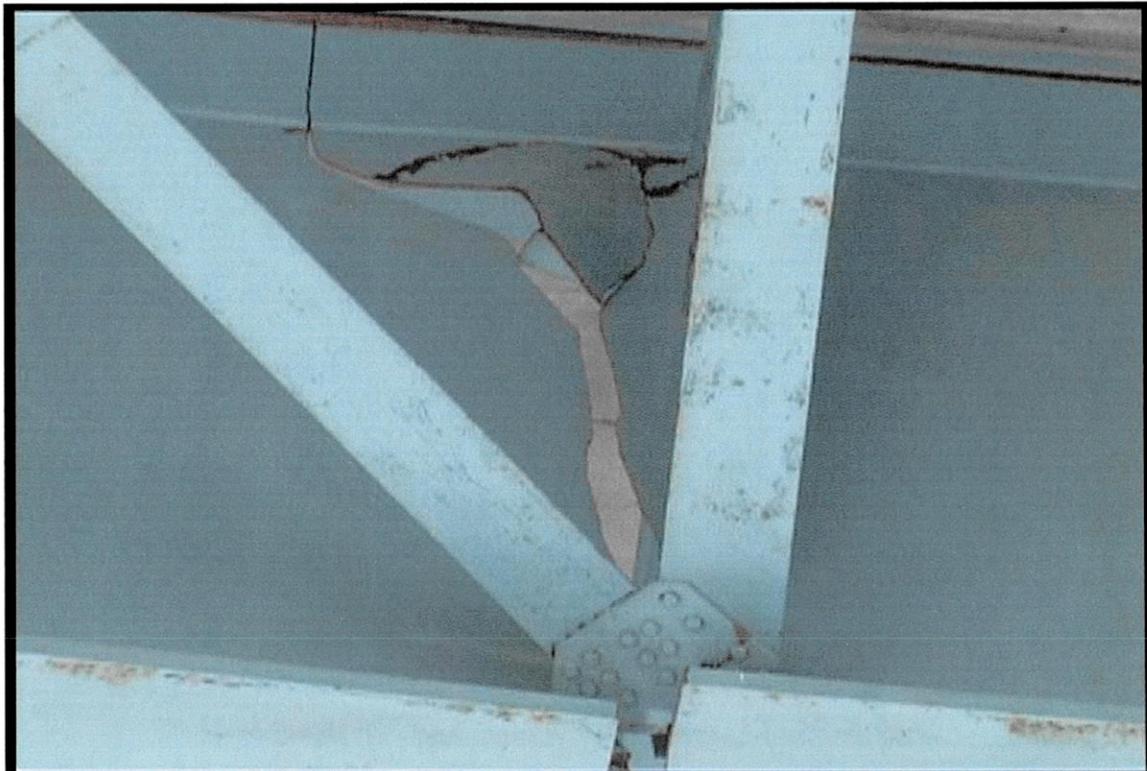
- The crack surfaces were examined under high magnification using a scanning electron microscope. The failure mode was positively identified as brittle, cleavage fracture. The fractures occurred suddenly and propagated through the girders at an explosive rate.
- The fractures initiated in the web plate, most likely the interior girder, at the joint where the lower lateral bracing system framed into the web. The initiation site was located in the gap between the gusset (shelf) plate and the transverse connection/stiffener plate. Figure 2 shows a view of the joint assembly where the fracture initiated.

**Figure 2** Joint assembly where the lateral brace system frames into the girder web.

The primary cause of fracture initiation was determined to be the geometry and fabrication tolerance of the joint where the lateral bracing frames into the web. The joint was detailed with a narrow web gap that caused a local high constraint, increased stiffness, and reduced the apparent fracture resistance. As ideally detailed, the joint has only 1/8 in. separating the welds on the two plates. The fabrication tolerance resulted in reduced gaps as well as intersecting welds in many locations throughout the structure. Stress analysis showed that the intersecting welds increased the rigidity of the joint and made the constraint problem worse. This non-ductile behavior in the joint caused by a triaxial constraint and state of stress has never been documented before as being a potential problem in bridge detailing. This is the first time this problem is being reported.

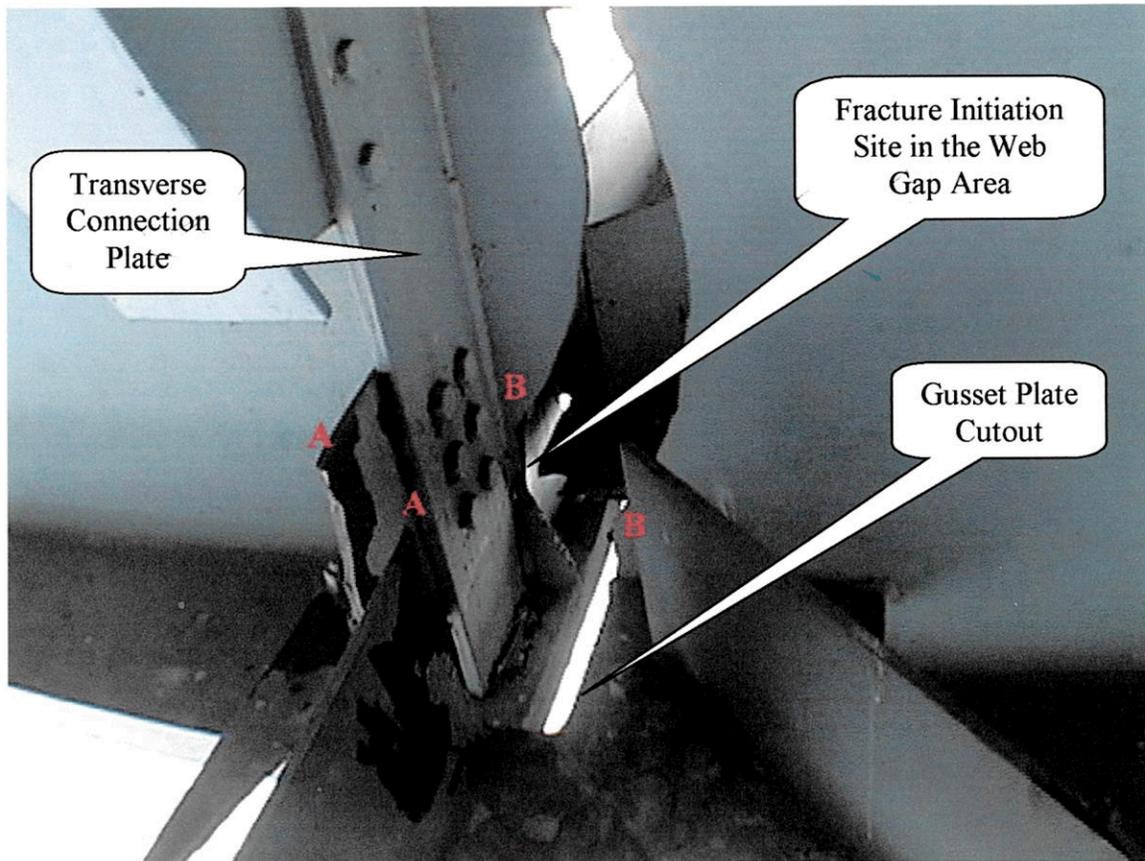
Figure 3 Fracture initiation site in the web gap Area.

- A narrow gap between the gusset plate and the transverse connection/stiffener plate created a local triaxial constraint condition and increased the stiffness in the web gap region at the fracture initiation site. This constraint prevented yielding and redistribution of the local stress concentrations occurring in this region. As a result, the local stress state in the web gap was forced well beyond the yield strength of the material. Under triaxial constraint, the apparent fracture toughness of the material is reduced and brittle fracture can occur under service conditions where ductile behavior is normally expected.

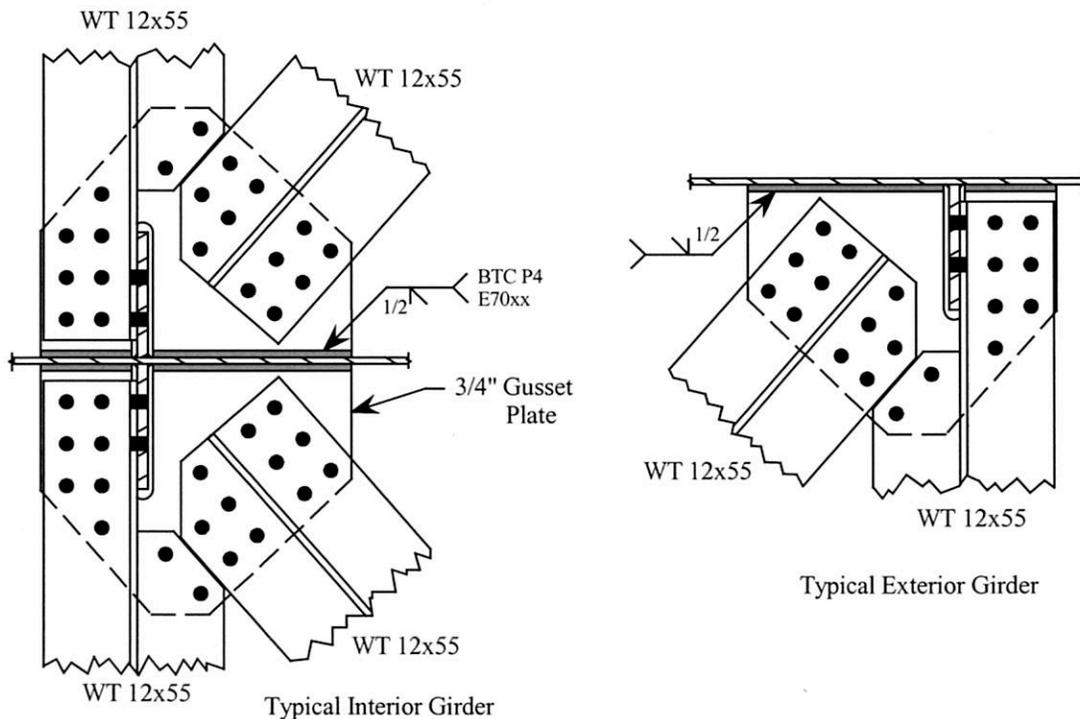
Figure 1 shows a top view of the connection details used in the Hoan Bridge. The gusset plates have a 1-1/2 in. slot cut to clear the 3/4 in. transverse connection/stiffener plate. The resulting web gap is 3/8 in. on each side of the connection/stiffener plate if the gusset plate is perfectly centered during fabrication.

Figure 1 Lateral brace connection for the exterior and interior girders of the Hoan Bridge.

The gusset plate causes a large stress concentration in the web gap area. On the short side of the gusset plate, the transverse WT12x55 lateral brace is bolted both to the gusset plate and the transverse connection/stiffener plate. This creates a positive attachment between the two plates and minimizes any added stress due to out-of-plane distortion.

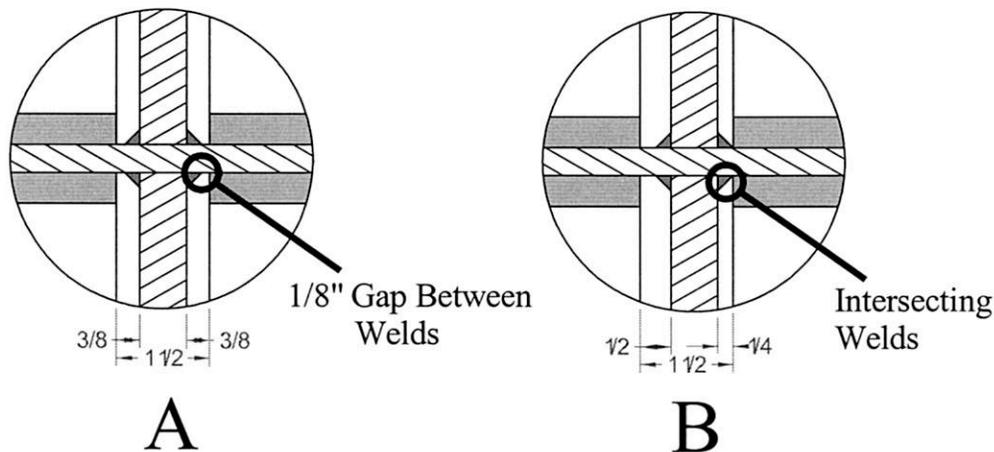
Finite element analysis has shown that minor changes in web gap size have a very large effect on constraint. Figure 2 shows two web gap conditions that were observed in the Hoan Bridge. Case A shows a perfectly centered gusset plate resulting ideally in a small gap between the fillet weld toe on the transverse connection/stiffener plate and the partial penetration weld on the gusset plate. In case B, the gusset plate was offset, allowing the gusset plate weld to touch the toe of the fillet weld on the connection plate. When a gap exists between the two welds, this results in the normal condition of biaxial constraint where the web is free to yield under high stress concentrations. When the gap is reduced to zero, this creates a triaxial constraint condition and increases the stiffness in that localized region. The difference in gap has little effect on the stress concentration determined from linear elastic analysis. However, non-linear plastic analysis revealed that there is a large difference in the plastic constraint. In case A, the elastic stress concentration is relieved by local yielding of the web in the gap area. In case B, triaxial constraint prevents yielding and the stress level increases to levels several times the yield strength of the web. This explains the explosive rate of the fracture as the energy is released from the constraint once fracture is initiated.

Figure 2 Small changes in web gap has a large effect on constraint.

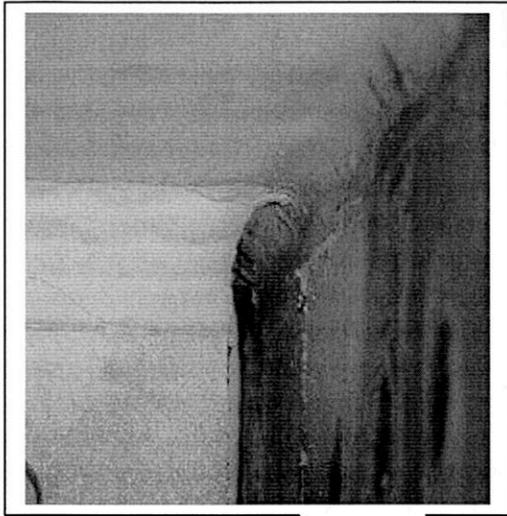
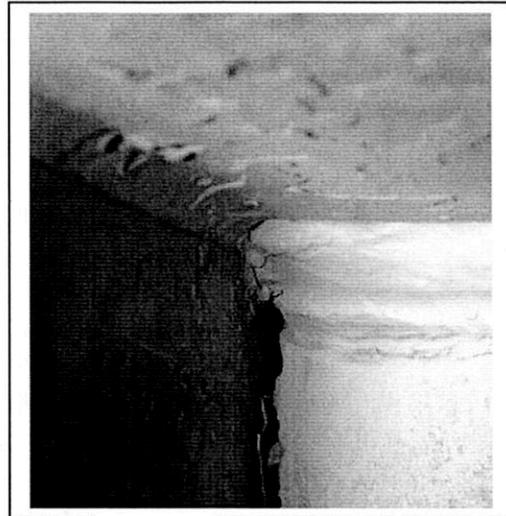
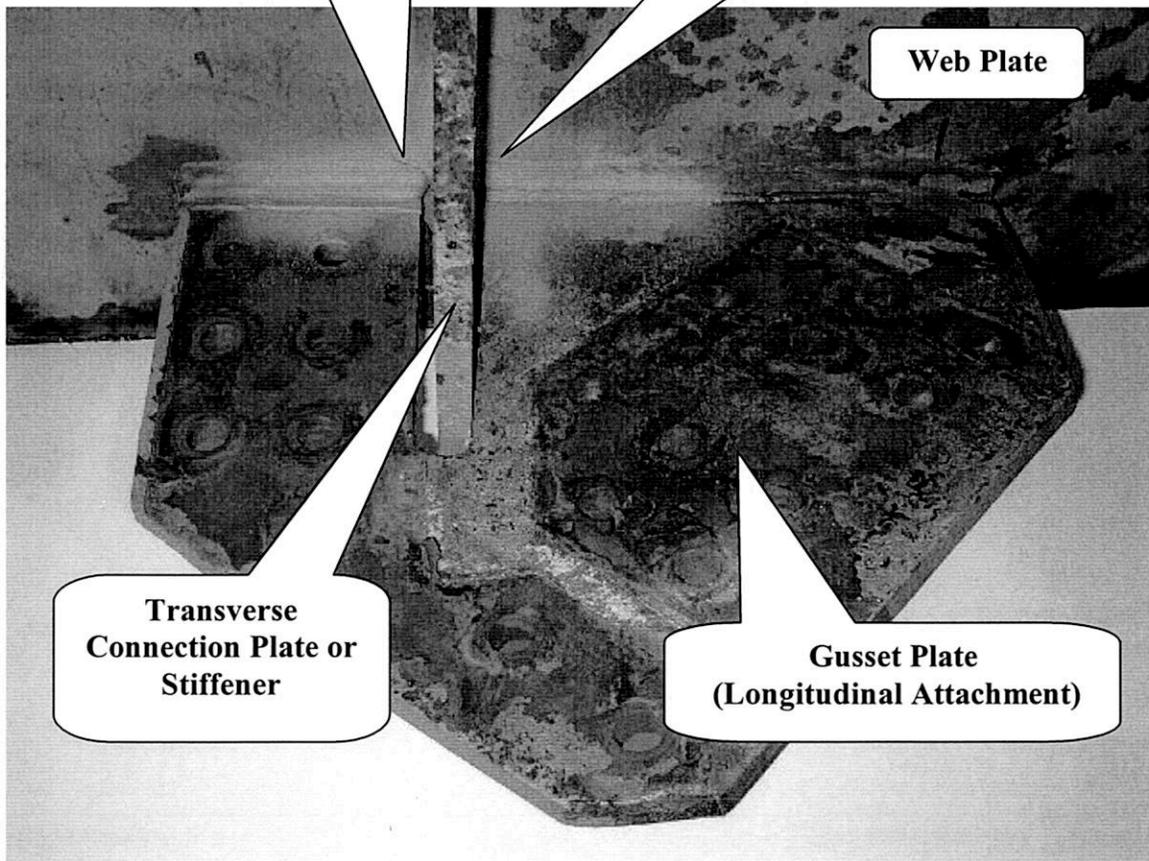
**Figure 3** Examples of contact between longitudinal and transverse welds.

The results indicate that the case where the welds touch or intersect has a much higher constraint level than the case where there is a small gap between welds. This indicates that touching or intersecting welds in the web gap area should be considered an indicator of possible constraint problems. Intersecting welds also increase the likelihood that weld defects will be present in the web gap area. Even a small gap appears to be sufficient to relieve constraint and reduce the vulnerability to fracture.

Figure 3 shows a typical gusset plate detail from the Hoan Bridge with the lateral bracing removed. Typical examples of touching and intersecting welds are shown in the insets. In addition to gusset plates, any detail where longitudinal web attachments come close to transverse attachments should also be considered vulnerable to constraint problems. At the present time, any details where longitudinal and transverse plates terminate close together in should be examined for intersecting and touching welds. This only applies to sections of the structure where there is a net tensile stress due to the combination of all loads. Details in areas of compressive stress will not be vulnerable to fracture.

Retrofit options can include hole drilling and/or grinding to separate the welds and eliminate the weld intersection. This option needs to be performed with caution, since widening the web gap can make the connection more flexible and vulnerable to distortion-induced fatigue.
