The following Questions (Q) and Answers (A) were generated to support the implementation of Technical Advisory (TA) 5140.32, "Inspection of Fracture Critical Bridges Fabricated from AASHTO M270 Grade 100 (ASTM A514/A517) Steel," dated September 12, 2011.

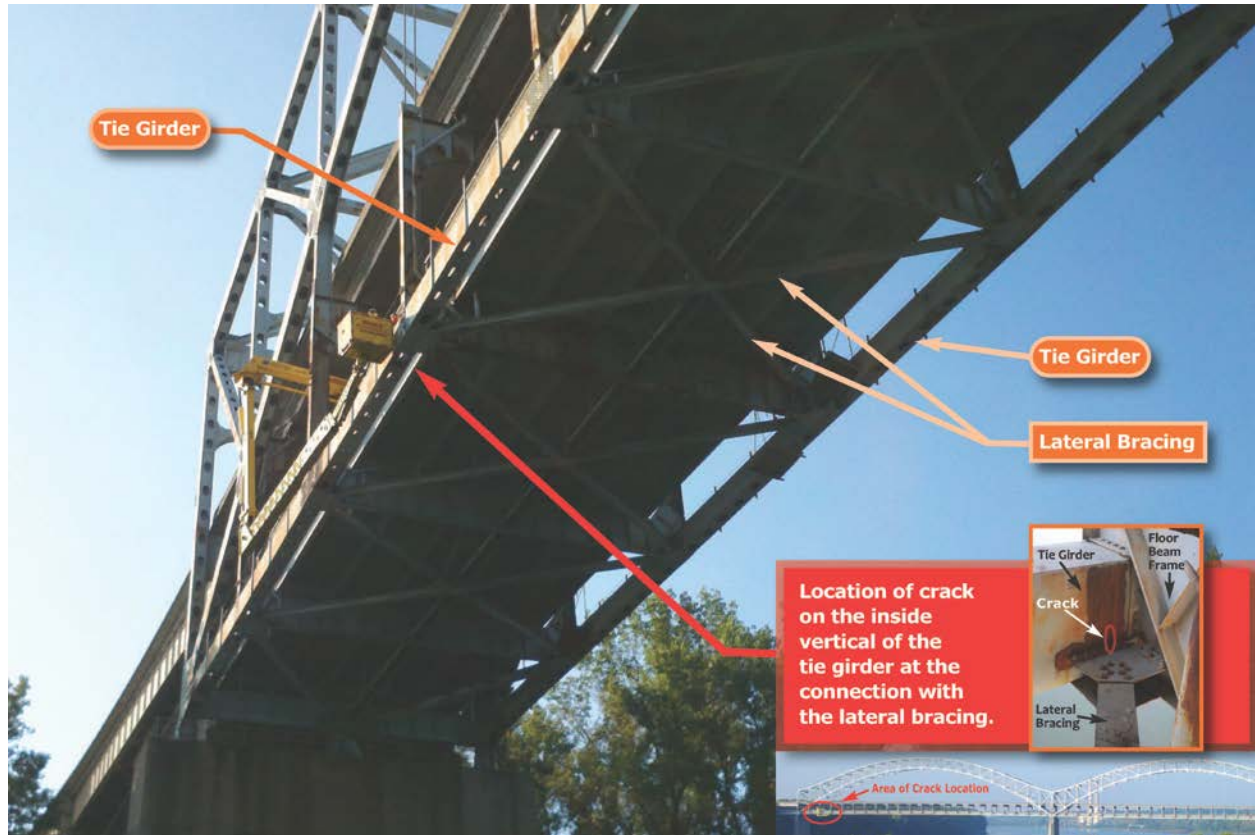
During follow up special inspections of the structure in the spring and summer of 2011, it was determined that these cracks were caused by hydrogen captured in the molten metal during the welding process. A more rigorous and expanded inspection found many more cracks in the butt welds and fillet welds of the tie and in the groove welds connecting elements to the tie. The most significant of these cracks are located in the butt welds. Many of these cracks have been removed and studied and the results have all indicated the same cause; lack of hydrogen control during fabrication. The tension ties were fabricated from T-1 steel, which is very susceptible to this type of cracking. The accompanying document titled "How to Weld USS T-1 Steel" published by U.S. Steel Corporation (USS) provides a very plain language explanation of this phenomenon.

surface breaking crack was found that, based on its size, orientation and location, resulted in the closing of the bridge. The location of this crack can be seen in the inset of Figure 1.

Figure 1. Location of crack initially responsible for closing the Sherman–Minton Bridge.

In response to this new information, INDOT initiated a retrofit project that included addressing the surface breaking cracks in the tie butt welds and fillet welds, removing the groove welds and replacing them with a bolted connection and better characterizing all the butt welds with either RT or a high-energy X-ray technique to determine which butt welds would need retrofitting. During the removal of one of the groove welds which passed horizontally over a vertical butt weld in the tie, an approximate 2½ inch

It is also important to note in the ongoing management of this structure that, to date, no cracking found in or on the tie has originated in the base metal or as a result of fatigue. This fact has contributed to the retrofit strategy that was chosen to bring the bridge back into service. That strategy includes tactically locating crack arrest details into the existing plates of the tie, in addition to adding new steel plates along the entire length of the current tie side plates providing what is essentially a new tie.

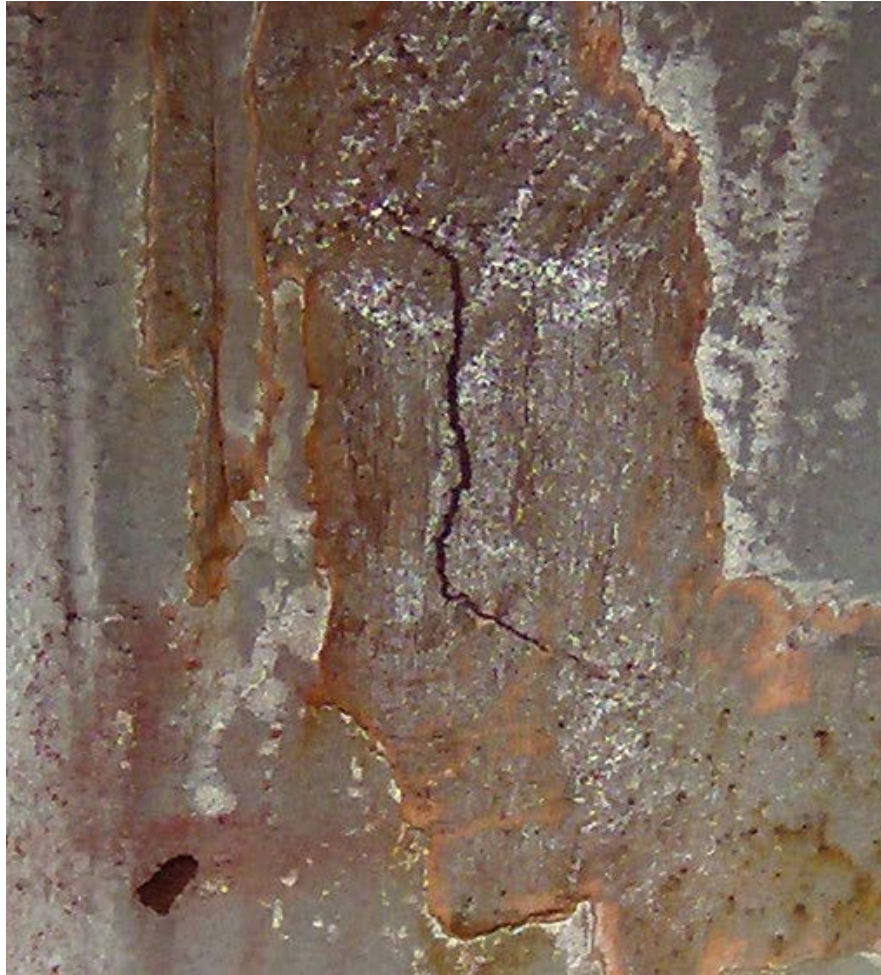
It should also be noted that (INDOT) was operating on incorrect advice from a consultant responsible for the inspection of the Sherman–Minton Bridge. Large surface breaking cracks found in the welds of the tension tie as early as 30 years ago were not classified as critical findings and as a result not appropriately addressed [see Figure 2].

Figure 2. A crack measuring approximately 2 1/8 inches long by 1 1/4 inches deep in the side plate of the south tie of span 2 of the Sherman-Minton Bridge.
