MISSOURI STATE HIGHWAY PATROL ACCIDENT RECONSTRUCTION REPORT

| Date of Report: | October 27, 2011 |

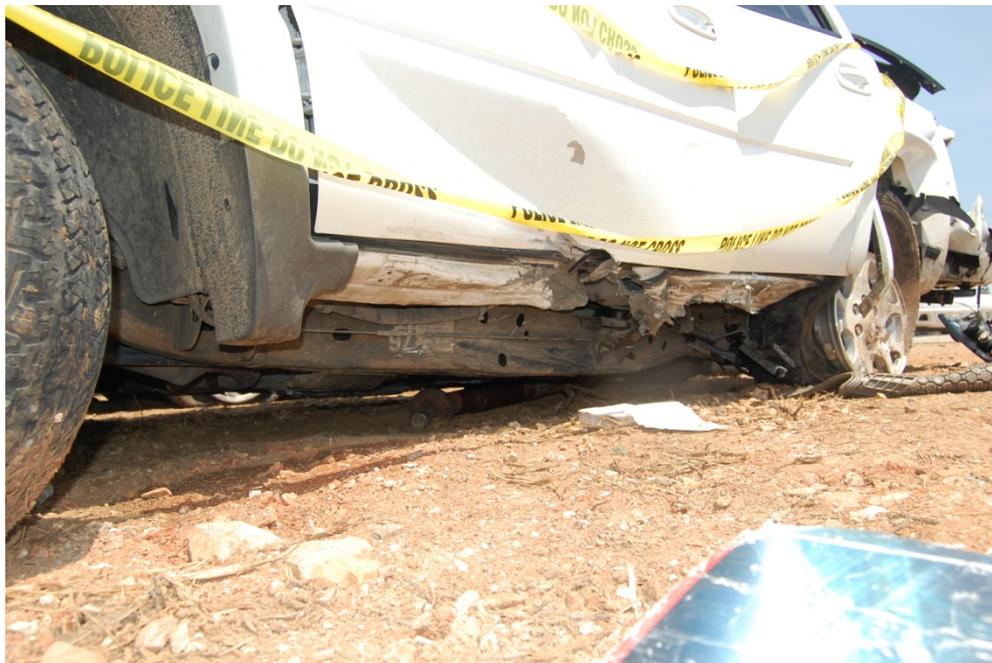
DSC_0022.jpg

On August 1, 2011, I examined vehicle # 1 at Jack's Towing in Waynesville, Missouri. Vehicle # 1 sustained damage to its driver's side rocker panels and the lower portions of the driver's side entry doors from its initial impact with the guardrail.

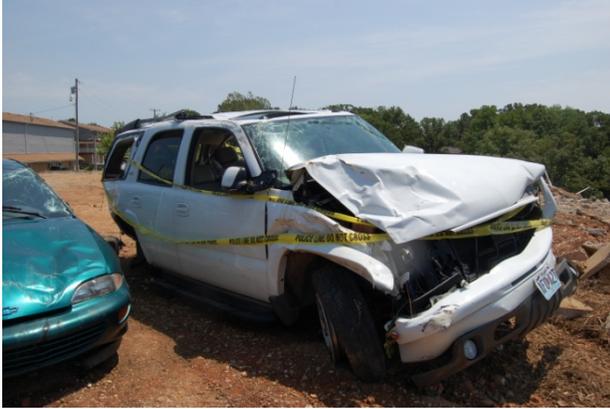
DSC_0017.jpg

Most of the remainder of vehicle # 1 sustained contact and induced damage as it traveled down the embankment and overturned.

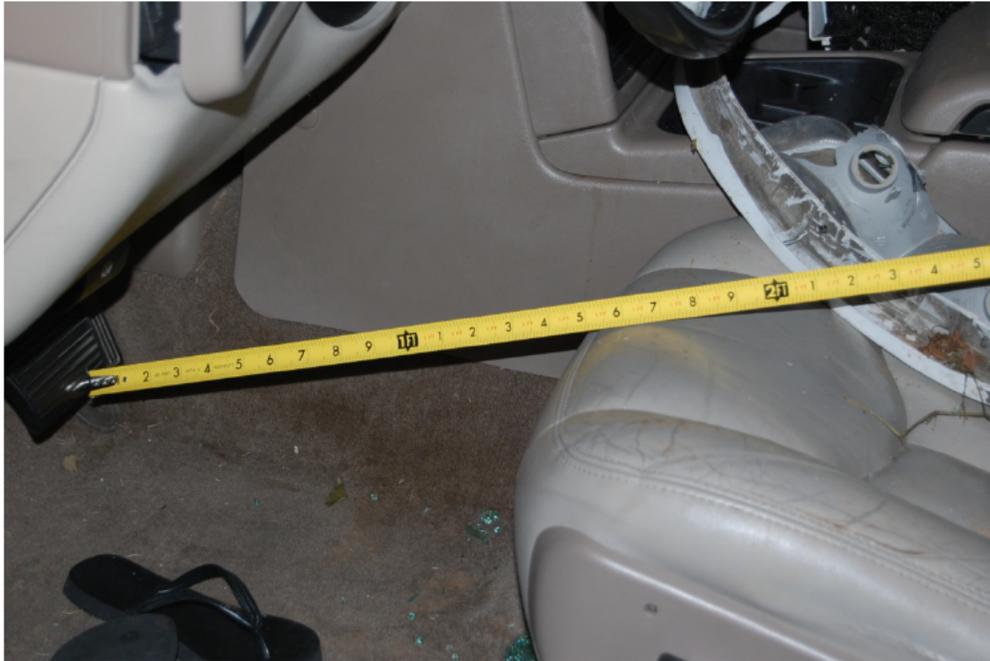
DSC_0052.jpg

Sergeant Suhr and I also measured the distance from the front of the driver's side front seat to the brake pedal with an engineer's tape measure. That distance was approximately 1.5 feet.

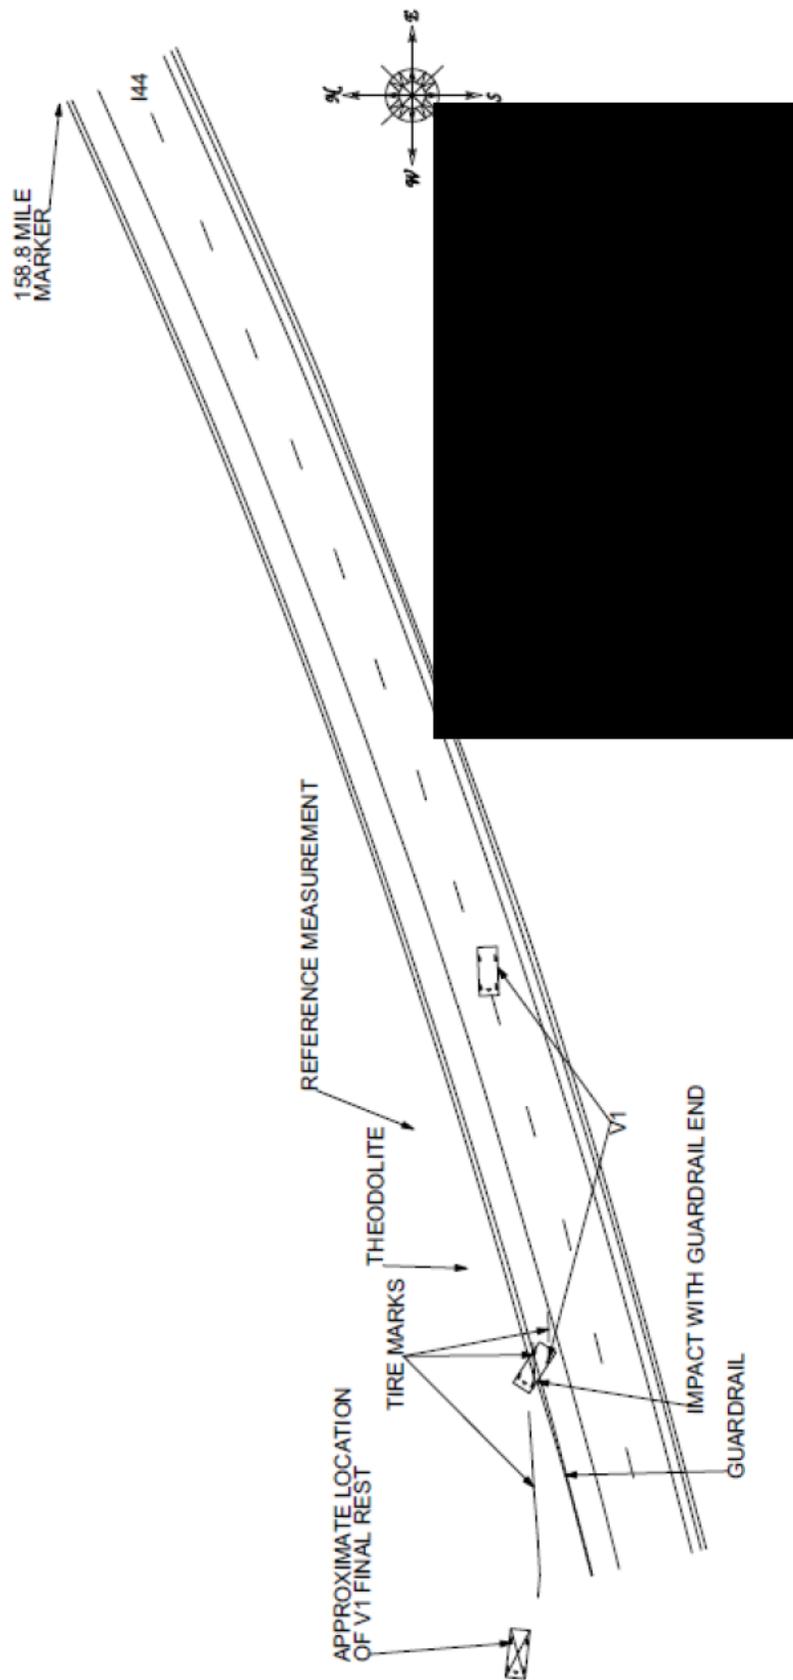
Appendix III - Forensic Map

Using the forensic map I generated with the data gathered with the total station, and my CAD drawing program, I drew a line from point #124, a point shot to document the location of the 158.8 mile marker sign to the westbound inner fog line. That line will be referred to herein as the "reference line" and will be used to describe east and west measurements. The westbound outer fog line will be used to reference north and south measurements. Measurements to the "reference line" and to the fog line are perpendicular. All measurements are approximate.

Vehicle # 1 made a pre-impact tire mark with its driver's side rear tire that first became visible 442.8 feet west of the reference line, 0.5 foot north of the westbound outer fog line. It was no longer visible 452.1 feet west of the reference line, 3.0 feet north of the westbound outer fog line.

Vehicle # 1 made a pre-impact tire mark with its driver's side front tire that first became visible 450.2 feet west of the reference line, 8.2 feet north of the westbound outer fog line. It was no longer visible 464.6 feet west of the reference line, 12.6 feet north of the westbound outer fog line.

As vehicle # 1 traveled off the north side of the roadway it struck a guardrail. The easternmost guardrail post was 462.9 feet west of the reference line, 10.5 feet north of the westbound outer fog line.

Vehicle # 1 made a tire mark after it struck the guardrail that first became visible 471.1 feet west of the reference line, 16.0 feet north of the westbound outer fog line. It was no longer visible 530.1 feet west of the reference line, 29.2 feet north of the westbound outer fog line.

Vehicle # 1 came to rest on its top at the bottom of a steep embankment. Its exact final rest location was not marked, but the approximate locations of its front and rear were marked on the ground above the embankment. The rear of vehicle # 1 was located approximately 543.5 feet west of the reference line while its front was located approximately 552.5 feet west of the reference line.
