MISSOURI STATE HIGHWAY PATROL CRASH RECONSTRUCTION REPORT

Original Investigating Officer:	Trooper Q. D. Bland,
Troop Reconstructionist(s):	
Assisting Officer(s):	Sergeant G. Q. Billings
Assisting Agency(ies):	
Level IV Reconstructionist(s):	Corporal G. D. Ward
Date of Report:	April 5, 2013

Section I - Synopsis

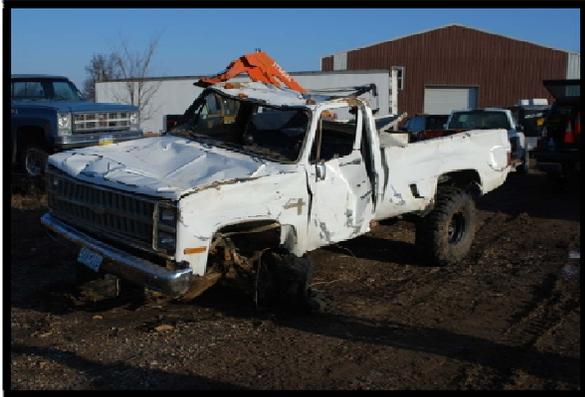
DSC_0009.JPG - Rollover Damage

The Vehicle #1 front bumper was partially detached, as was the right marker light. Both sides of the truck and its hood were crumpled. The roof was crumpled and forced downward. The frame was bent as was obvious by the large gap between the bed and cab on the right side of the vehicle. The truck's right tail light cover was completely detached. The front left wheel and suspension system were bent and pushed rearward into contact with the vehicle body. The front left tire was deflated and displayed a large rip in the outside sidewall of the tire, attributable to striking the bridge rail end. All other tires remained inflated. Both front tires were worn smooth near the center of the tire tread pattern. All of the truck's glass was gone except for the right door glass.

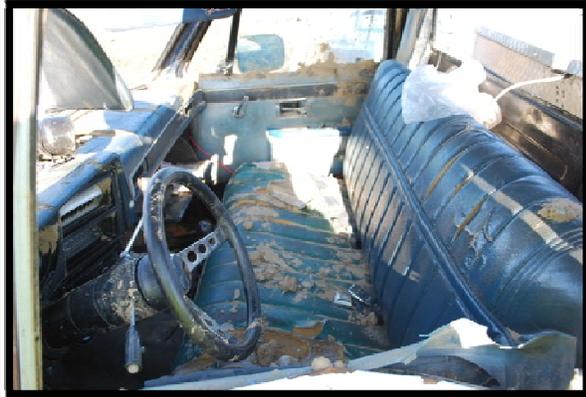
DSC_0016.JPG - Water Damage and Debris

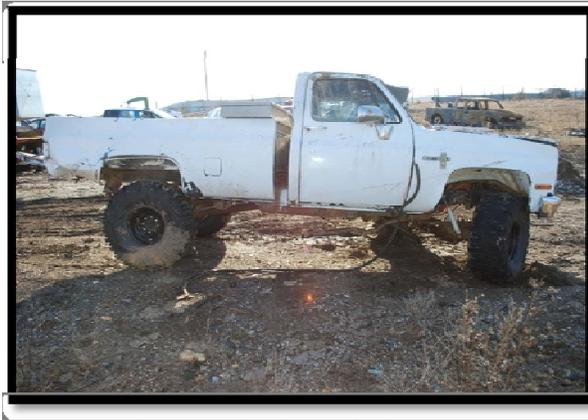
DSC_0004.JPG - Gap Indicating Bent Frame

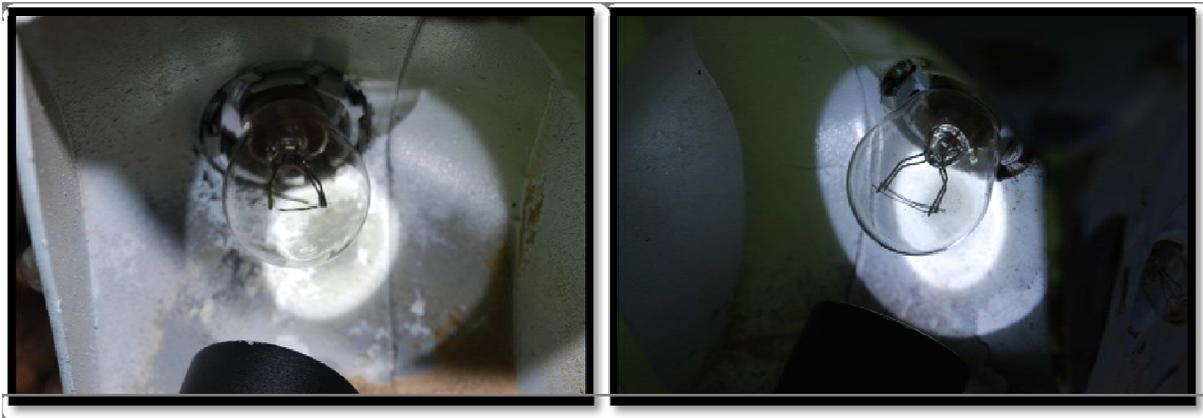
Inspection of the Vehicle #1 taillights indicated the brake lights were not activated at the time of the crash, due to the lack of hot shock in the brake light filament considered in conjunction with the lack of skid marks at the approach to the bridge.

DSC_0024.JPG - Left Rear Taillight Bulb

DSC_0021.JPG - Right Rear Taillight Bulb
