Guardrail Terminal Crashes Reconstructed by both Missouri and FHWA

Additional Guardrail Terminal Crashes Identified by Motorists in Missouri

Additional Guardrail Terminal Crashes Identified by Missouri DOT Officials

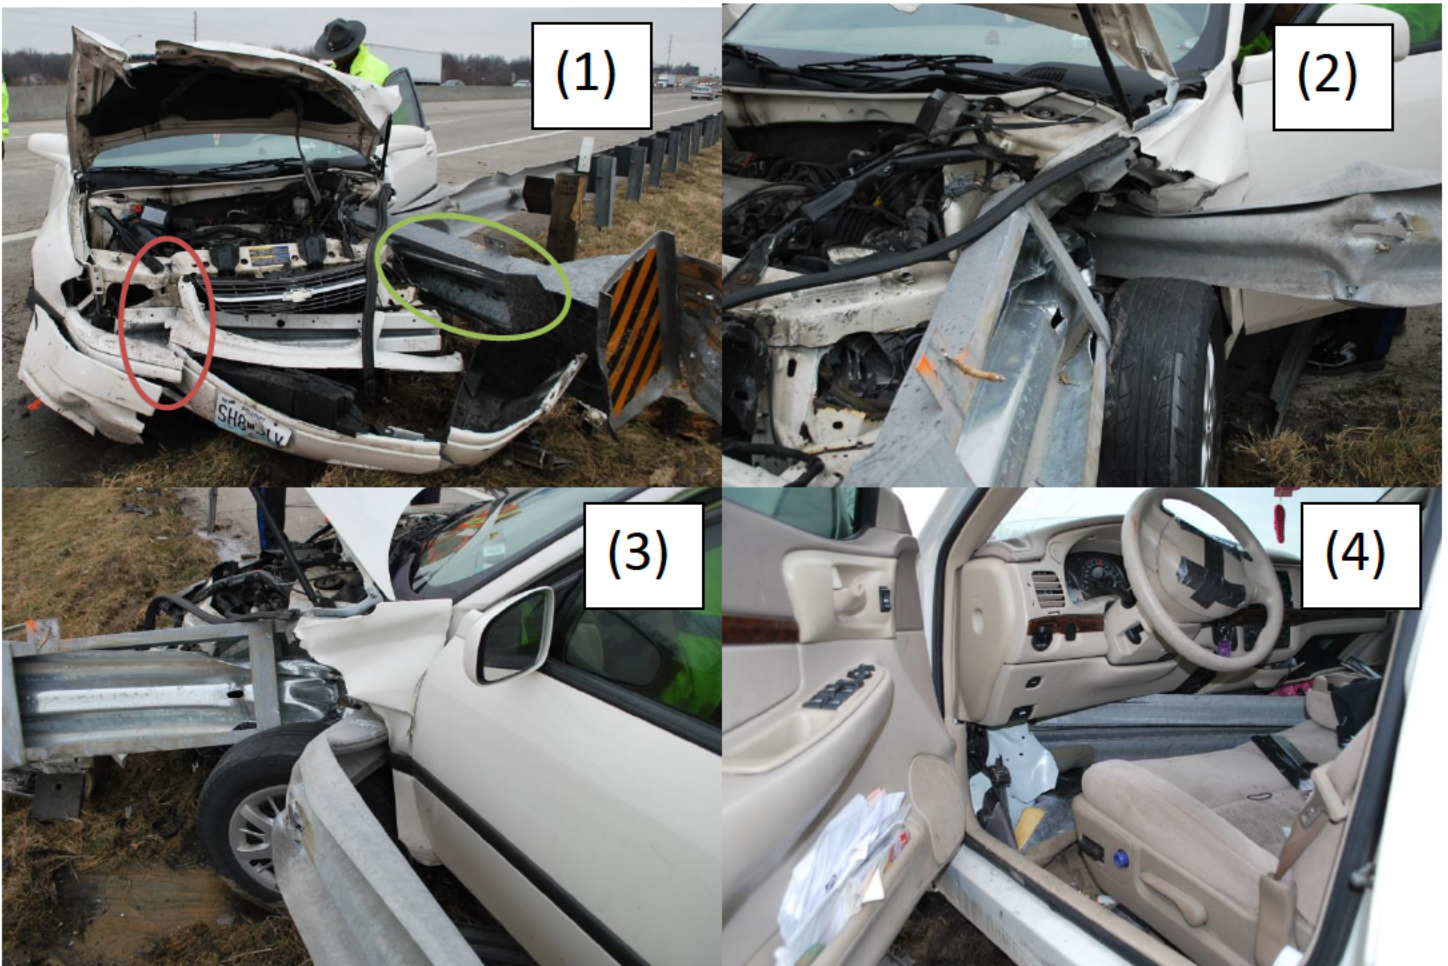
Description: A 4" ET-Plus was struck at nearly head-on conditions. Gating did not occur since the vehicle came to rest nearly adjacent to the guardrail system. The vertical teeth of the ET-Plus engaged the vehicle on the front bumper near the passenger side, circled in red in picture 1. This caused the vehicle to yaw with the rear of the vehicle rotating back to the road. Approximately 15 to 20 feet of rail was extruded. An abrupt buckling in the rail occurred once the yawing reached a critical limit. There is also evidence that the guardrail locked up since it is slightly protruding out of the traffic-side widow (green circle). Once the buckling occurred, the terminal head folded over, leaving an exposed elbow in the rail. Since the impact angle was low, the vehicle stayed relatively aligned with the guardrail, allowing the elbow to strike, and ultimately impale the occupant compartment. This crash was an "A" injury, where the victim sustained lacerations to the right leg.

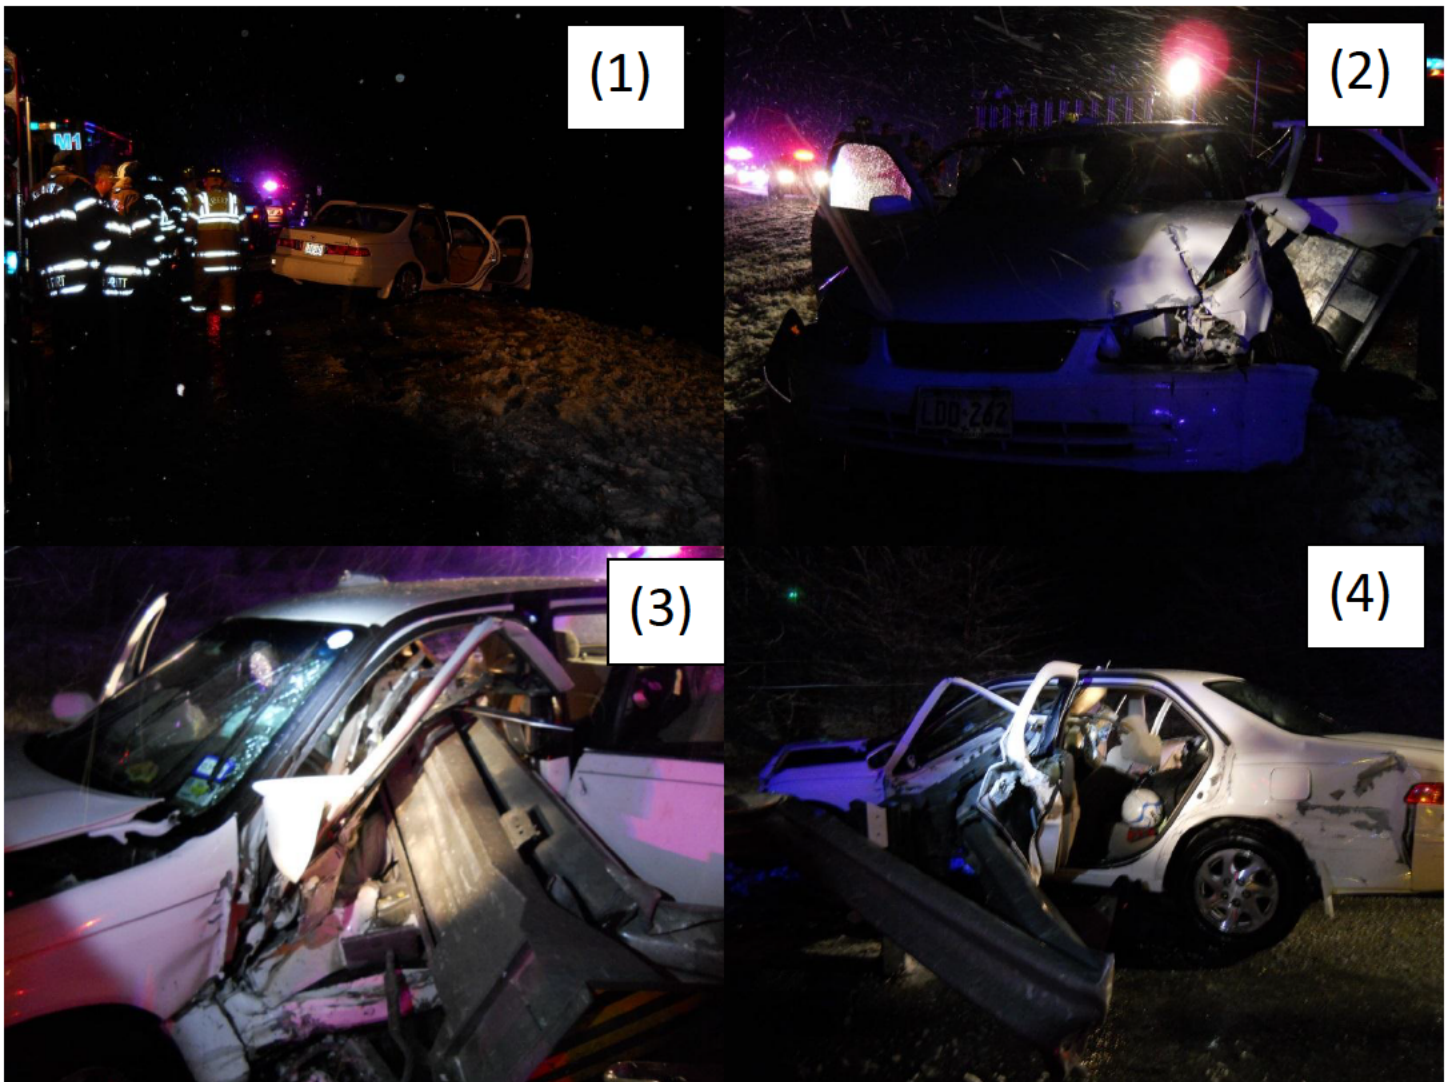
Description: A 4" ET-Plus was struck nearly head-on. The terminal did not gate, as evidenced by the vehicle being adjacent to the guardrail system (picture 1). The impact occurred on the driver's side of the bumper (picture 2) where the 15" footprint of the ET-Plus can be seen. Picture 3 shows no extrusion, and the anchor cable is in view. This indicates a very early buckle in the rail. In fact, numerous full buckles occurred almost immediately (see picture 4) indicating high levels of energy at the time of buckling (mode 2 and 3 buckling). Witness accounts indicated that the vehicle was sliding. This impact condition was supported by the relative angle made by the footprint in picture 2. However, the impact was still low angle. Upon buckling (almost immediately), the newly-formed elbow in the rail penetrated the occupant compartment through the driver's door. The driver was struck by the elbow and killed immediately.

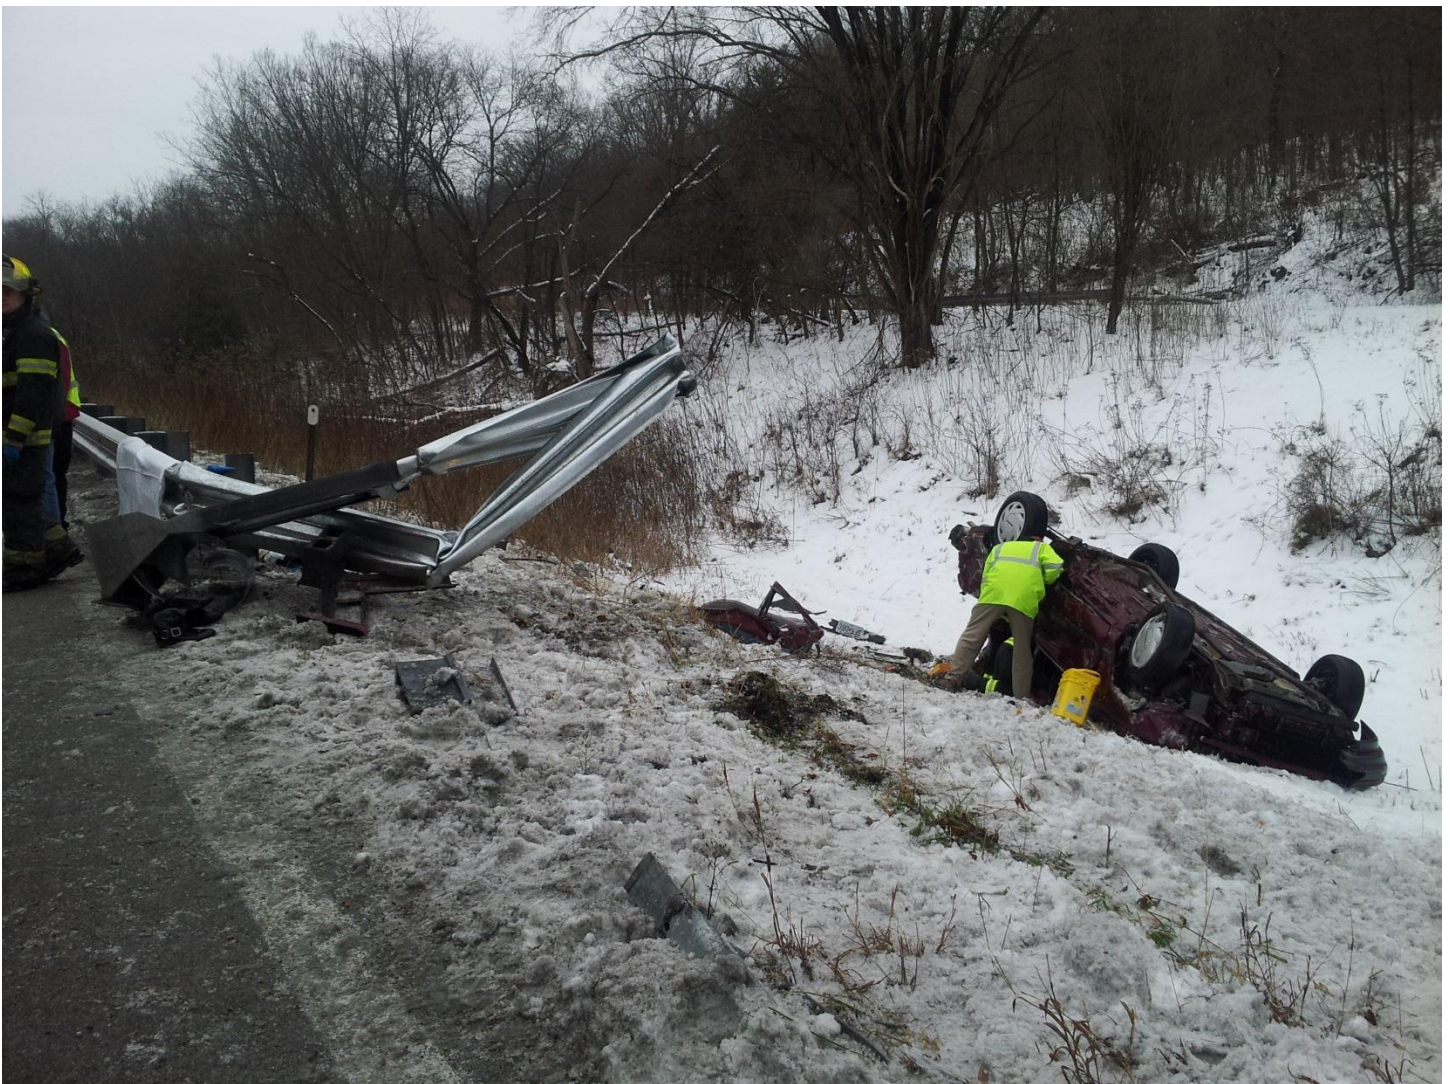
Description: A 4" ET-Plus terminal was struck wherein approximately 4 to 5 feet of rail was extruded. The guardrail buckled early in the event, and some part of the guardrail system struck the rear door on the driver's side, partially penetrating the compartment. The subsequent impact between the door and the occupant in that seat lead to a fatality. It's unclear exactly where initial contact was made (either rear driver's side door or front left corner). The vehicle rolled over, killing one and injuring two others.

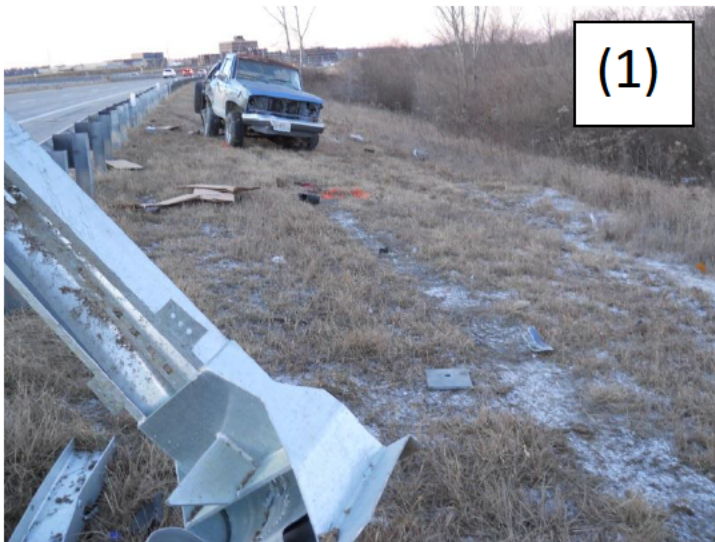
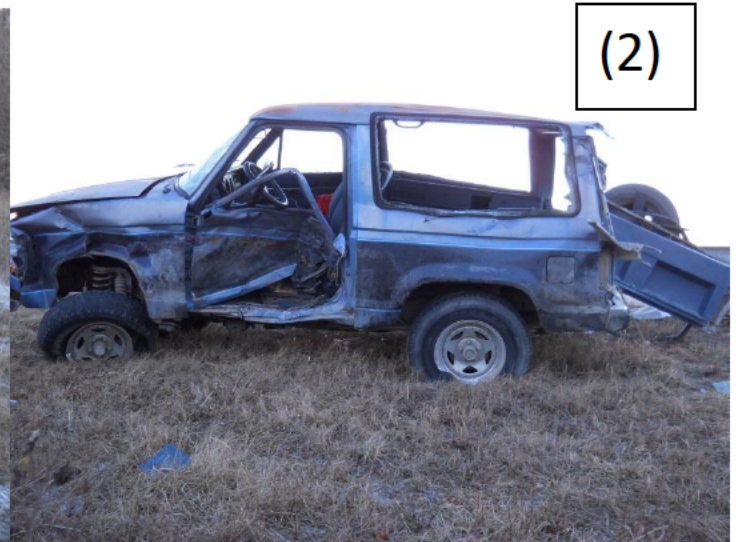
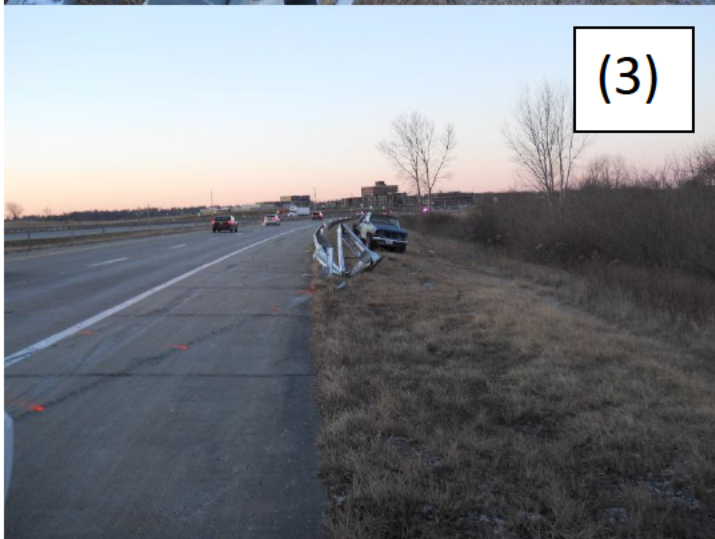
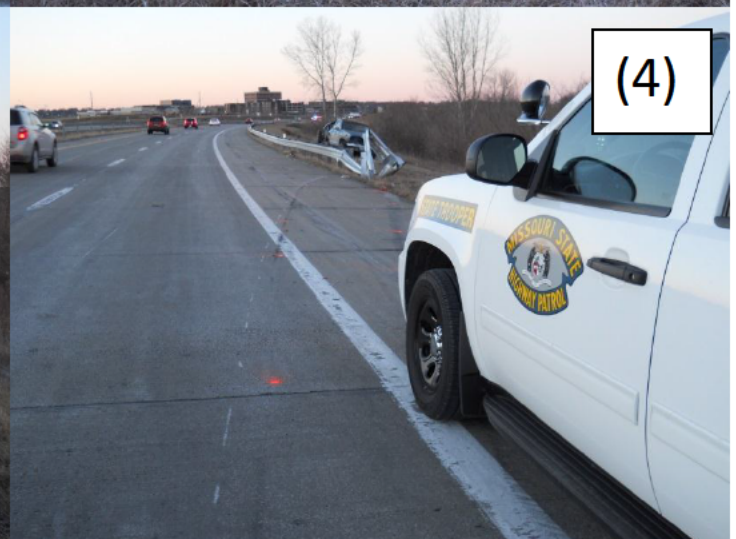
Description: This crash was reconstructed by the Missouri State Highway Patrol. A mid-sized sedan struck the Bronco, causing it to veer to the right and strike the end of a guardrail (4" ET-Plus). According to a passenger in the Bronco, they were sideways at the time of the impact, indicating that the terminal head struck the driver's door, partially penetrating the compartment and ejecting the driver out the back of the vehicle. The driver was killed and the passenger was injured.

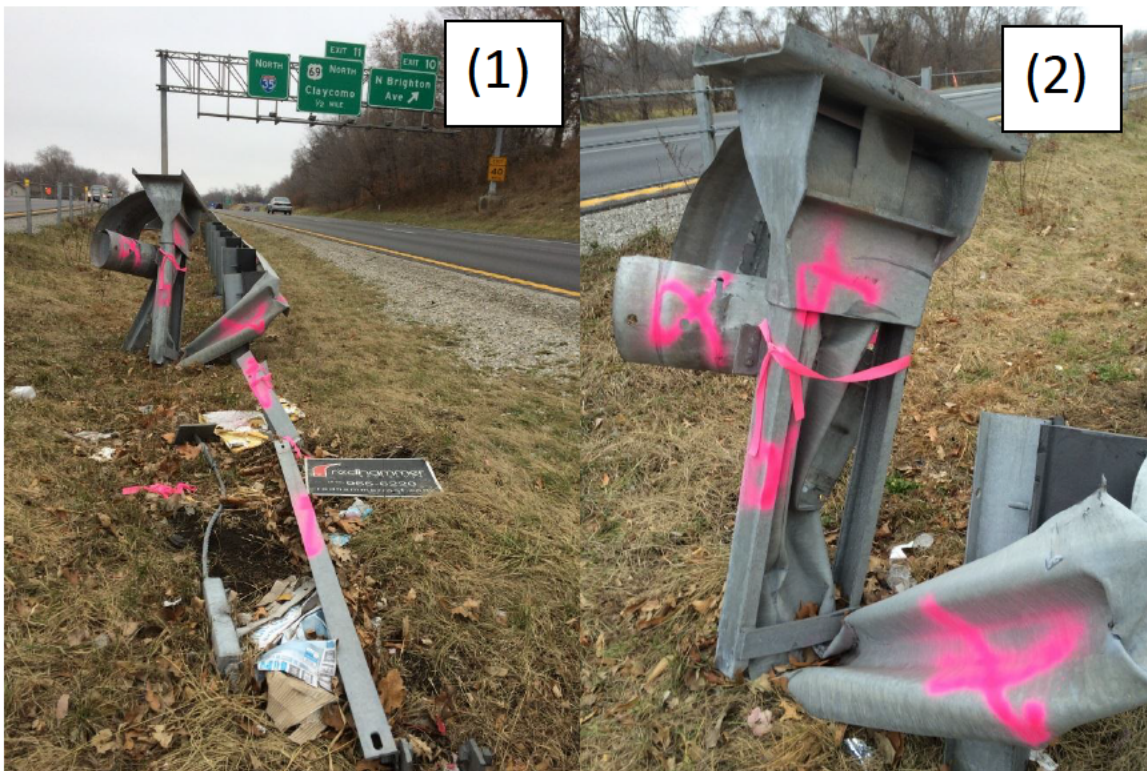
Description: This crash involved a 4" ET-Plus. It extruded approximately 5 to 7 feet. The guardrail inside the terminal but upstream of the squeezer plates appears to be substantially deformed (picture 2), indicating that the guardrail locked up inside the head.

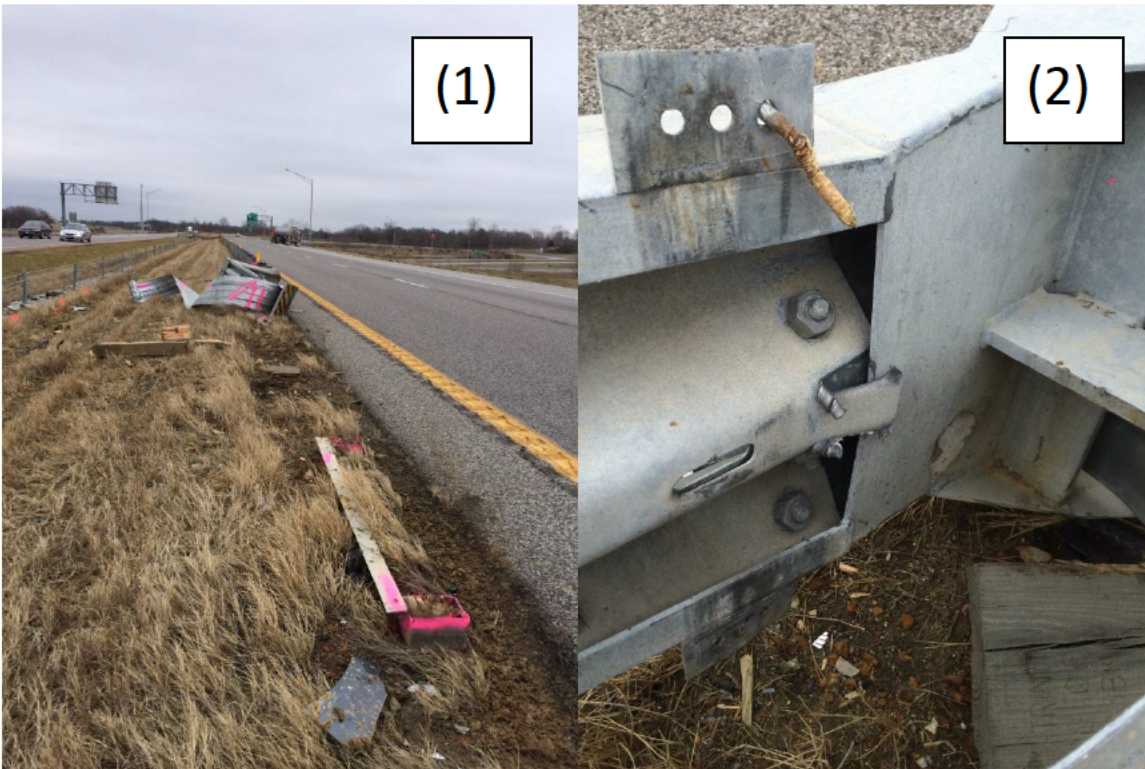
Description: This crash involved a 5" ET-Plus. It extruded approximately 25 feet. The leading edge of the second rail section was struck by the leading edge of the inlet to the terminal head (picture 2). This caused extrusion to stop and the rail to buckle.

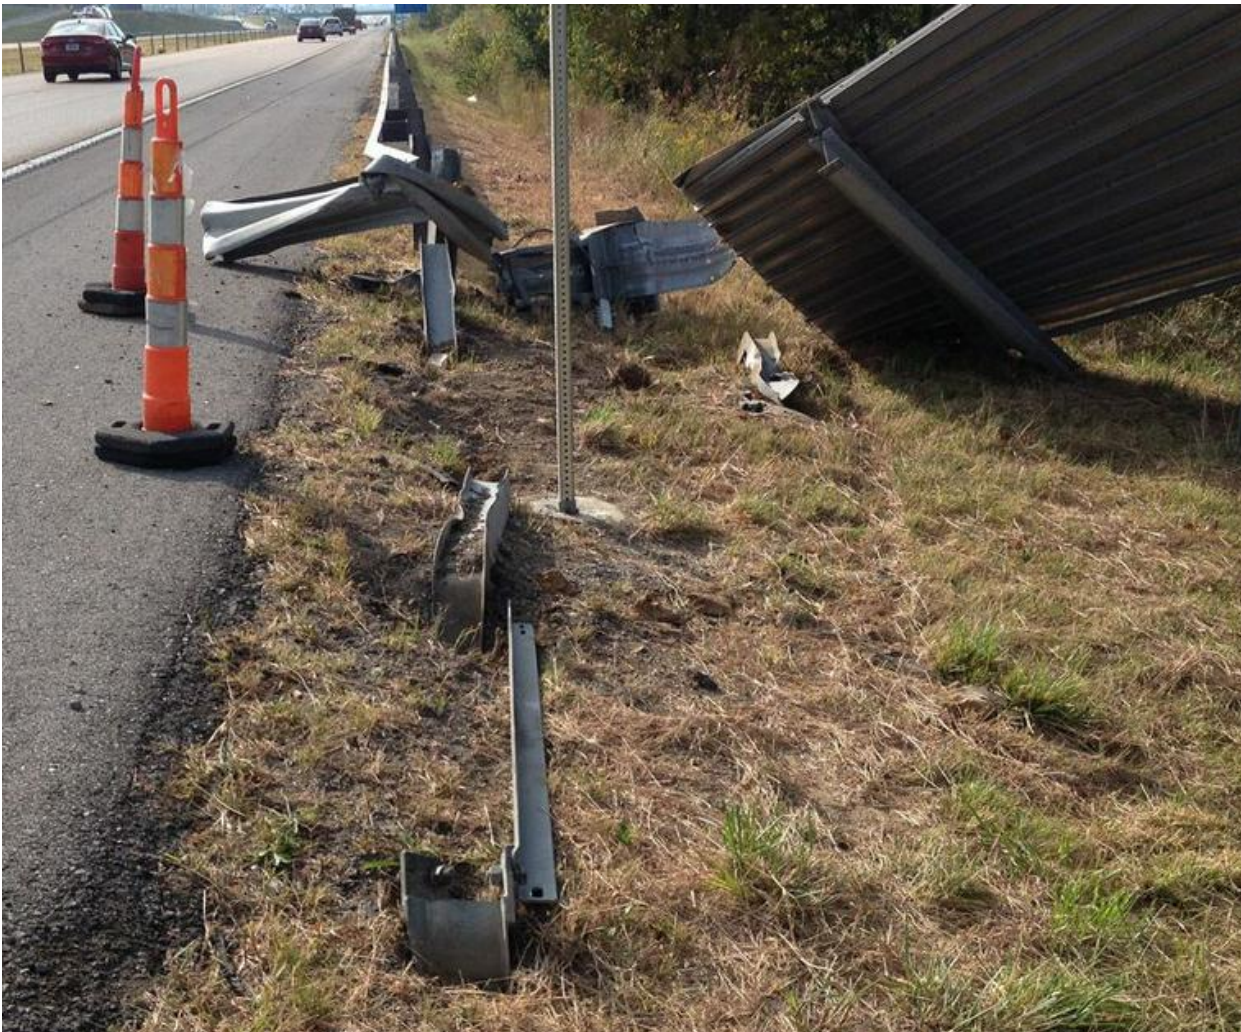
File: 1

Description: This crash involved a 4" ET-Plus. It extruded approximately 5 feet. Contact was most likely toward to the driver's side of the front bumper, considering the secondary impact with the sign support breakaway pole. The terminal head did not appear to extrude properly, and upon impact and subsequent seizing up, the rail buckled in numerous locations. The result of the impact was vehicular rollover, for which the driver sustained severe, "A" level injuries.

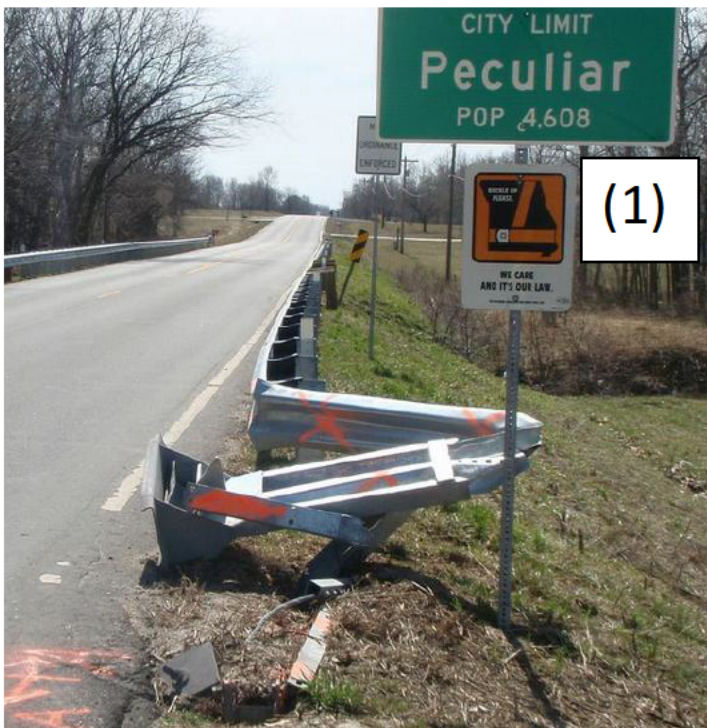
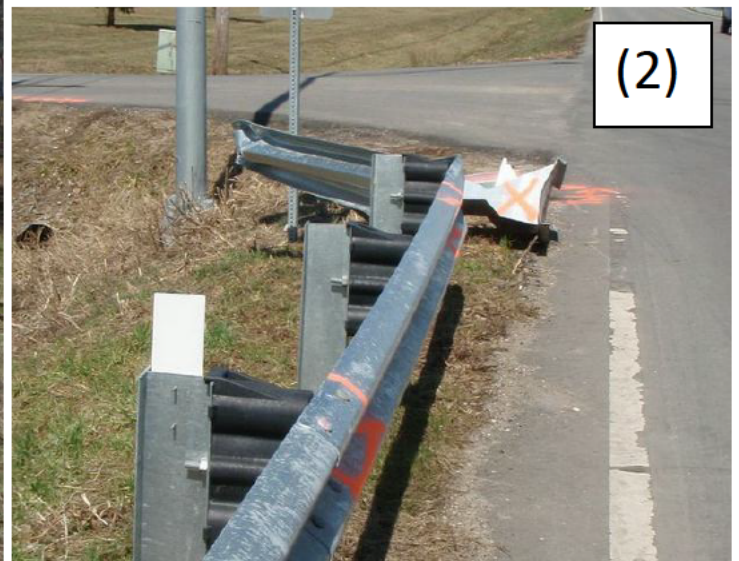
File: 2

Description: This crash involved a 4" ET-Plus. It extruded approximately 1 ½ feet. The HBA post and cable bracket are still near their original locations. This road has a posted speed limit of 45 mph, and this crash appears to be a low-speed event. However, there was enough resistance in the head of the terminal such that the energetically favorable mode was buckling in the rail. Therefore, this head locked up and did not perform properly. Note that the two buckles are opposing in direction, indicating that gating did not occur.

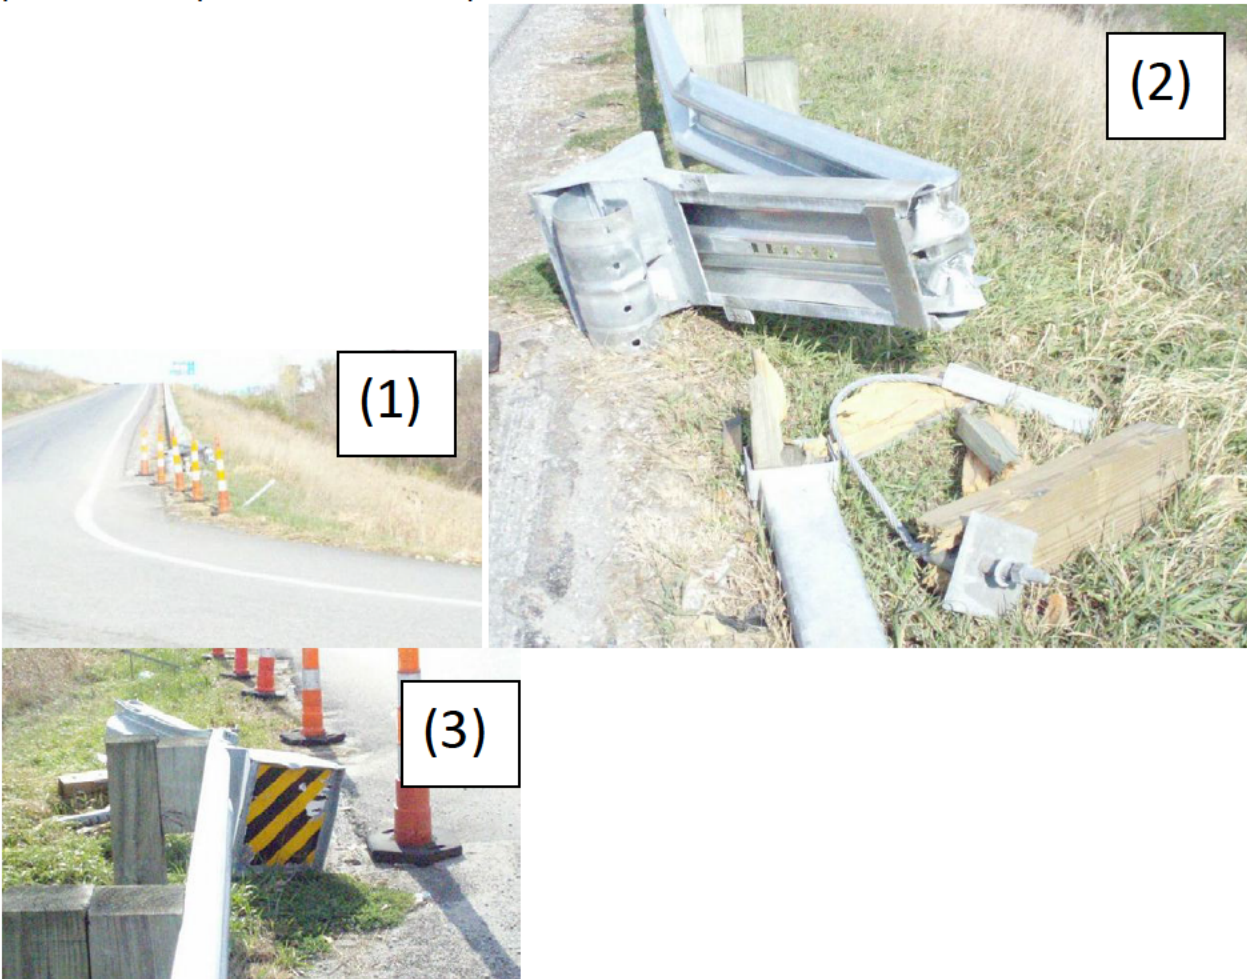
File: 3

Description: This crash involved an ET-2000. The rail extruded only about 2 feet, and the cable and bracket assembly are near their original locations. The extreme buckle in the rail immediately upstream of the leading edge of the terminal head indicates that this terminal was struck by a vehicle making a shallow right-hand turn onto the ramp. As such, the terminal gated in the opposite direction (relative to NCHRP Report 350 Test No. 3-30, for example). This terminal performed as expected under those impact conditions.

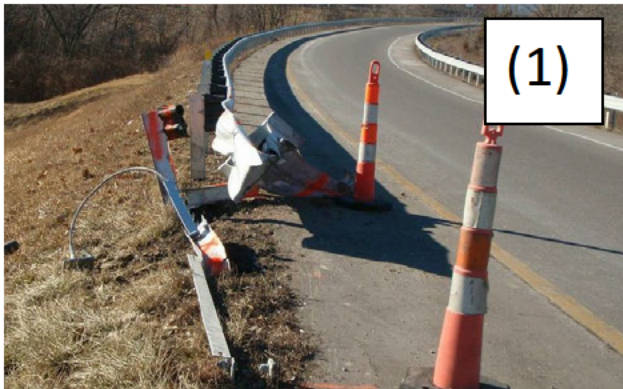
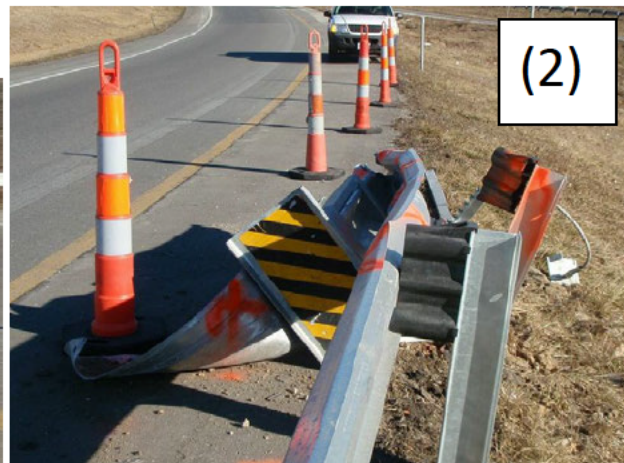
File: 4

Description: This crash involved a 4" ET-Plus. The driver lost control of his vehicle on ice and struck the end of the terminal. The rail extruded approximately 3 feet before the upstream guardrail buckled. The HBA post is on the traffic side of the remaining line posts and not far from its original location. This is a possible indication that the trajectory of the vehicle was angled back to the road rather than away from it. Upon impact, and after extrusion, the upstream rail first pushed post 3 backwards before the rail at post 2 buckled as the terminal gated. This appeared to perform properly. The occupant was unharmed, and the crash was listed as PDO.

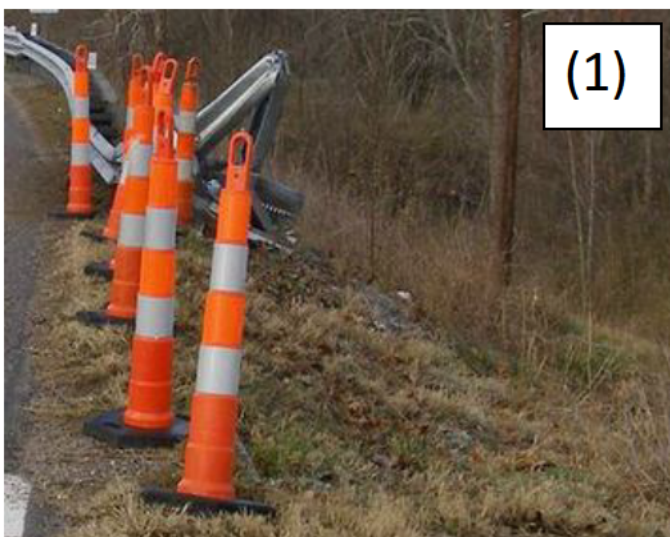
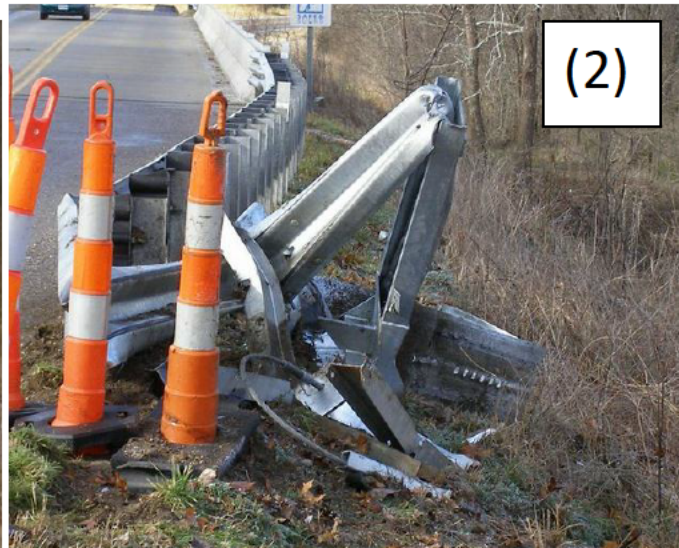
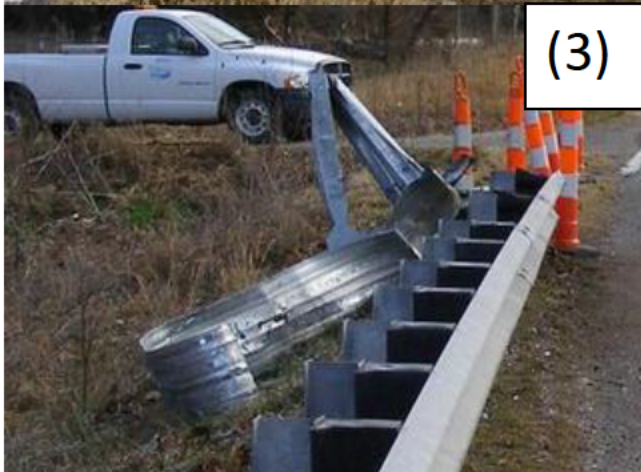
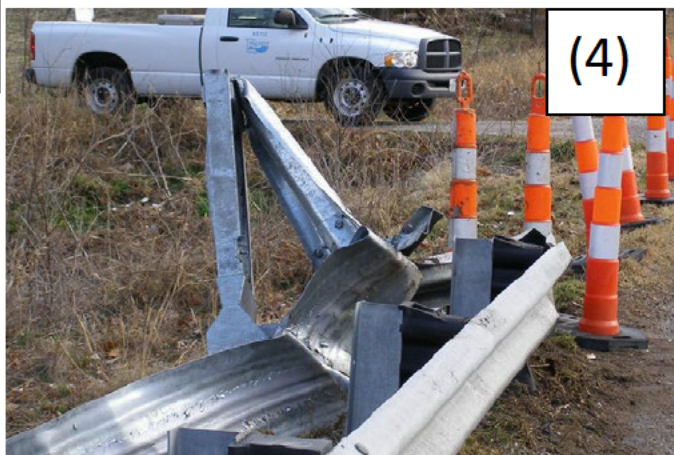
File: 5

Description: This crash involved a 4" ET-Plus. The guardrail extruded approximately 19 feet before the guardrail buckled ahead of the terminal. The vehicle rolled down the embankment shown in the photos. Knowing this, and seeing the deformation to the terminal, it is likely that the heavy vehicle had enough kinetic energy to continue on, up and over the terminal, leading to the instability that caused the rollover. There is some evidence of contact with the truck at the buckle immediately upstream of the terminal head (and with the terminal head itself). This indicates that the vehicle was partially speared and vaulted, but likely not penetrated. The driver fled the scene, and as such, the injuries were unknown.

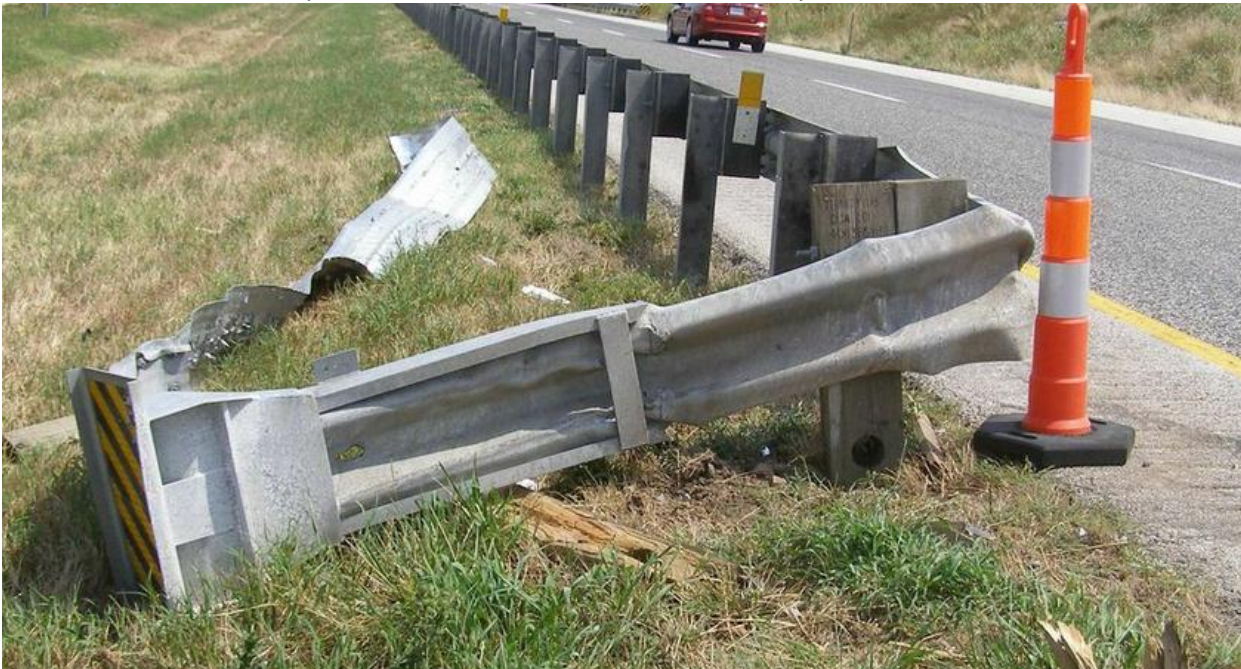
File: 6

Description: This crash involved a 4" ET-Plus. The guardrail extruded approximately 30 feet before the upstream guardrail buckled. The impacting vehicle came to rest in the road. This indicated that the impact was on the driver's side of the front bumper. The force of the impact cause the vehicle to spin out, as commonly seen in ¼ point offset, head-on crash tests. This terminal performed as intended. The crash severity was listed as PDO.

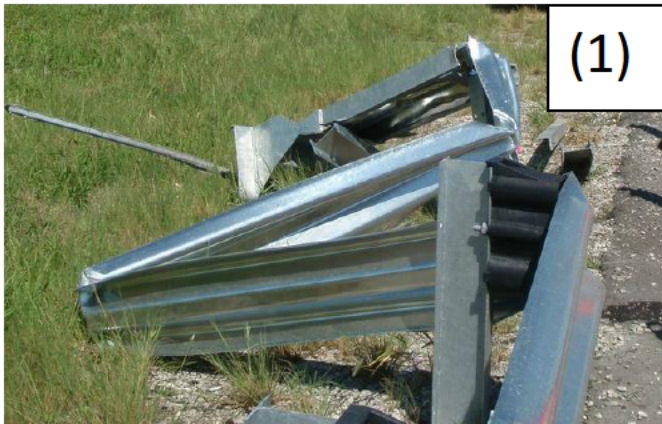
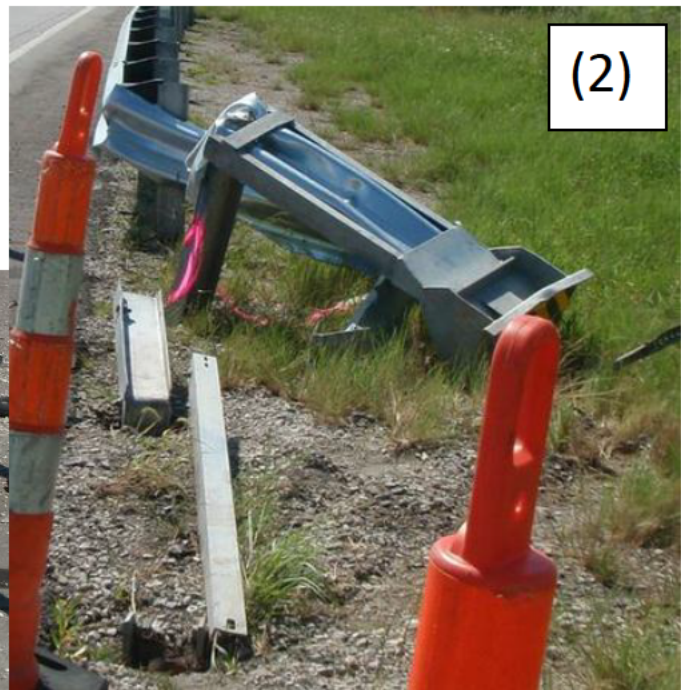
File: 7

Description: This crash involved a 4" ET-Plus. There was almost no evidence of any rail extrusion. The driver stated that he lost control, and the rear of his vehicle slid out from behind him. This indicates that the crash may have included a side impact although it is not explicitly stated in the crash report. However, the terminal did not extrude rail or gate (as evidenced by the fact that the rail has two opposing kinks). Also, the rail inside the window of the terminal head shows evidence of large compressive forces following rail lockup. Therefore, this terminal did not perform as intended. In fact, the vehicle overturned, leading to "B" level injuries.

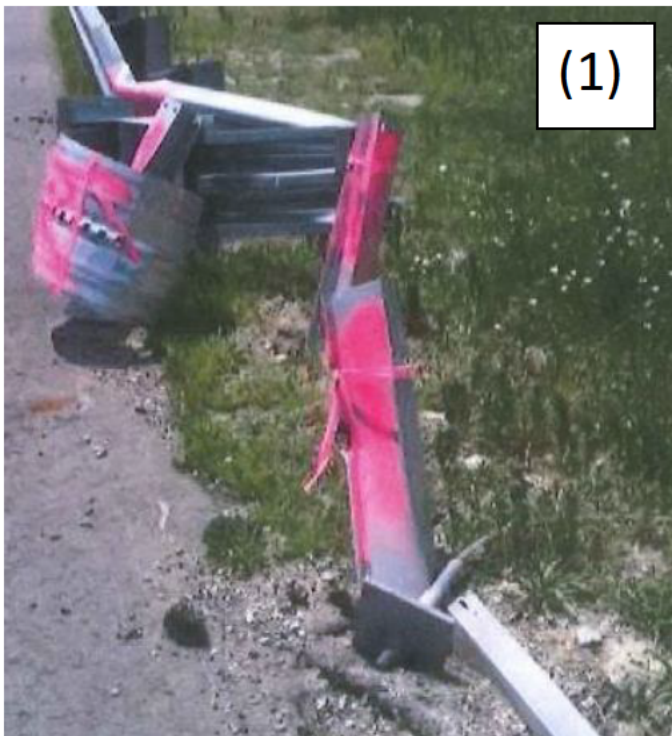
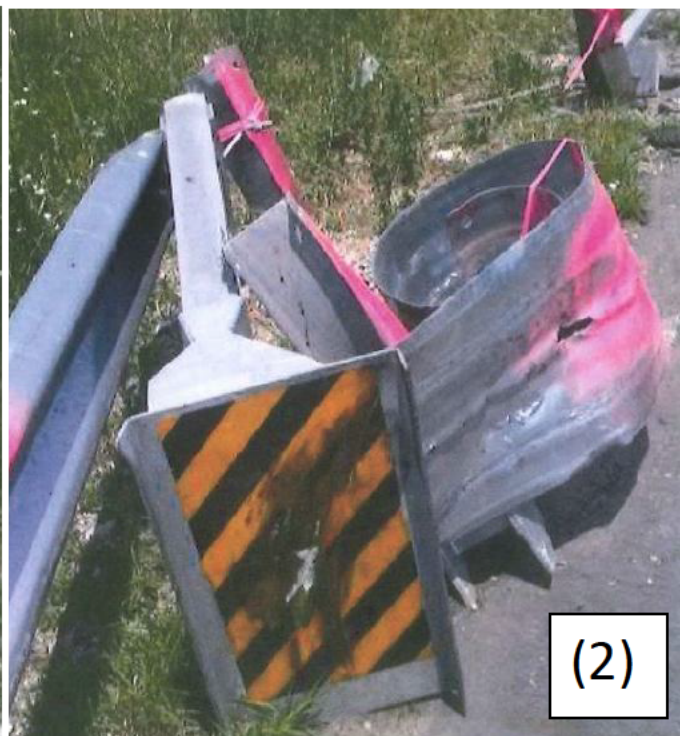
File: 8

Description: This crash involved a 4" ET-Plus. The rail extruded approximately 12 feet. The crash appears to have been close to head-on or a low angle impact. Initial impact was made on the passenger side front bumper. The offset of the impact location caused the vehicle to yaw counterclockwise, pushing the terminal head back to the road. Before the vehicle came to rest or passed in front the barrier, the rail ahead of the terminal buckled in two locations. However, without knowing more specifics of the crash, it would appear that the terminal performed properly.

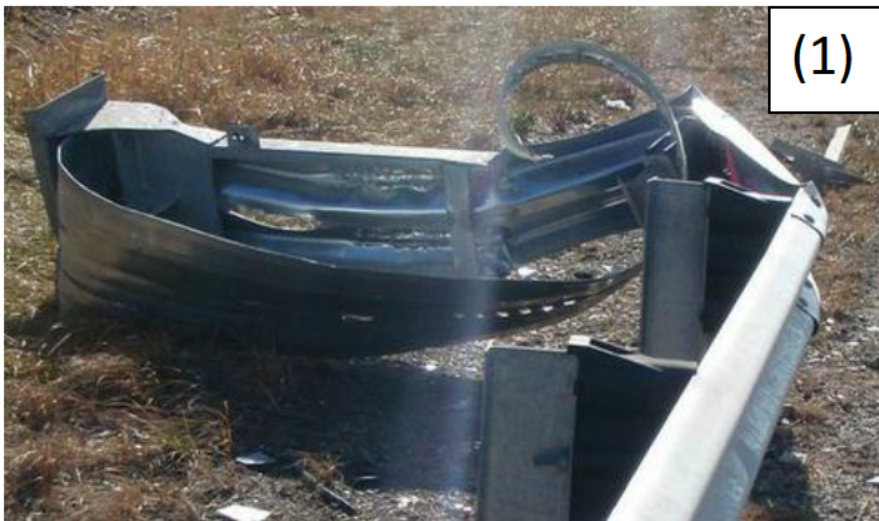
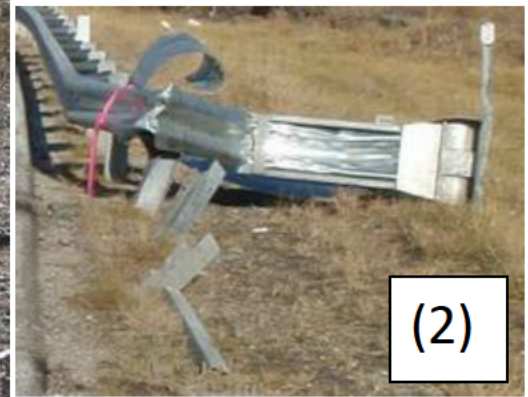
File: 9

Description: This crash involved a 4" ET-Plus. The rail extruded approximately 8 to 10 feet. The rail visible in the window of the terminal head is substantially damaged and includes a long tear. Therefore, this rail was likely locked in the squeeze plates, causing numerous modes of buckling in the flanges of the W-beam rail. Additionally, upon buckling and twisting relative to the vehicle, the guardrail in the window of the head could have been exposed to a hard point that may have cut the guardrail in the fashion depicted. This terminal did not function properly. The driver initially declined medical treatment, but revised that decision, prompting the officer to report "C" level injuries.

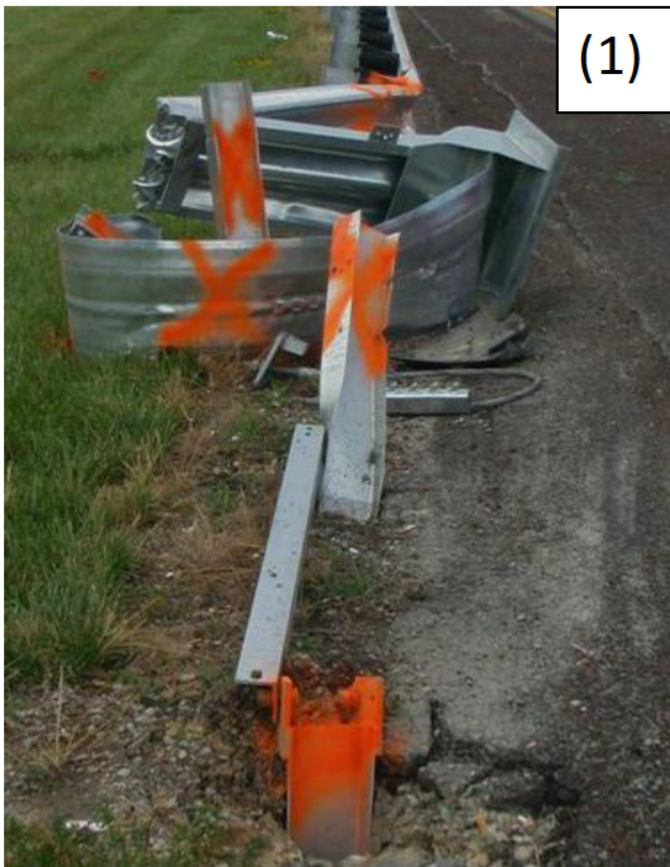
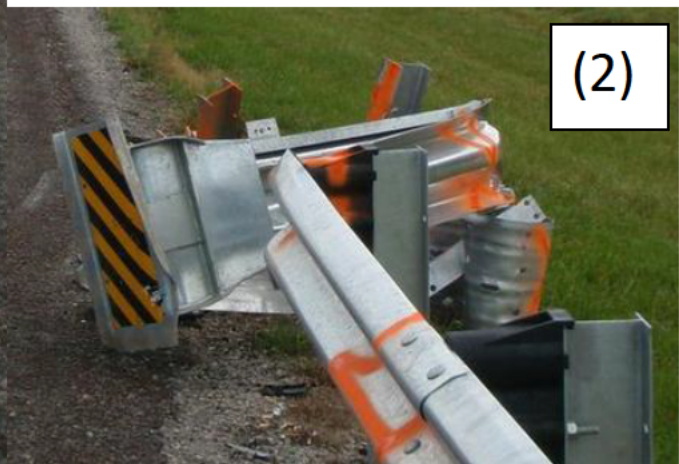
File: 10

Description: This crash involved a 4" ET-Plus. The rail extruded approximately 8 to 10 feet. The direction of the bent posts and the fact that the head has rotated back to the road indicates a low angle impact with contact on the passenger's side of the front bumper. This caused the vehicle to yaw clockwise, thus rotating the terminal relative to the upstream guardrail. Inside the window to the head, the guardrail has some non-contact deformation. This indicates that the rail seized up in the squeeze plates, leading to a premature buckling. This terminal appears to have not performed as intended.

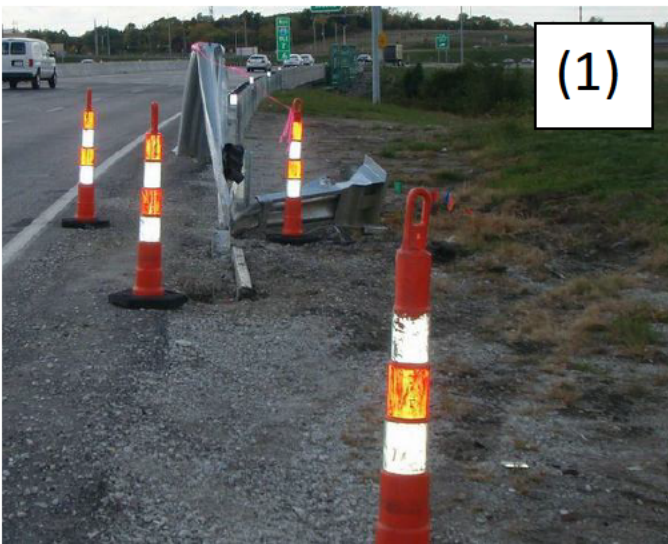
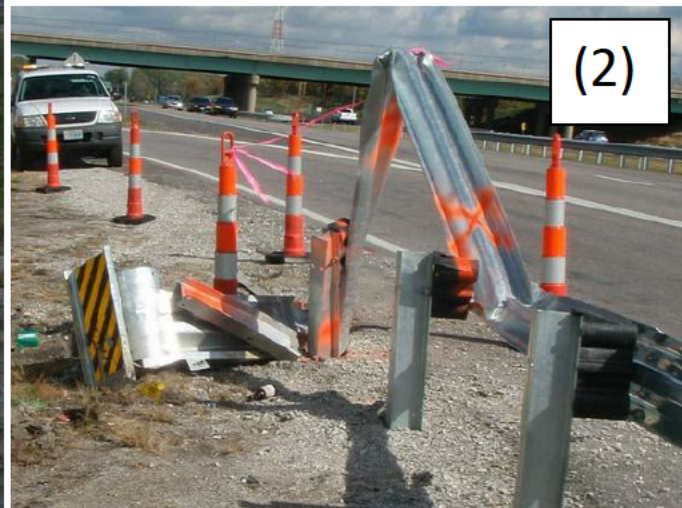
Description: This crash involved a 4" ET-Plus. The rail extruded approximately 2 feet. The scene and vehicle damage diagrams in the crash report indicate that this was a side impact crash. The tire marks in picture 1 could be from the impacting vehicle, but it could also be a first responder or a tow truck. In picture 1, the rail is buckled about a foot ahead of the upstream end of the terminal head. In the one-foot space, the guardrail exhibits a wavy deformation pattern, indicative of high forces. With 3 major buckling points, it appears that the terminal did not gate properly.

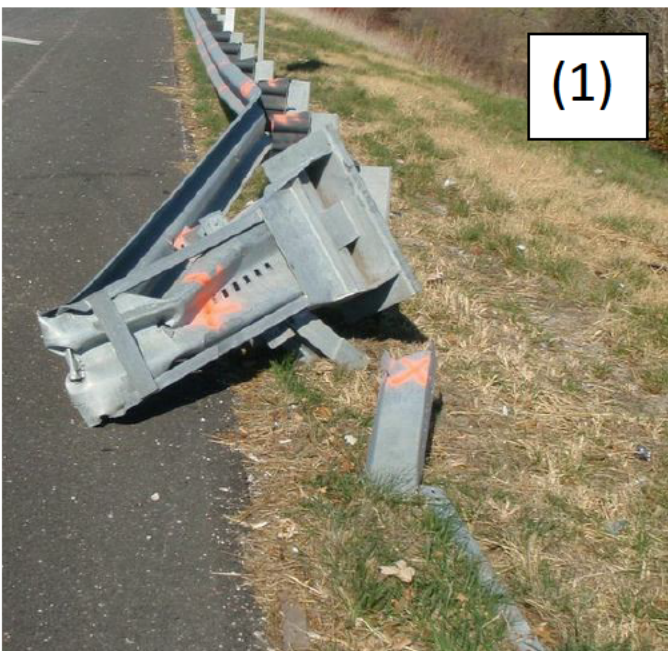
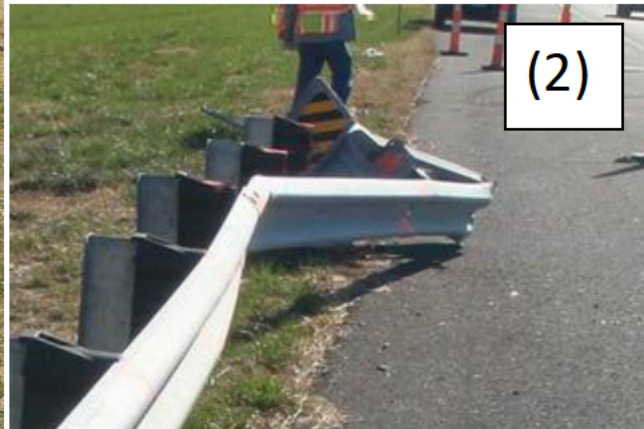
Description: This crash involved a 4" ET-Plus. The rail extruded approximately 4 feet, based on the location of the cable mounting bracket holes. Icy conditions led to the vehicle spinning out and, according to the scene diagram in the crash report, striking the guardrail end with the rear of the vehicle. There is a substantial amount of local buckling in the rail seen in the window of the terminal head. This would indicate high forces, indicating that the rail locked up. Therefore, this terminal did not perform as intended. The occupant was unharmed in the crash.

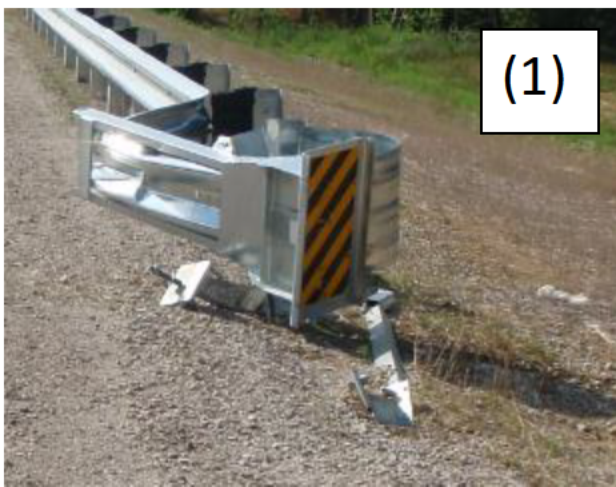
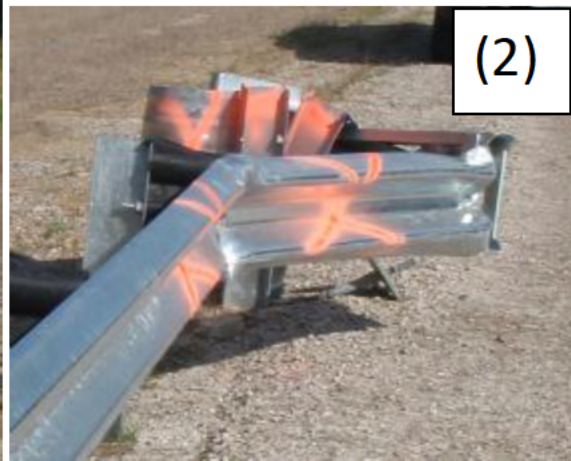
Description: This crash involved a 4" ET-Plus. The rail extruded approximately 4 feet. A tire on the impacting vehicle blew out, and according to witness accounts, this caused the vehicle to go off to the side of the road. Then, the vehicle traveled parallel to the roadway before striking the guardrail. Guardrail in the guide channels shows damage consistent with a large compressive force, indicating that the rail locked up in the terminal head. Altogether, the terminal did not perform as intended. The driver sustained "A" level injuries in the form of seizures.
