Guardrail Terminal Crashes Reconstructed by both Missouri and FHWA

Additional Guardrail Terminal Crashes Identified by Motorists in Missouri

Additional Guardrail Terminal Crashes Identified by Missouri DOT Officials

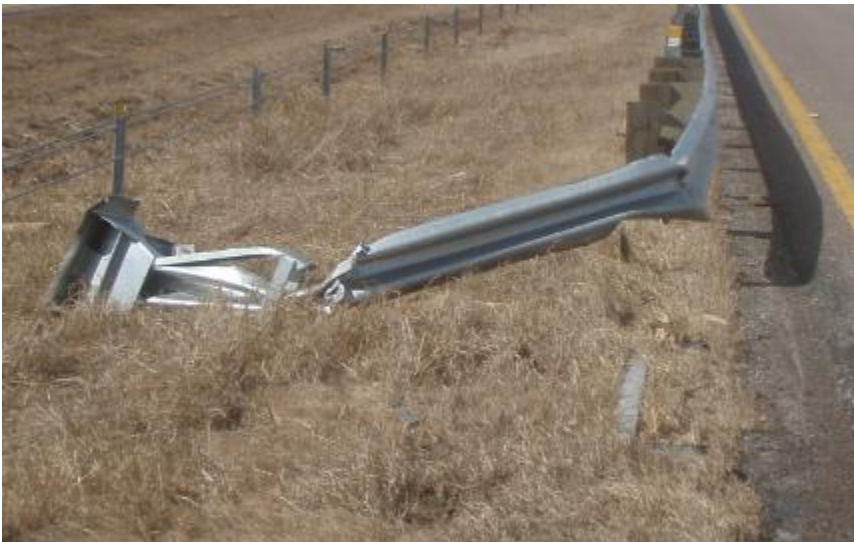
Description: This crash involved a 4" ET-Plus. Rail extrusion was minimal. It appears that the cable did not release at all. This is evidenced by the large deformation in the guide channels. When the cable doesn't release, the cable mounting bracket becomes a rigid object. When the guide channels strike the mounting bracket, the force causes the guide channels to bow. In addition, the angle of the cable pulls the upstream end of the terminal head and the guardrail itself to the ground, often resulting in vehicle instability. In this incident, it appears that the vehicle did, in fact, go up and over the top of the face plate of the ET-Plus. It did not perform as intended.

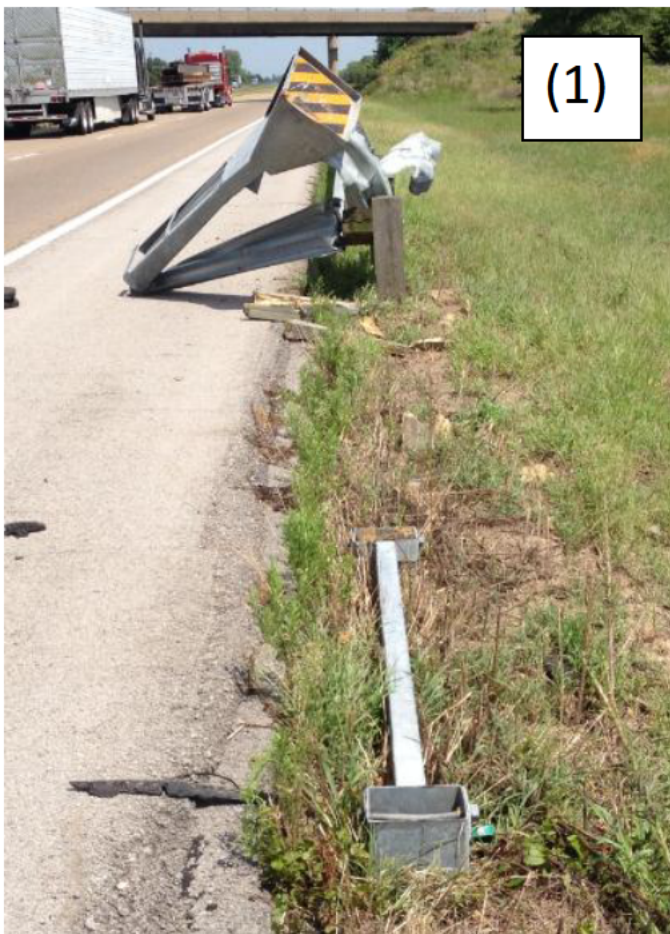
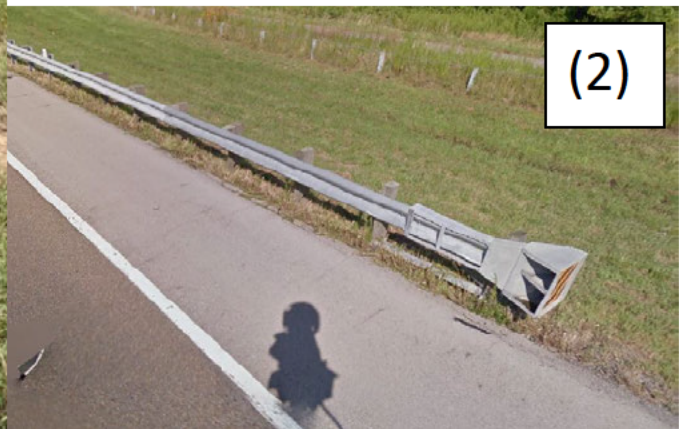
Description: This crash involved a SKT. The crash report indicates that the vehicle was traveling 70 mph and no braking occurred immediately prior to the crash. The vehicle overturned and ended up on the backside of the barrier. In addition, the face plate of the terminal does not show uniform contact. This indicates that the vehicle clipped the head. The buckling in the rail and the offset nature of the impact indicate that the vehicle was likely yawing or sliding as it struck the terminal, which caused the rail to fold as shown in picture 1. Contact with the terminal would have exacerbated the yawing, leading to rollover. Picture 2 was taken about one month prior to the crash, and it shows a deficient rail mounting height. This lowered center of mass would have contributed to the tripping mechanism that caused the rollover. This terminal was not installed properly at the time of the crash, but in spite of that, the terminal gated for the yawing vehicle as intended. The driver sustained "B" level injuries upon being ejected after the rollover.

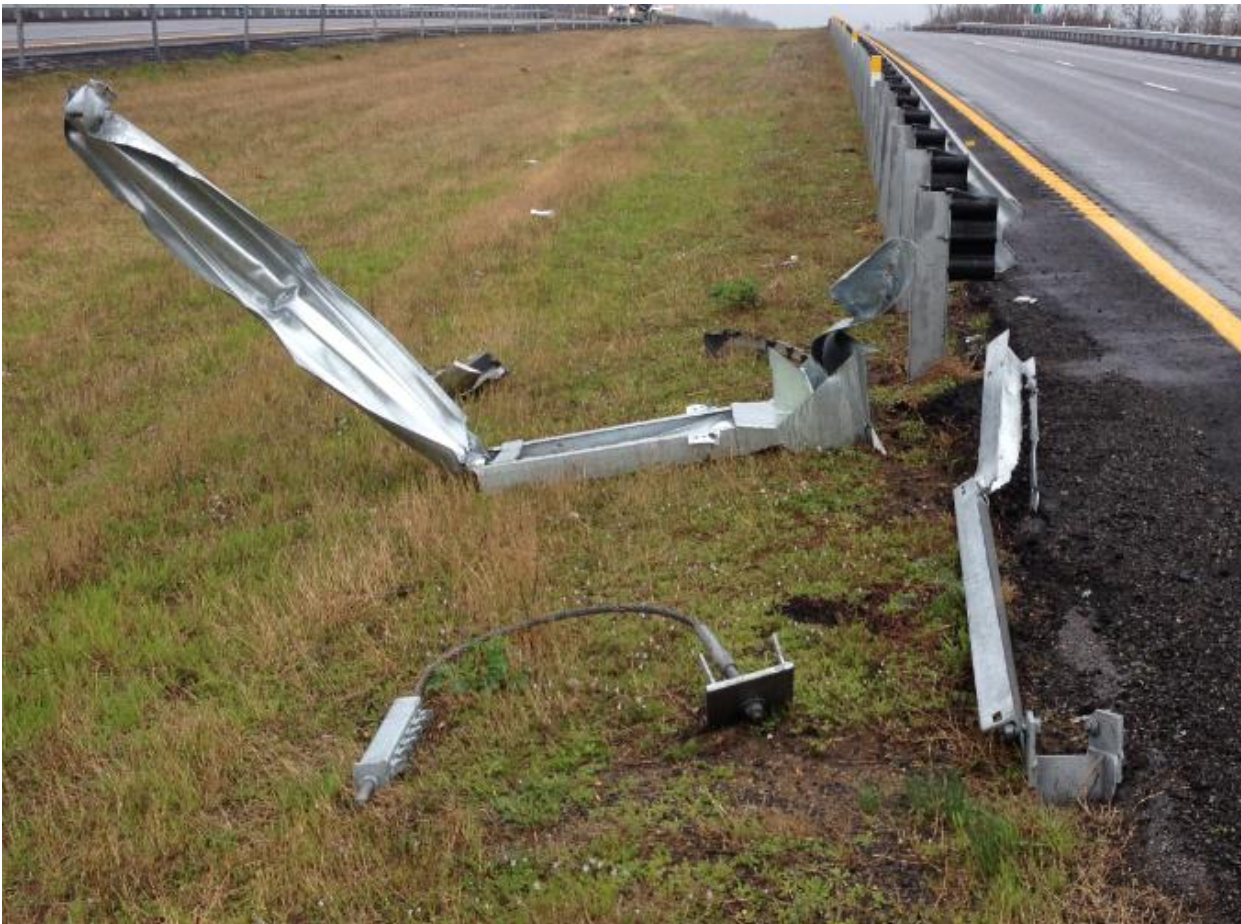
Description: This crash involved a 4" ET-Plus. Rail extruded approximately 3 feet. The rail was cut, most likely by emergency responders. Tire tracks in the picture are consistent with the scene diagram provided in the crash report, where the vehicle passed hundreds of feet behind the terminal. The picture indicates that the rail in the window of the terminal head was slightly crushed which in this case was likely caused by the terminal being bent backwards and slightly upwards as the vehicle gated through. The impact angle appears to be approximately 10 degrees, based on the tracks shown in the picture. The driver sustained "A" level injuries.

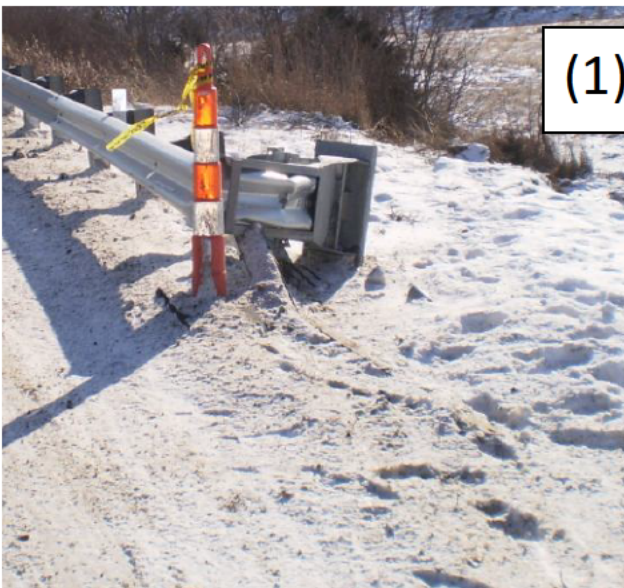
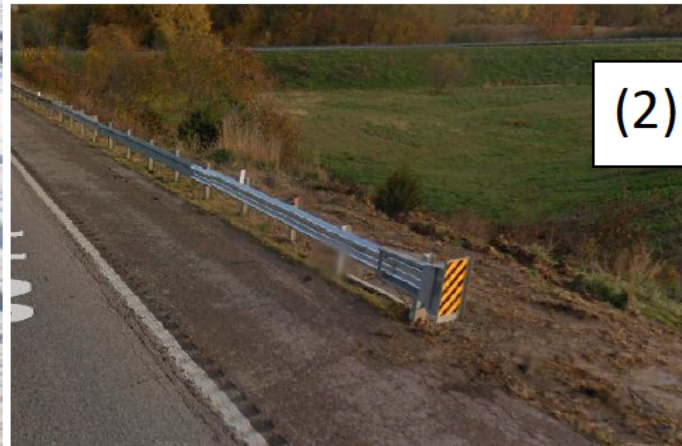
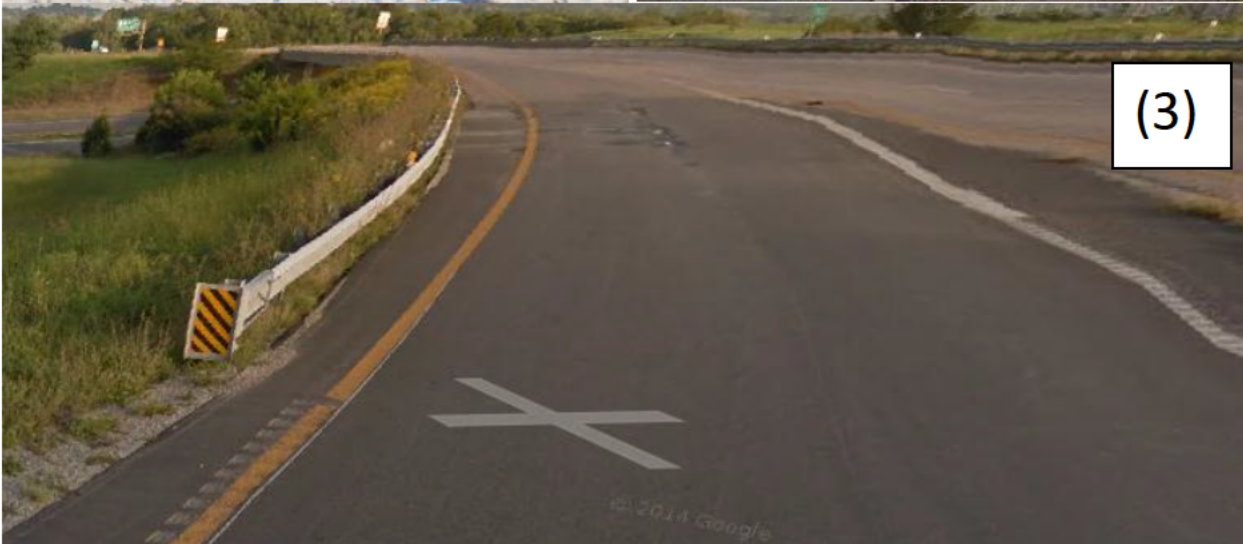
Description: The provided photos do not appear to align with the location description or scene diagram in the crash report, even though the reported latitude and longitude are close. Picture 1 is the provided photo of a damaged ET-Plus (5"), and picture 2 is a Google street view of the same location taken in October 2013, the same month as the crash. Picture 3 is a Google street view taken in September 2013 and matches the scene diagram and location description. Therefore, the crash report could not be used to supplement picture 1. The terminal in picture 1 shows substantial rail damage in the window of the terminal, indicative of excessive forces caused by a locking up of the rail. Therefore, that terminal did not function properly.

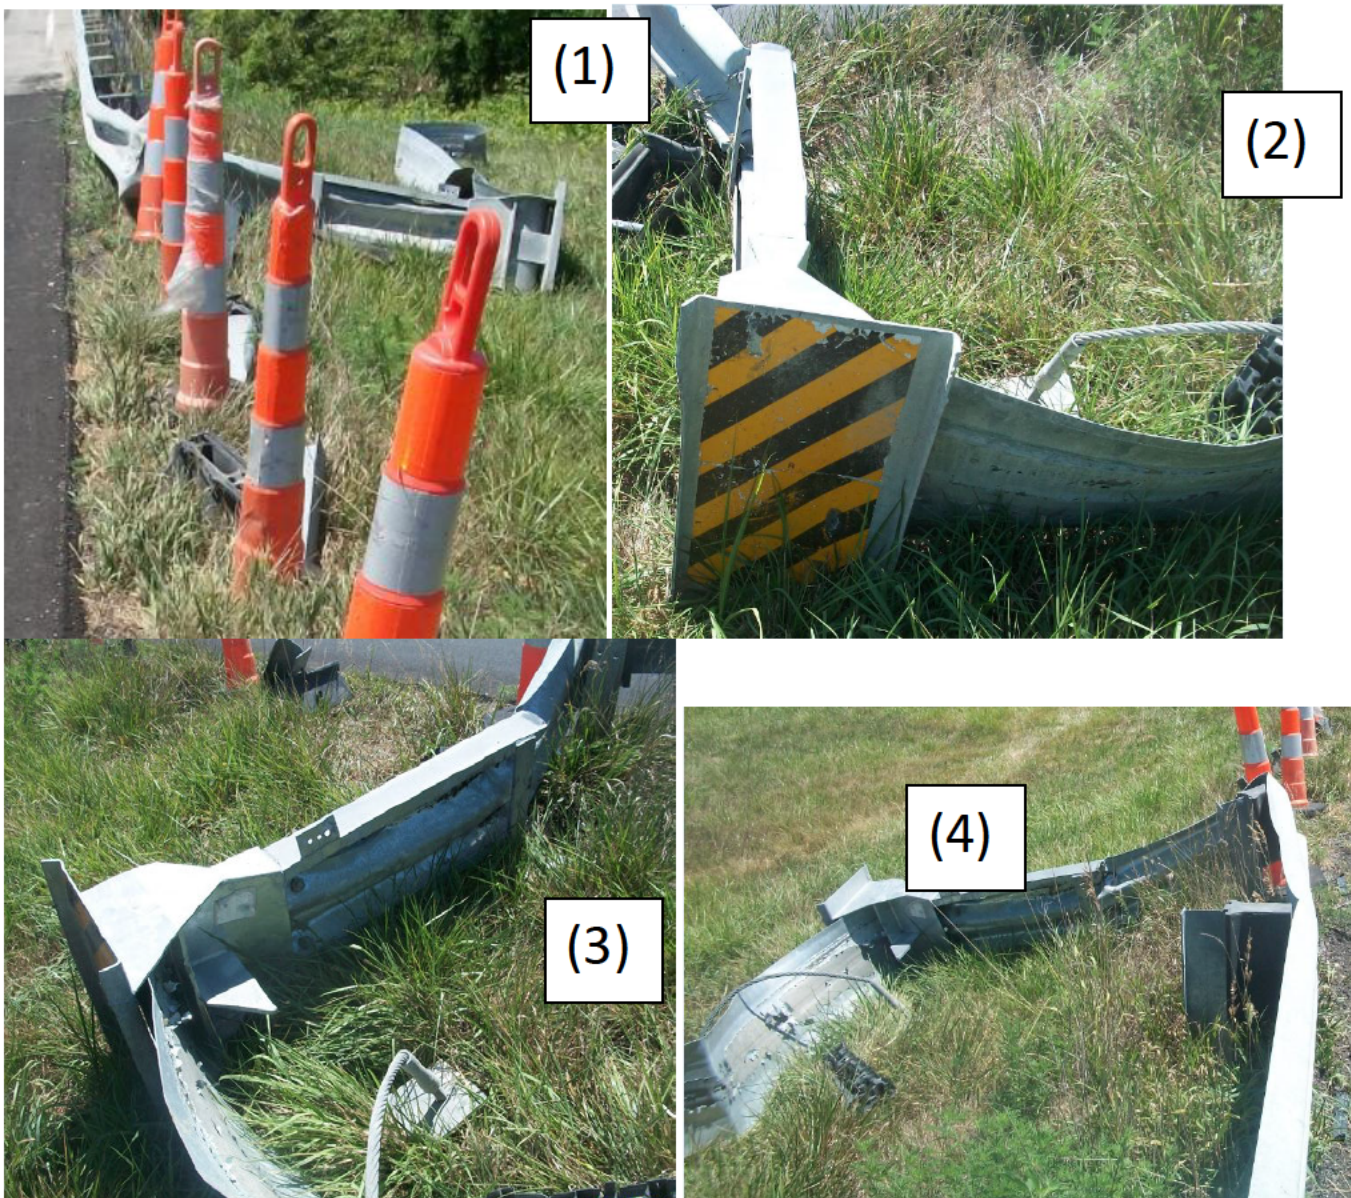
Description: This crash involved a 4" ET-Plus. Approximately 25 feet of rail was extruded (see splice bolts in picture 3). In that same picture, there appears to be some compressive buckling in the rail caused by the passing of the splice bolts through the exit gap. Prior to this point, the terminal performed properly. However, due to this locking mechanism, the rail buckled ahead of the terminal, leaving an exposed end. Therefore, the terminal did not perform properly throughout the entire duration of the crash.

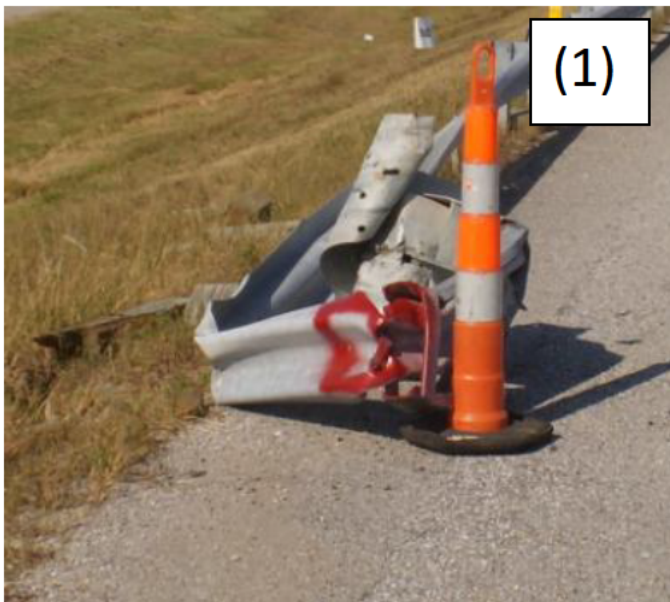
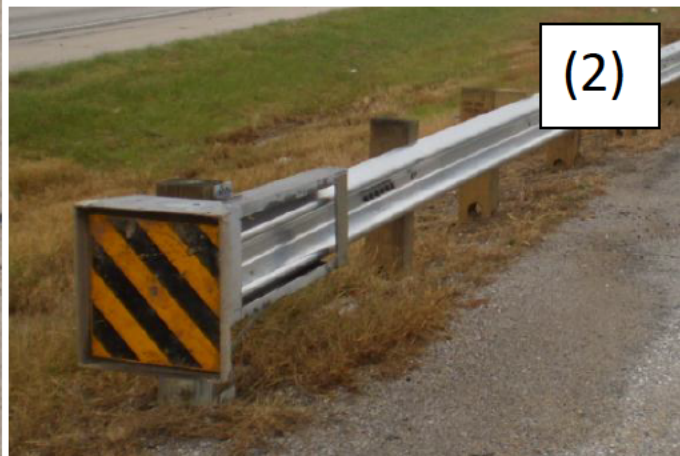
Description: This crash appeared to have involved a 4" ET-Plus. Picture 1 shows a face plate that appears more like the ET-Plus than the ET-2000 (shown in the repaired terminal in picture 2). Also, the mangled guide channels feeding into the terminal inlet appear to be inserted rather than butt welded, indicating the 4" version. Only about 3 feet of rail extruded. Regardless of the impact conditions, this terminal did not perform as intended. However, the exact nature of its malfunction may be any number of possibilities. One possibility is that the cable did not release, causing the guide channels to strike the rigid cable mounting bracket and deform as shown in the picture. Also, earlier evaluations in this paper showed some similarities of deformation when struck by a semi tractor-trailer. Unlike those large-vehicle collisions, this one shows almost no damage to the upstream guardrail (in contrast, see File 24).

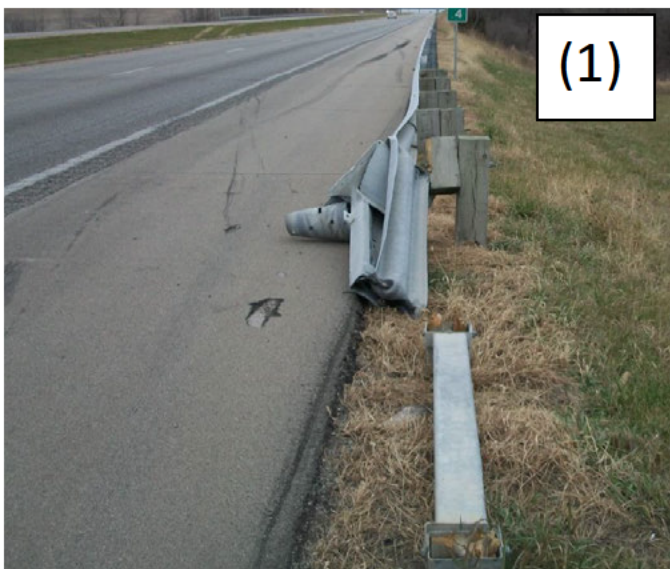
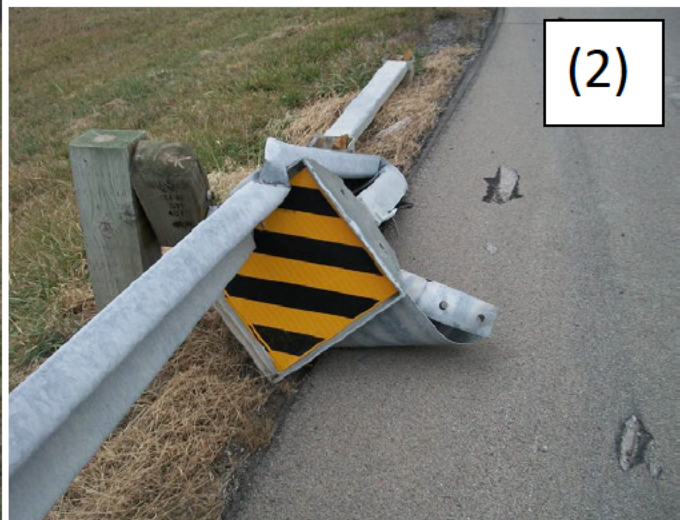
Description: This crash involved an ET-2000. Tire and gouge marks on the pavement indicate a trajectory that would have merely clipped the terminal head. Only about 3 feet of rail extruded, however, the clipping nature of contact and the impact angle (which appears to be headed back into the traveled way) would cause the terminal to gate. It appears that the terminal performed properly.

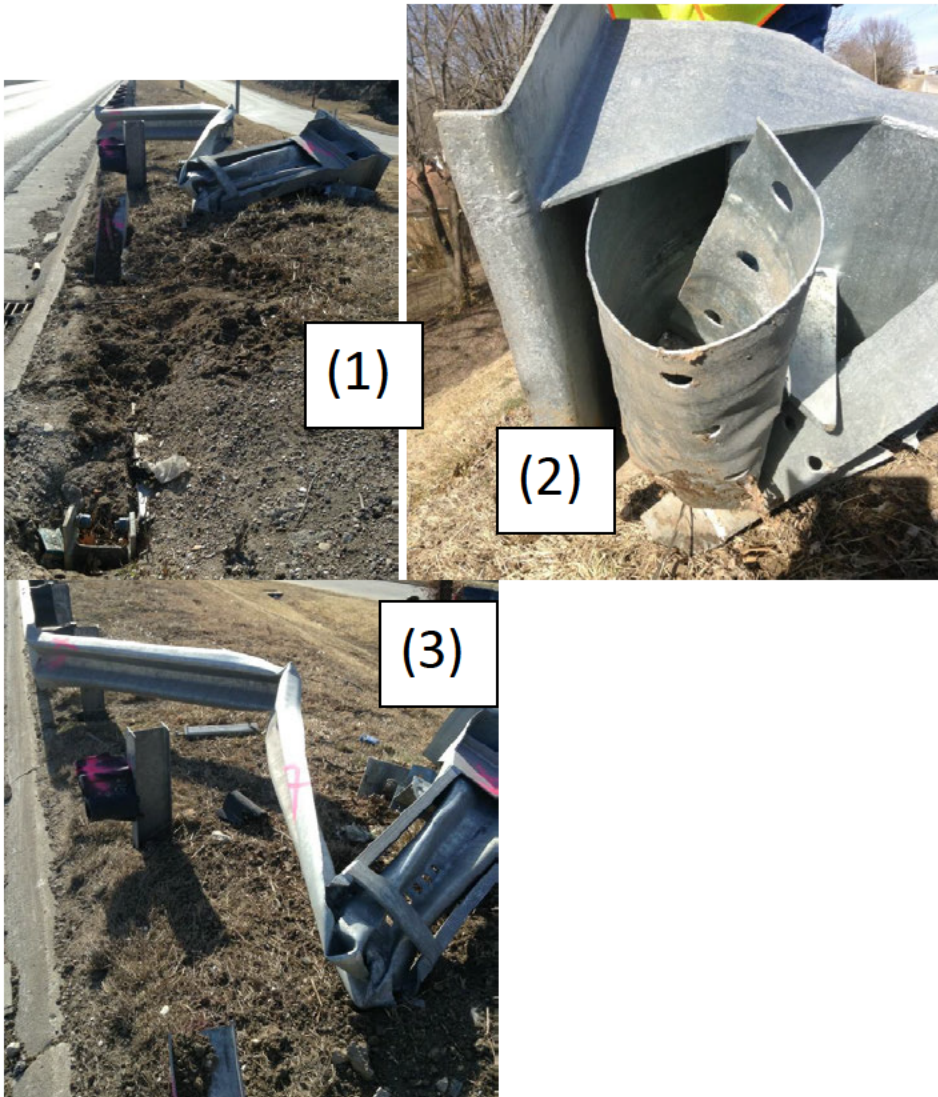
Description: This crash involved a 4" ET-Plus. Rail extruded approximately 2 to 3 feet. Three buckles formed in the rail upstream of the leading end of the terminal. This indicates that the terminal did not gate. The vehicle was entering the highway from a ramp. The driver stated that she over-corrected after swerving. This caused the vehicle to impact the terminal on the head at a low angle. The crash report also indicates that the vehicle rolled onto its side after passing behind the terminal. Typically, when a car can pass behind a terminal, it does so safely only if the terminal gates. This terminal did not gate and presented a tripping mechanism. The rail inside the window of the terminal shows evidence of large compressive forces typical of a rail that has locked up inside the head. This terminal did not function properly. The driver did not sustain any injuries.
