# NCHRP Report 350 Test Report Compilation

## Full-Scale Crash Evaluations of the ET Plus<sup>®</sup> End Terminal with 4-inch Wide Guide Channel Installed with a Rail Height of 27¾ Inches

Tests: ET27-33, ET27-31, ET27-32 and ET27-30

SwRI<sup>®</sup> Project No. 18.20887

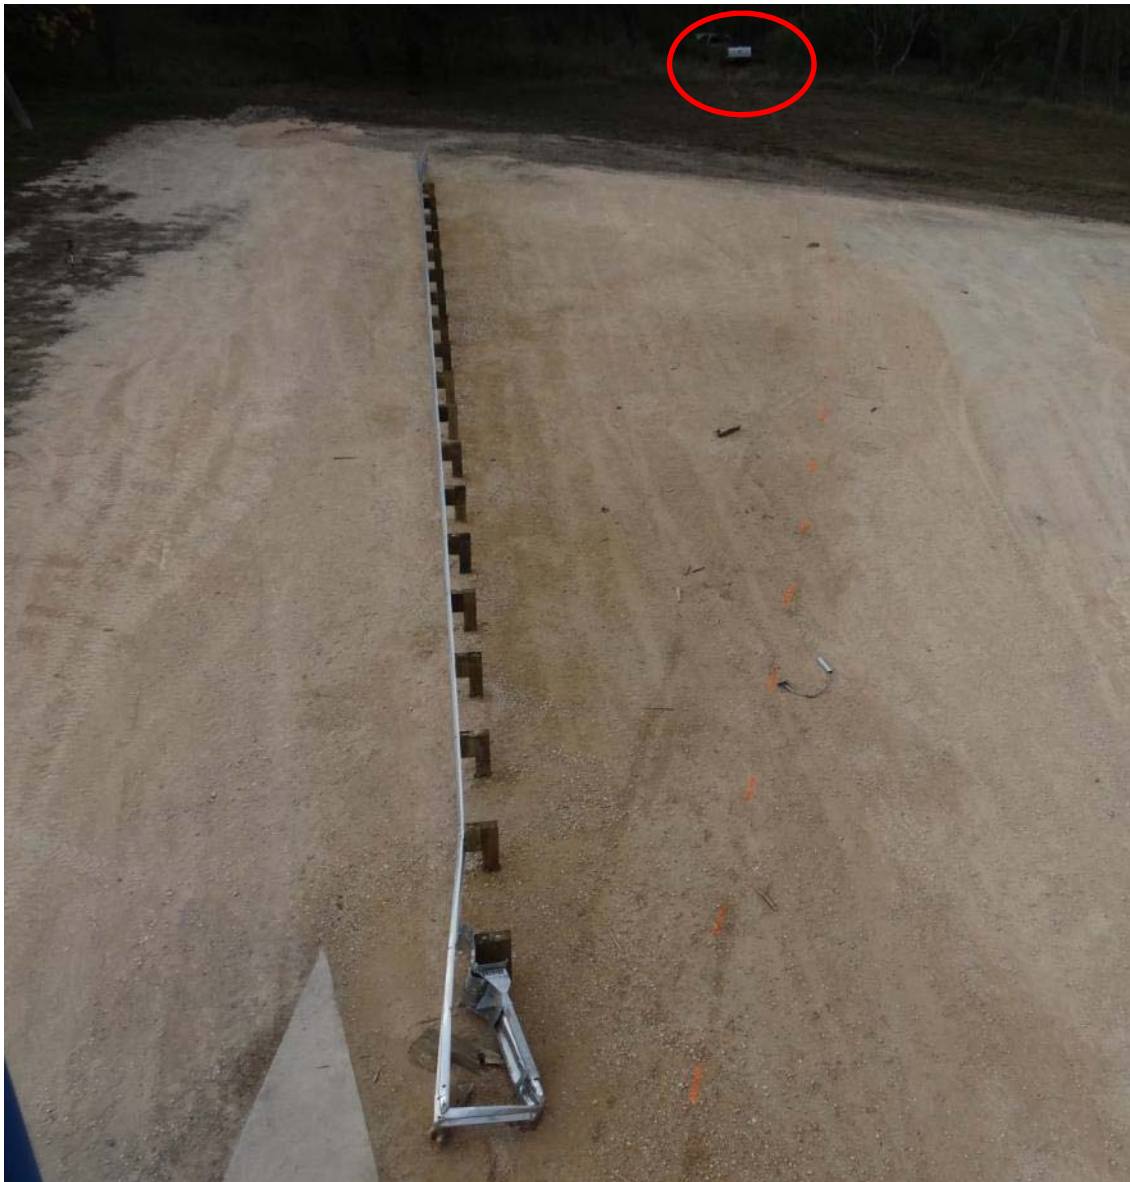
Figure 3.2 is an overhead photograph showing the post-test condition and location of the test article and test vehicle. Figure 3.3 through Figure 3.5 show that the test vehicle impacted the end terminal at a nominal 15° angle. The impact velocity of the test as measured by SwRI's speed trap system and verified by high-speed film analysis was determined to be 103.3 km/hr (64.2 mph). As a result of the test, the ET Plus extruder head moved 5.8 m (19.1 ft) longitudinally (downstream) and 0.4 m (1.5 ft) laterally as measured from its as-installed position. The total system deformation (i.e. longitudinal distance to closest point) measured after the impact was 4.23 m (13.9 ft) from the initial point of contact.

**Figure 3.2: Post-Impact Condition of the Test Article and Vehicle**

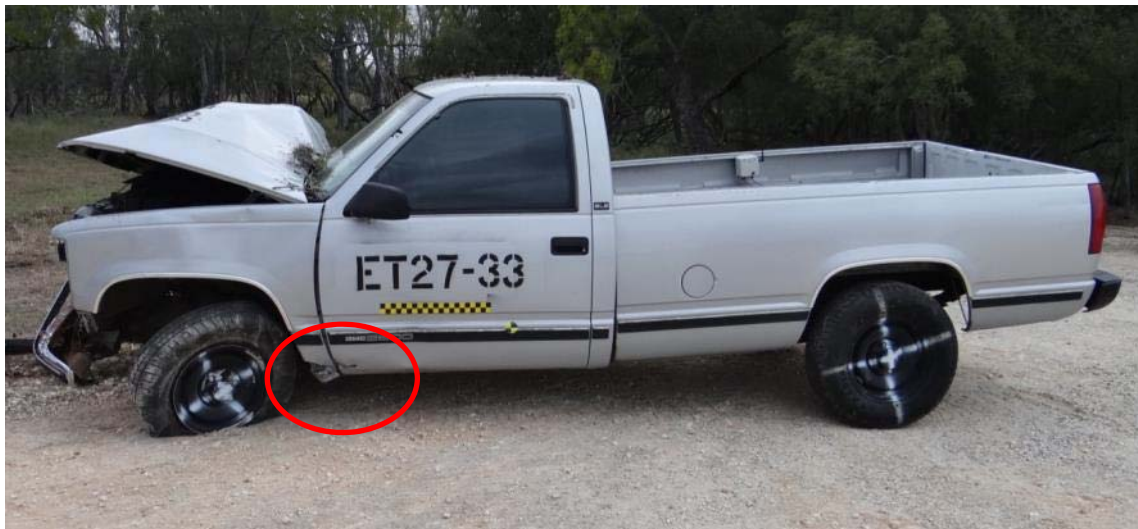
**Figure 3.46: Left Side Damage (Note: Hood Damage/Bent Frame Due to Impact with Tree)**

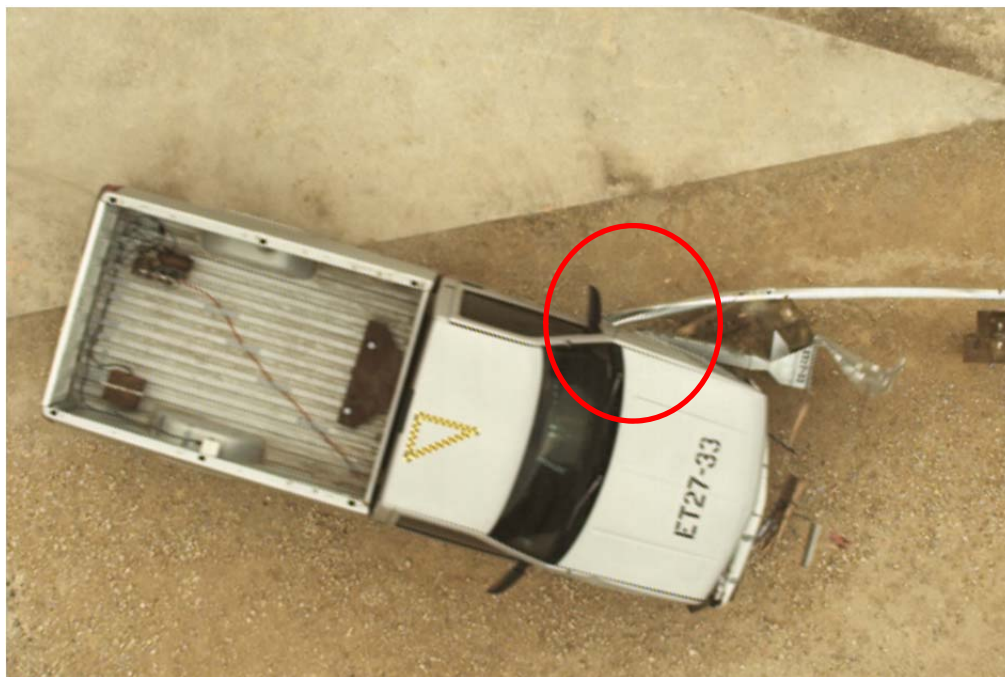
As the vehicle passed by the gated ET Plus extruder head, the corner of the folded W beam scraped the driver's side just past the front wheel well creating a tear approximately 9" long in the quarter panel and door surface; there was no intrusion or potential for intrusion of the test article into the occupant compartment based on the position of the guardrail relative to the vehicle trajectory when the damage occurred.

**Figure 3.48: Left Side Damage Caused by W beam**

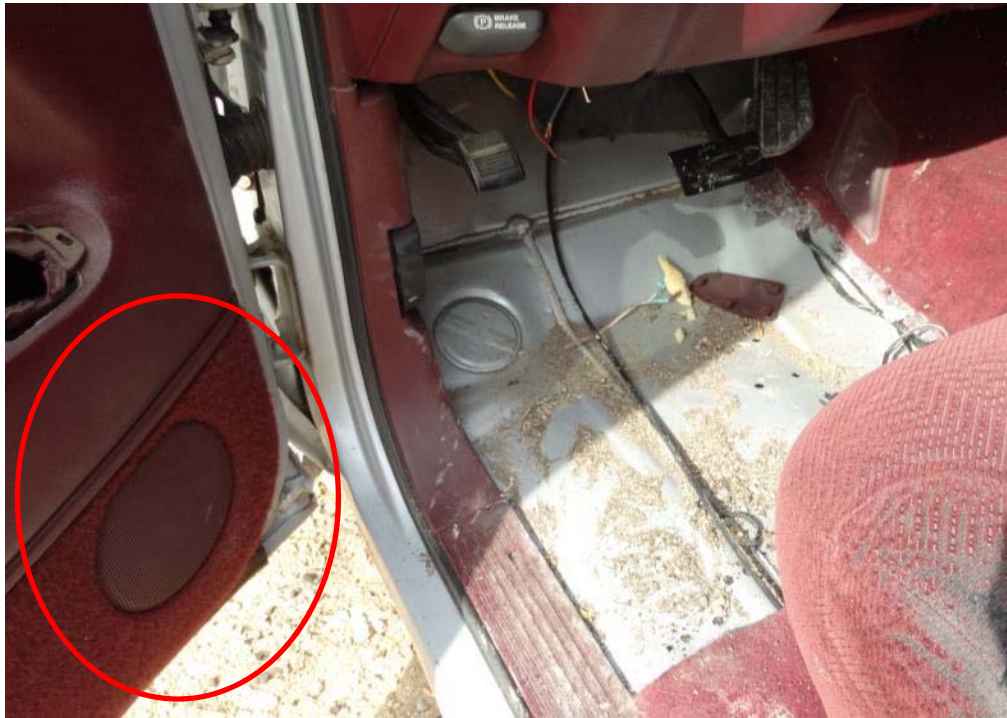
**Figure 3.49: Door Panel Intact Behind Tear in Door Skin**

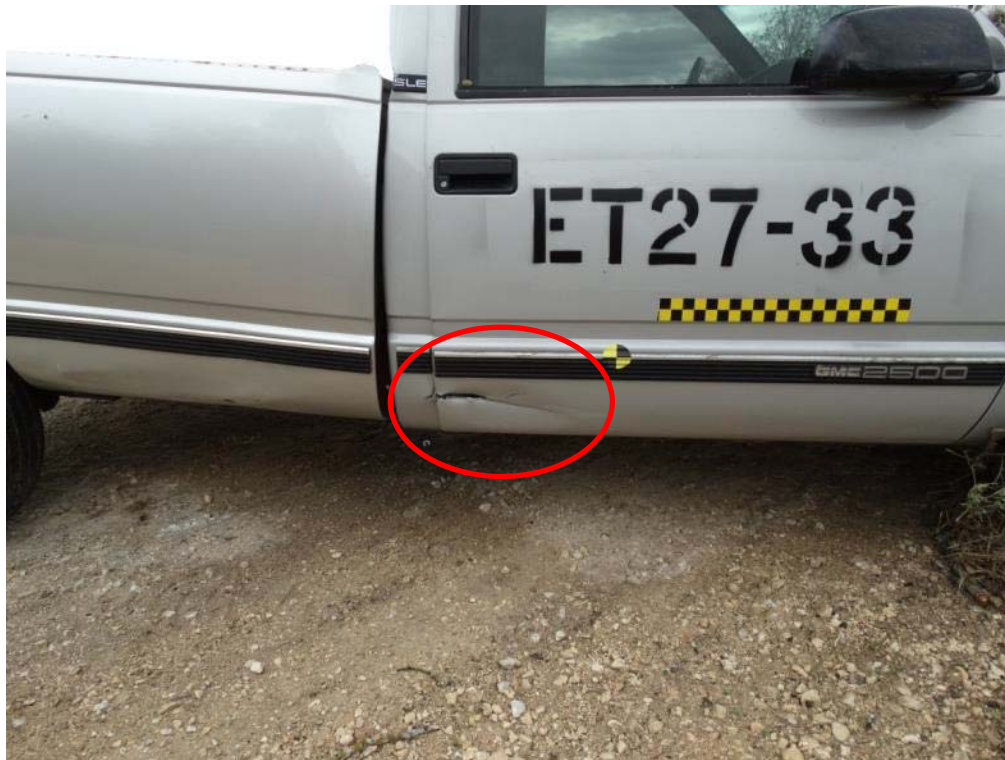
Immediately prior to the initial impact event, the steel rod used to support the steering cable mechanism on the test vehicle was knocked-off the vehicle as-designed. As the rod spun through the air, it impacted the test vehicle and created a tear in the door skin at the lower rear area of the passenger side door; this damage was unrelated to the test article and will not be used to judge performance of the ET Plus.

**Figure 3.51: Damage to Passenger Door Caused by Steering Cable Rod**

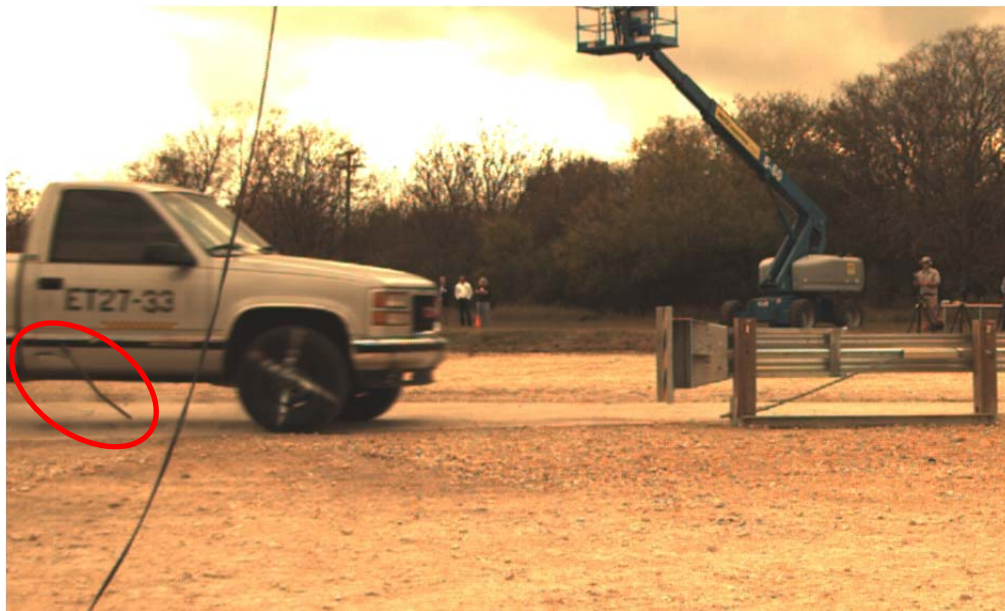
**Figure 3.52: Steering Cable Support Rod Creating Damage to Passenger Door Prior to Impact Event**

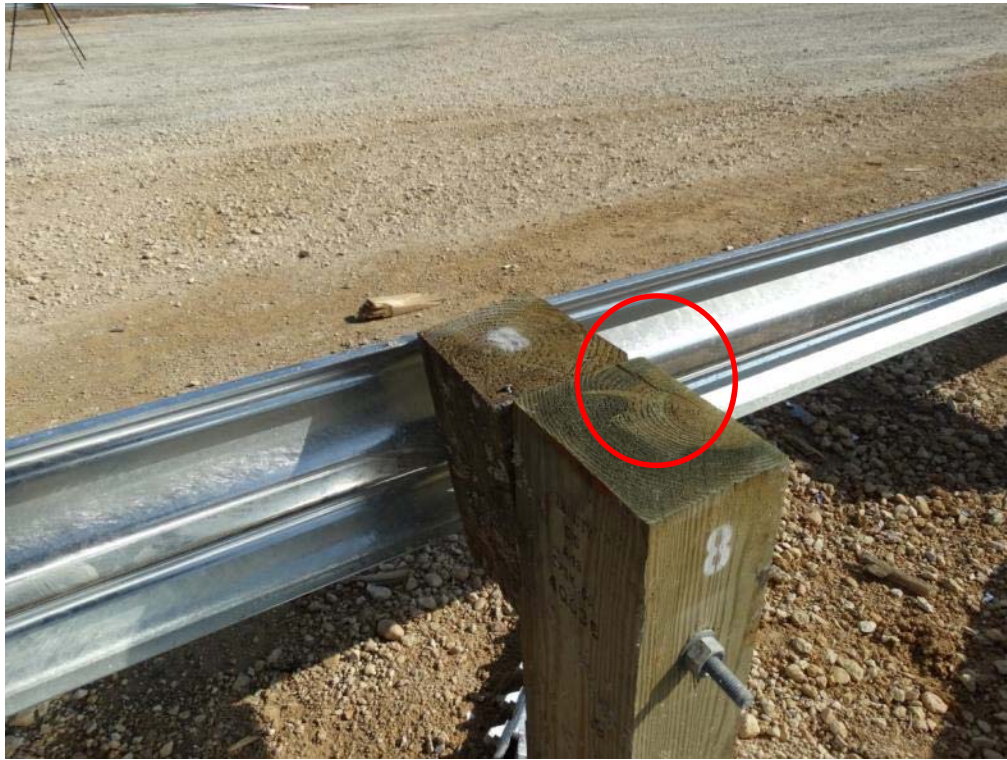
**Figure 3.14: Post Test – Post 8 Cracked, Blockout Twisted**

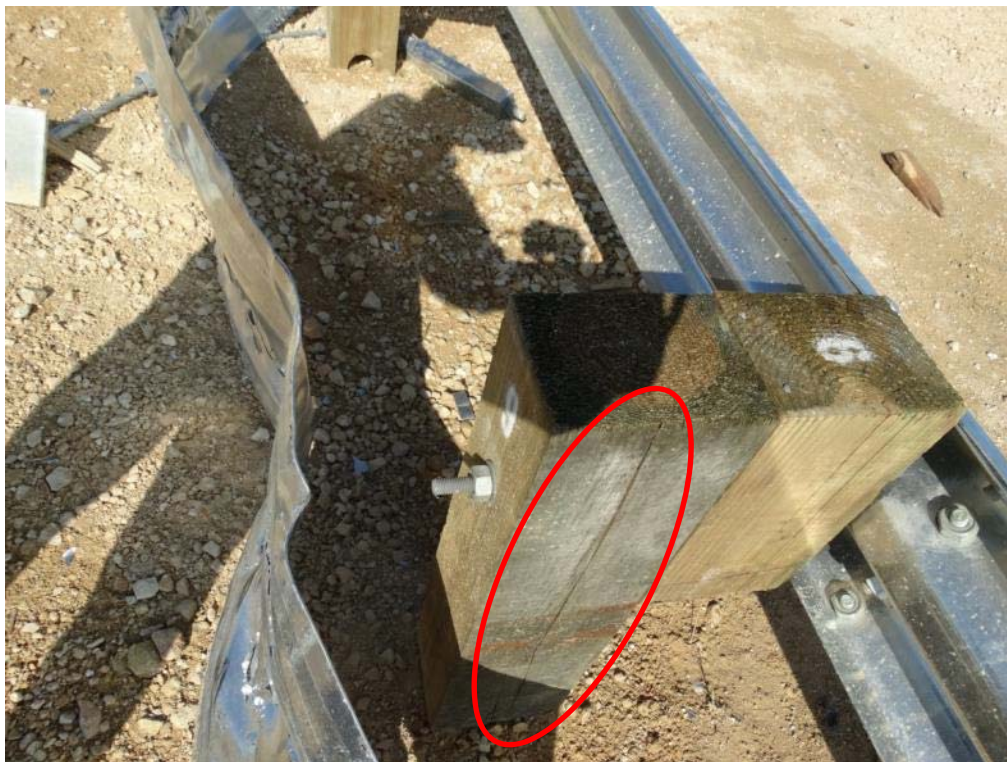
**Figure 3.15: Post Test – Post 9 Cracked**

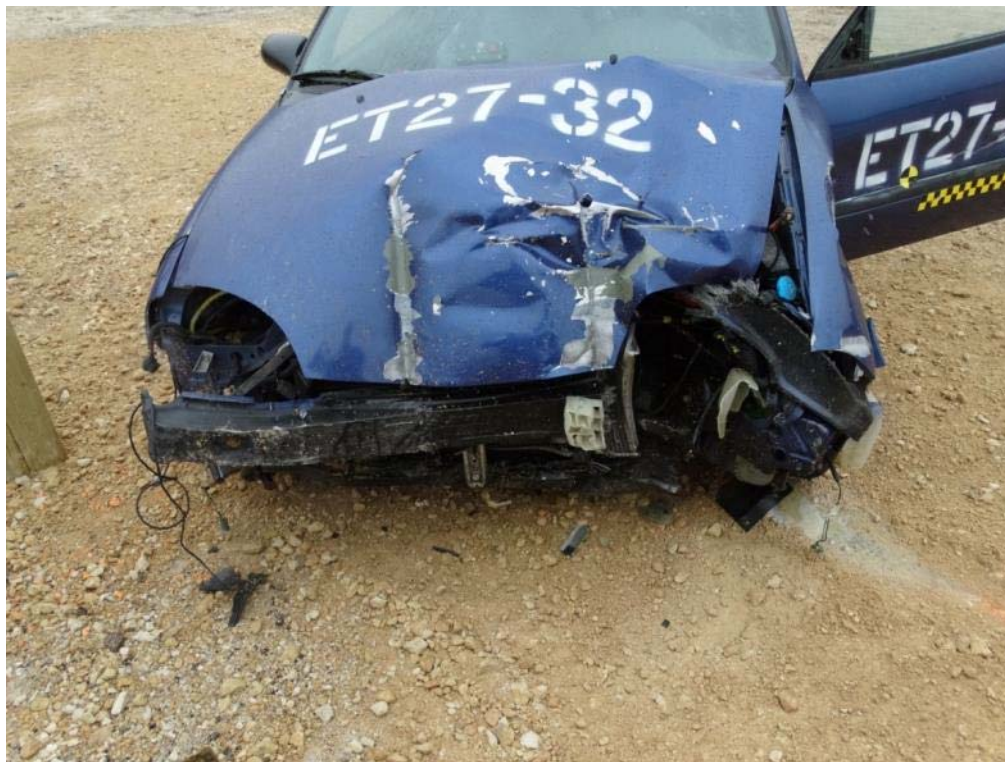
**Figure 3.33: Damaged Test Vehicle – Front View**

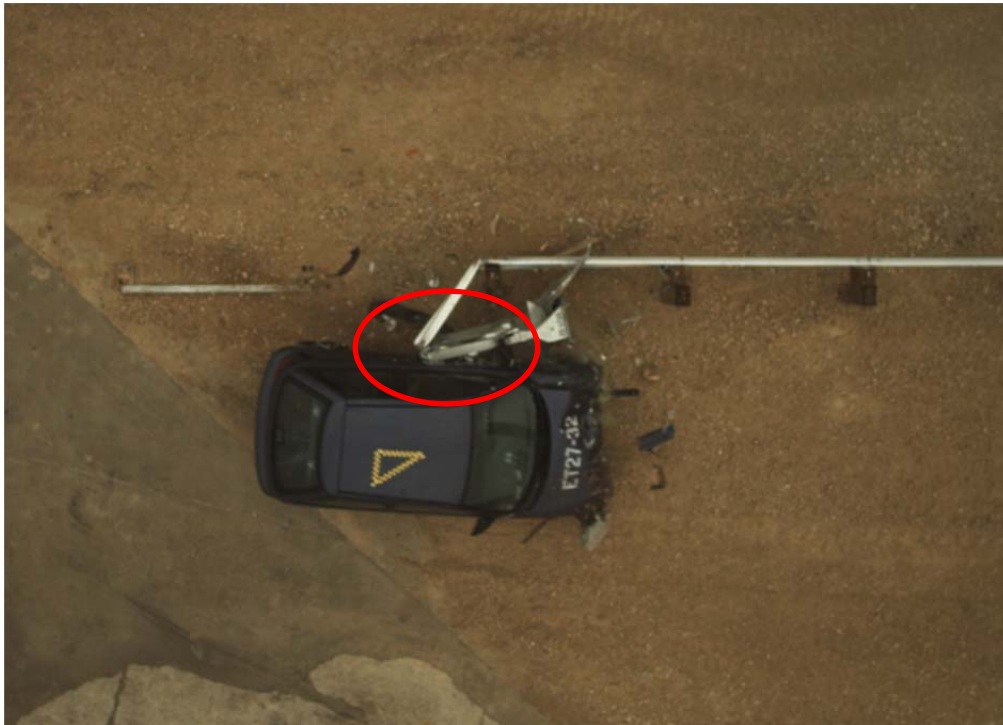
**Figure 3.37: Guide Channel at Driver Side Door During Test**

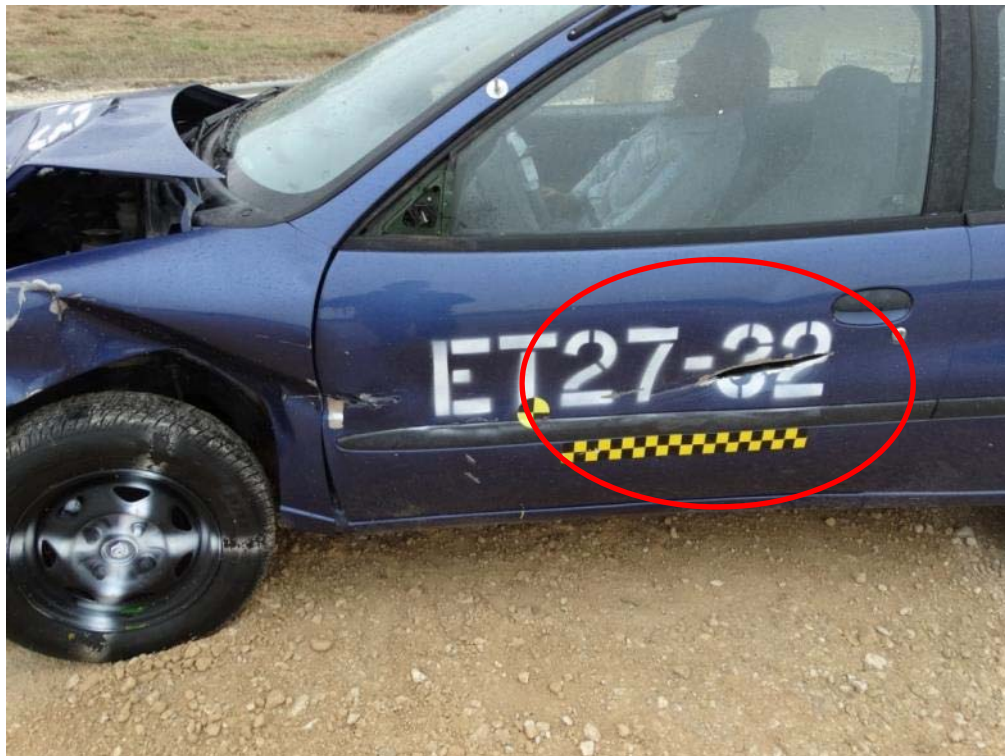
**Figure 3.38: Damaged Test Vehicle – Tear in Door Skin**

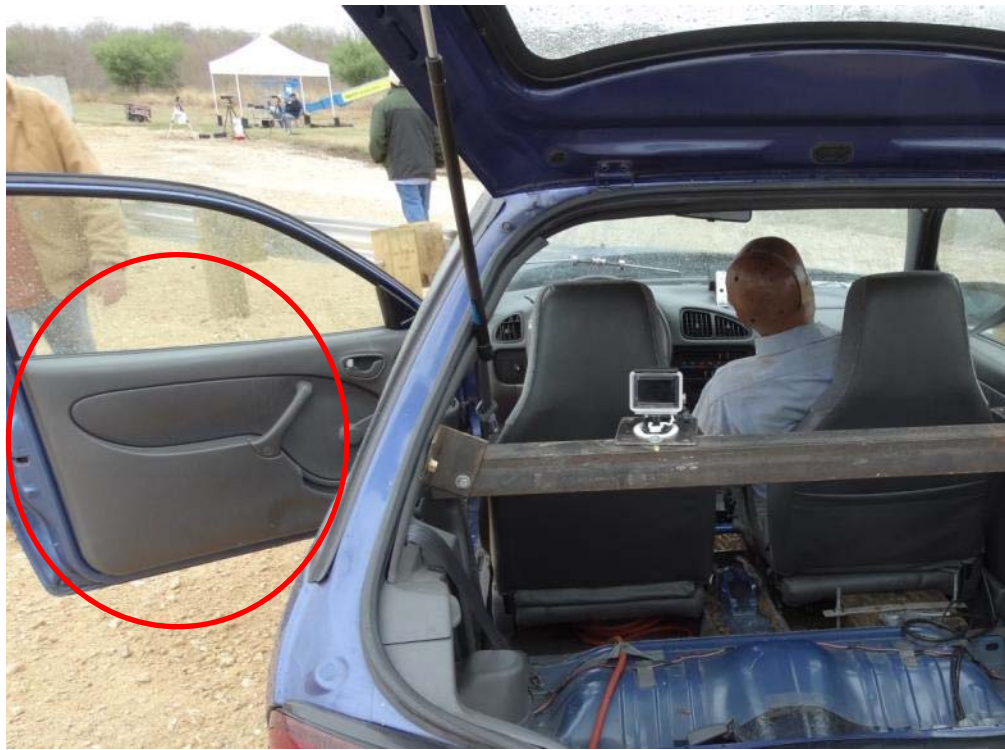
**Figure 3.39: Damaged Test Vehicle – Door Panel Intact behind Exterior Tear**

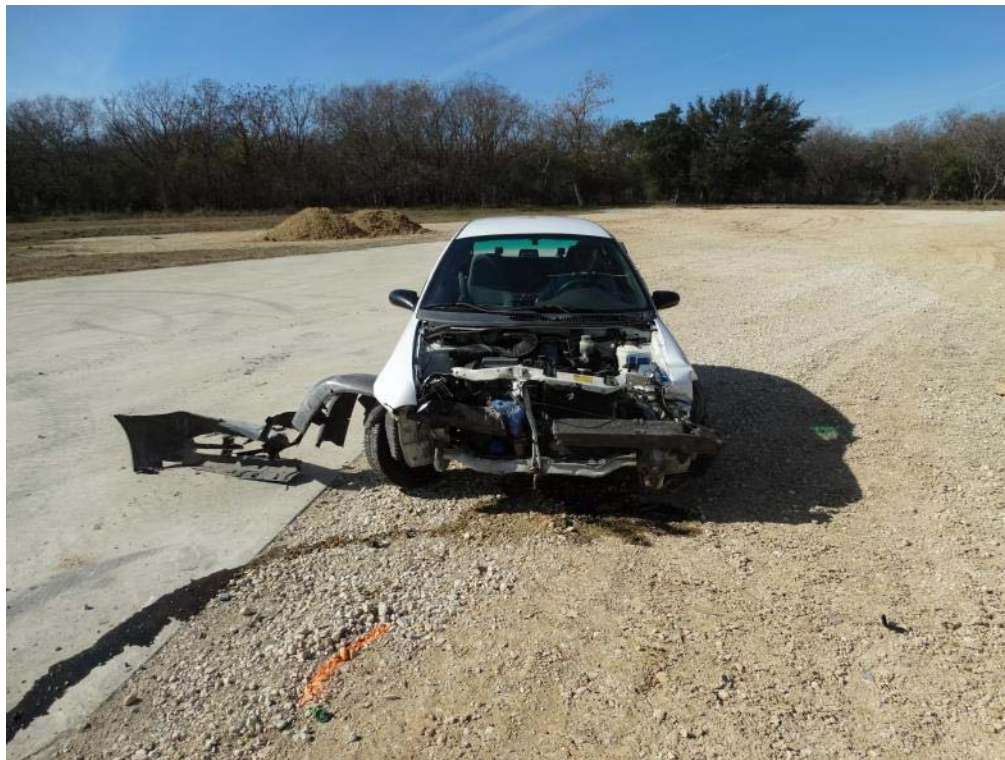
**Figure 3.31: Damaged Test Vehicle – Front View**

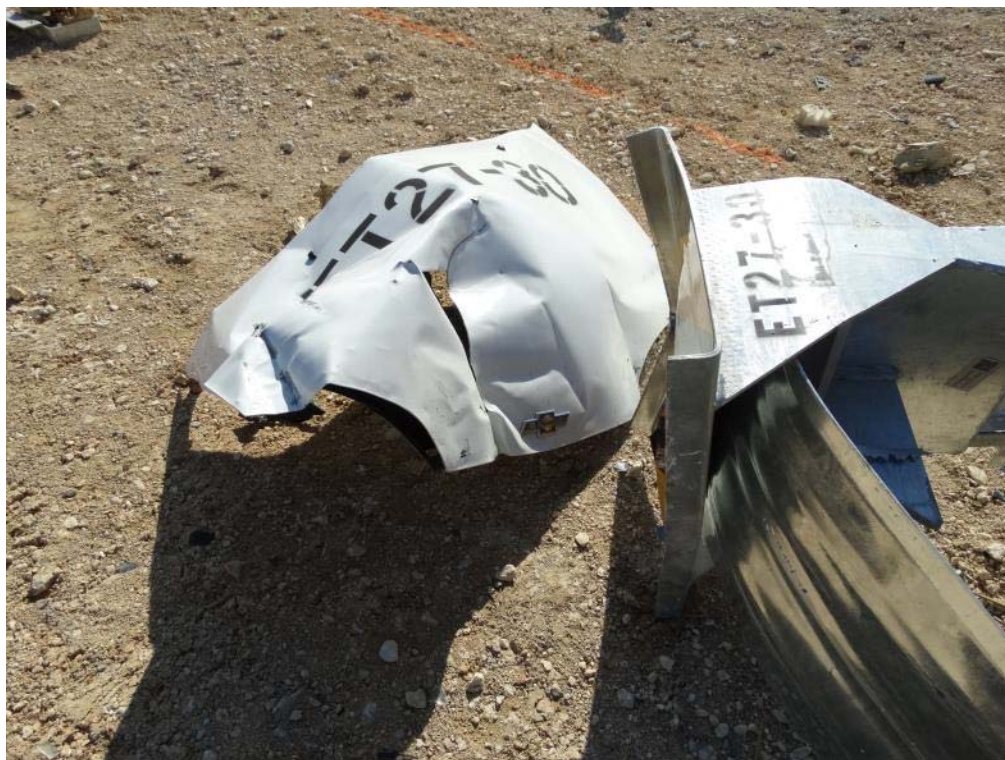
**Figure 3.35: Damaged Test Vehicle – Front Hood**
