Montana Demonstration Project: Innovative Culvert Rehabilitation Using Trenchless Technologies

> Final Report June 2009

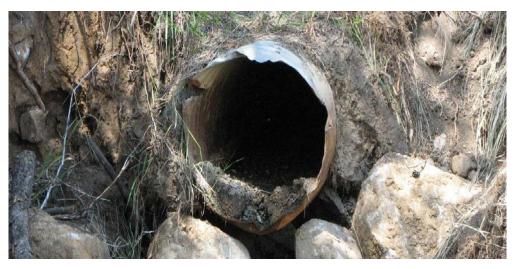
Ten of the corrugated steel pipes under U.S. 12 near Helena were in poor structural condition with deteriorated inverts and badly in need of replacement. Sand and debris were accumulating in these culverts, reducing their capacities and requiring constant care by maintenance forces. The poor condition of the culverts prompted MDT to take immediate mitigating measures. MDT had two options to address the problem. Option 1 was to excavate and replace the culverts, which would have required lane closures that interfered with traffic flow. Option 2 was to reline the culverts using trenchless technologies without impeding traffic flow. After exploring the two alternatives and evaluating project and user costs, MDT selected the trenchless technologies to rehabilitate the culverts under U.S. 12. The rehabilitation strategies included the following innovative techniques:

Figure 2. Existing condition of a typical culvert at the project site.

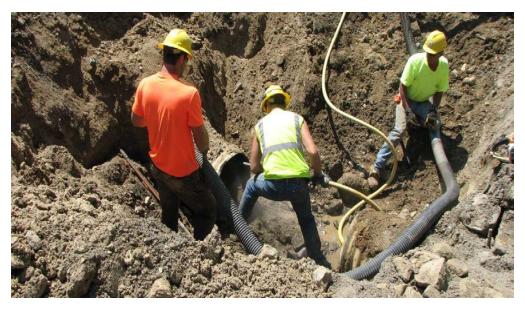
Figure 3. Cleaning and removal of debris from the existing CSP.

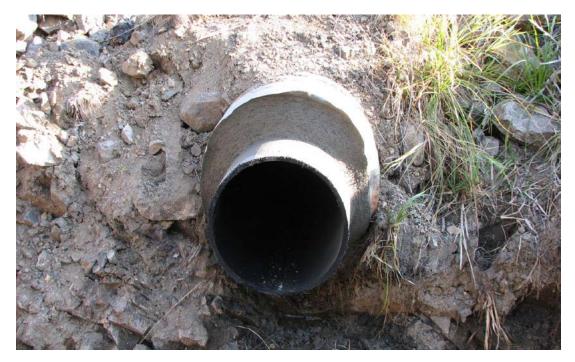
Figure 10. Fully installed HDPEP and the cementitious materials.

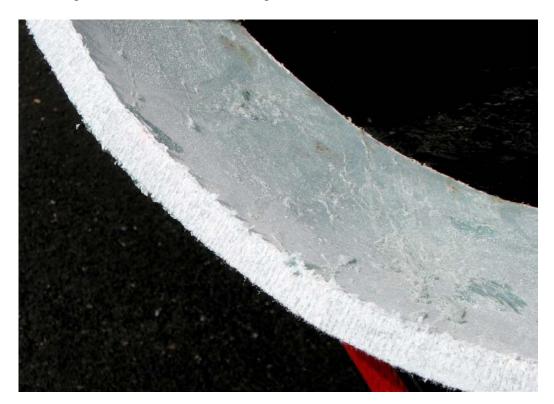
- A close-up view of a fully cured CIPP liner is shown in figure 20. All three polyester layers of the liner are bonded, forming a composite monolithic rigid layer with an average thickness of 0.625 in (15.8-mm).

Figure 20. View of a fully cured CIPP.

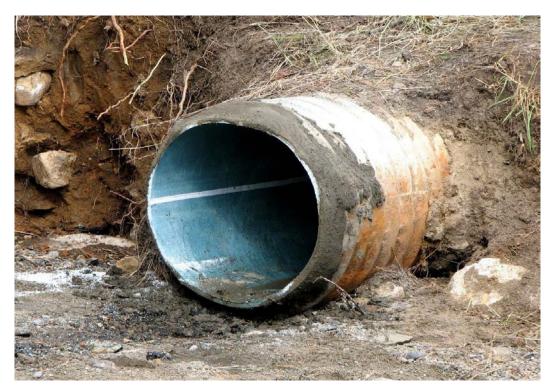
Figure 21. View of a fully installed CIPP liner (Note intimate contact of the liner with the pipe).

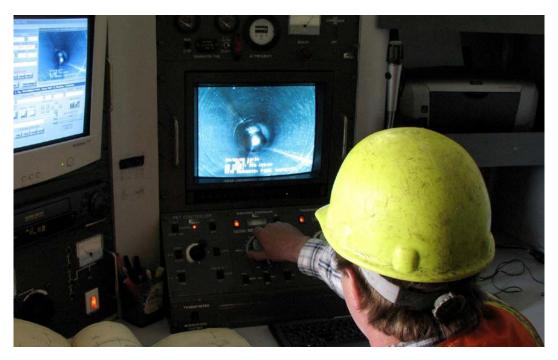
Figure 22. Remote monitoring and inspection.
