Federal Highway Administration
Every Day Counts
Innovation Initiative

Safety Edge_{SM}
Demonstration Project
Elizabethtown,
Pennsylvania

Field Report
May 24, 2011

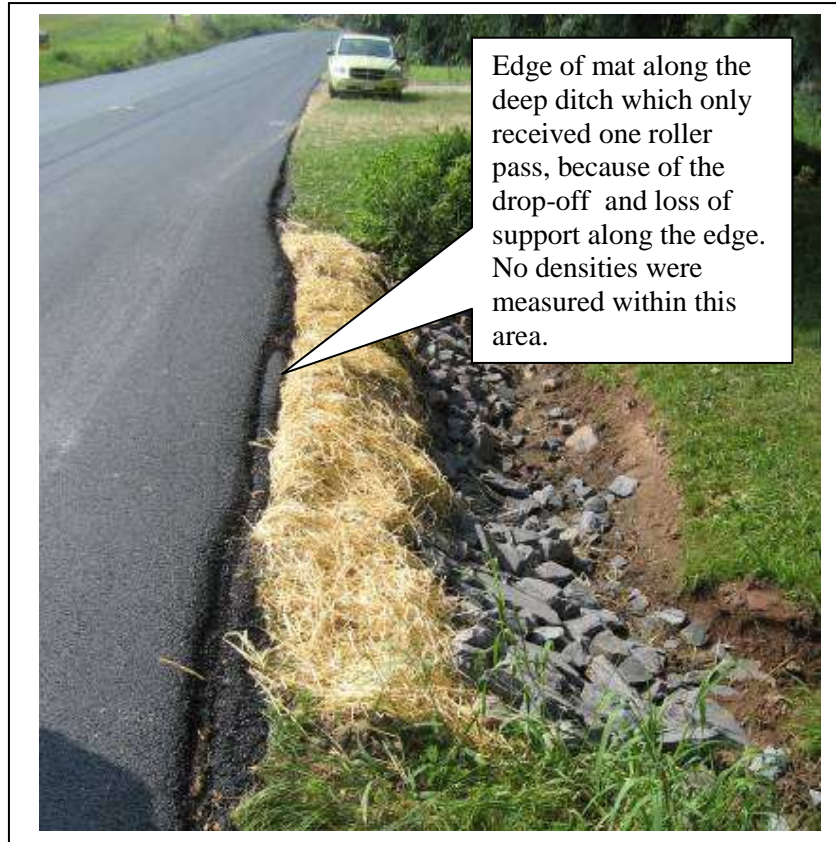
The ditches along the edge of the pavement were generally shallow or almost level with the existing pavement (refer to Figure 2), with the exception of a few areas (refer to Figure 3). An HMA base mix had already been placed on both sides of the road to widen the roadway. Some areas had narrow ditches that were approximately one to two feet in depth, but were covered or hidden in grass.

Figure 3. Localized area with deep ditches adjacent to the pavement.

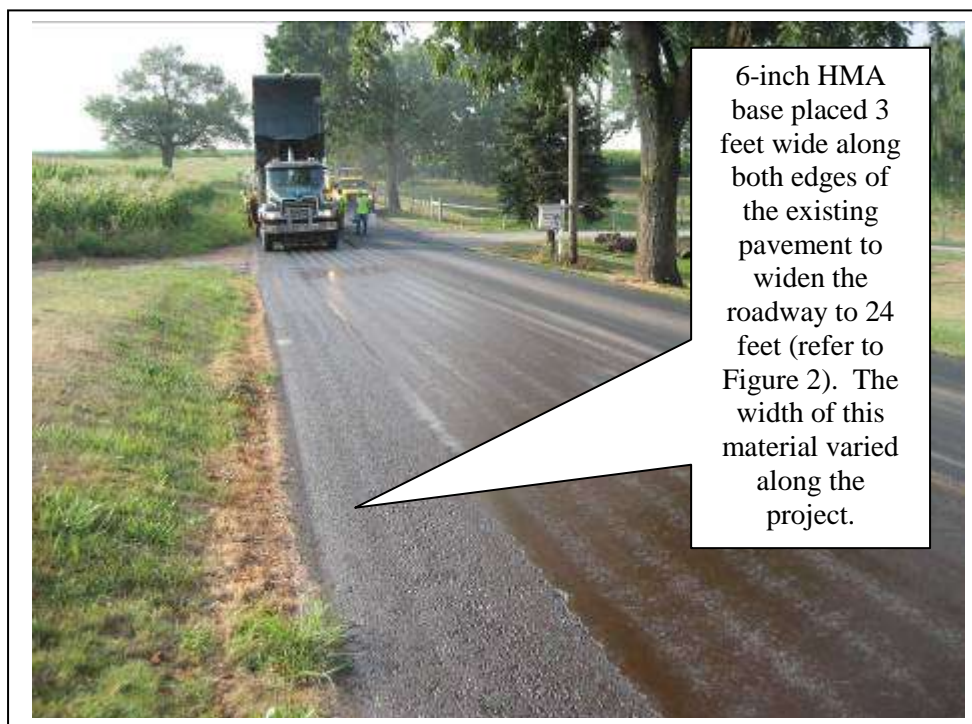
As noted above, the existing pavement was widened on both sides by about 1 foot, by placing an HMA base mix (refer to Figure 4). The HMA base mix had already been placed along the pavement's edge. The surface of this material was rough, as shown in Figures 4 and 5. The width of the pavement varied significantly along the project because of site features and driveways that exist along the project (refer to Figures 3 and 6).

Figure 4. Additional HMA base material placed along each edge of the roadway.

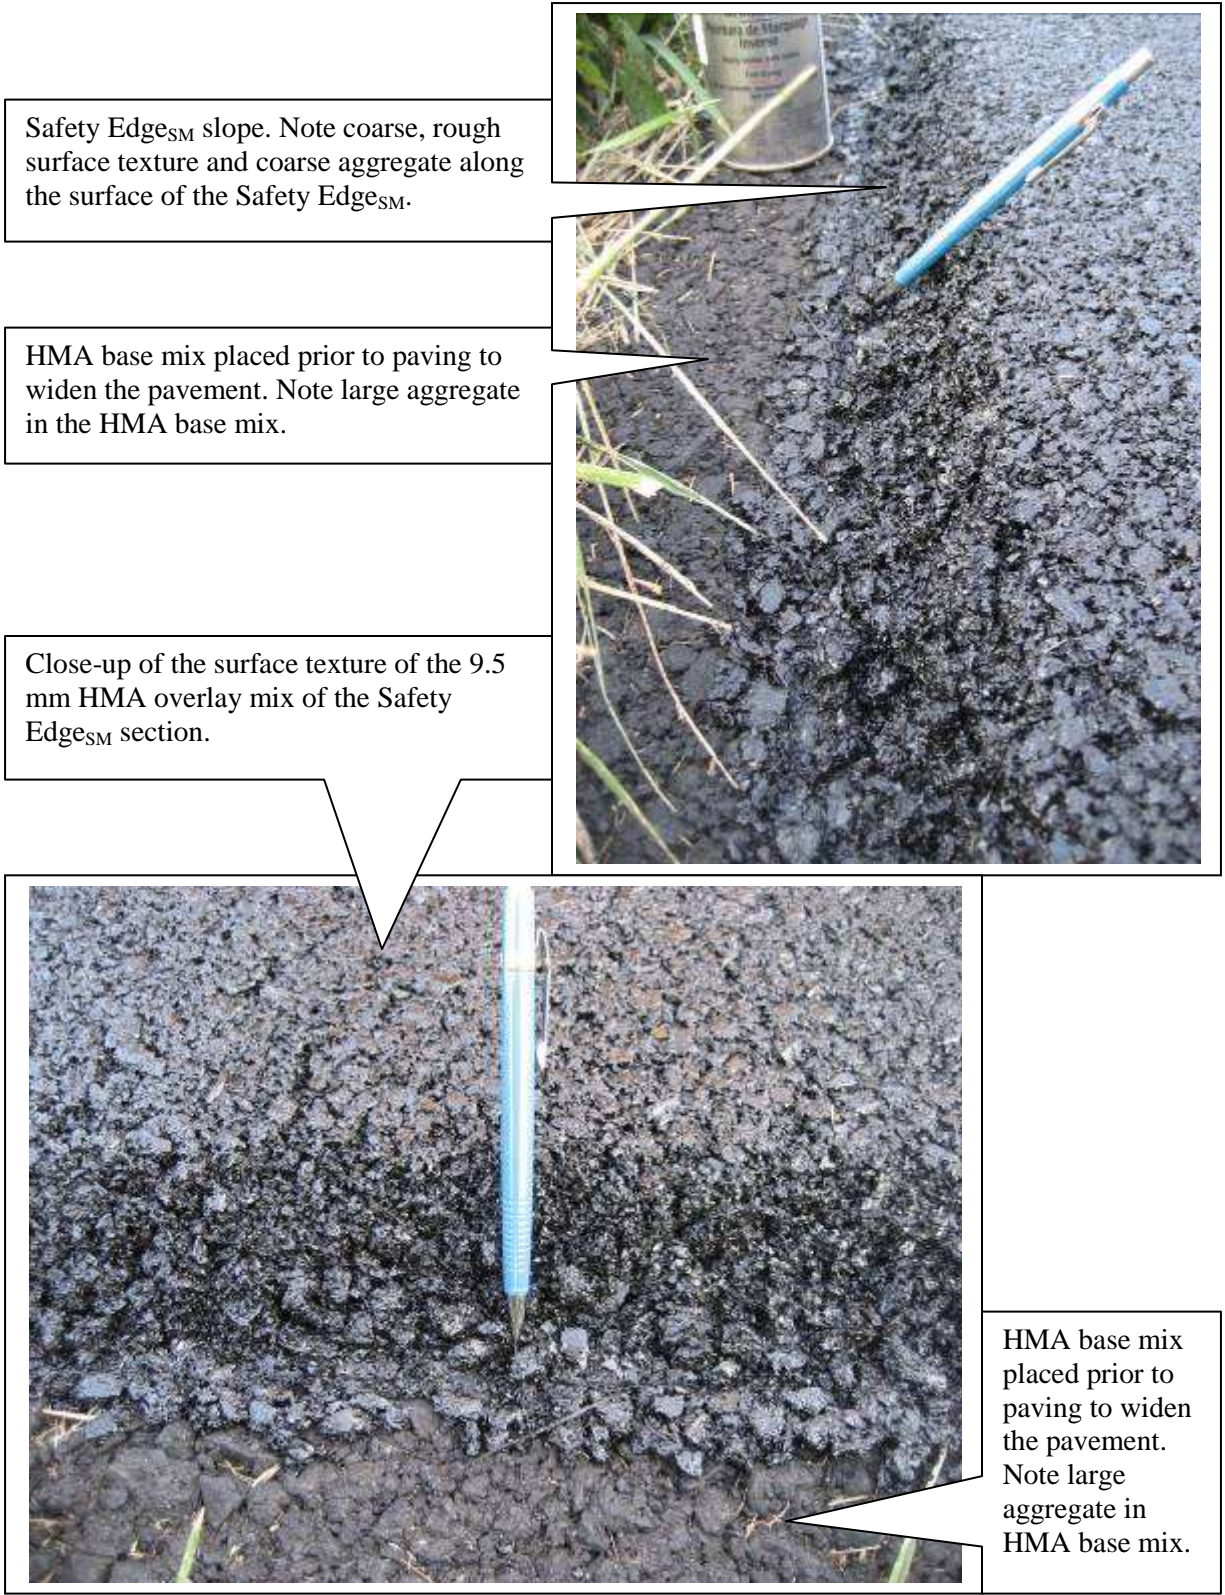
Figure 5. Surface of the HMA base that had been previously placed to widen the roadway.

The slope measurements were found to be variable, because it was difficult to locate the toe of the slope of the Safety Edges_{SM} in areas where some of the 9.5 mm mixture was under the screed end plate (refer to Figure 5). The screed operator did try to lower the screed end plate, but the end plate pulled dirt and weeds into the mix within the screed extension in some areas.

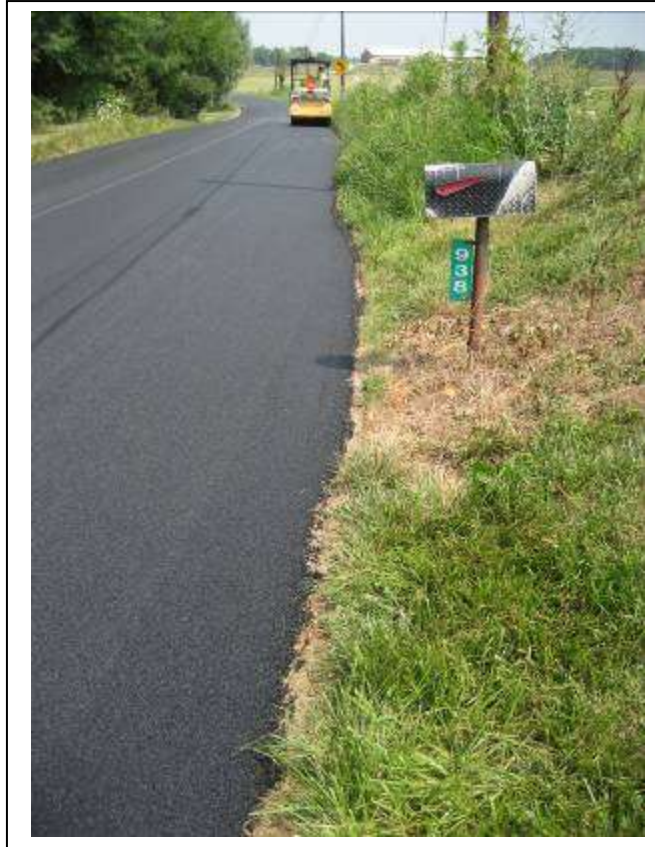
Figure 6. Variable pavement width along the project and shoulder condition.

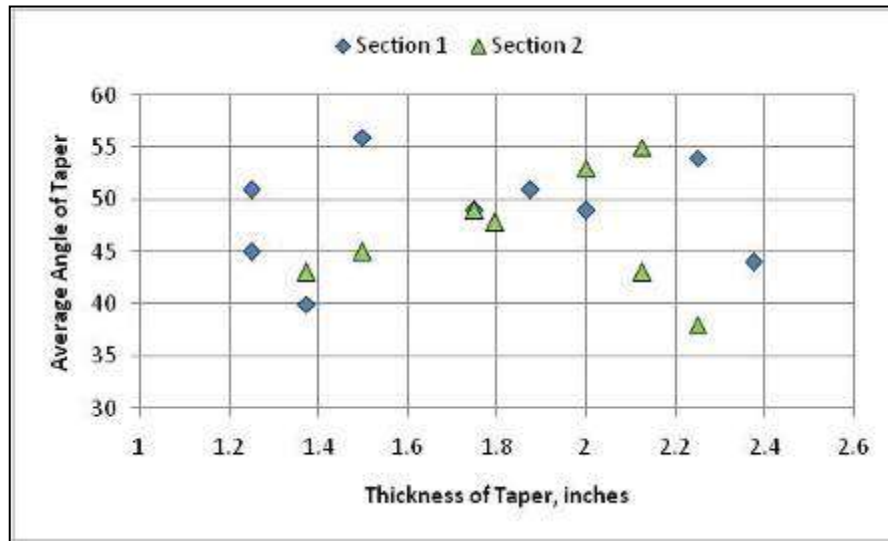
Slope measurements were taken using a straight-edge to measure the width and thickness of the taper of the Safety Edge_{SM} (refer to Figure 8). The average slope of the Safety Edge_{SM} was 48°. Table A-1 in Appendix A contains slope measurements recorded at each individual measurement location. Only one of the measurements was less than 40°. Figure 9 includes a comparison between the slope of the Safety Edge_{SM} and mat thickness at the Safety Edge_{SM} for the two test sections. As shown, there appears to be no correspondence between mat thickness and the slope of the Safety Edge_{SM}.

Figure 9. Comparison of the Safety Edges_{SM} slope and mat thickness adjacent to the edge.

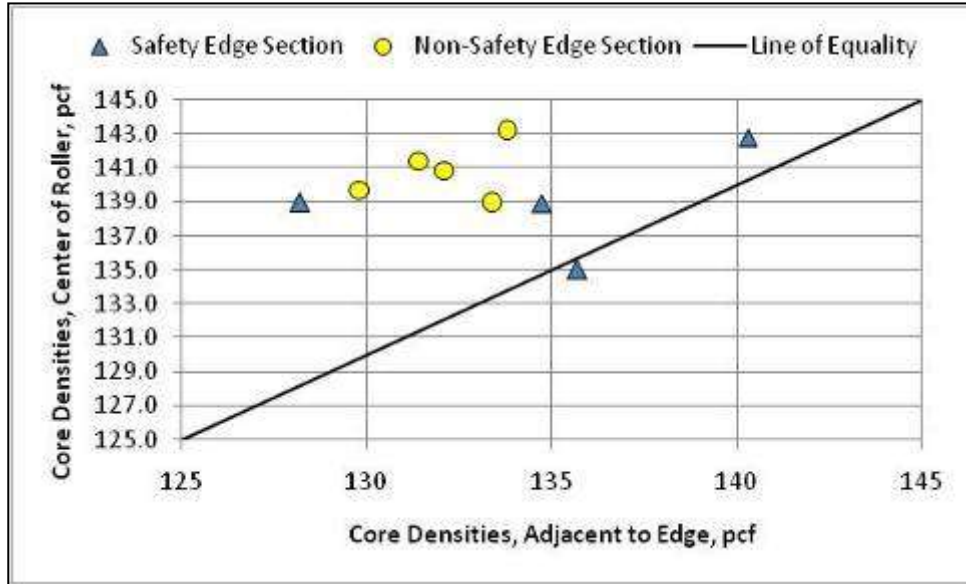
Tables A-2 and A-3 in Appendix A include a summary of the core thickness and bulk specific gravities (saturated surface dry) converted to bulk densities. Figure 11 shows a comparison of the core densities taken along the edge and near the center of the steel drum roller for the Safety Edge_{SM} and non-Safety Edge_{SM} sections. As expected the densities near the center of roller are significantly higher than along the edge of the mat (unconfined edge). More importantly, the core densities taken along the pavement's edge are consistently higher for the Safety Edge_{SM} section than for the non-Safety Edge_{SM} section. Only one of the cores taken along the edge of the Safety Edge_{SM} section was found to have a lower density than for the non-Safety Edge_{SM} section. These results suggest that the Safety Edge_{SM} is providing better confinement for rolling the unconfined edge of the mat.

Figure 11. Comparison of core densities adjacent to the edge of pavement and near the center of the steel drum roller.

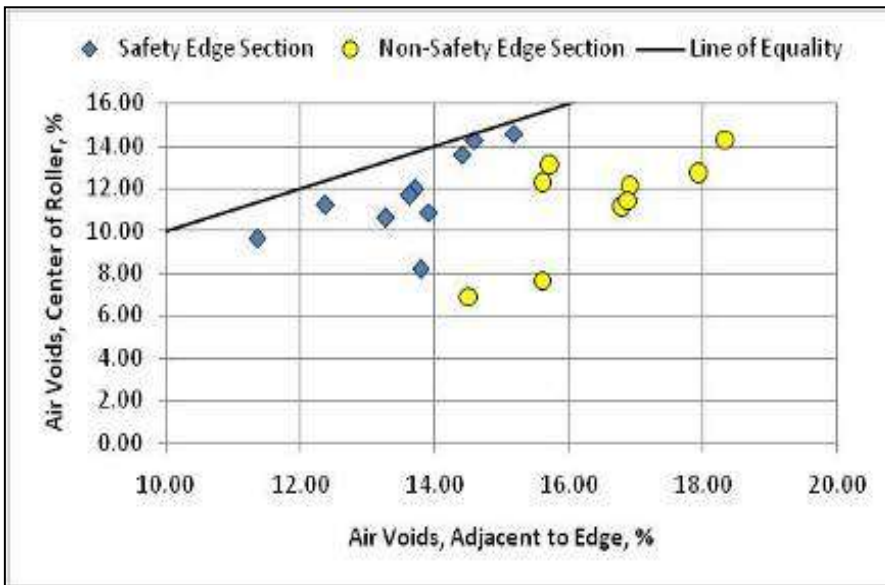
Figure 13 shows a comparison of the adjusted nuclear density gauge readings taken adjacent to the Safety Edge_{SM} and in the center of the vibratory steel wheel roller. Figure 13 also includes a comparison of the HMA air voids between both areas. As shown, the air voids are much higher adjacent to the Safety Edge_{SM}, but are higher than desirable for both areas. The other important observation from this data is that the density is higher and the air voids are consistently lower for the Safety Edge_{SM} sections, in comparison to the non-Safety Edge_{SM} section.

Figure 13. Comparison of the adjusted nuclear density readings and air voids between the areas adjacent to the edge and center of the steel drum roller.

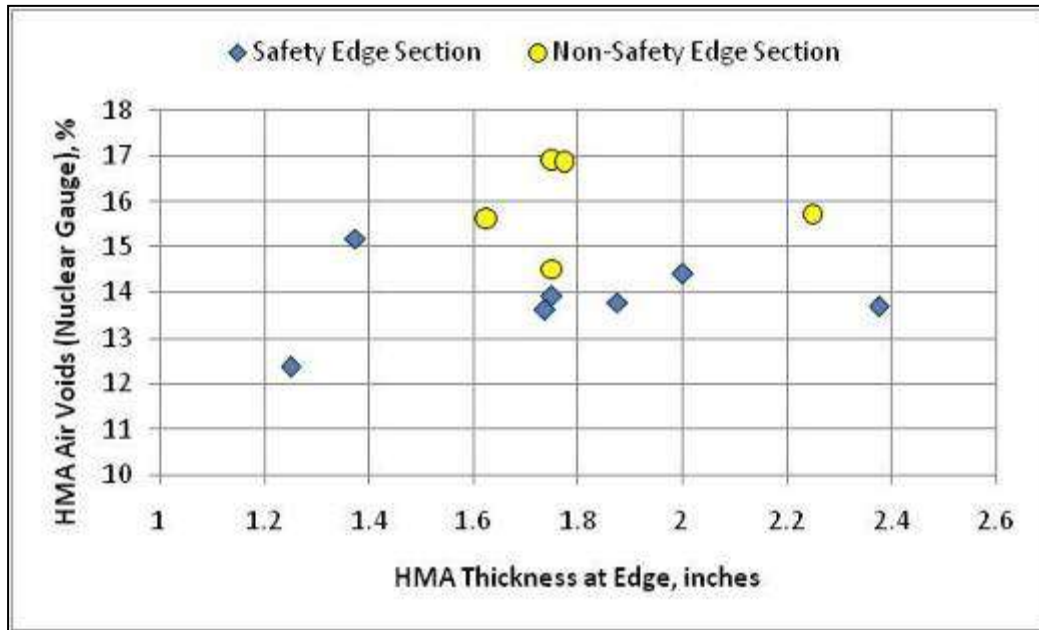
Figure 14 compares the HMA mat thickness (near the Safety Edge_{SM}) and slope of the Safety Edge_{SM}. As shown, the thickness of the HMA mat appears to have no effect or impact on the slope of the Safety Edge_{SM} device.

Figure 14. Comparison of HMA thickness at the edge of the mat and HMA air voids.

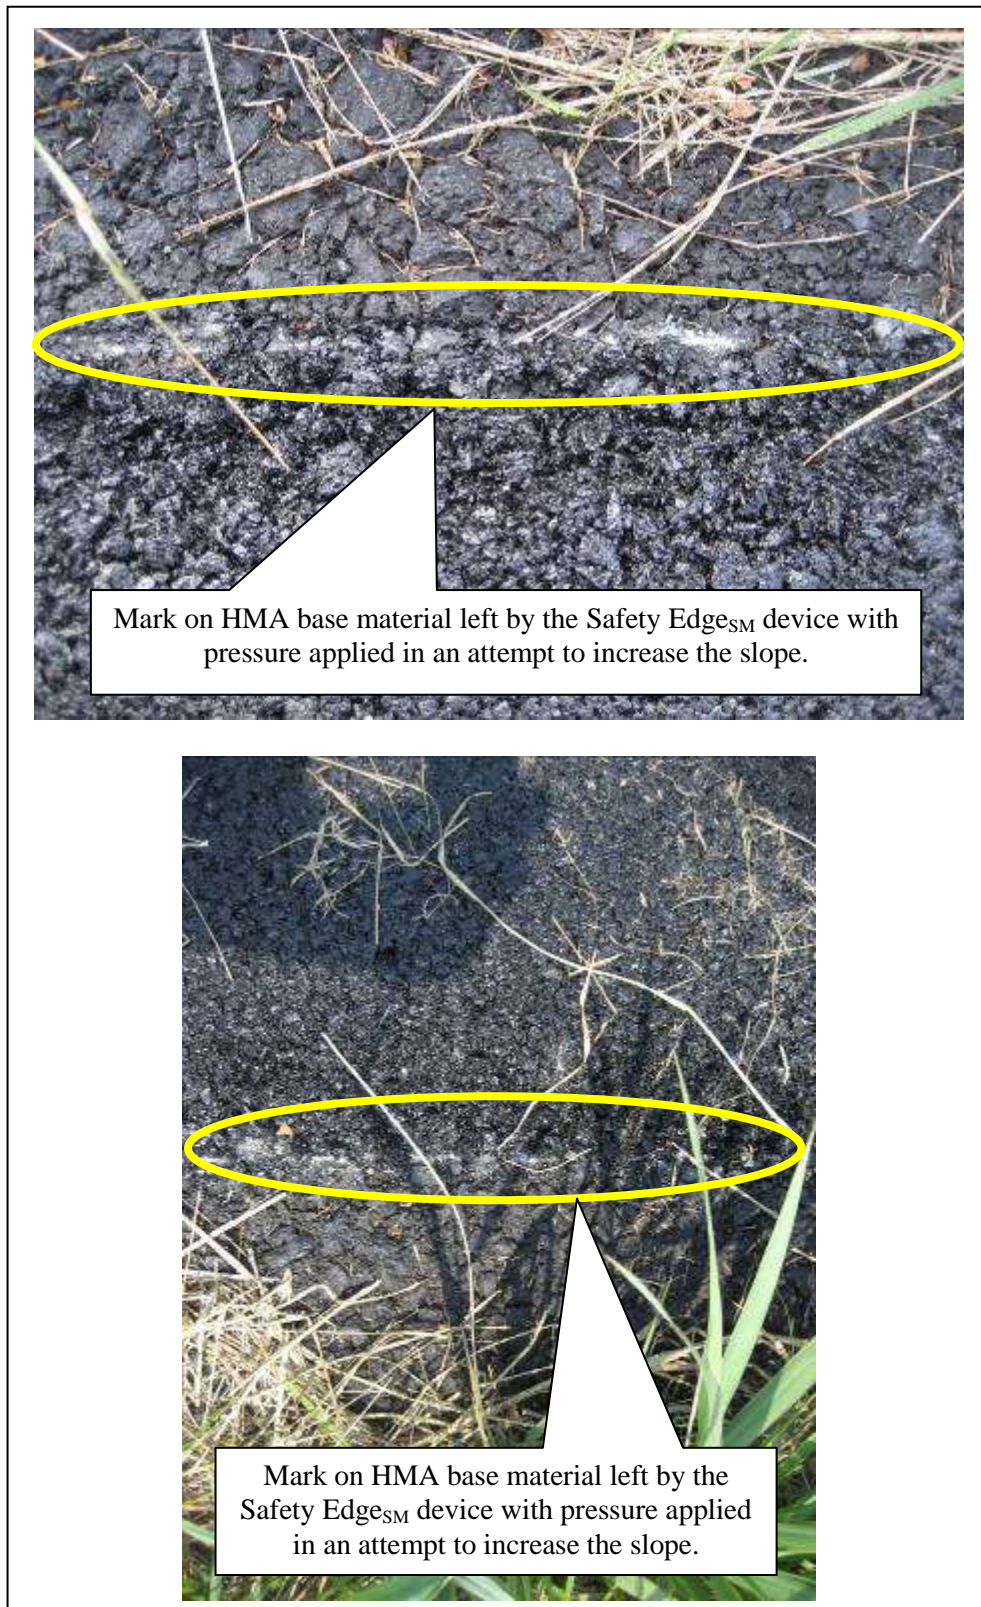
Edge_{SM} device down onto the HMA base in accordance with the manufacturer recommendations, which was evident by scratch marks on the surface of the HMA base (refer to Figure 18 that shows this condition). It is expected that excessive downward pressure exerted on the Safety Edge_{SM} device could cause the screed to rise in areas where the device was in contact with the HMA base. To prevent this condition, the screed operator suggested raising the Safety Edge_{SM} device to a height about 0.5 inches above the bottom of the end plate. The screed operator also suggested attaching the Safety Edge_{SM} device to the screed end plate rather than to the screed. The screed end plate, however, would need to be significantly stiffened.

Figure 18. Gouges in the HMA left by the Safety Edge_{SM} device riding on the surface of HMA base mix.

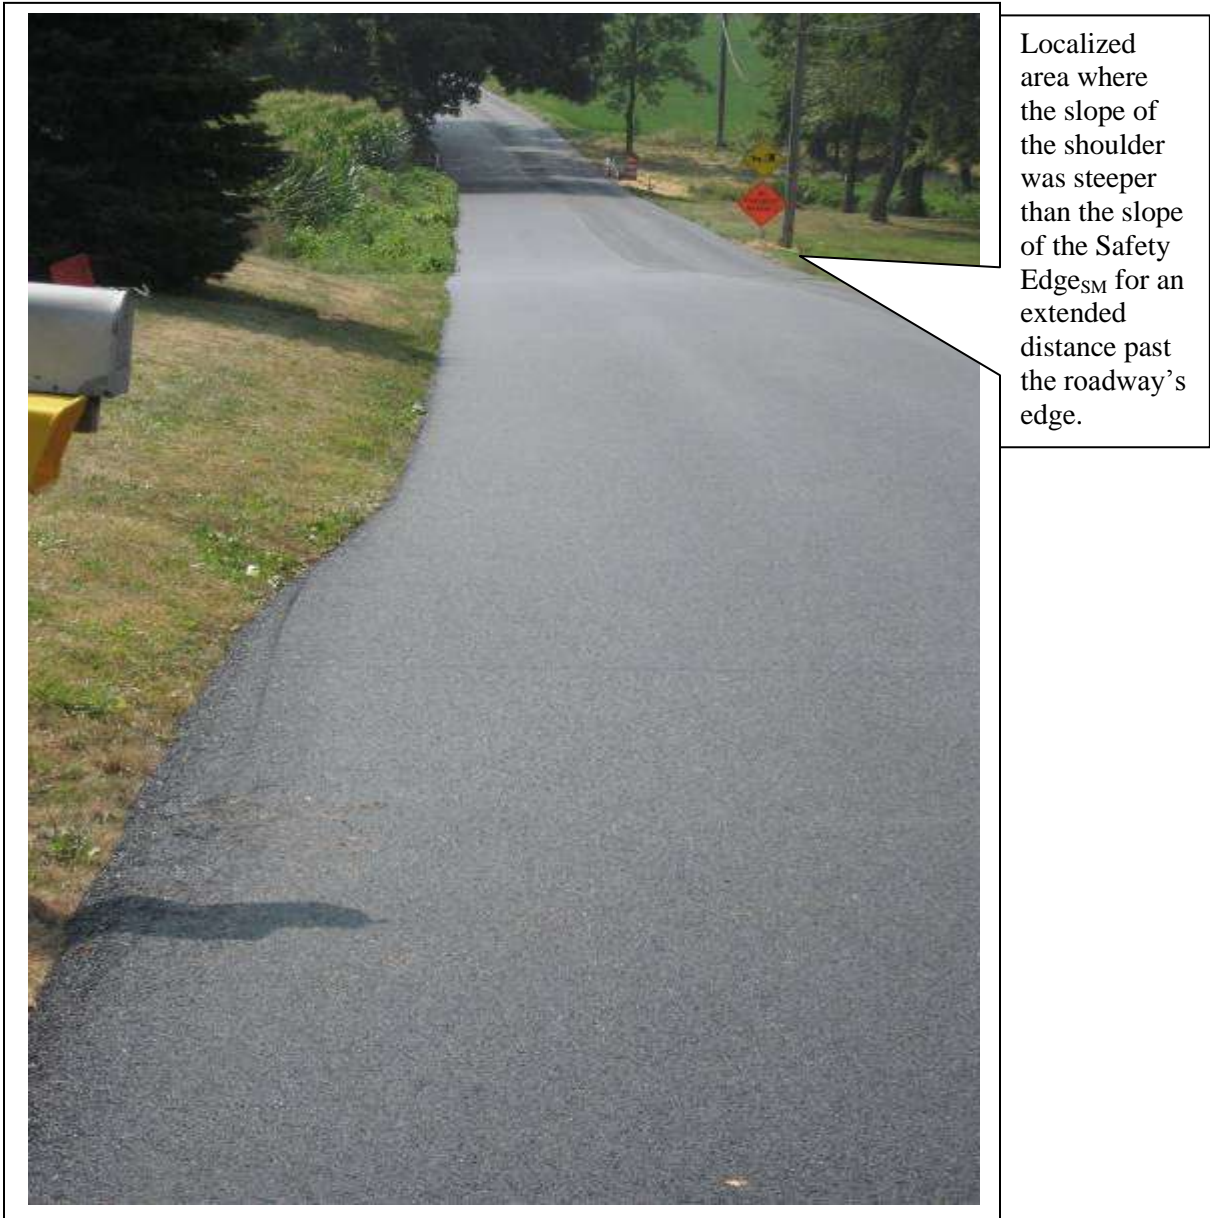
- There were localized areas along the northern portion of the project where the slope of the shoulder was steeper than 30° for an extended distance past the pavement's edge. In these areas, the screed operator did not extend the screed out, but raised the Safety Edge_{SM} device and lowered the screed end plate ski to create a non-Safety Edge_{SM}. This is what the screed operator should do under these conditions. One of these areas is shown in Figure 19.

Figure 19. Area where the slope of the shoulder was steeper than the Safety Edge_{SM} slope.

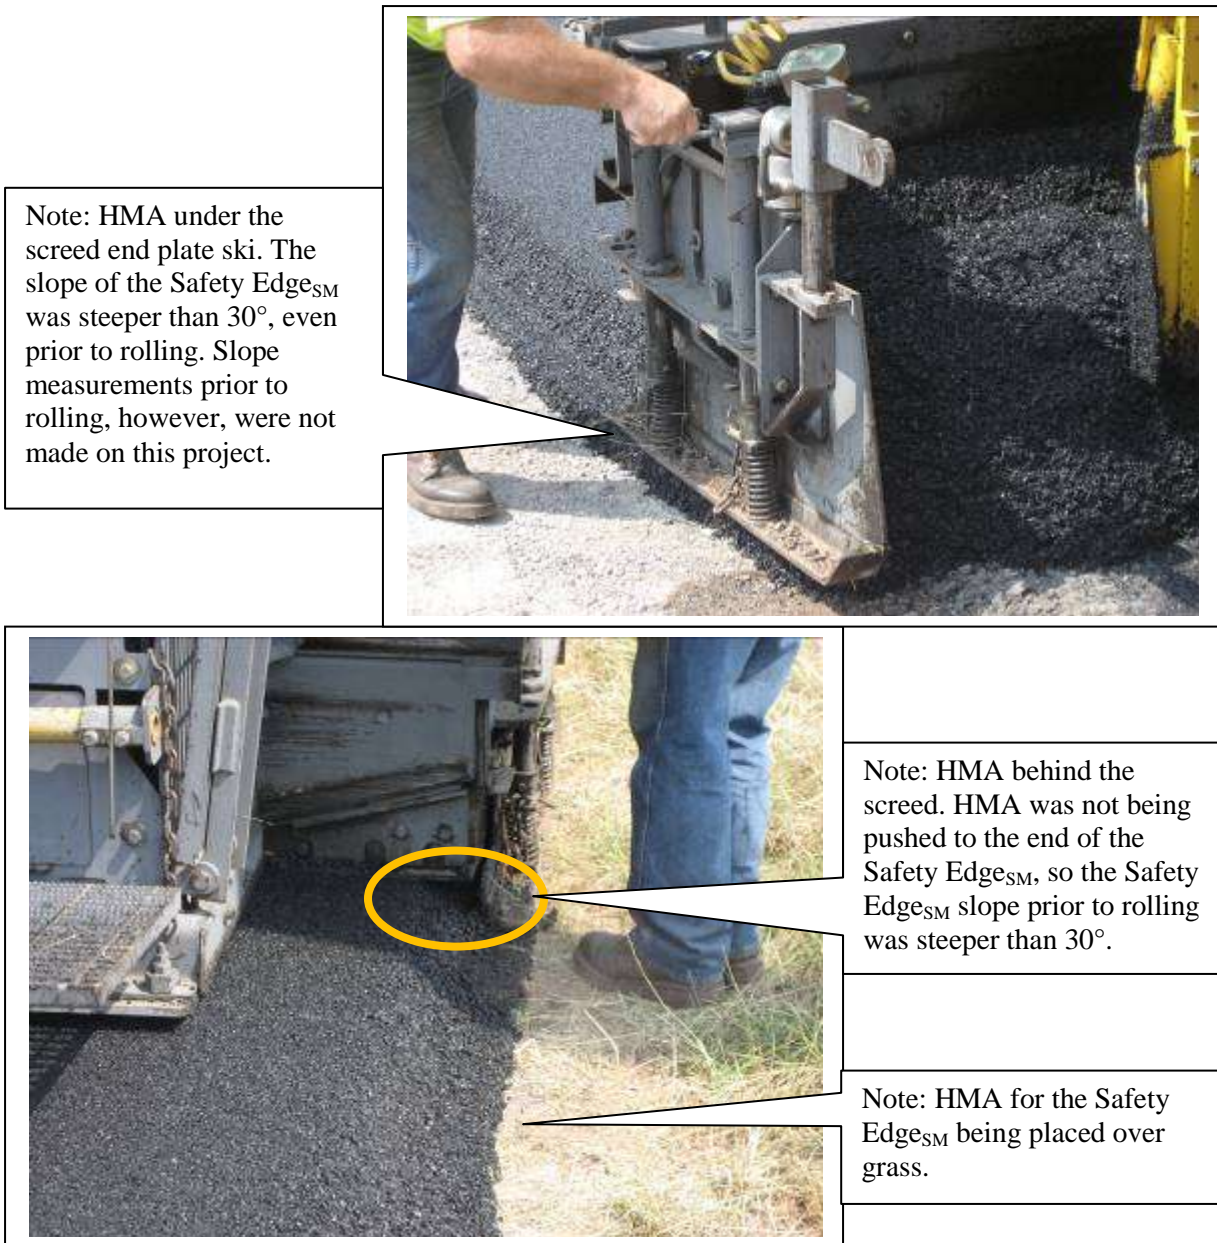
Observations made during paving showed that the HMA mixture was not being pushed to the end of the Safety Edge_{SM} device. Figure 23 shows HMA behind the screed and the Safety Edge_{SM} slope prior to rolling. The slope of the Safety Edge_{SM} was steeper than planned prior to rolling because the mix was not being pushed to the end of the Safety Edge_{SM}. The specific reason for the HMA not being pushed to the end of the Safety Edge_{SM} device is unknown for this project. The only mixture design parameter that might have an impact on the slope of the Safety Edge_{SM} and surface texture, however, was voids in the mineral aggregate (VMA). The design VMA was reported to be 17.4 and is considered high for this HMA mixture. It is unknown whether the higher VMA resulted in the steeper slopes measured along this project.

Figure 23. HMA shown under and behind the screed; the HMA was not pushed to the end of the Safety Edge_{SM} resulting in a steeper slope prior to rolling.
