# ND Condition Assessment of George Washington Memorial Parkway/Arlington Memorial Bridge

TRB 93<sup>rd</sup> Annual Meeting  
LTBP Program Workshop – Program Briefing  
Washington, DC – Thursday January 16, 2014

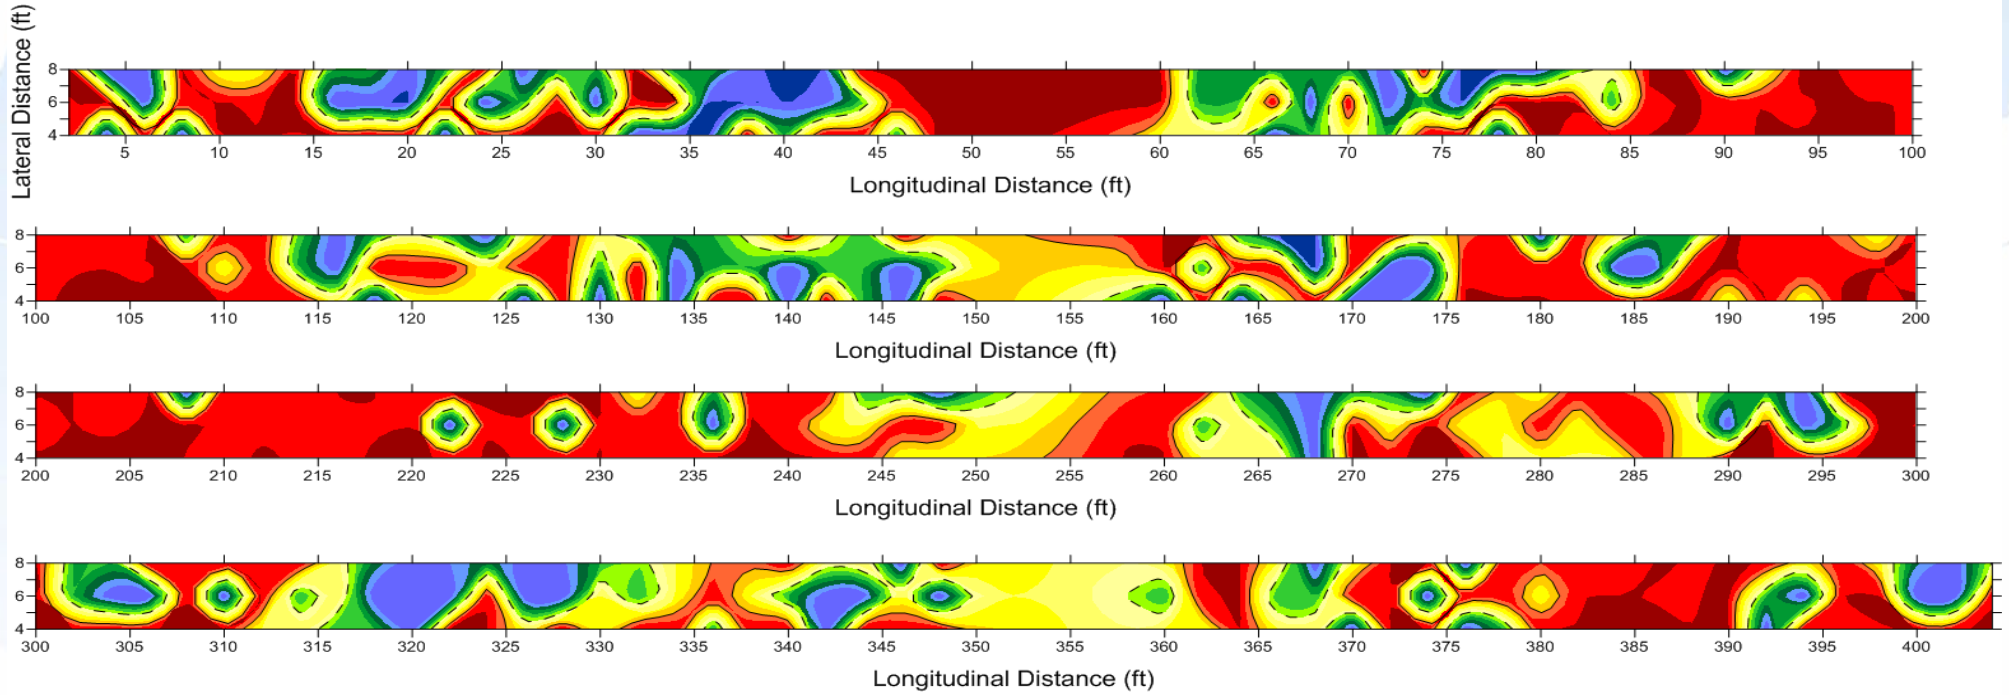
# Delamination Assessment – Lane 1 (Lincoln Memorial Side)

***Because of the asphalt overlay, some detection is a result of asphalt debonding, or disintegration of near surface concrete.***

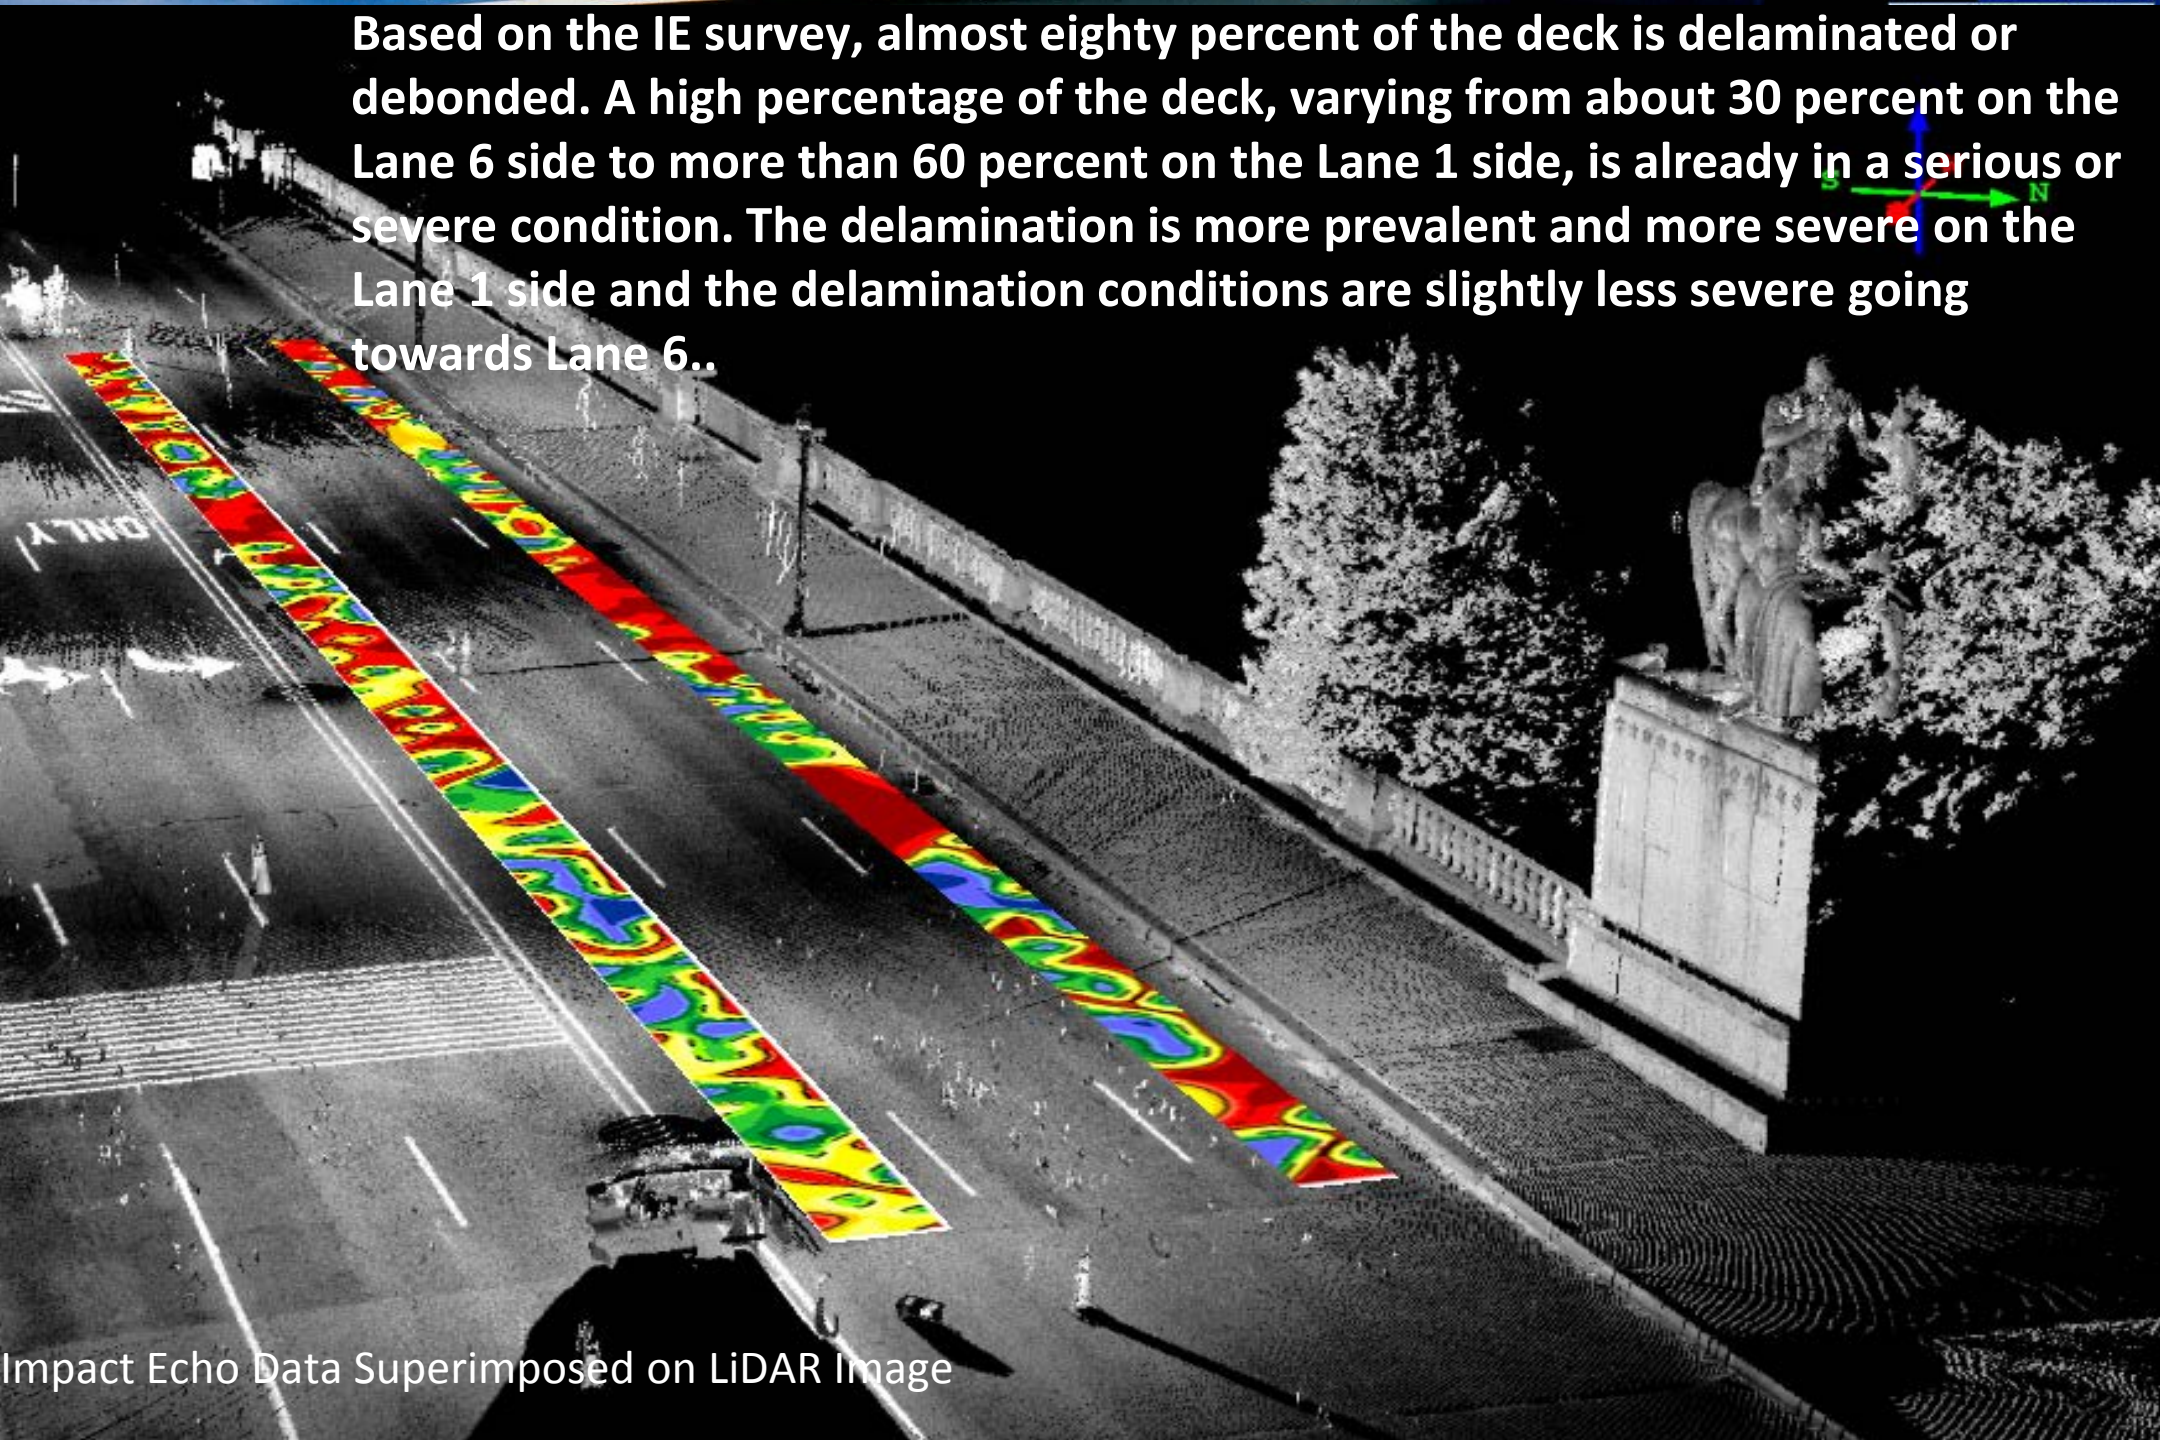
Impact Echo Data Superimposed on LiDAR Image

Based on the IE survey, almost eighty percent of the deck is delaminated or debonded. A high percentage of the deck, varying from about 30 percent on the Lane 6 side to more than 60 percent on the Lane 1 side, is already in a serious or severe condition. The delamination is more prevalent and more severe on the Lane 1 side and the delamination conditions are slightly less severe going towards Lane 6..

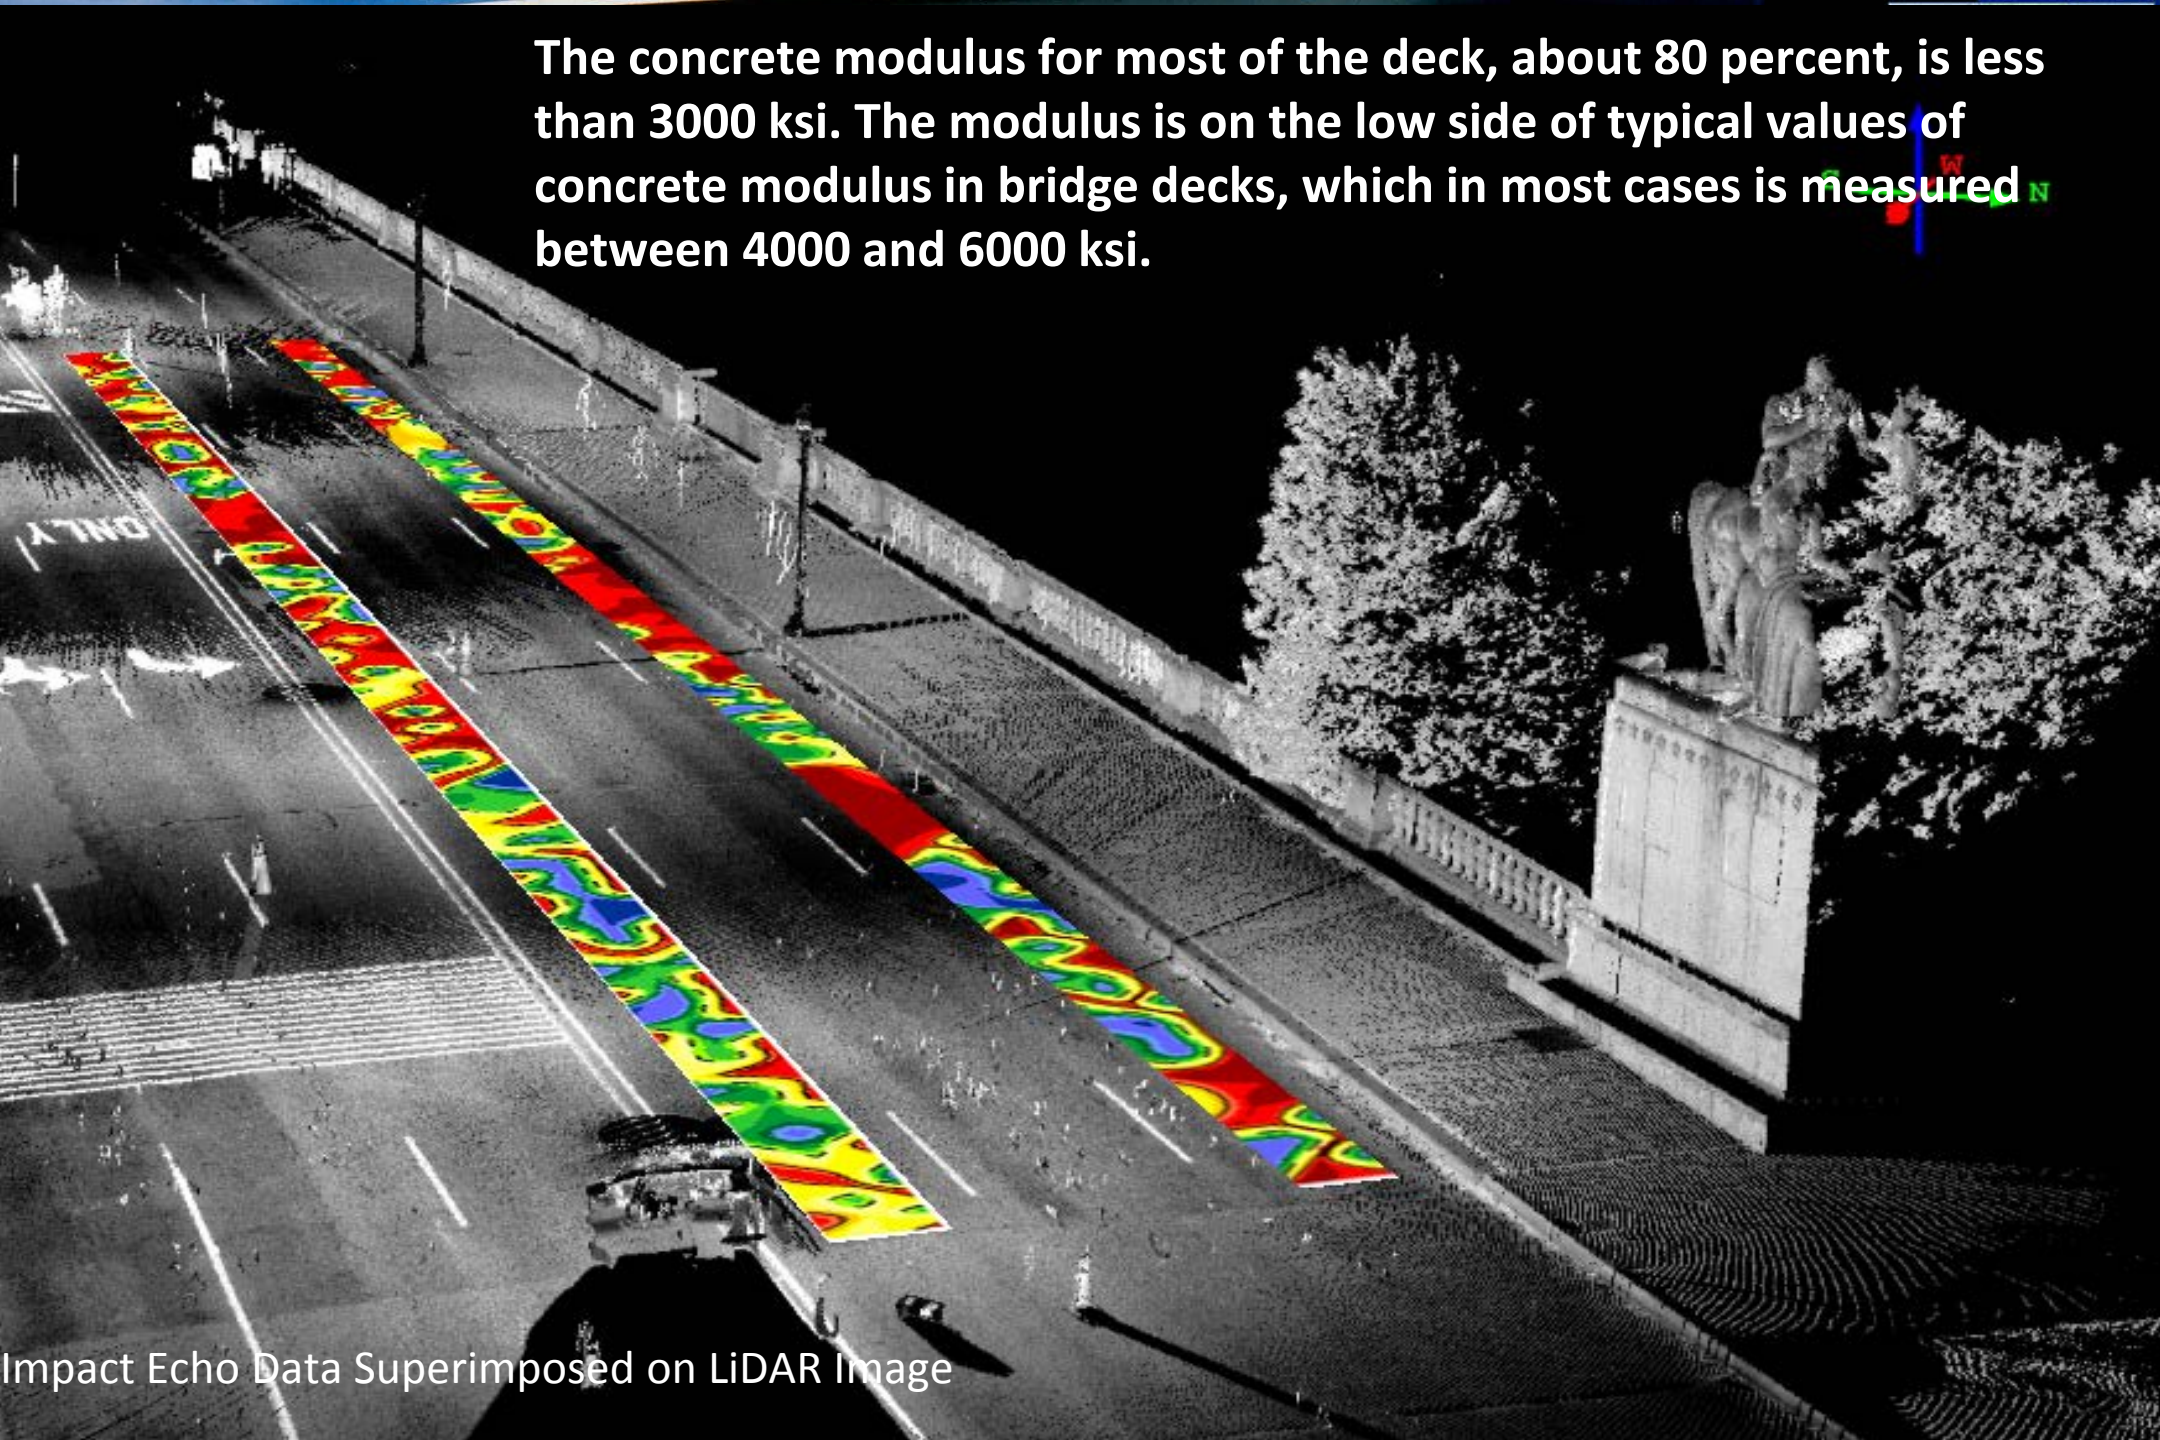
Impact Echo Data Superimposed on LiDAR Image

The concrete modulus for most of the deck, about 80 percent, is less than 3000 ksi. The modulus is on the low side of typical values of concrete modulus in bridge decks, which in most cases is measured between 4000 and 6000 ksi.

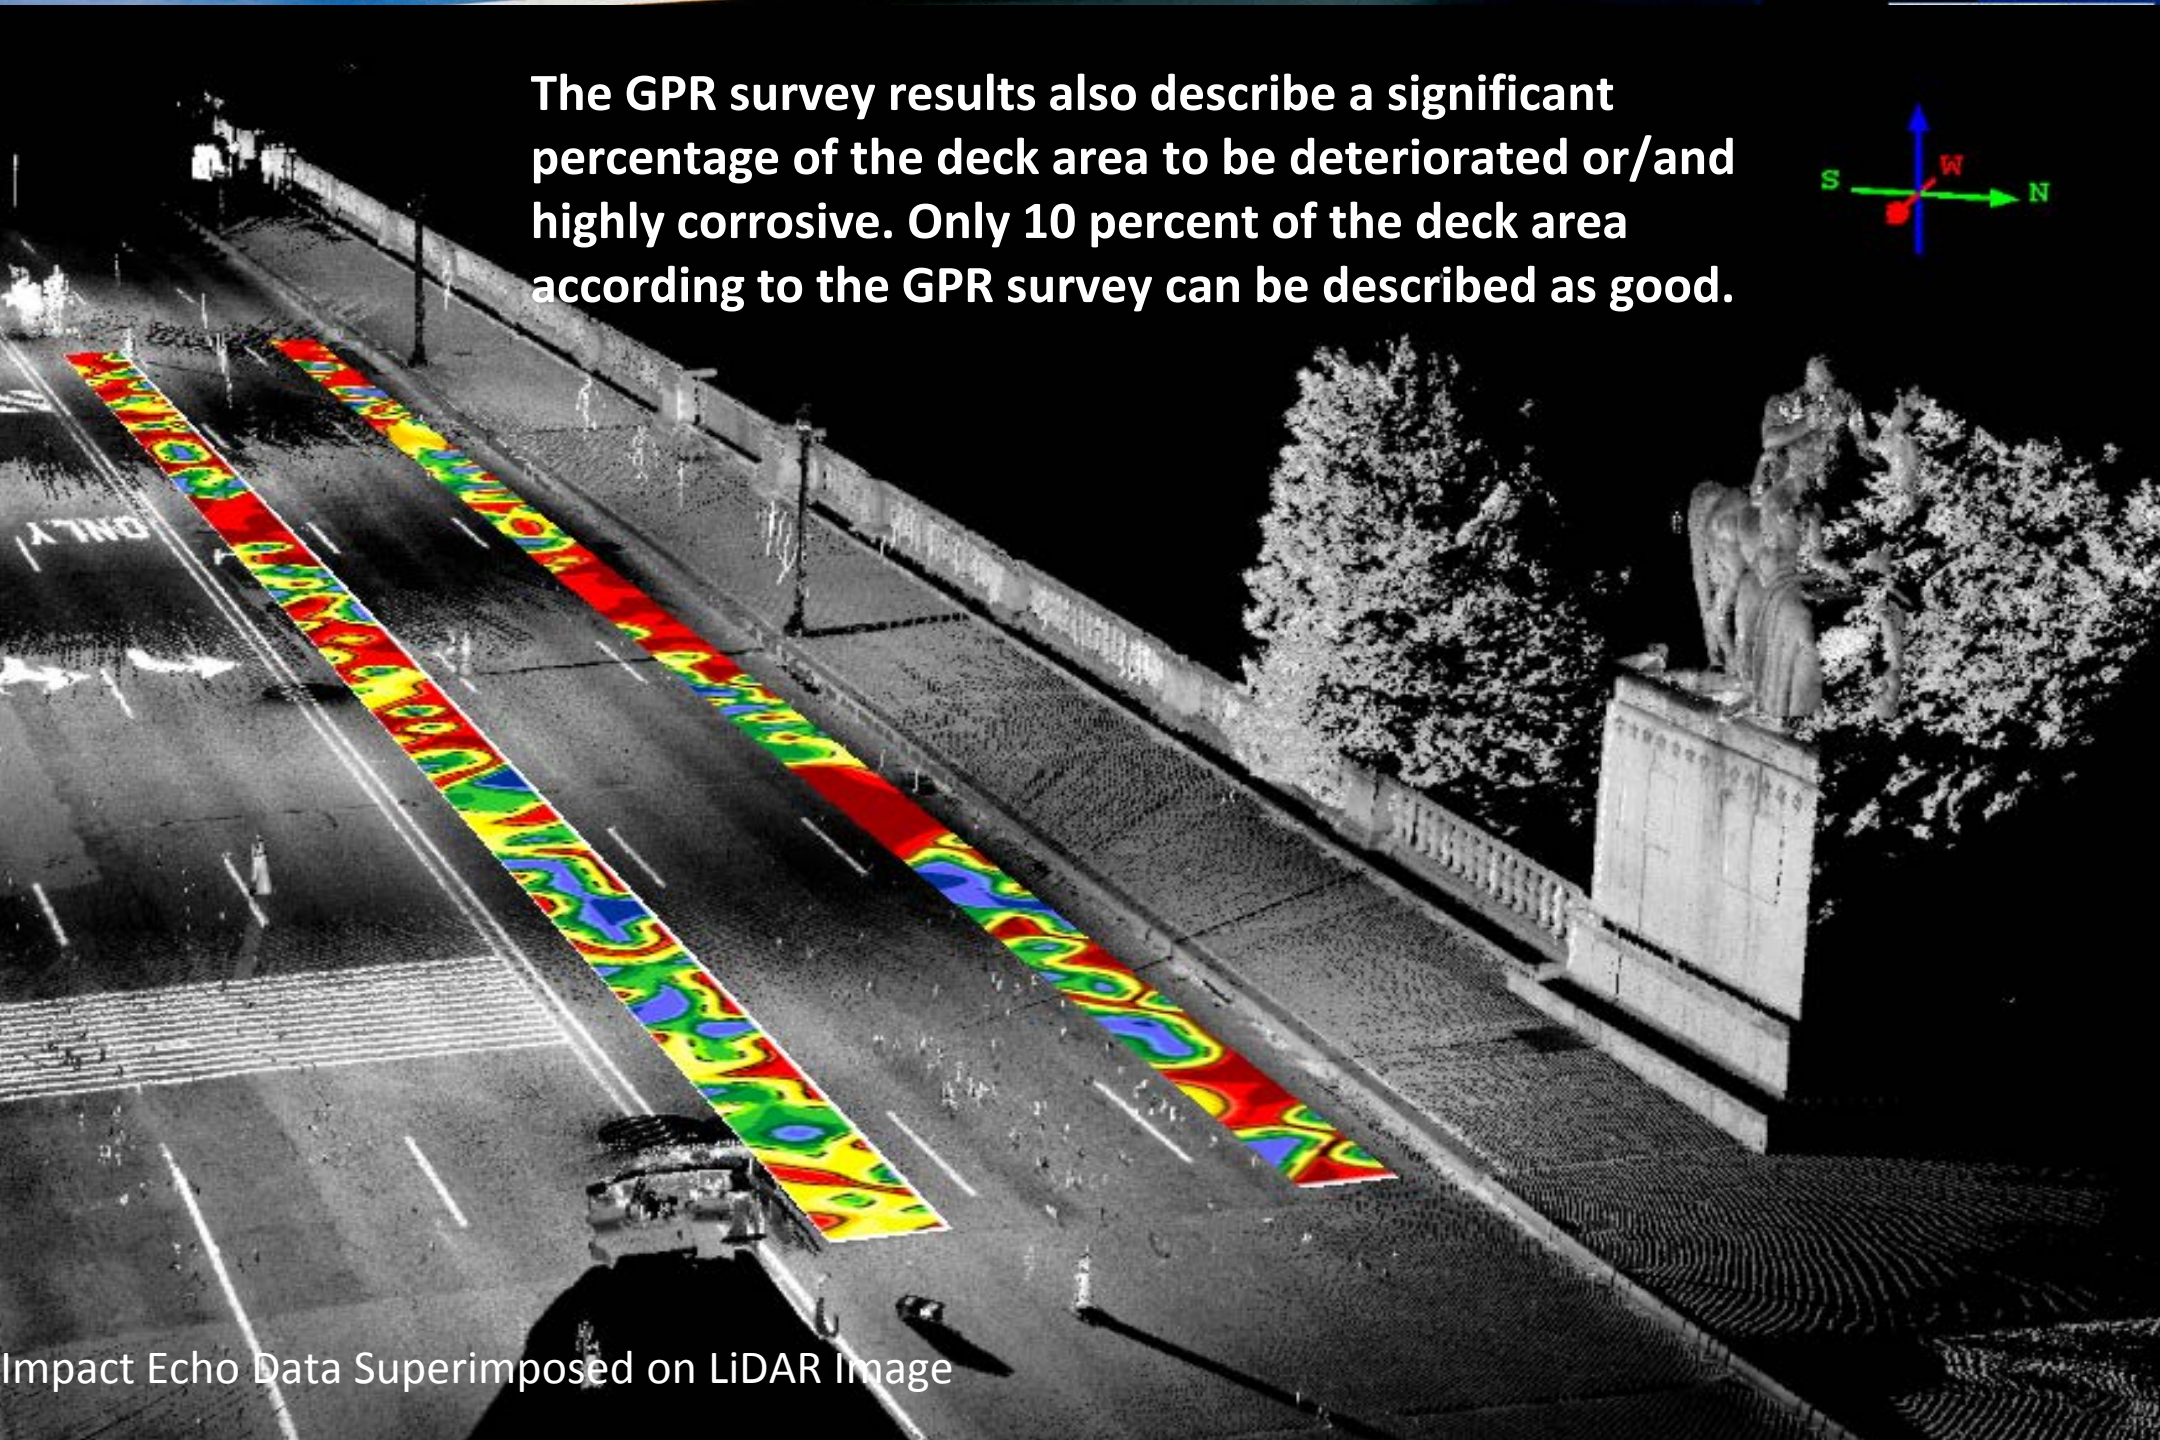
Impact Echo Data Superimposed on LiDAR Image

The GPR survey results also describe a significant percentage of the deck area to be deteriorated or/and highly corrosive. Only 10 percent of the deck area according to the GPR survey can be described as good.
