U.S. Department
of Transportation
**Federal Highway
Administration**

February 1995

Maintenance of Pavement Underdrain System

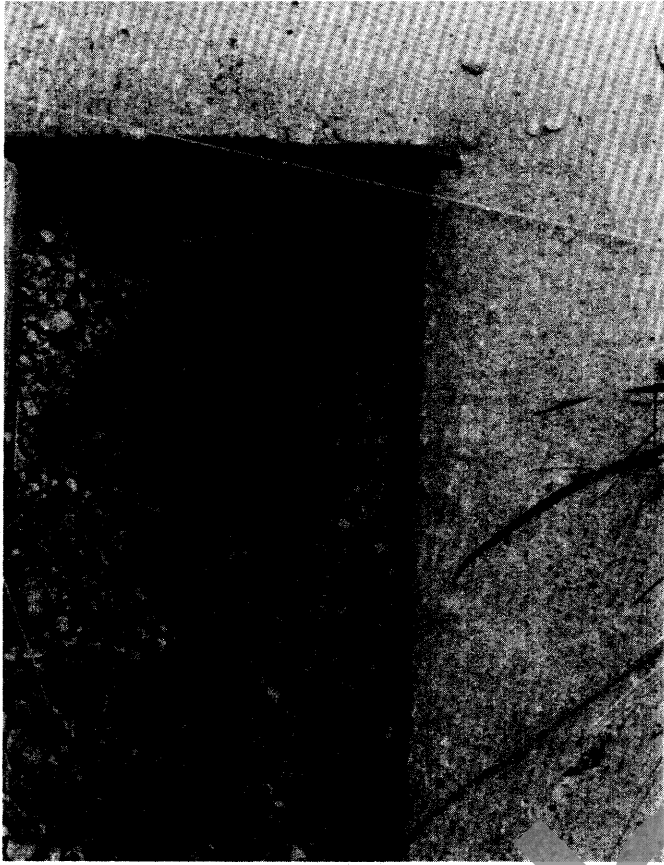
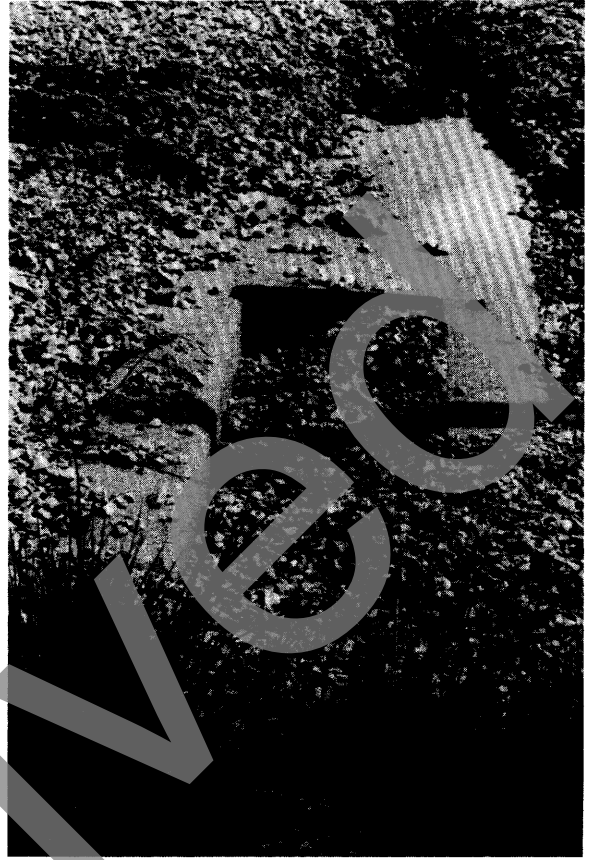
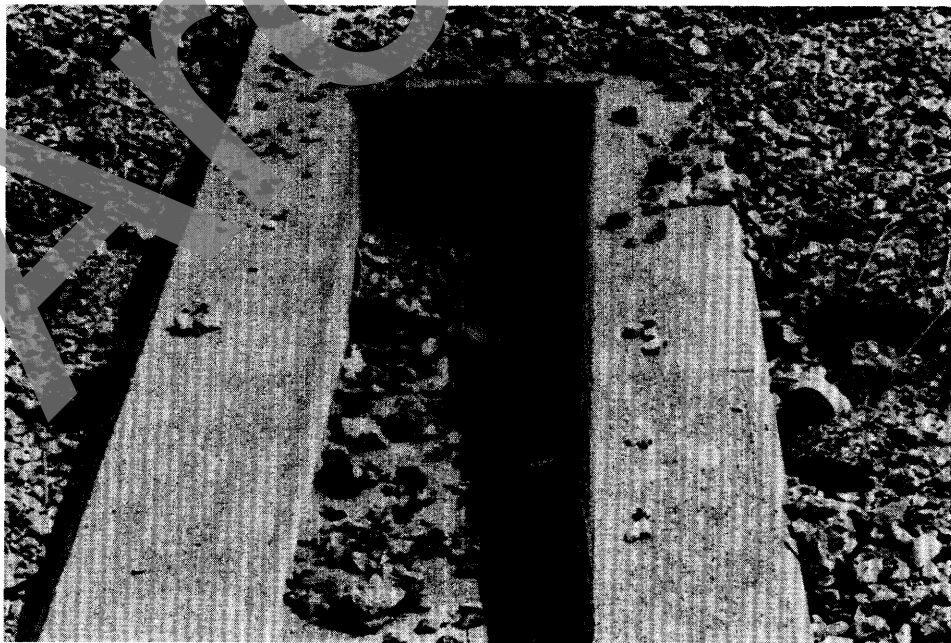
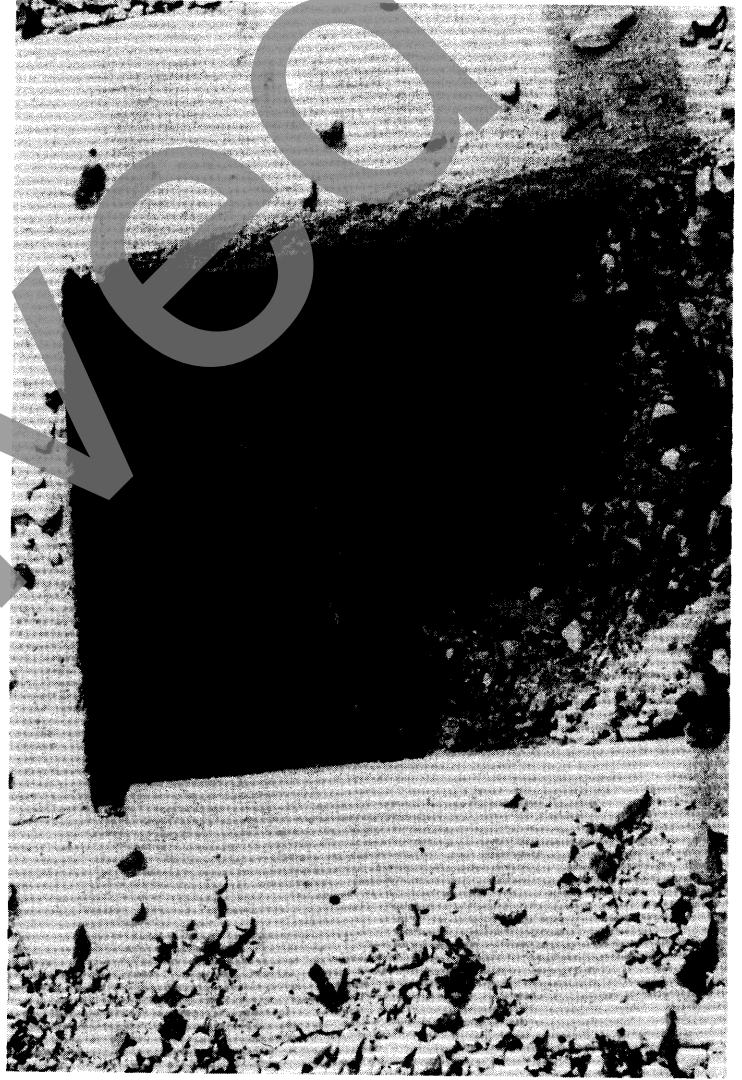
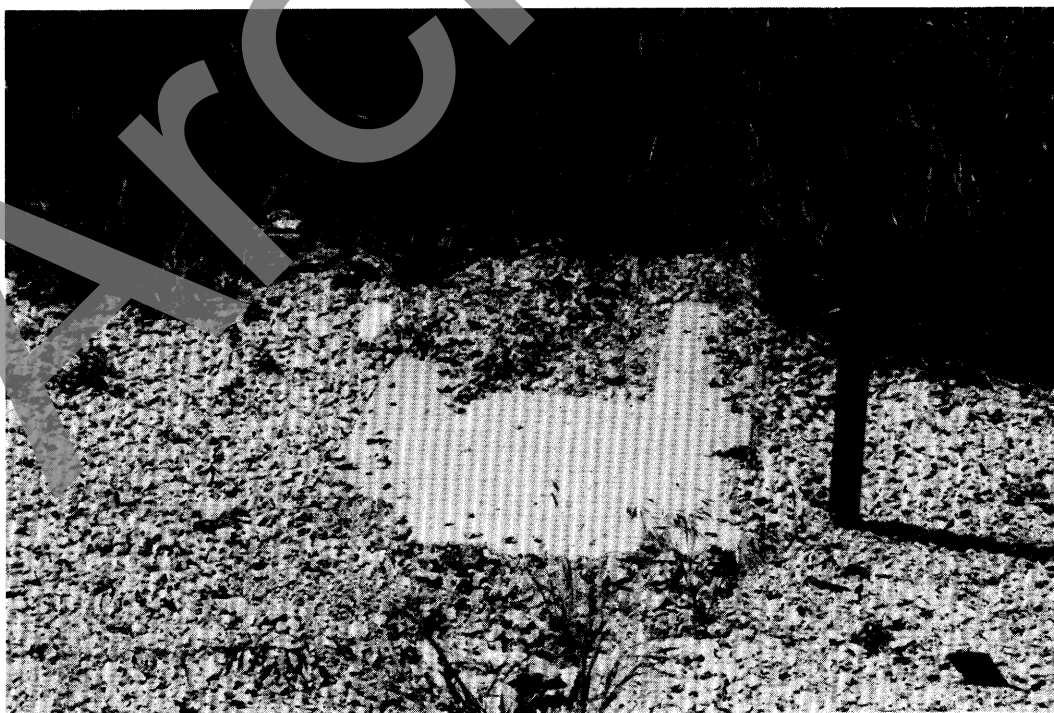
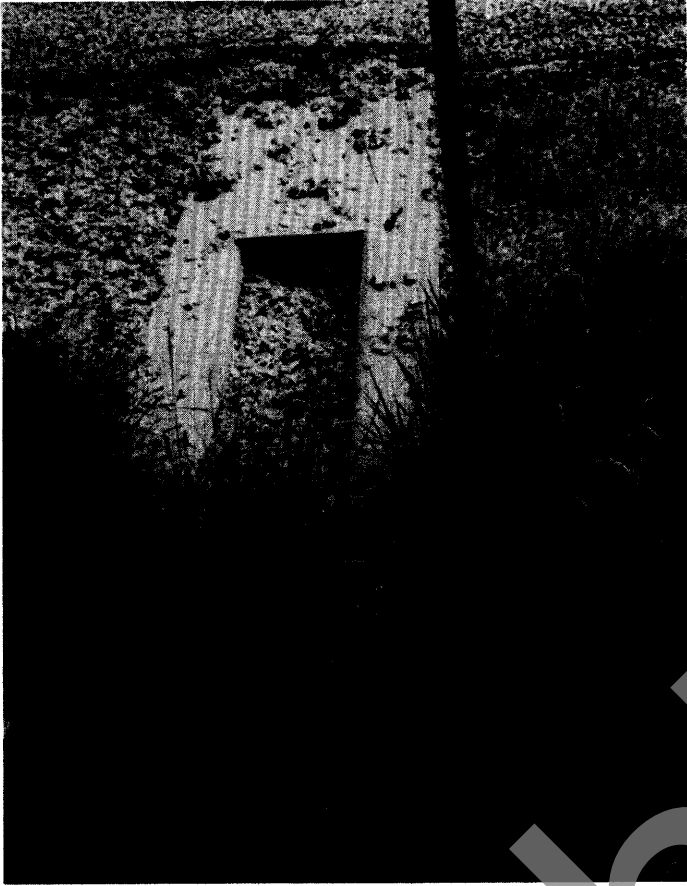
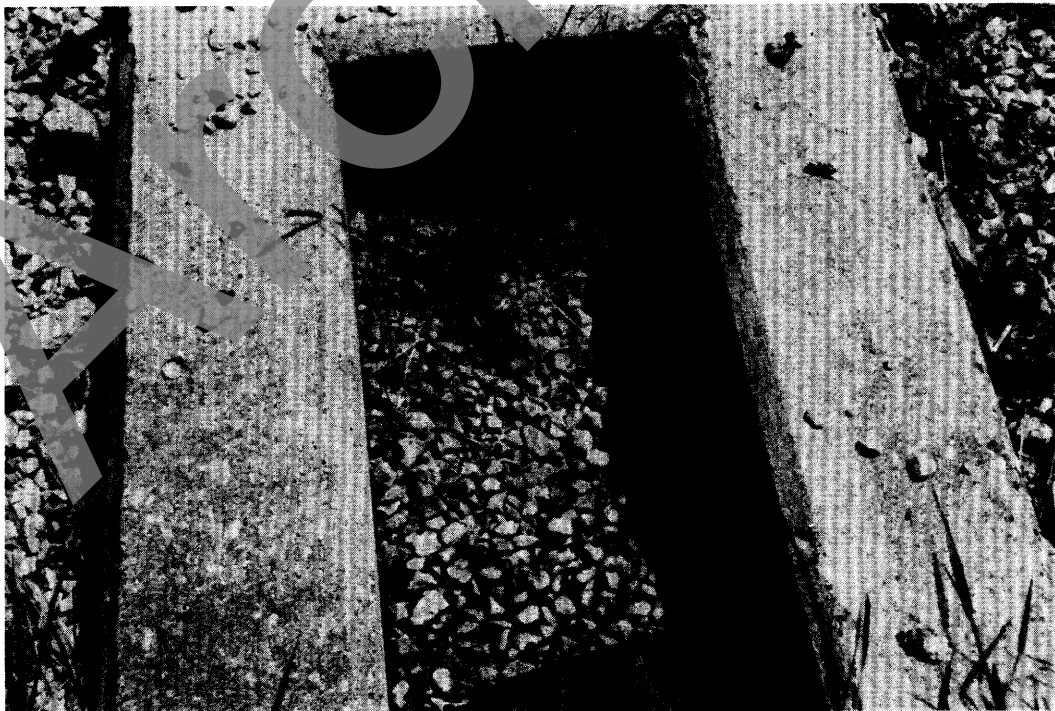
ROCK BLOCKING OUTLET

- **Rock Blocking Outlet, Attachment A**
Crushed stone from the shoulders was found to be the most consistent and probable cause of the blockage. Occasional maintenance checks should have greatly eliminated this problem.

- Dense graded aggregate and/or chip seal aggregate from the shoulder had filled numerous troughs resulting in the pipes becoming totally clogged.

It is recommended that a list of locations of headwall troughs prone to blockage be kept so frequent checks are assured.

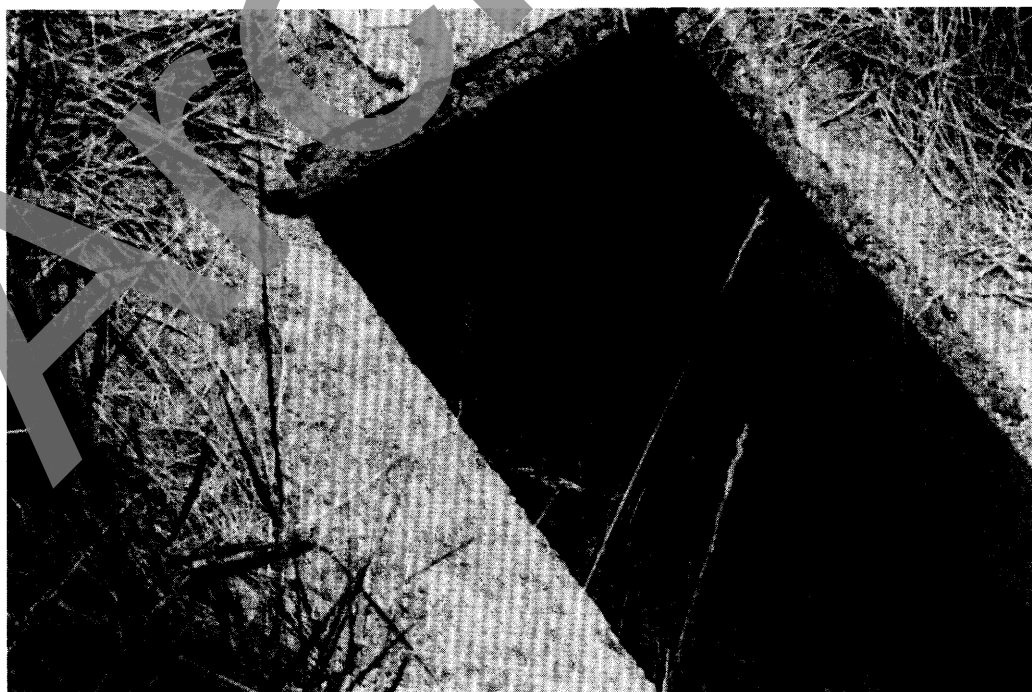
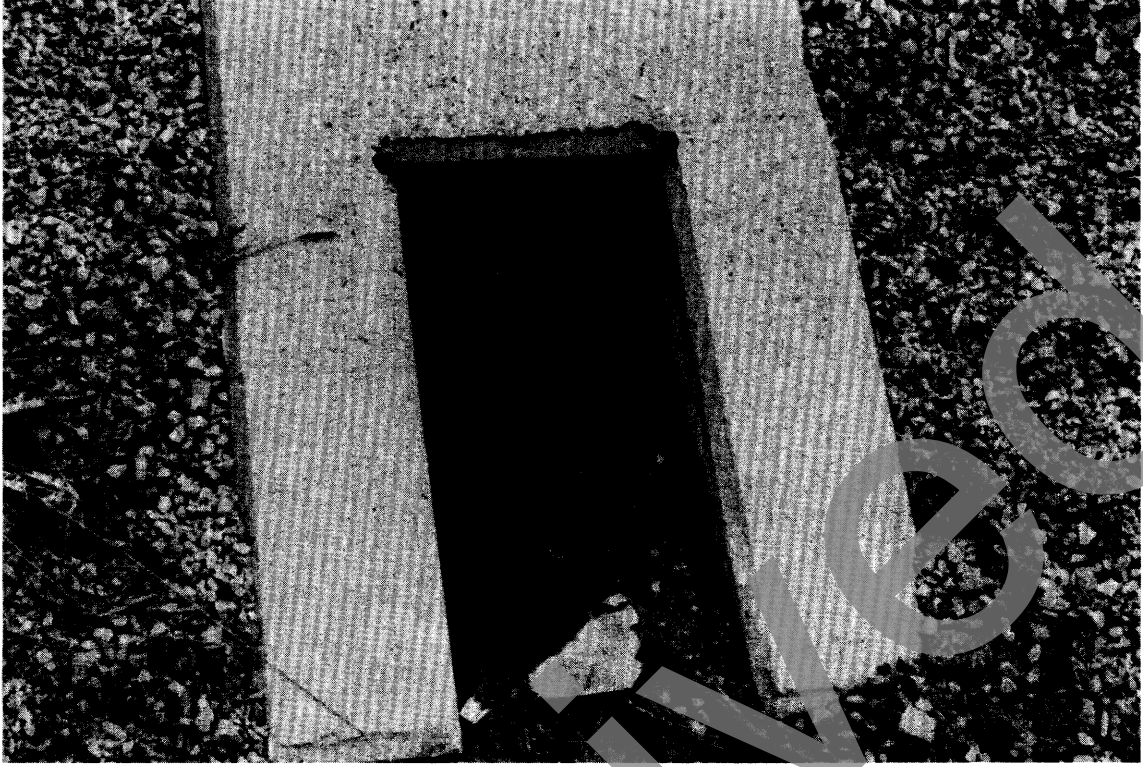
SILTED HEADWALL TROUGHS

- **Silted Headwall Troughs, Attachment B**
Partially blocked headwall troughs allowed silt to build-up in the troughs preventing silt from being washed through the trough. Some large cut sections have ditches filled with material possibly completely covering the headwalls.

- There were numerous headwall troughs completely full and many more partially filled from sediment.

It is recommended that the design for underdrain pipe headwalls be revised to have the pipe outlet above the headwall apron to allow for some sediment, if routine maintenance is expected to be haphazard and infrequent.

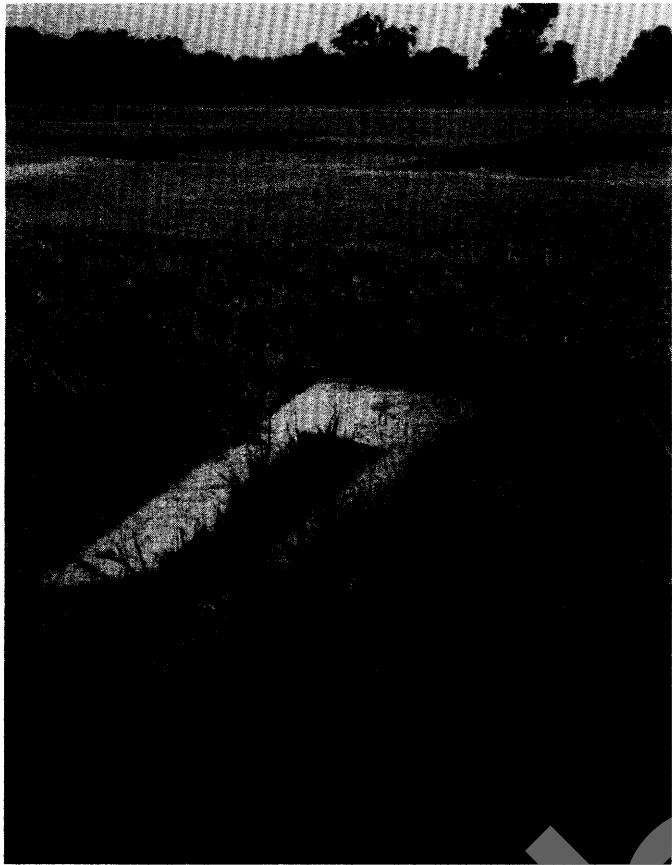
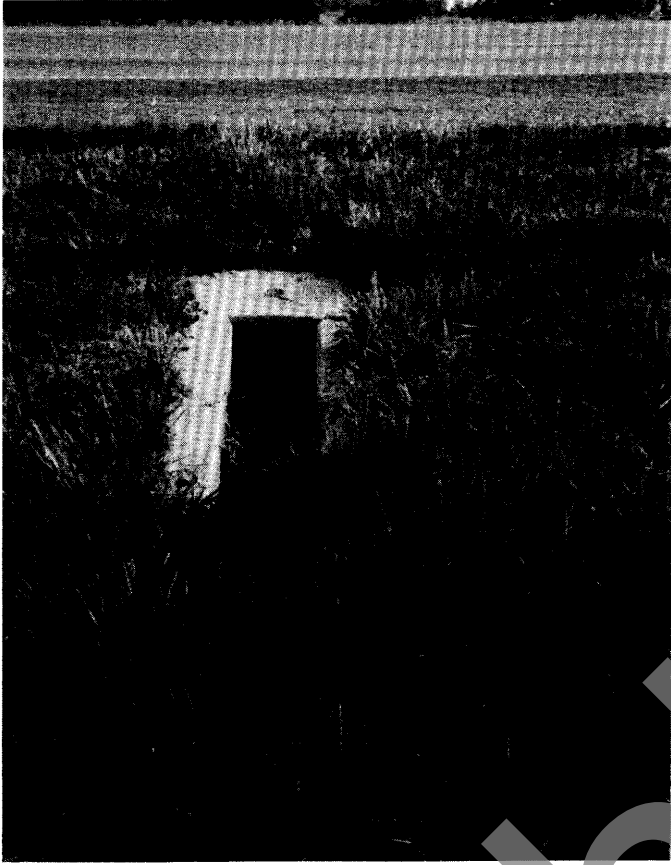
VEGETATION BLOCKING OUTLET

- **Vegetation Blocking Outlet, Attachment C**
Vegetation retains the silt causing gradual build-up to where many outlets were largely blocked. Trimmings from mowing operations were found to be the cause of some blockages.

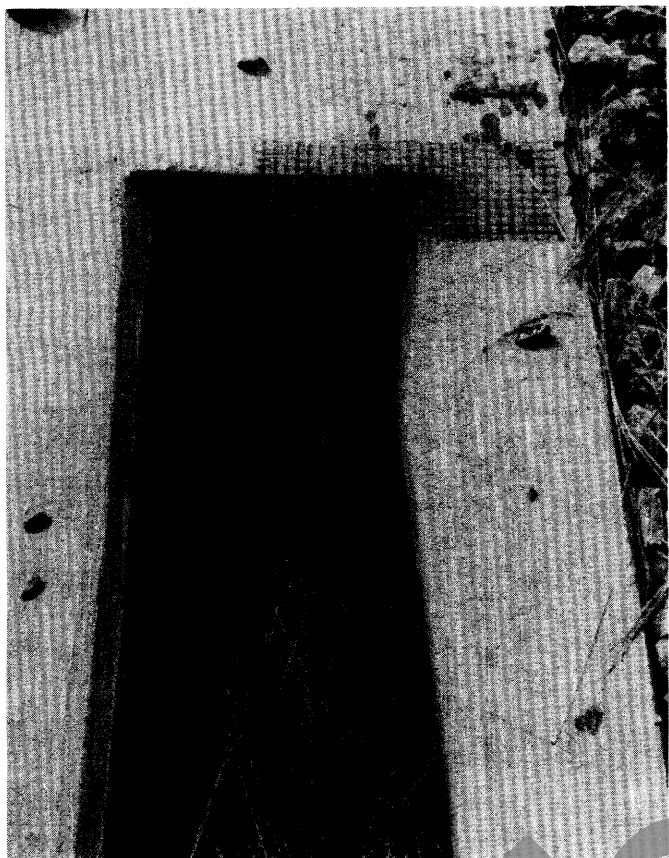
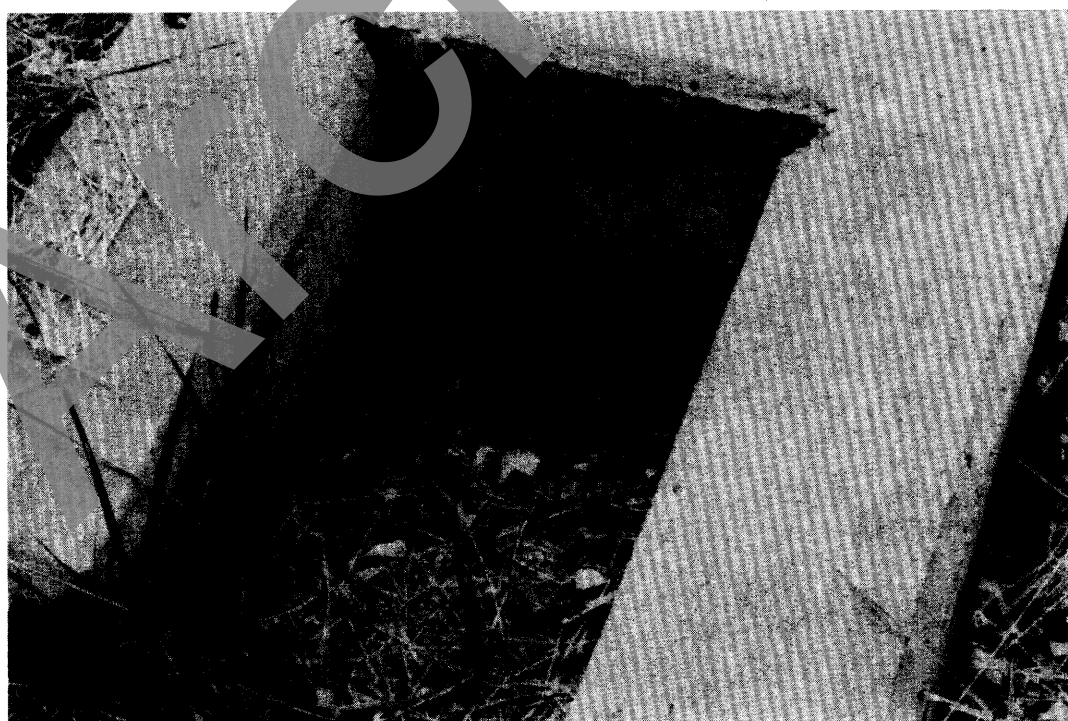
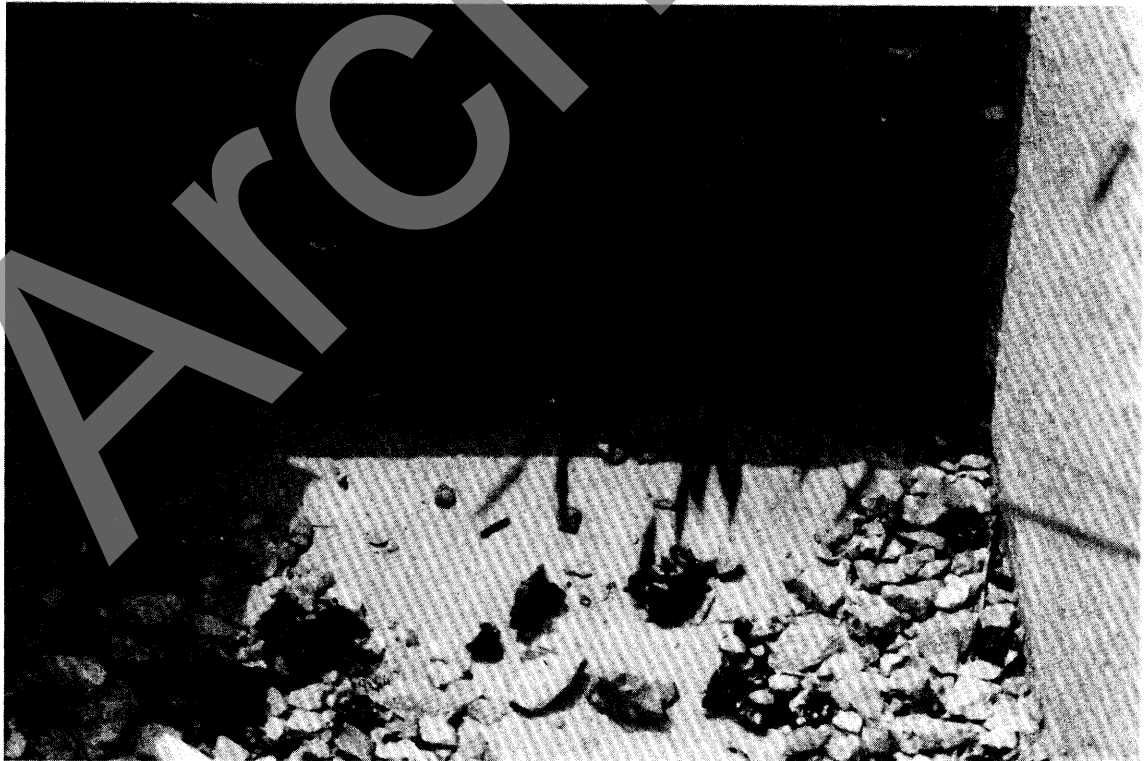
CLOGGED OUTLET PIPE

- **Clogged Outlet Pipe, Attachment E**
Clogged outlet pipes were found at many locations. Some were recent installations. Some had the old heavy type screens. Some pipes were clogged even though the troughs were clear, perhaps cleared after the blockage.

- There were several old-heavy type screens that may have caused the pipes to become silted back of the screens.

It is recommended that consideration be given to removing these screens in areas that silt has built up.

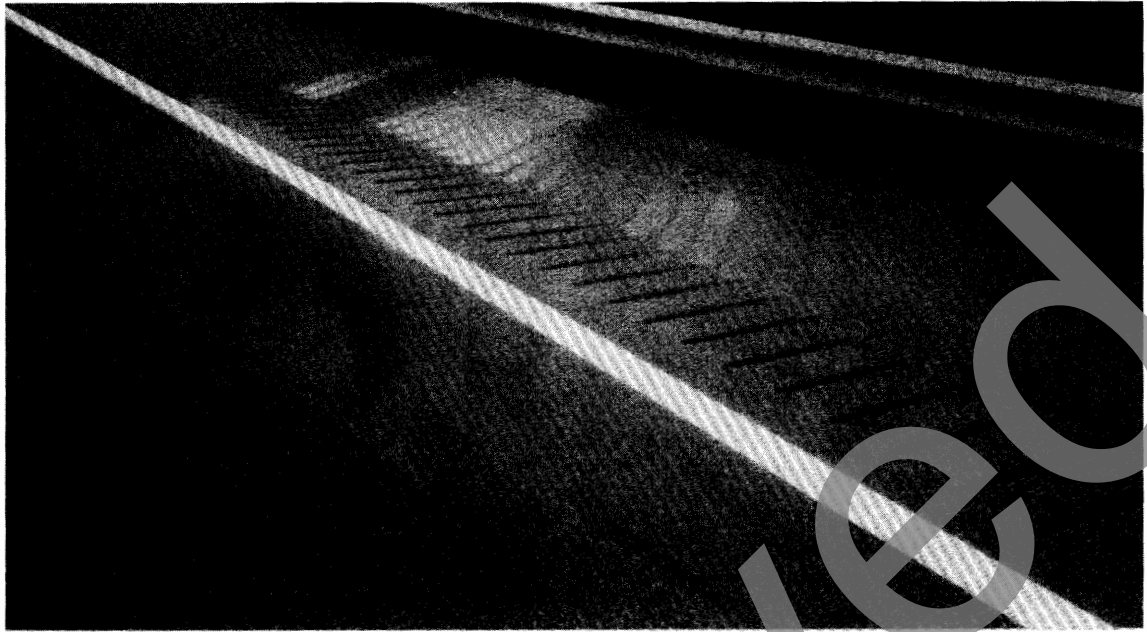
WATER PAVEMENT DAMAGE

The last page of photographs is of typical pavement damage that results from water in the pavement. (Attachment F)
