Federal Highway  
Administration

# Video Inspection of Highway Edgedrain Systems

April 1998

FHWA-SA-98-044

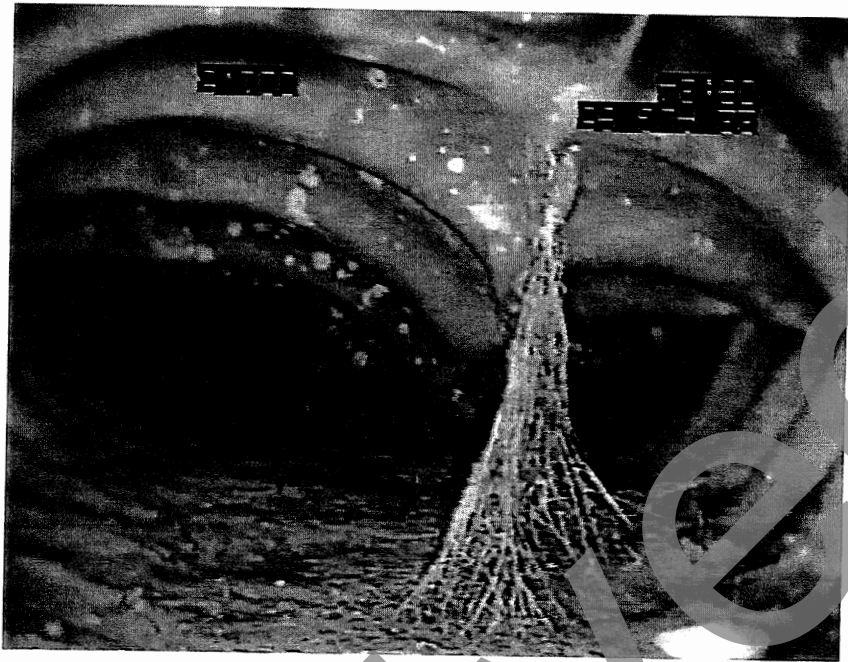
Of the 287 lateral/mainline edgedrain systems attempted, over 100 demonstrations were terminated due to defects with the laterals. Fifty-two (18%) had crushing in the lateral. Another 50 (17%) of the lateral systems were silted-in, limiting the investigations on these systems (Figure 8 and 9). In addition, 36 (13%) were composed of geocomposite sock, panel drain, drop tees, drop inlets, or no mainline systems at all (Figure 10).

Figure 8. Silted and Crushed Lateral, Just Inside the Lateral Outlet (1.5 Feet).

(Note: The Image is Upside Down)

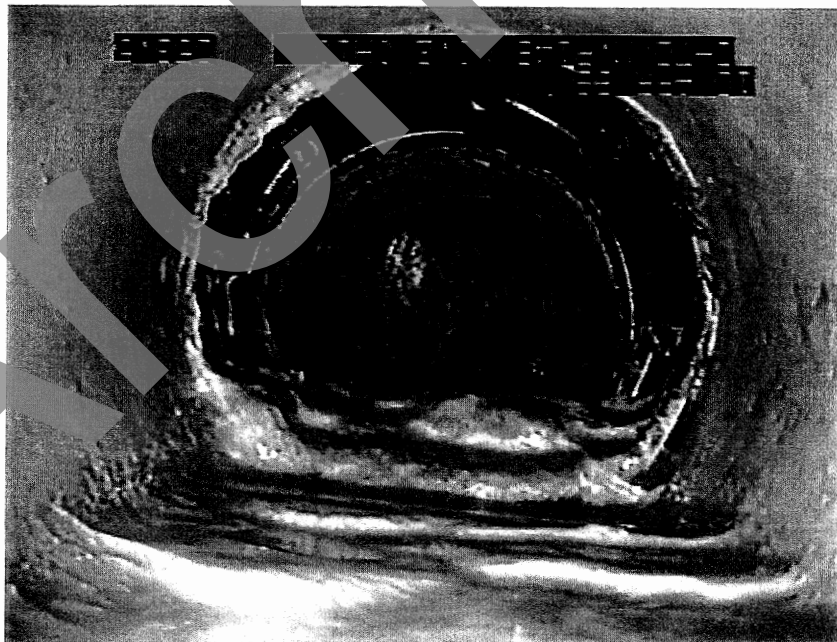
HEAVY SILTED AREA AT LATERAL/MAINLINE JUNCTION

Figure 9. Heavy Silt Flow at Lateral/Mainline Junction.

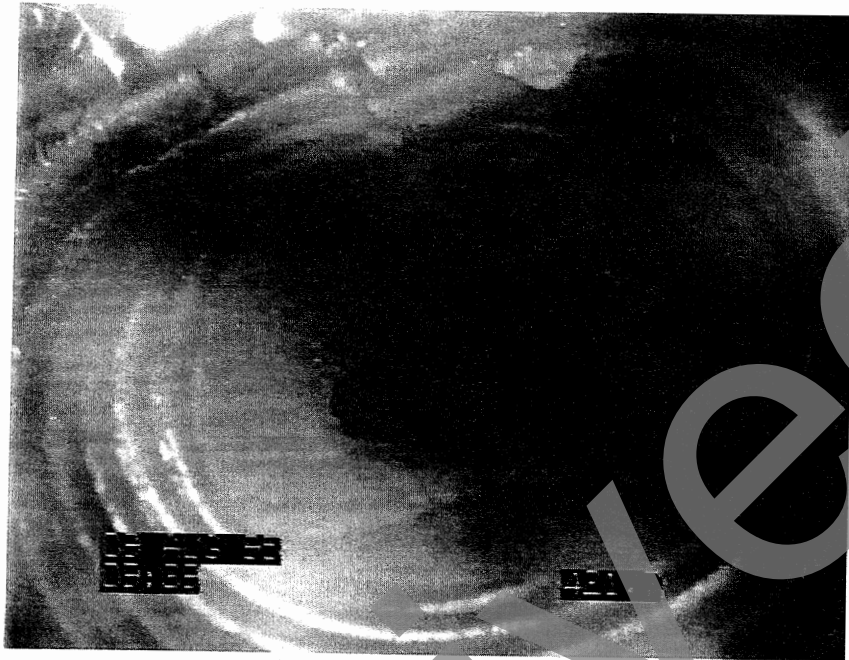
Figure 14. Inferior Construction Materials (A Brick End Cap)

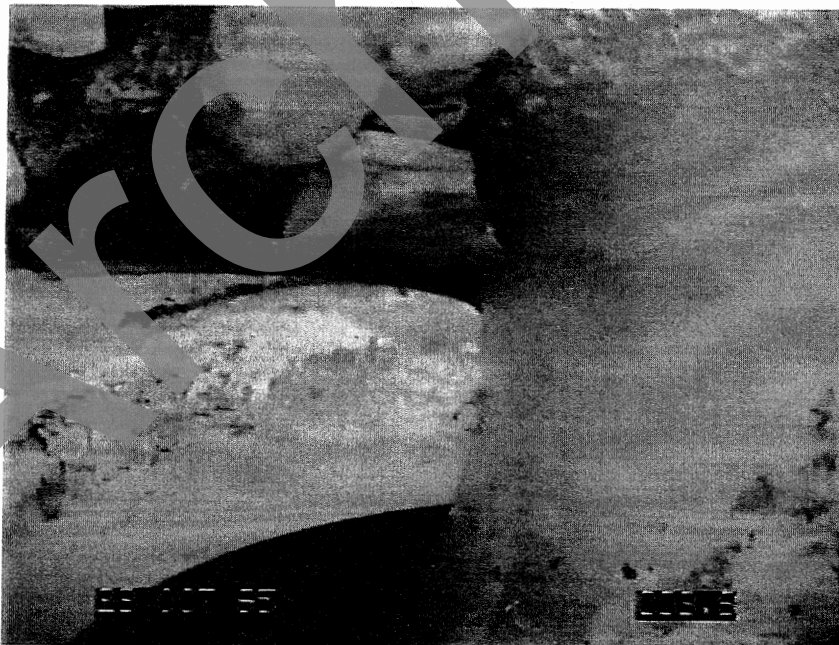
Figure 15. Materials/Obstructions Introduced During Construction. Note: PVC

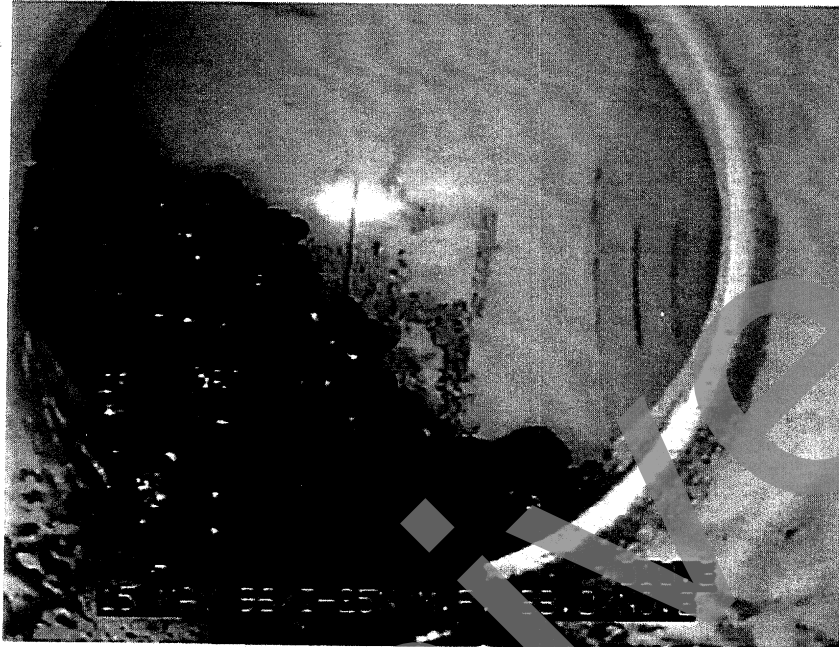
**Figure 16. Asphalt-Stabilized Base in Edgedrain.**

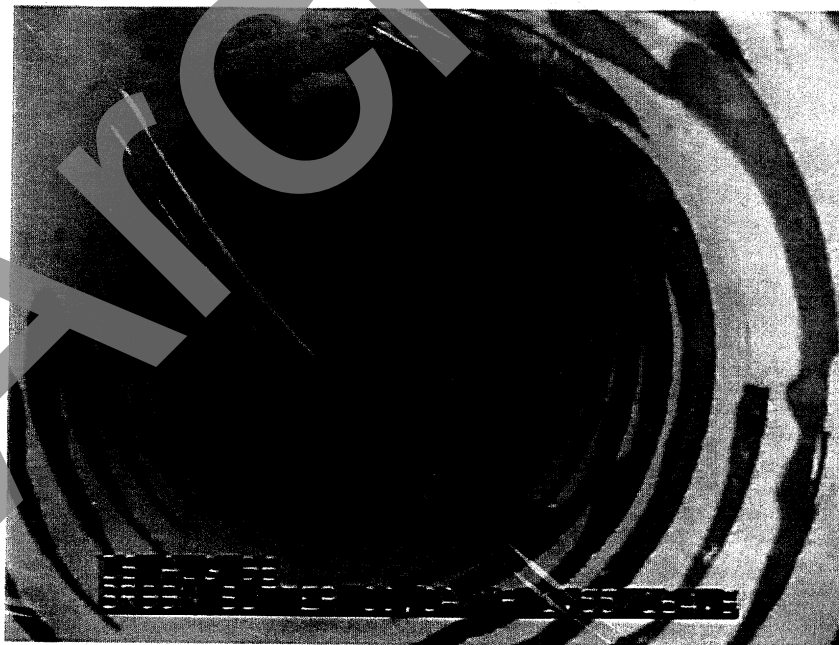
**Figure 17. Asphalt Base Permeating Slots in Drain.**

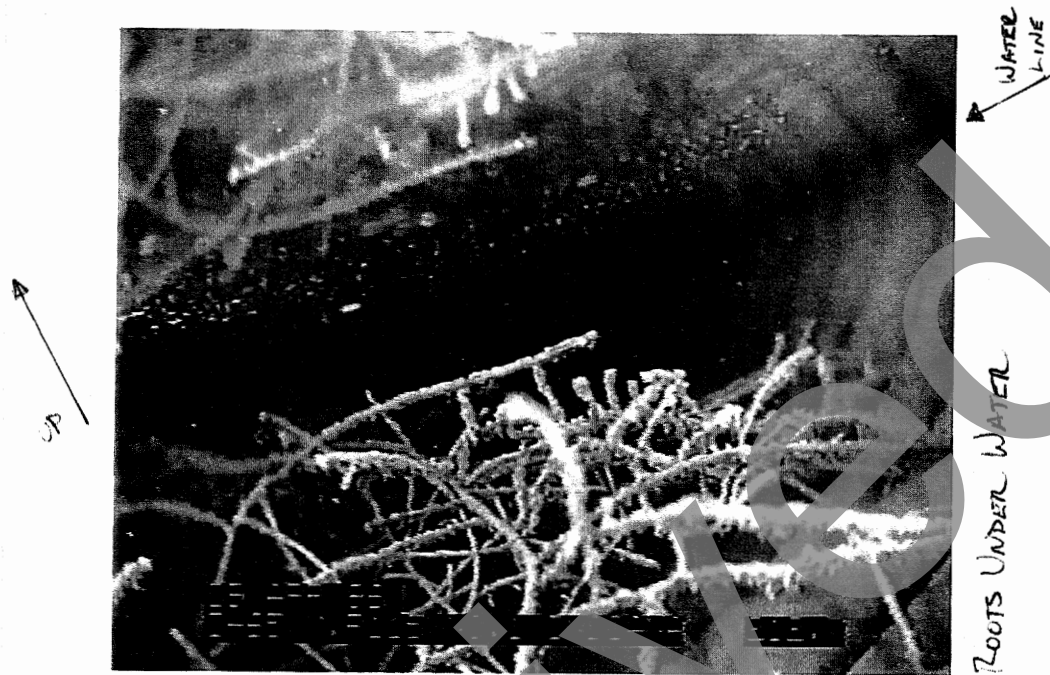
**Figure 18. Root Growth Underwater.**

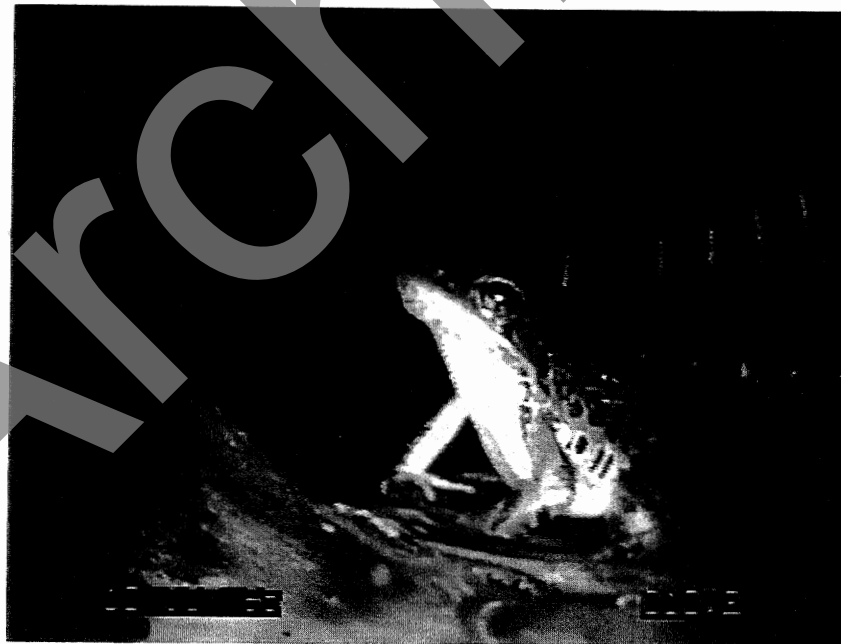
Similarly, if the pipe is not placed to an uniform grade, sags will develop which can lead to other concerns. These sags will collect water which fosters weed growth (Figure 18) and a habitat for all sorts of creatures, such as turtles, snakes, crawfish and frogs (Figure 19). If rodent screens are not

**Figure 19. Sags With Standing Water Provide a Desirable Environment for Unwanted Inhabitants.**

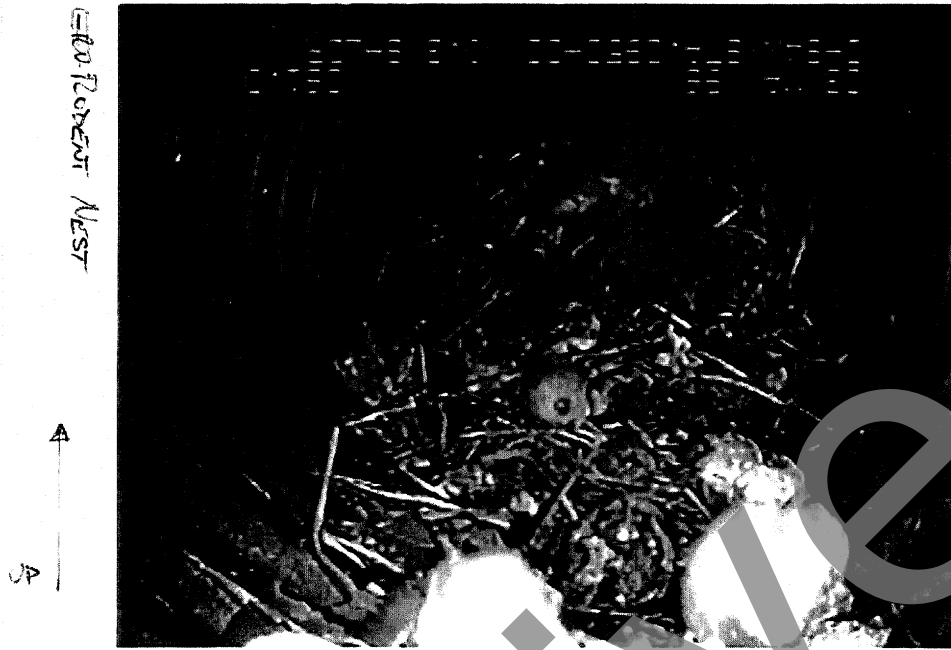
Figure 20. Rodent's Nests Found Blocking the Mainline at 61.0 Feet.

incorporated in these systems, this can lead to other obvious unwanted inhabitants (Figures 20 and 21). These and other revealed problems highlight the need for video inspections of highway edgedrain systems as a quality assurance tool for both rehabilitation and new projects. Detailed observations are included in Appendix A.

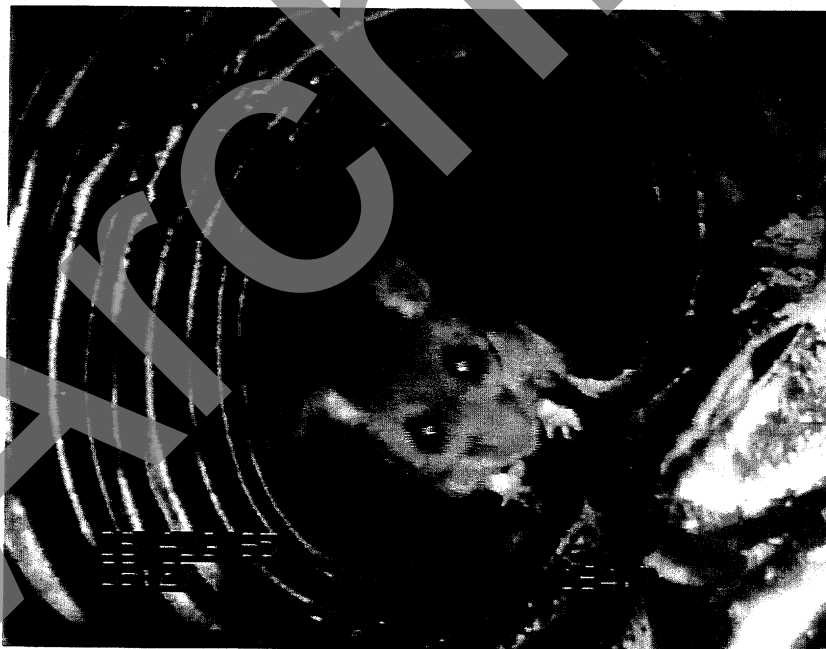
*Crushed mainline segment  
and Moose*

Figure 21. Mouse in Mainline.
