Emergency Relief Program Resilience Case Study – Arizona

Resilience to Changing Hydrology in the Beaver Dam Wash Bridge

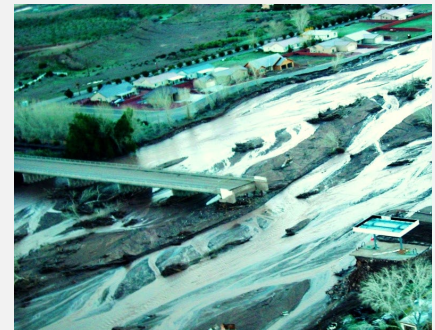
The flood washed out the southern approach to the Beaver Dam Wash Bridge that carries County Road 91. The waters also scoured the piers; uprooted trees, causing further damage; and almost overtopped the bridge. Erosion and the uprooted trees shifted the channel path upstream, which put the bridge in the main channel of the stream and exposed it to greater potential damage.

Figure 1: Damage to the Beaver Dam Wash Bridge following heavy floods in January 2005. Source: Mohave County

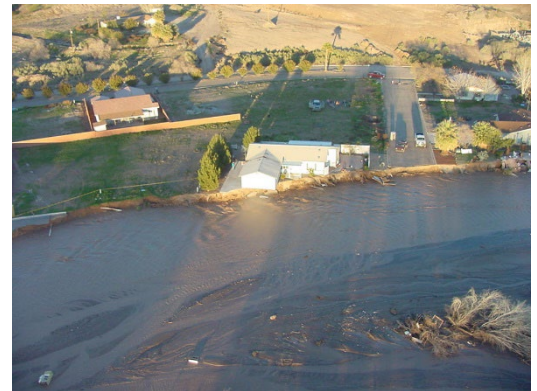
Figure 2: Damaged house and flooded bank on Beaver Dam Wash from 2005 flood. Source: Mohave County

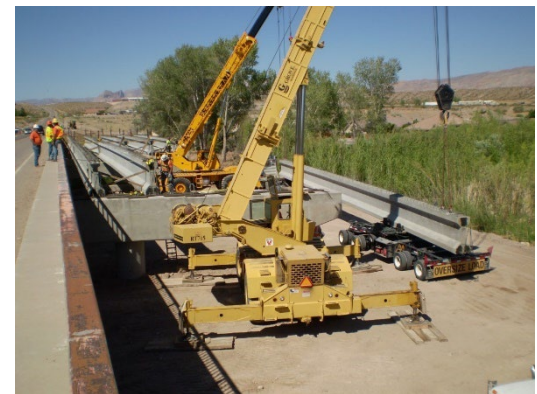
Figure 3: Construction of the new Beaver Dam Wash Bridge. Source: Mohave County

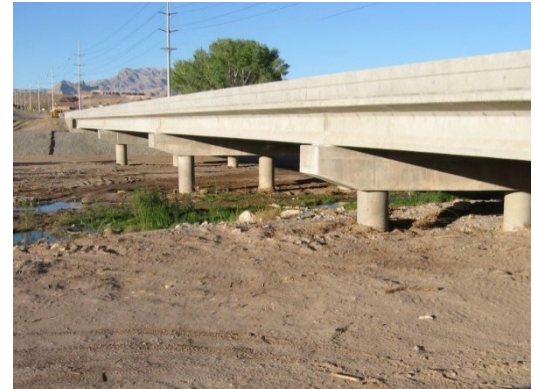
Figure 4: New Beaver Dam Wash Bridge.
Source: Mohave County

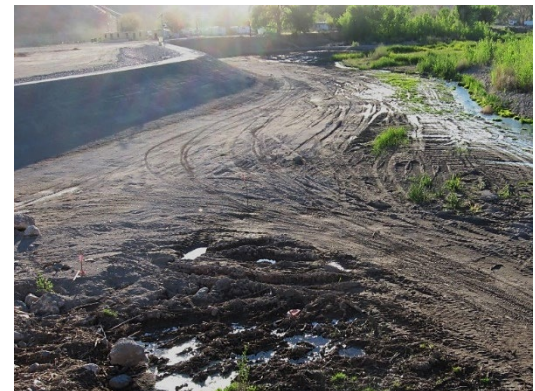
Figure 5: Gabion-lined training dikes upstream of the replacement Beaver Dam Wash Bridge.
Source: Mohave County
