## **5.4. STATE-DEPENDENT INSPECTION RESULTS**

### **5.4.1. State-Dependent Task Descriptions**

### 5.4.3. Task I

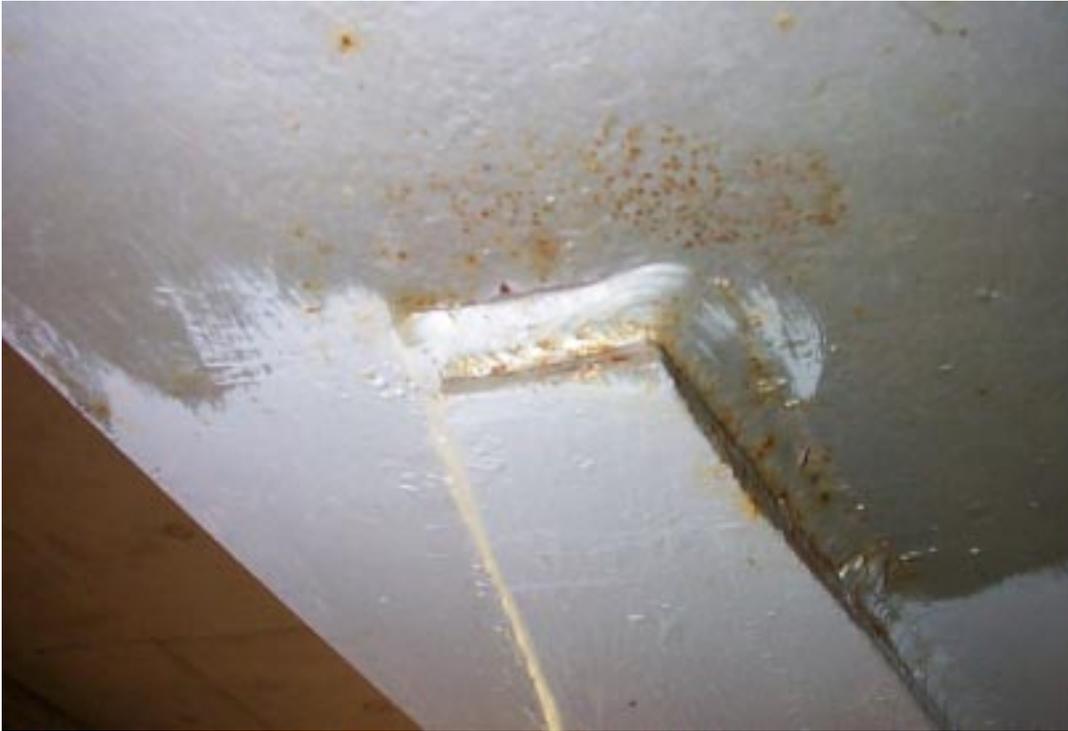
Figure 170. Girder close-up example photograph.

90 STEEL PAINTED BEAMS:  
There are four lines of steel beams laterally braced at 1/4 points. The intermediate diaphragm supports are welded to the webs of beams, many appear cracked - rusty cracked paint along the vertical welds, could not clean to verify. The beams have bottom cover plates and cracks appear to have started at south ends of beams 1C and 2B and north end of 1D.

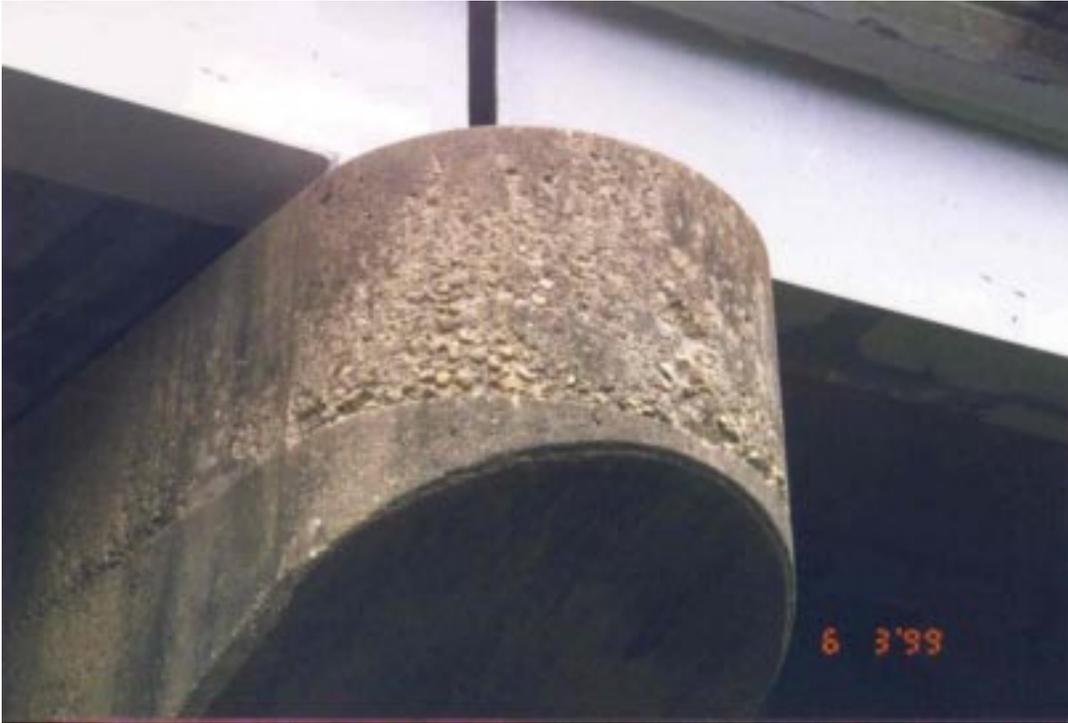
Figure 175. Pier cap close-up example photograph.

ELEMENT	RATING	COMMENT
CAP	G-F	LITE SCALE, Z WIRE POPOUTS ON BOTTOM
COLUMNS	G	
PLUMP	G	
FOOTINGS	NV	
BEARING	F	SLITE CORROSION, PAINT SCALE, LITE RUST

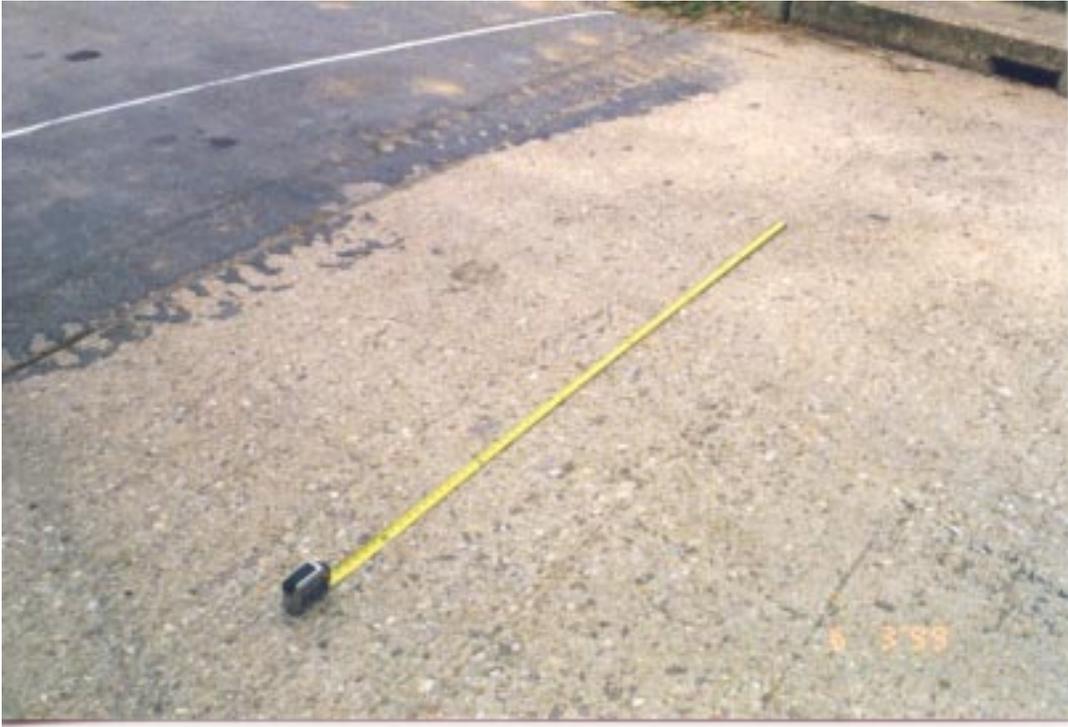
Figure 177. Deck close-up example photograph.

12 CONCRETE DECK:  
Worn to aggregate in wheel lines. Scattered transverse cracks. A few pop-outs and mudball voids. Chain dragged the southbound lane - 5%-20% surface delaminated. Light scale throughout. Minor "D" cracks forming at joints.  
Longitudinal and transverse hairline cracks in soffit.

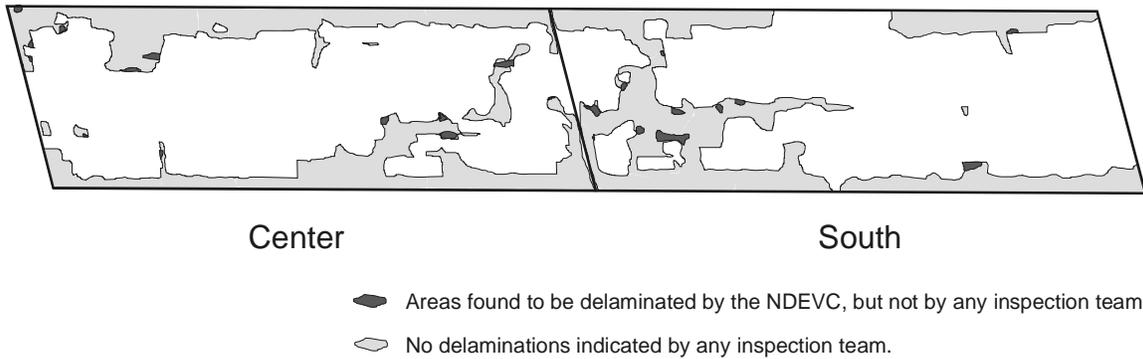
Figure 212. Areas all teams indicated were intact.

*COMMON AREAS NOT INDICATED AS DELAMINATED:* Superposition of the delamination maps provided by the 20 teams can be used to illustrate areas that none of the teams indicated were delaminated. This superposition is shown in figure 212, where areas indicated to be delaminated are shown in white, and areas not indicated to be delaminated by any team are shown in either light or dark gray. Recall that no adjustments were made to the sketches as drawn, so some errors exist within this superposition, but it remains illustrative of several points. Approximately 31 percent of the deck, largely concentrated along the curbs, did not receive any delamination calls. Conversely, the union of all of the areas indicated as being delaminated is 69 percent. Recall that the average deck delamination was 13 percent, and the highest team total was 35 percent. This indicates a significant divergence of opinion as to where the delaminations are located. Figure 212 also indicates the areas identified as being delaminated by the NDEVC that were not indicated by any of the inspection teams on any of the delamination maps. These areas are shaded more heavily, and comprise about one-half of 1 percent of the deck area. As shown, these areas are typically very small and near the edges of the areas called out as delaminations. It seems reasonable to assume that a large percentage of these areas exist due to errors in recording the delaminations identified.

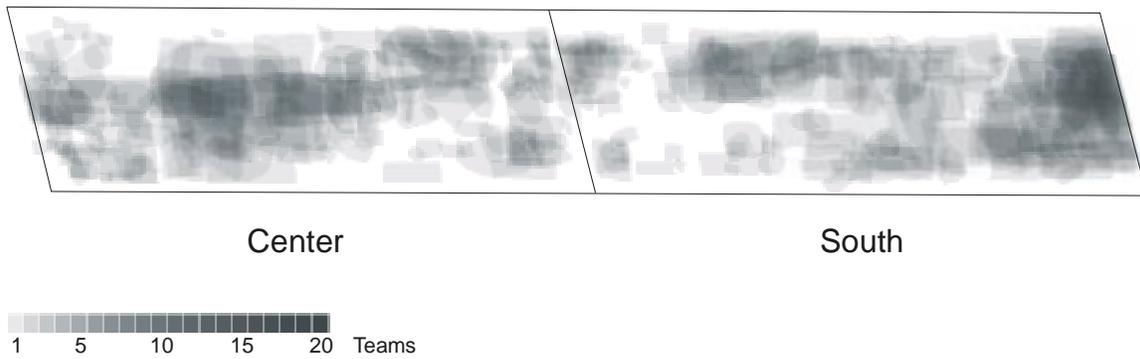
Figure 213. Transparent overlay of all delamination maps.

An alternative method of presentation to illustrate commonly indicated delaminated areas was developed that uses additive fills for each team's delaminations. As the fills overlap, a darker shading results. The degree of shading indicates the frequency of delamination calls. The complete additive overlay is presented in figure 213. In parallel with figure 213, table 238 quantifies the percentage of deck area at each level of commonality (i.e., the percentage of the deck covered by areas indicated as being delaminated by exactly N teams). This table also shows the maximum amount of deck area to receive at least N delamination calls. In examining this table, it can be seen that the highest degree of commonality for any single, sizable delamination (0.2 percent of the deck area, or 0.4 m<sup>2</sup>) was 15 teams. Figure 214 shows the delamination map representing delamination calls by at least 15 teams. This image actually indicates a maximum degree of commonality of 17 teams (this area is actually less than 32 cm<sup>2</sup>). This area is small enough that it is probably outside the tolerance of the map and may not actually exist.

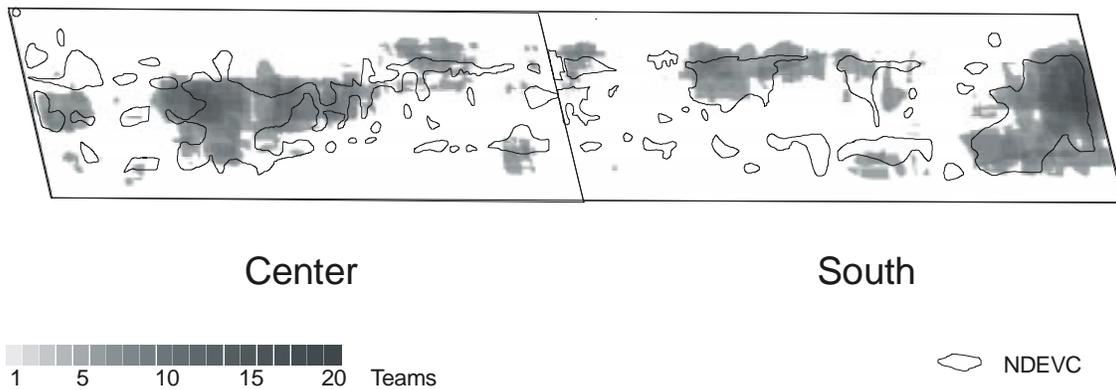
Figure 216. Areas indicated as containing delaminations by five or more teams, together with the results of the NDEVC survey.

Two other commonality levels were studied graphically. First, since the delamination maps submitted by the teams were approximate, the areas indicated as being delaminated by at least three teams were investigated. This investigation may reduce some of the errors within the maps by eliminating unique delamination calls and the first intersection level, both of which may be mislocated due to positioning errors in recording the data. As shown in figure 215, the total area with at least three delamination calls covers 40 percent of the deck area. Second, it was calculated that the amount of the deck area covered by at least five delamination calls was 21 percent. This level is closest to the 19 percent indicated by the NDEVC survey. Figure 216 compares the delamination map showing at least five delamination calls with the survey performed by the NDEVC.

The coring program that was mentioned previously also investigated some of the differences between team delamination calls and the NDEVC survey. Specifically, four of these disputed areas were cored; half of which were considered to be delaminated by the NDEVC. In addition, one of the disputed areas had at least five delamination calls by teams, although the NDEVC did not detect any signs of delamination. The results of the coring program determined that all four of the disputed areas were properly called by the NDEVC.
