# Event Report

## FHWA Office of Bridges and Structures

**Subject:** Ft. Pitt Tunnel Luminaire Connection Failure

**Location:** Pittsburgh, PA

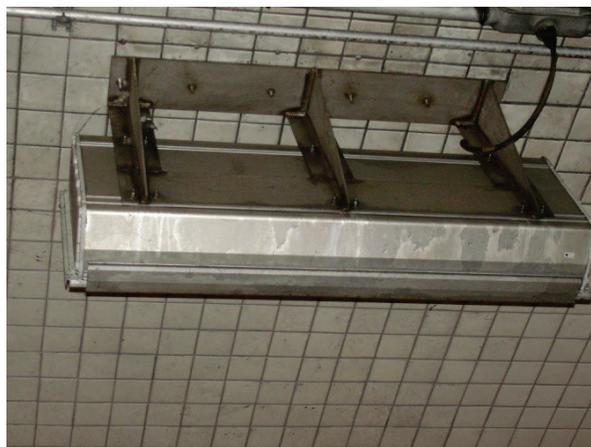
**Current Report [October 25, 2012]:** A luminaire similar to the one that fell is shown in Figure 1. The luminaires are approximately 49-inches long and weigh 75 lbs. Like the one that fell, the fixture shown is mounted to the ceiling of the tunnel over an area used by maintenance workers and tunnel operators to park their vehicles just inside one of the tunnel portals. However, a large majority of the 1374 luminaires in the eastbound and westbound bores of the Ft. Pitt Tunnel are wall mounted.

Figure 1. A ceiling mounted luminaire similar to the one that fell.

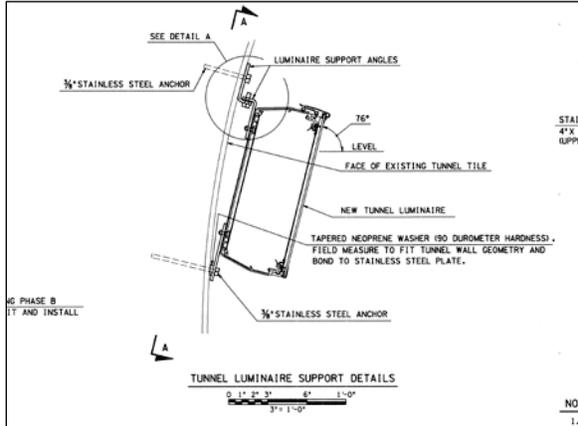
clamp the flanges of the aluminum channel against the stainless steel bracket by the heads of the bolts. Figure 2 shows a detail of the wall mounted luminaire. The view in Figure 3 is an enlarged portion of the detail included in Figure 2. Figure 3 shows the position of the stainless steel bolt (shaded in blue), the head of which is in the upper aluminum channel (hashed in yellow), and the shank of which passes through the upper stainless steel mounting bracket. The flanges of the aluminum channel are not shown on this detail.

Figure 2. Wall Mounted Luminaire Detail.

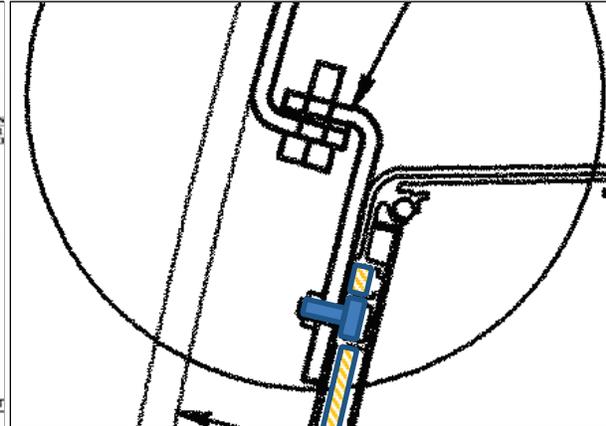
Figure 3. Enlarged Detail of the Connection.

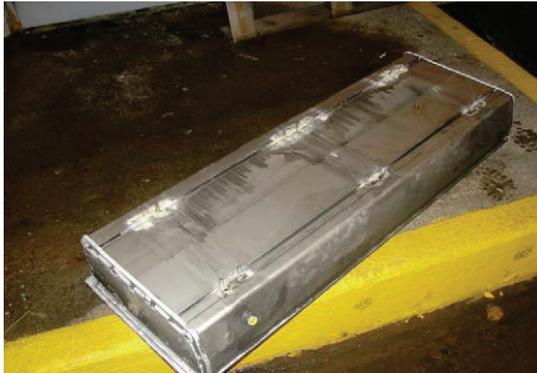
Figure 4 shows the back of a typical luminaire that was removed from its mounting brackets so that the connections could be inspected. The flanged channels which run longitudinally near the outside of the luminaire along its back are visible as well as the (shiny) efflorescence from galvanic corrosion where the stainless steel brackets were attached with the stainless steel bolts. Figure 5 shows an enlargement of the stainless steel bolt head slotted in one of the aluminum flanged channels.

Figure 4. Back of typical luminaire.

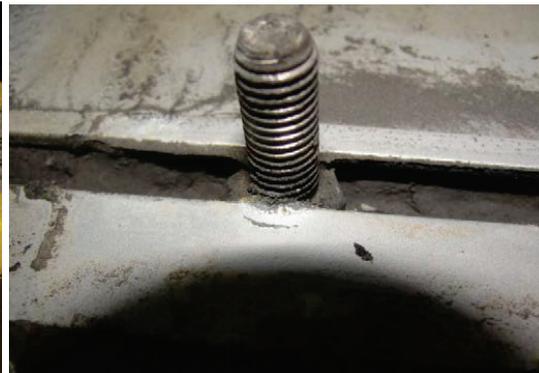
Figure 5. Bolt head in aluminum channel.

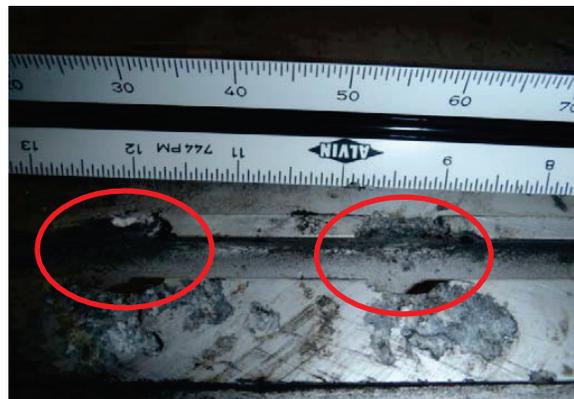
**Summary:** The Ft. Pitt Tunnel carries I-376 through Mt. Washington between downtown Pittsburgh and its west end. On September 30, 2012 an overhead luminaire (lighting fixture) fell from its support bracket onto a parking apron within the portal of the tunnel on the downtown side. The connection failed as a result of galvanic corrosion between the aluminum frame of the luminaire and the stainless steel bolts connecting it to the support bracket. The fixture was manufactured by Schröder Lighting.

Figure 6 shows a close up of the flanged aluminum channel on the back of the luminaire that fell. The locations where two of the bolt heads pulled through the deteriorated flanges are indicated by the red ovals. As the lighting fixtures were originally installed in 2002 this level of deterioration was the result of 10 years of exposure.

Figure 6. Close up of back of luminaire that fell showing deteriorate aluminum flanges

Although 4 luminaires inspected were found to have advanced states of corrosion, none of those 4 exhibited the same level of deterioration as the one that fell. Regardless, to insure the long-term viability of these lighting fixtures, once it is developed, PennDOT will be deploying a permanent retrofit to insure the electrical isolation of the dissimilar metals used in the connection. It is currently expected that this retrofit will be in place by the end 2012.
