REHABILITATION OF THE HAMMOND BRIDGE IN MARION COUNTY, IOWA

**REPORT COMPILED BY JAN OLIVE NASH
TALLGRASS HISTORIANS L.C., IOWA CITY, IOWA**

2004

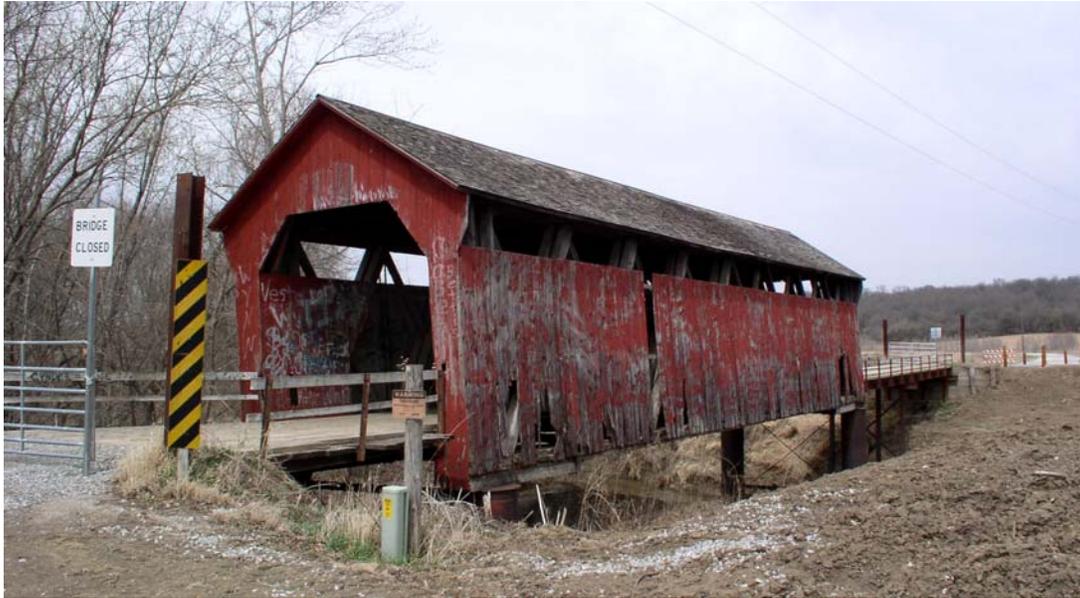
Figure 8 Hammond Bridge just prior to its rehabilitation in April 2003. (Nash photo)

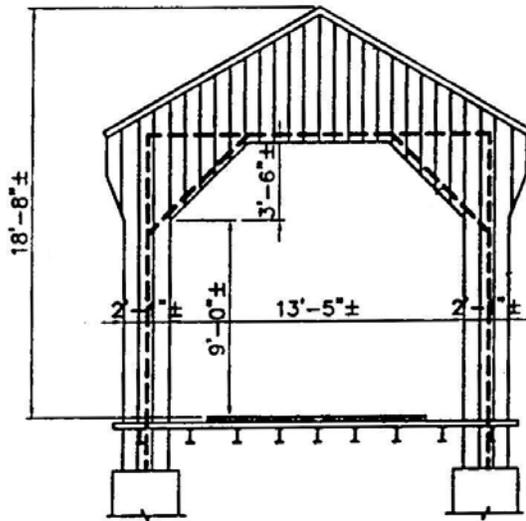
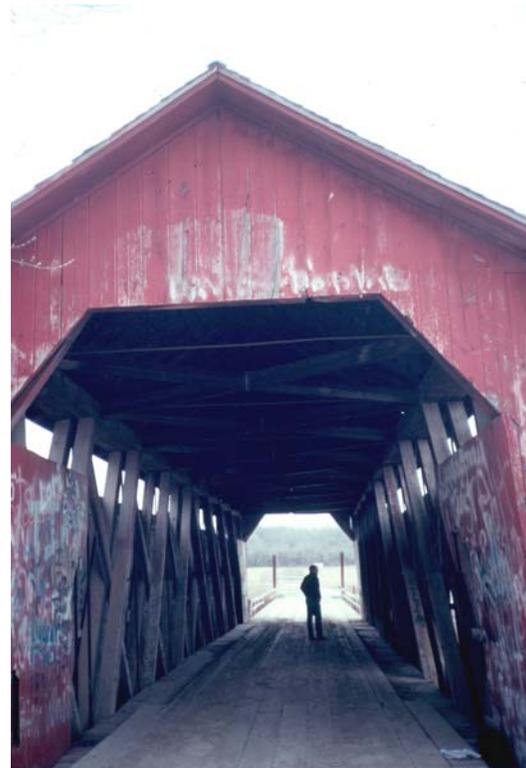
Figures 11 and 12 South portal plan (left) and pre-rehabilitation photo (right), facing north. The north portal is similar. (Drawing adapted from Shuck-Britson Inc. rehabilitation plans dated January 2003; Nash photo on right)

Eighty years after it was constructed, a truck that was too tall for the portal attempted to cross the bridge. The resulting accident closed the bridge between 1977 and 1979 for “minor repairs” (Iowa Historic Bridge Inventory/HAER, 1). The bridge is now closed to motor traffic with the road diverted to a concrete ford just downstream (Fig. 19).

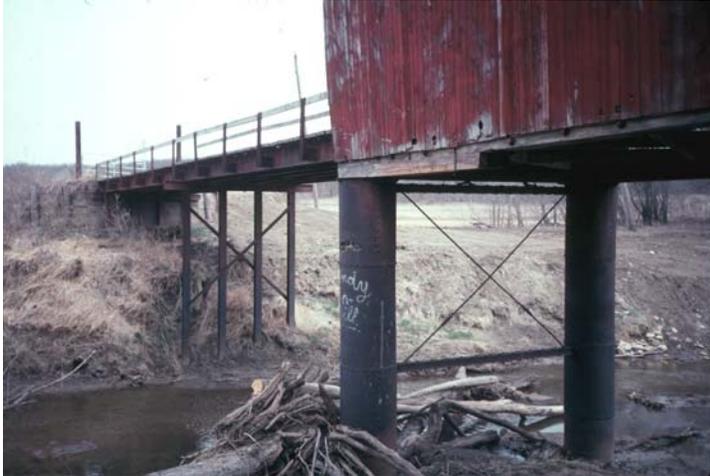
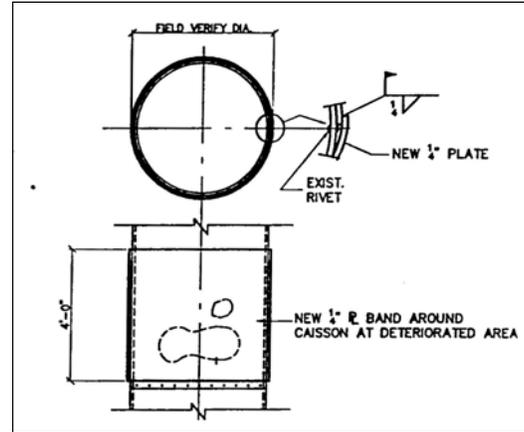
Figures 14 and 15 Northwest cylinder pier and its repair plan.
(Drawing adapted from Shuck-Britson Inc. rehabilitation plans dated January 2003; Nash photo on left)

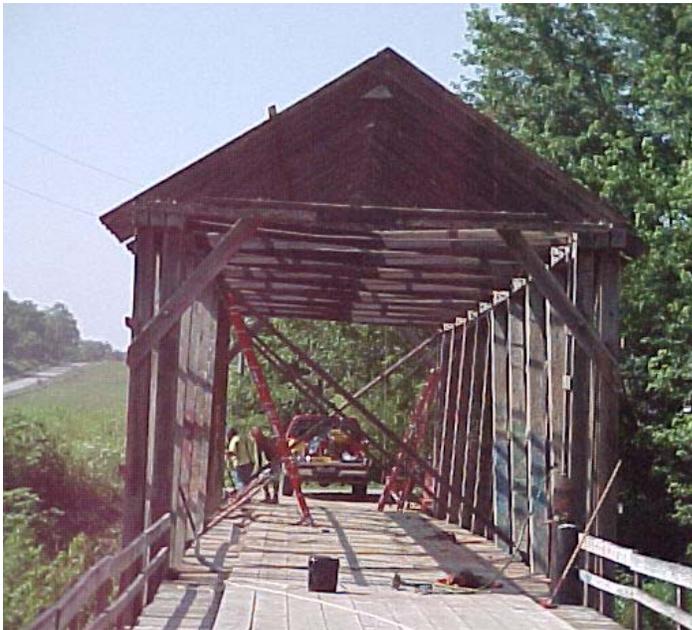
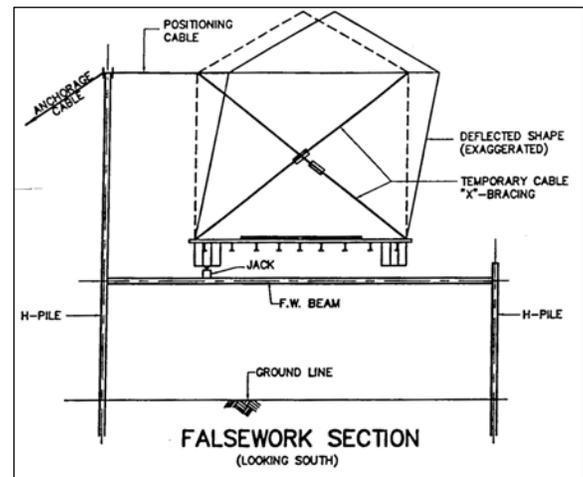
Figures 16 and 17 Straightening the trusses, looking south.
(Drawing adapted from Shuck-Britson Inc. rehabilitation plans dated January 2003; Jay Davis photo on left)

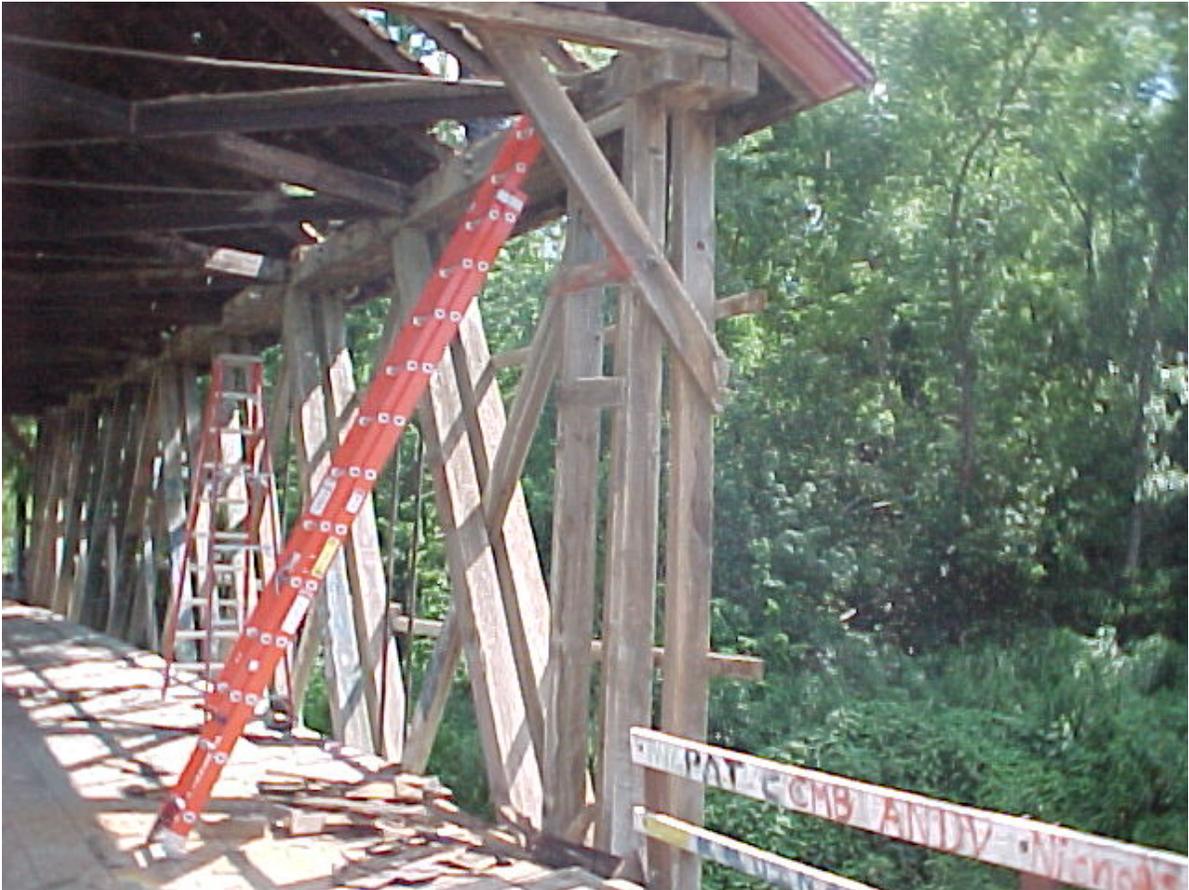
Figure 21 Representative location of the new steel portal frame.

Repair methods throughout the project were performed in such a way as to maintain the original appearance of the bridge. The installation of a “portal frame” was one of the more notable examples. A new steel frame was added between existing wood members to strengthen the structure and keep it from leaning after it was straightened (Figs. 21-29). To do this, a steel framework was welded together and then bolted to the wood structure. The steel was then covered with cedar lumber. Cost for this procedure was \$28,000 (refer also to the table of costs below). Also, the timber member at the northwest caisson or cylinder pier was badly decayed. This decayed section was removed and a similar timber was cut to match the size and shape. Bolts and epoxy were used to secure the repaired timber. The cost for this procedure was \$695. Finally, since the roof rafters were not the standard dimension of today’s lumber, the contractor’s crew cut replacements for the rotten rafters out of timbers, matching the dimensions of the historic lumber (not a separate cost item).

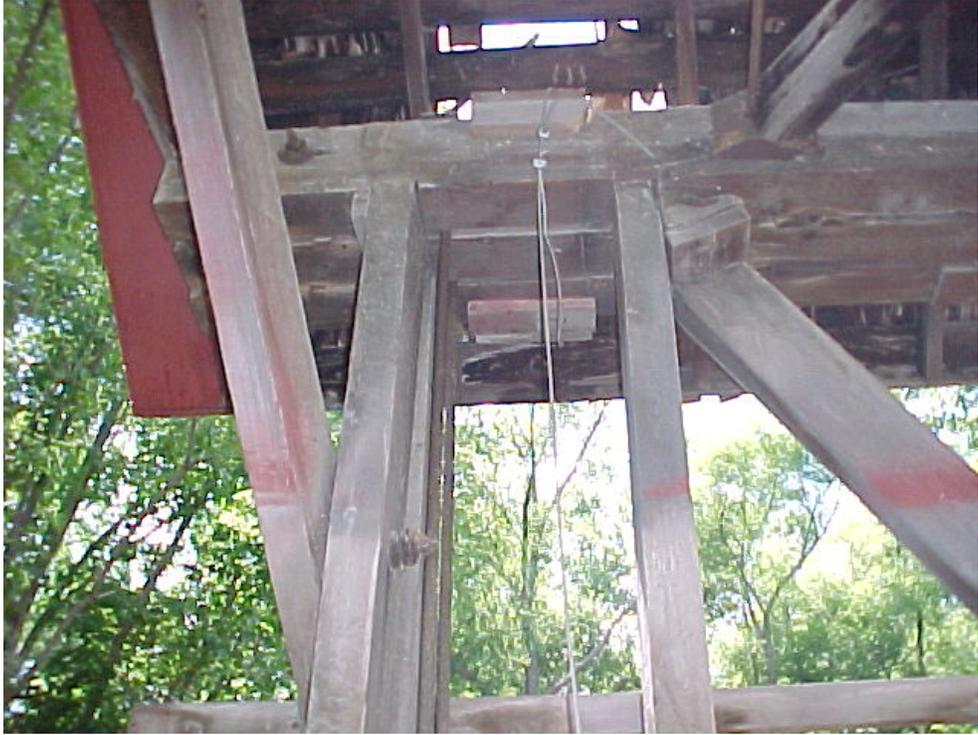
Figure 22 The steel was installed in the space between timber uprights.

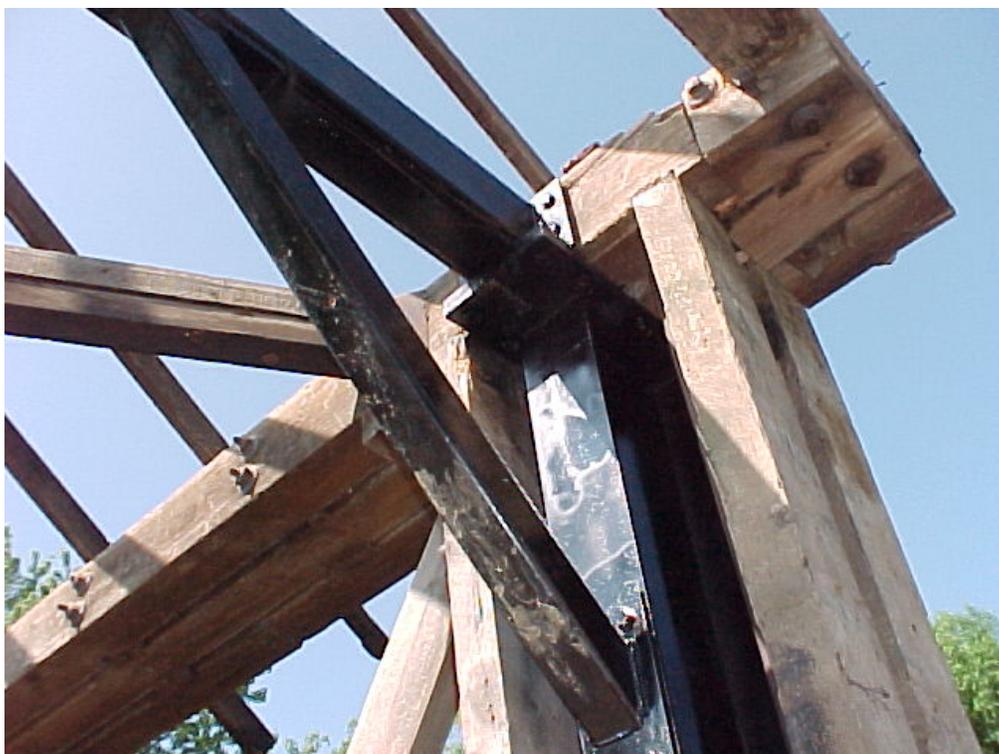
Figure 26 Juncture of the steel portal upright and beam, as bolted to the wooden bridge.

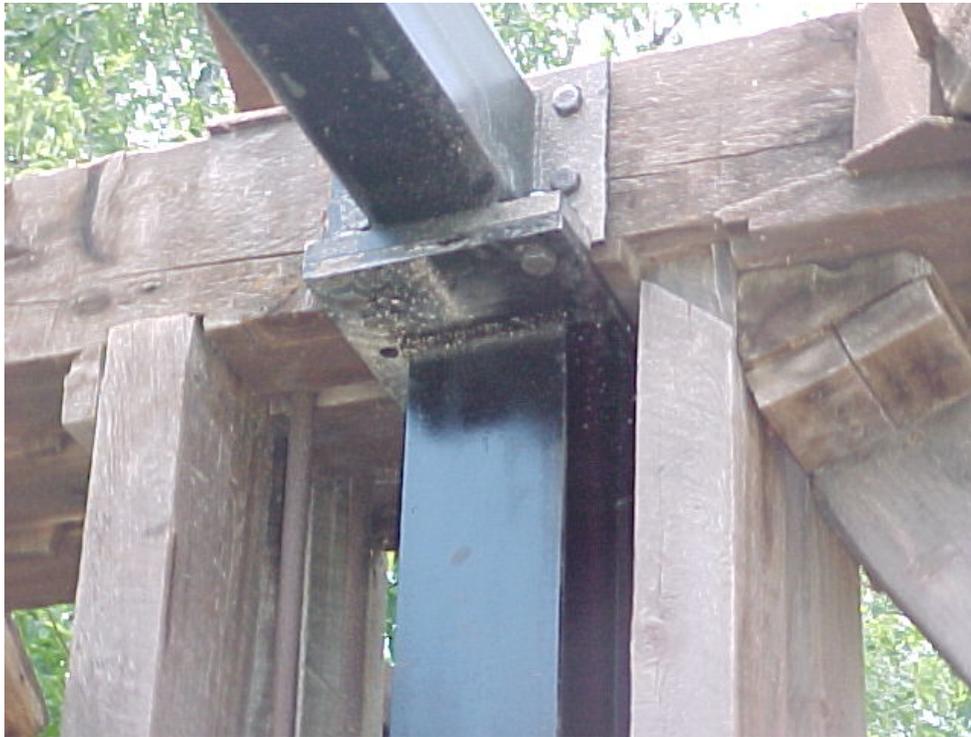
Figure 27 Steel bolted to the historic timber.

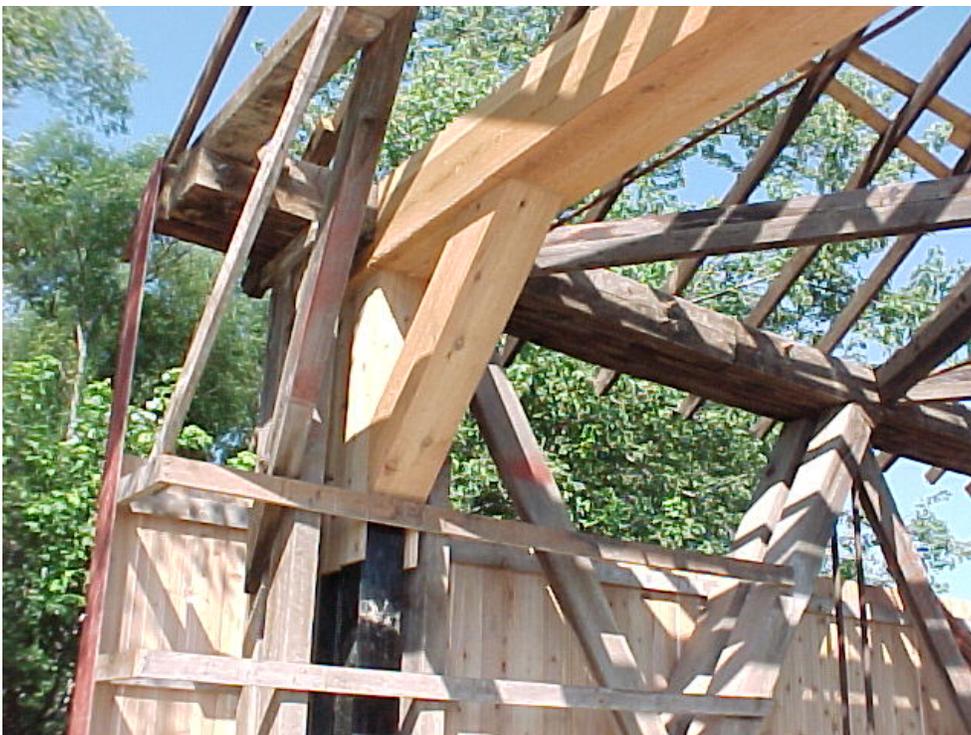
Figure 28 Cedar lumber hides the steel.

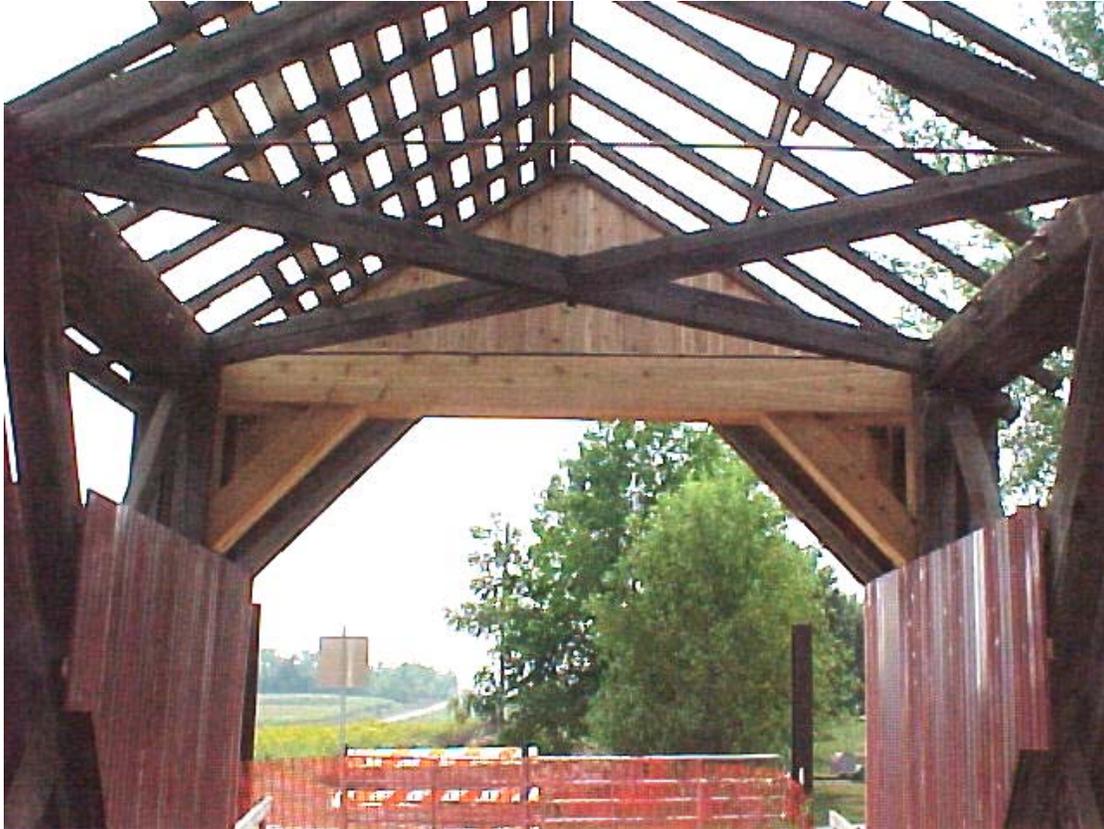
Figure 29 The reinforced southern portal, clad in new cedar.

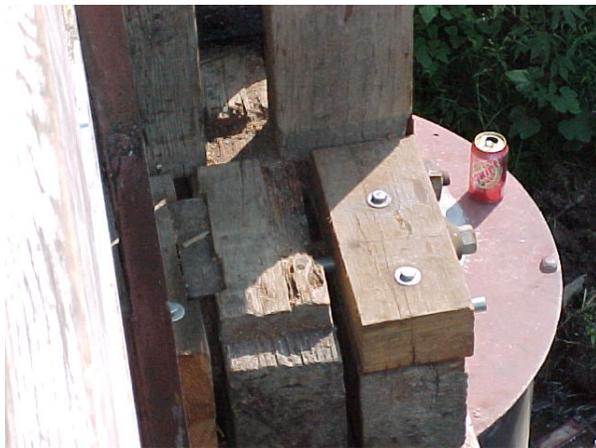
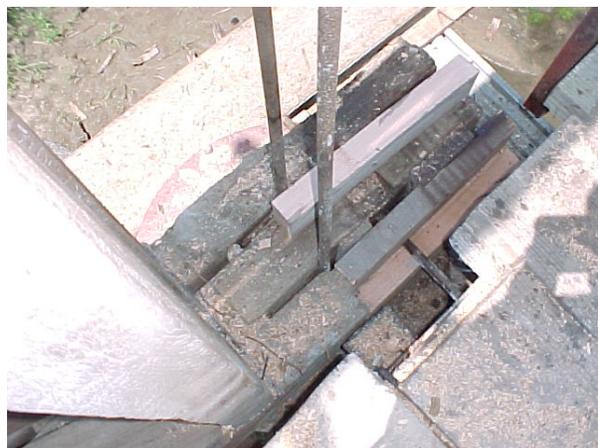
Figures 30 & 31 Floor beam and pier trouble spots.

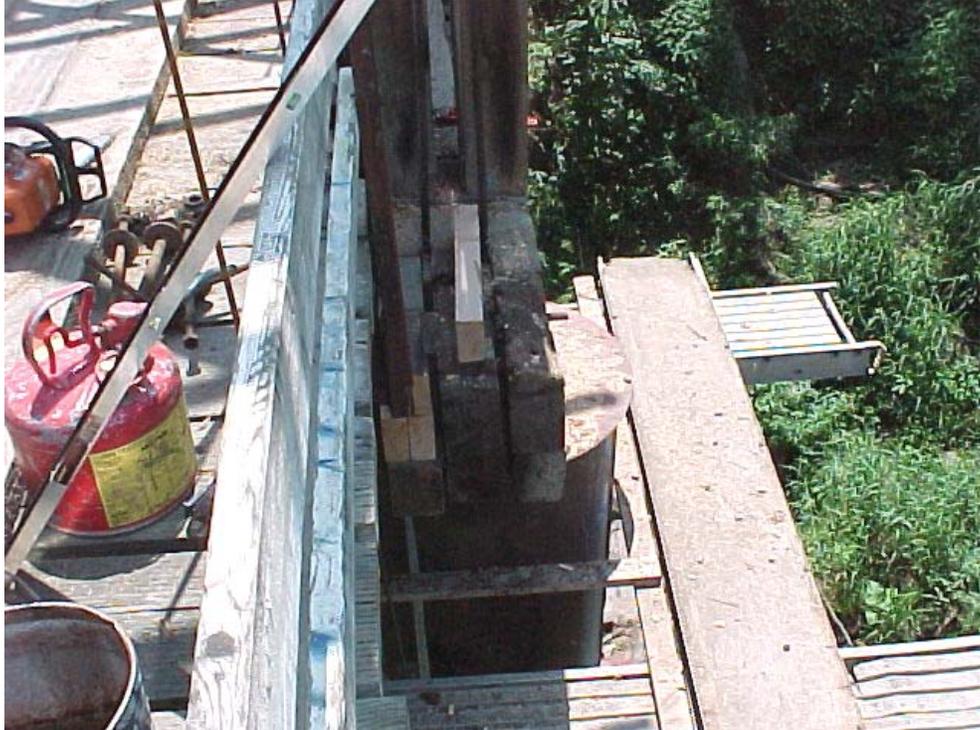
Figure 32 Repairing the rotten wood at the northwest caisson area.

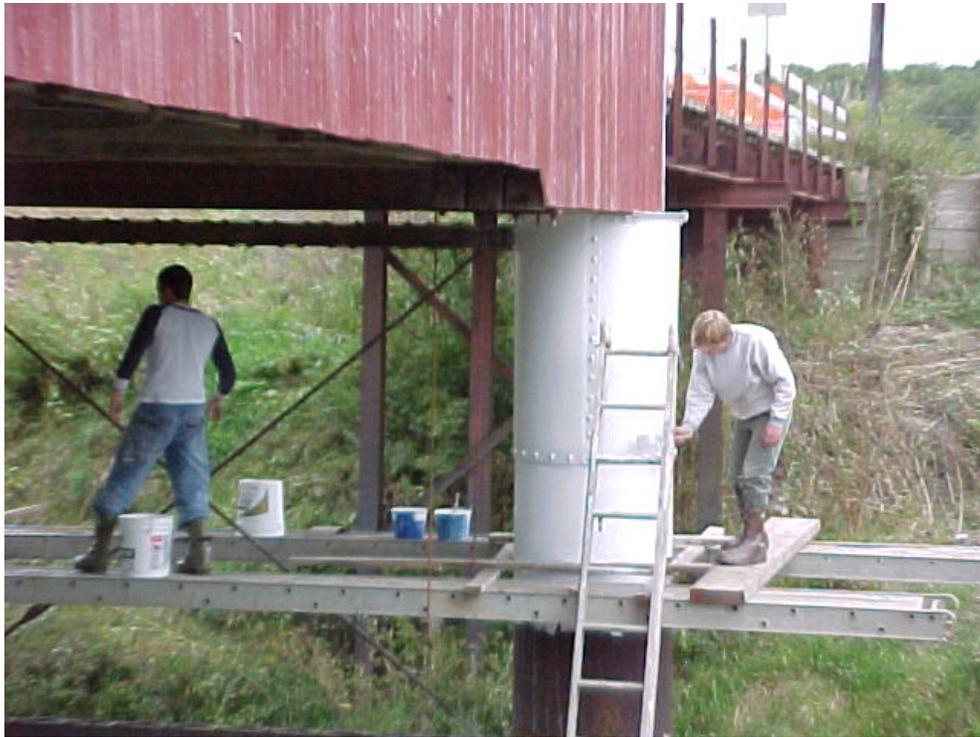
Figure 33 Priming a caisson/cylinder pier.

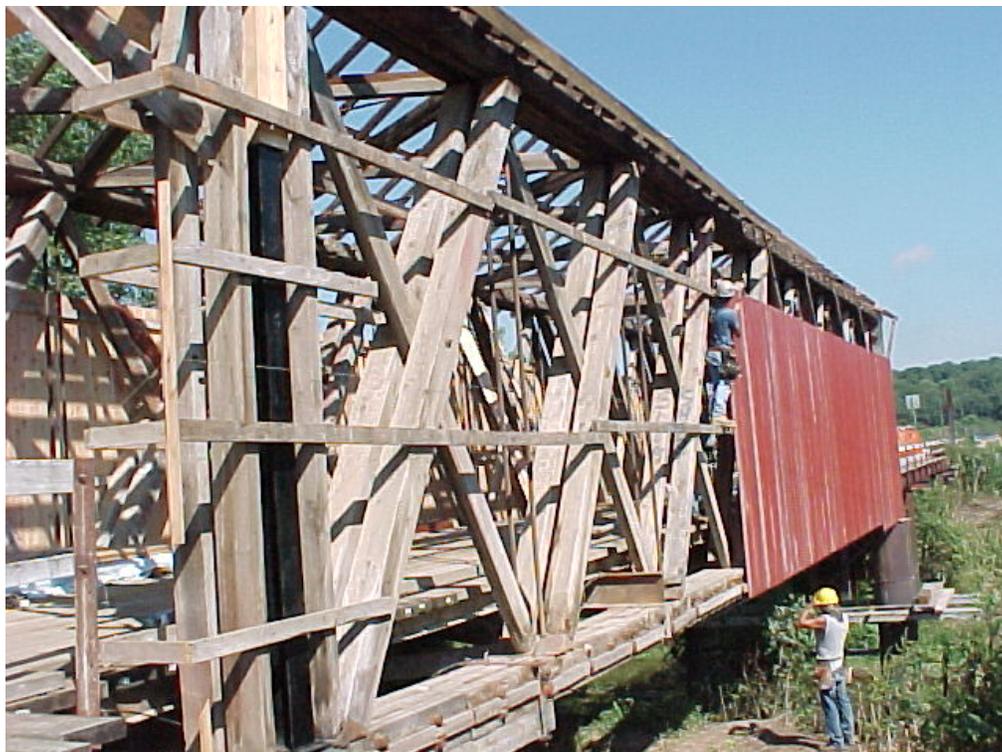
Figure 38 Replacing the siding.

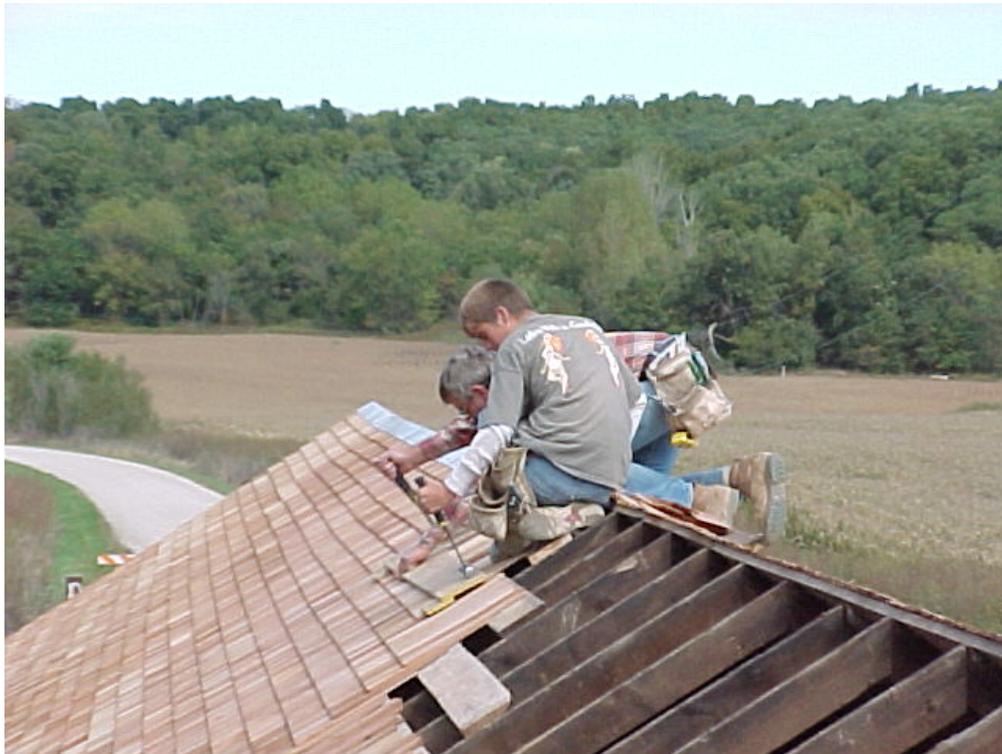
Figure 40 Re-roofing with cedar shingles.
