U.S. Department of Transportation
Federal Highway Administration

Framework for Improving Resilience of Bridge Design

Publication No. FHWA-IF-11-016
January 2011

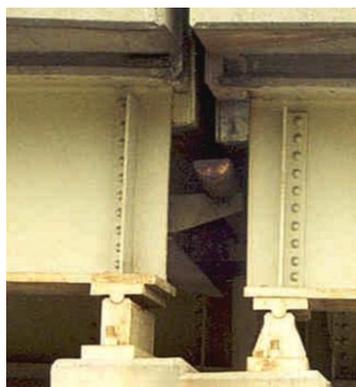
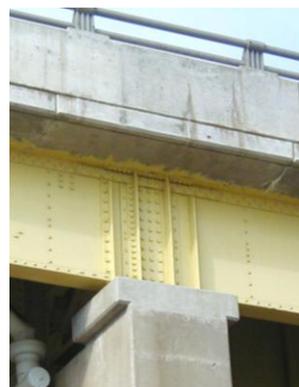
It is important to locate drainage scuppers and connecting elements in regions of the superstructure where, if they become clogged with debris, they will cause the least damage. It is also important that the down-spouting be accessible for inspection, maintenance, and repair, and has the necessary slopes and connections to prevent clogging. In addition, it may be advantageous to make the steel superstructure continuous and eliminate expansion joints, thus eliminating drainage details that cause problems. An example of where simple spans are made continuous, to eliminate poor drainage details is shown in Figure 2-3. Adequate drainage and the layout of the drainage elements will help to prevent girder corrosion.

Figure 2-3 Photos showing the before and after of the elimination of trough-type drainage details by making simple steel spans continuous during a rehabilitation project.

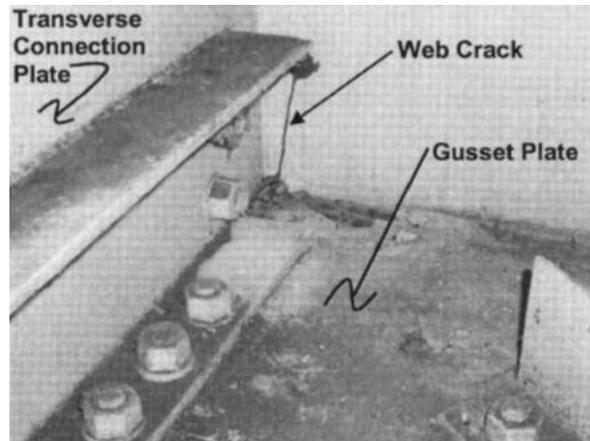
- In 2003, a fracture was found during a routine inspection on one of the main girders of the US 422 Bridge over the Schuylkill River in Pottstown, Pennsylvania. The bridge is a six-span two-girder steel structure, and employed a lateral bracing system near the bottom flange. The fracture, shown in Figure 2-4, was located in a positive moment region, and initiated at the intersecting welds connecting the web, lateral bracing gusset plate, and transverse connection plate approximately 3 in. above the bottom flange [17]. The fracture propagated upward in the web, above the gusset plate, and also propagated downward and completely severed the bottom flange.

Figure 2-4 Photo of fractured girder of the US 422 Bridge showing a crack in the web emanating for intersecting welds (taken from [17])

The US 422 Bridge and Hoan Bridge fractures resulted from constraint-induced fracture, CIF [17]. Conner et al. [17] states that three conditions must be present for a detail to be vulnerable to CIF.

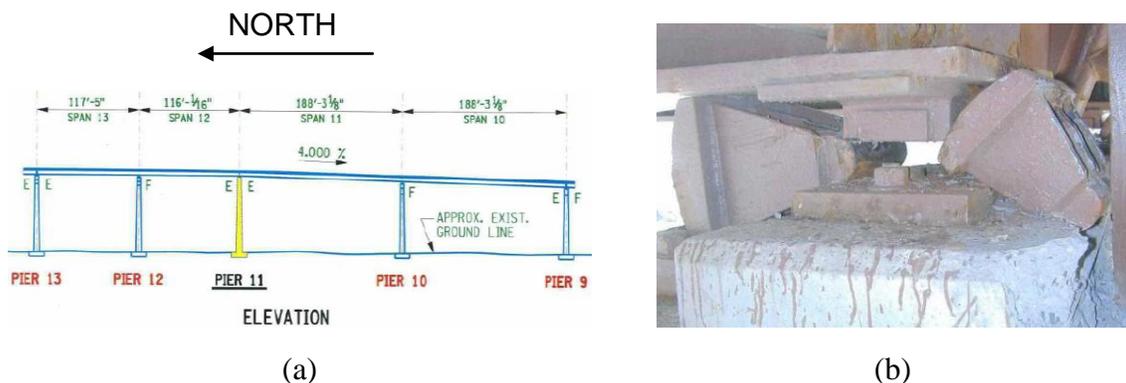
Figure 2-5 *Dunn Memorial Bridge Interchange Rocker Bearing Failure: (a) Sketch of the bridge elevation from Pier 9 to Pier 13; (b) Photo of the failed rocker bearings at Pier 11 showing them tipped over (taken from [29]).*

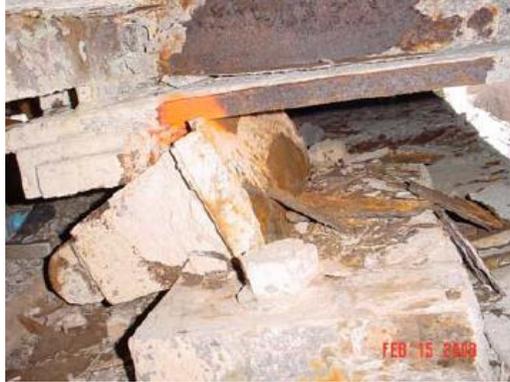
- A similar rocker bearing failure occurred in a steel plate girder approach span of the Birmingham Bridge in Pittsburgh, Pennsylvania, in February 2008. The rocker bearings at Pier 10S tipped over, dropping the steel girders and roadway approximately 8 inches. Based on the forensic investigation, the rocker bearings most likely tipped over at the pier due to a combination of events, including improper installation and a leaking expansion joint above the bearings that contributed to and accelerated the corrosion of the bearings. Collecting debris also allowed the ratcheting effect [30]. A photo of the tipped bearing at Pier 10S is shown in Figure 2-6.

Figure 2-6 *Photo of failed rocker bearing at Pier 10S of Birmingham Bridge Approach Span showing the rocker tipped over with girder sitting on top of failed bearing (taken from [30]).*

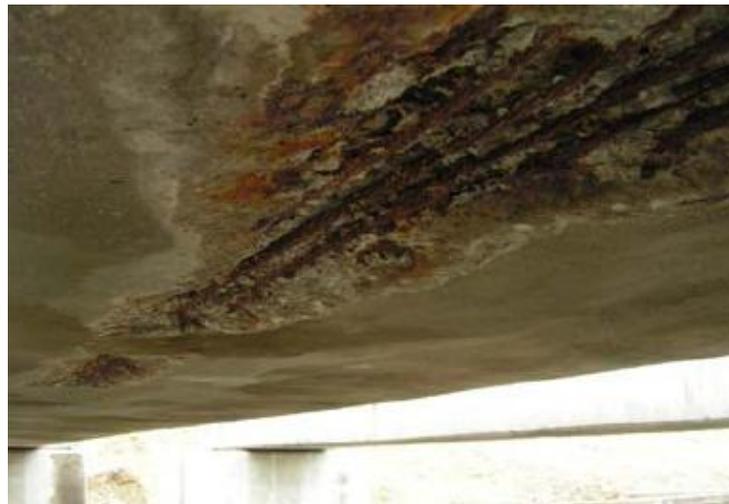
onto the bridge girders overhead. Salt-spray, and its effect on rate of corrosion, was one of the potential causes of the collapse of the exterior girder of the Lake View Bridge over I-70 in 2005 in Washington, Pennsylvania. Based on the pre-test inspections conducted, it appeared that the most exterior prestressing strand damage resulted from vehicle impacts damaging the concrete cover, followed by corrosion of the exposed strands [43]. A photo of the another beam in the structure, that did not collapse, showing the damaged girder and corroded strands is provided in Figure 3-3.

Figure 3-3 Photo showing results of vehicle impact and subsequent corrosion damage to prestressing strands from a prestressed concrete box beam in Lake View Bridge over I-70 (taken from [43]).

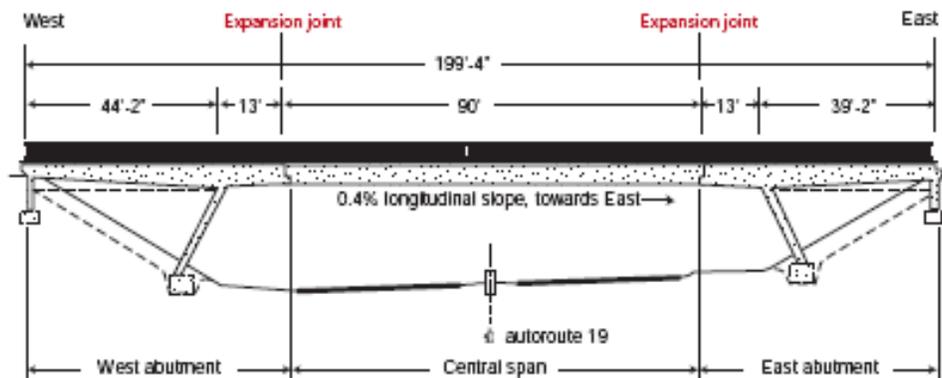
The collapse of the de la Concorde overpass shows that the bridge designer must fully consider the effects of reinforcement details in a concrete superstructure. An inquiry into the collapse of a portion of the overpass in Laval, Quebec, Canada, on September 30, 2006, found that improper detailing and installation of the steel reinforcement was a contributing factor to the bridge failure [52]. The simple single span of the bridge consisted of adjacent box girders, which rested on a beam seat. The beam seat was built into the thickened slab that cantilevered from the abutments at each end, as shown in Figure 3-4. The commission determined that in the as designed structure, the concentration of numerous reinforcement bars on the same plane in the upper part of the thickened cantilever slab created a plane of weakness where horizontal cracking could occur [52]. Top bars in the thickened slab were not sufficiently anchored. Additionally, the improper placement of several reinforcement bars during construction created a much larger zone of weakness extending into the thickened slab [52].

Figure 3-4 Sketch showing the elevation of de la Concorde overpass; the simple central span of the bridge consisted of adjacent box girders, which rested on a beam seat that was built into the thickened slab that cantilevered from the abutments at each end (taken from [52]).

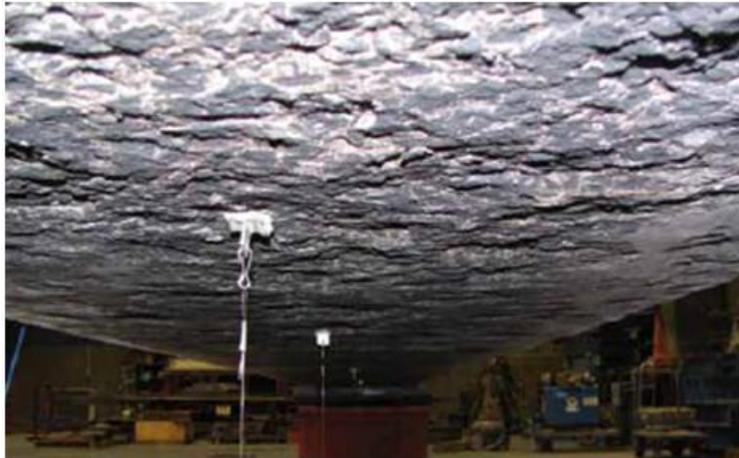
On July 12, 2005, a significant fire incident occurred near Ridgefield, Connecticut which caused significant damage to an adjacent box-beam bridge. The Connecticut DOT coordinated with the FHWA's Turner Fairbank Research Center to investigate the flexural capacity of the beams removed from the bridge after the fire. The results of the investigation showed that the beams still had sufficient flexural capacity but the long-term viability of the beams was questionable. The visual and petrographic examinations showed that the damage to the bottom flange concrete was sufficient to allow pathways through the concrete to the depth of the bottom prestressing stands [56]. This could potentially lead to the accelerated deterioration of the bottom row of strands due to water ingress and subsequent corrosion. A photo of the bottom face of one of the tested beams is provided in Figure 3-5.

Figure 3-5 *Photo of the bottom face of a tested beam subjected to fire while in service showing that the concrete has deteriorated such that sufficient pathways through the concrete to the bottom layer of prestressing strands have developed (taken from [56]).*

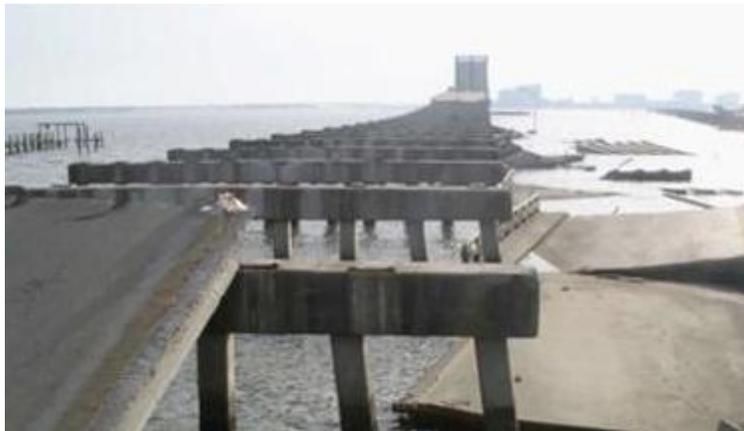
In August 2005, several concrete girder bridges were damaged or completely destroyed in Alabama, Louisiana, and Mississippi during Hurricane Katrina. Padgett et al. [57], used data from 44 damaged bridges to develop relationships between storm surge elevation, damage level, and repair costs. The authors point out that several traditional fixed spans displaced due to a combination of buoyant forces and pounding by waves. The US-90 Biloxi-Ocean Springs Bridge suffered severe damage due to a combination of storm surge and wind/wave induced loading [57]. The four-lane, 1.9 mile, multi-span concrete girder bridge had low-lying spans. The storm surge caused severe damage to the bearings, and most connections between the deck and the pier caps were destroyed, allowing free movement of the spans. In fact, several spans on the western half of the bridge became completely unseated and were submerged in the bay, as shown in Figure 3-6. In traditional hurricane prone areas, the designer should take measures to reduce the likelihood of failure caused by storm surge: the bridge could be designed to a higher elevation, provide details such as transverse shear keys to prevent lateral movement, or tie downs to prevent upward movement.

Figure 3-6 *Photo showing the spans of the US-90 bridge completely unseated and submerged in the water due to storm surge induced loading (taken from [57]).*
