Protocols for the Assessment and Repair of Bridge Foundations

Final Report

August 2016
FHWA HIF-17-044

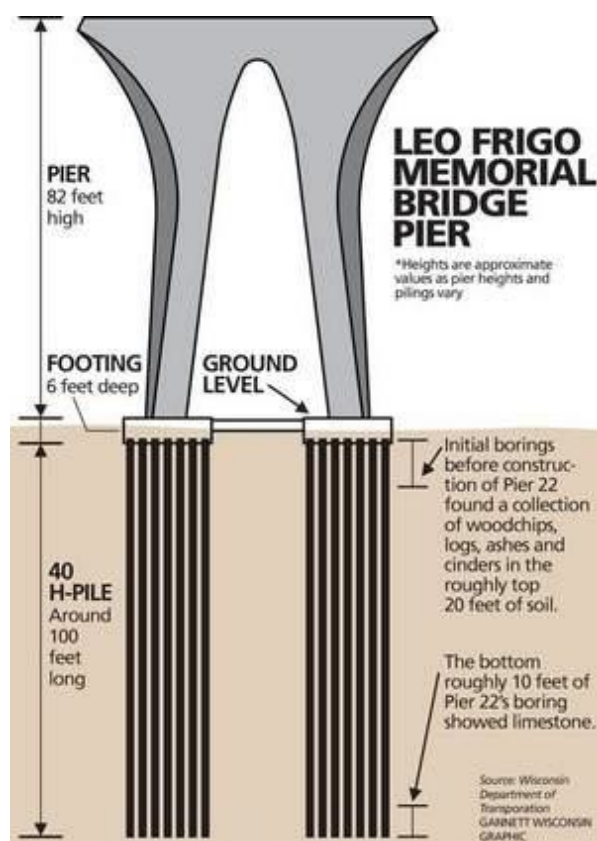
The Leo Frigo Memorial Bridge, part of Interstate 43, carries an average 40,000 vehicles per day over the Fox River in Green Bay, Wisconsin (Phelps, 2013). The 1.5-mile-long bridge consists of four lanes, two lanes carrying traffic in each direction. The tied-arch bridge was originally constructed in 1981, with 52 concrete piers each supported by 40 steel H-piles (WisDOT, 2015). Piles were driven approximately 100 feet deep, with the pile tips bearing either in limestone or the dense clay above rock. Subsurface conditions consisted of approximately 20 feet of fill, including porous fly ash fill and industrial byproducts, overlying layers of dense clay and sand with rock at a depth of approximately 90 to 120 feet, as shown in Figure A-1 (Williams, 2013). The bridge was inspected in October of 2012 and determined to be structurally sound (NACE International, n.d.).

Figure A-1: Existing Conditions of Leo Frigo Memorial Bridge (Williams, 2013)

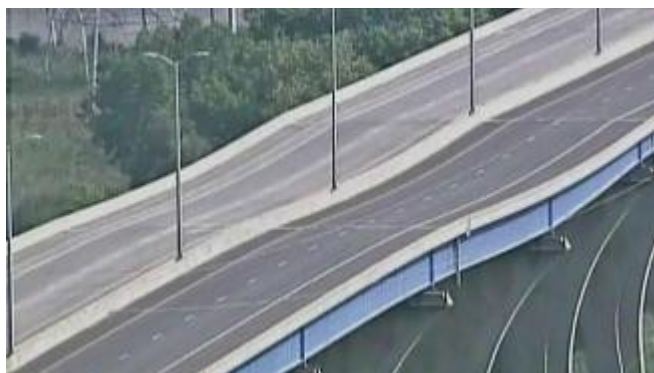
On September 25, 2013, Pier 22 suddenly settled approximately 2 feet between 3:00 and 3:45 AM. The bridge was closed after motorists called 911 early that morning to alert authorities about the resulting dip in the bridge deck. The vertical displacement of the 400-foot-long span of the bridge deck is shown in Figure A-2 (Phelps, 2013; WisDOT, 2015)

Figure A-2: Sagging Leo Frigo Memorial Bridge (Thompson, 2013)

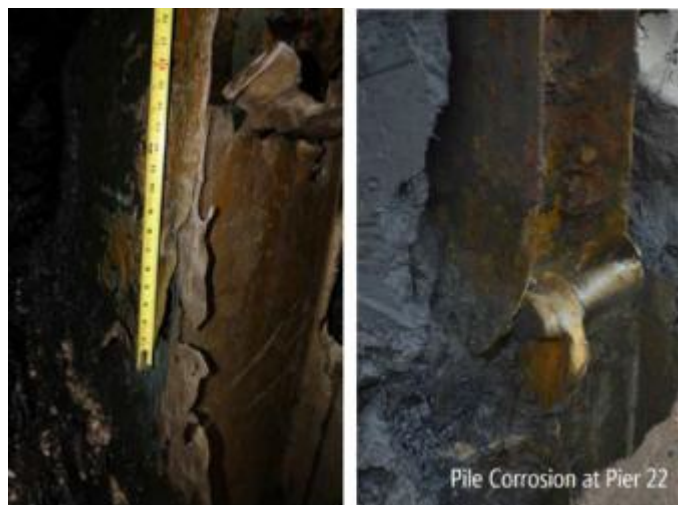
Subsurface explorations began on September 28 to investigate the cause of the sudden settlement. Robotic survey instrumentation was also installed to monitor any additional movement of the pier. Investigations revealed corrosion and subsequent buckling of the deteriorated steel H-piles supporting Pier 22 caused the observed settlement. Figure A-3 shows pile corrosion found under Pier 22. Pile corrosion was also found underneath Piers 21, 23, and 25. Investigations determined that the composition of industrial byproduct fill placed in the area of the corroded piles prior to construction interacting with groundwater led to accelerated steel pile corrosion. The porous fly ash fill had high levels of chlorides and sulfides and low resistivity, leading to increased corrosion. A clay layer underlying the fill also led to high differential oxygen levels and chemical concentrations, providing a corrosive environment. Microbial activity also likely played a role in increasing corrosivity. The problem was not detected earlier as checking for pile corrosion is not part of regular bridge inspections. (Phelps, 2013; WisDOT, 2015)

Figure A-3: Pile Corrosion at Pier 22 (Source: Wisconsin DOT)

All piers for the Leo Frigo Memorial Bridge were assessed for pile corrosion and grouped into three categories: tier 1, tier 2, and tier 3. Tier 1 piers showed severe pile corrosion and needed immediate repairs. Tier 2 piers showed some corrosion or potential corrosion, but were not an immediate safety concern. Further monitoring of tier 2 piers was recommended. Tier 3 piers did not show any pile corrosion and had very low potential for future pile corrosion. Piers 21, 22, 23 and 25 were identified as tier 1. Pier 24 was also identified as tier 1 due to its close proximity to other tier 1 piers, even though corrosion was not as severe at Pier 24. Seventeen piers were identified as tier 2. Monitoring instruments were installed on these piers and treatment options were identified should corrosion occur faster than anticipated. No action was required for the tier 3 piers. (WisDOT, 2015)

For tier 1 piers (Piers 21-25), repairs consisted of four 5-foot-diameter drilled shafts installed adjacent to each of the existing pile groups to an average depth of 125 feet, bearing in rock. A post-tensioned extension of each pile cap was constructed to transfer bridge loads to the drilled shafts rather than the steel piles. Buttress walls around the base of the piers were also constructed to transfer loads to the drilled shafts. Centrifugally cast, fiberglass-reinforced, polymer mortar (CCFRPM) casing was placed around the top 30 feet of drilled shafts to resist future corrosion. The new drilled shafts were designed to be capable of supporting the entire pier design load for 75 service years with no contribution from adjacent existing piles. Figure A-4 shows a schematic of repairs to the Leo Frigo Bridge. (Thompson, 2013; WisDOT, 2015)

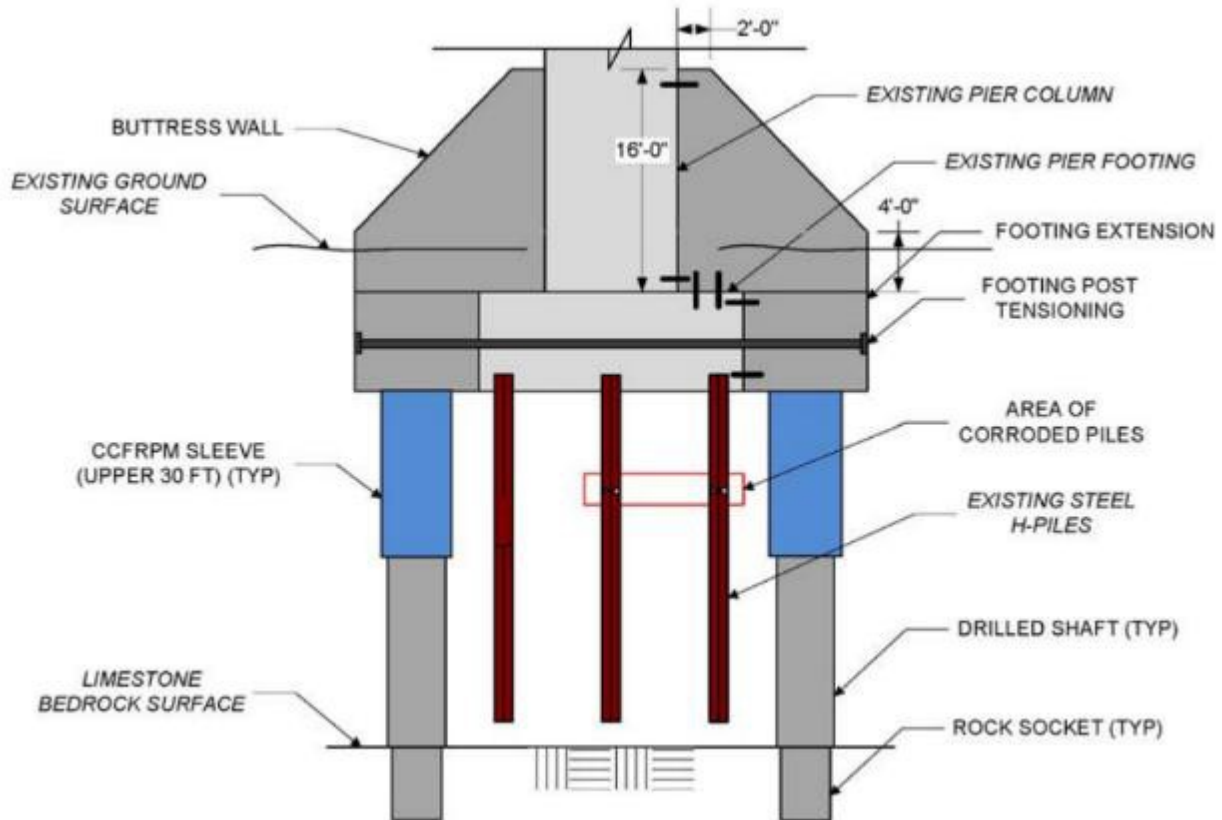
Figure A-4: Schematic of Repairs for Piers 21-25 (Source: Wisconsin DOT)

Repairs were completed and the bridge was re-opened in January 2014, just three months after the initial closing. Round-the-clock investigations and construction led to an ahead of schedule, under budget, and successful repair. The restoration of the Leo Frigo Bridge won an Engineering Excellence award from ASCE Wisconsin, recognizing the dedication of the project team and success of the repairs. Repairs cost \$8.45 million, including a \$750,000 bonus for finishing early. Costs were completely covered by federal emergency funding. (WisDOT, 2015; Michael Baker Jr. Inc., 2014)

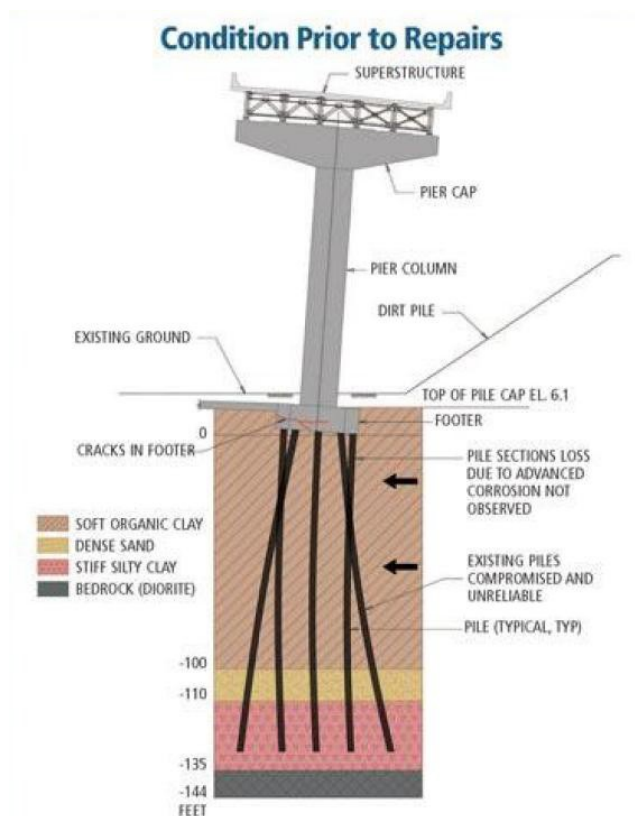
Figure A-5: Subsurface Profile and Observed Damage at I-495 Bridge (O'Shea, 2015)

The bridge was closed on June 2, 2014 after it was observed that 60-foot-high piers on the northbound side were tilting toward the east (Moffitt and Shelly, 2015). The damage was observed by a geotechnical engineer who was working for a third party and was on site to investigate whether a soil stockpile on adjacent private property had caused damage to an underground petroleum pipeline. The stockpile was adjacent to the northbound side of the interstate, specifically in the area of bridge piers 11 through 14. These piers were tilted as much as four percent out of the vertical alignment, resulting in an 18-inch difference in elevation between the median barriers. Subsequent investigations found that the stockpile had caused the bridge foundation failure by inducing lateral loads and deformations (lateral squeeze) into the thick soft clay layer, resulting in lateral displacements of the piles of up to two feet. Figure A-6 shows the soil stockpile adjacent to tilting piers. (Mohammad and Armfield, 2015; Burke and Montgomery, 2014)

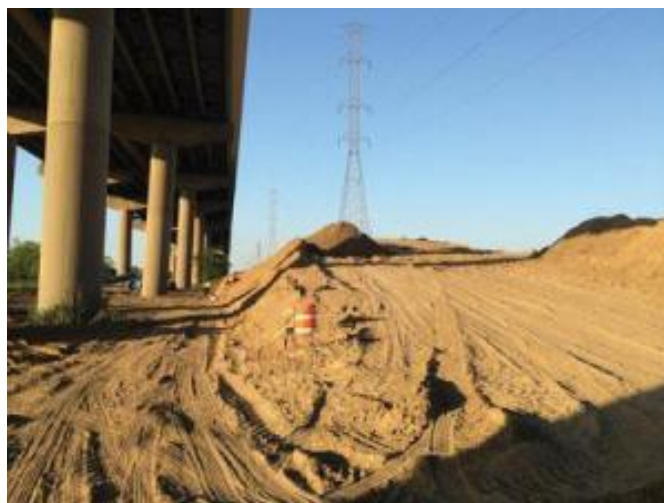
Figure A-6: Tilting bridge piers and adjacent soil stockpile (O'Shea, 2015)

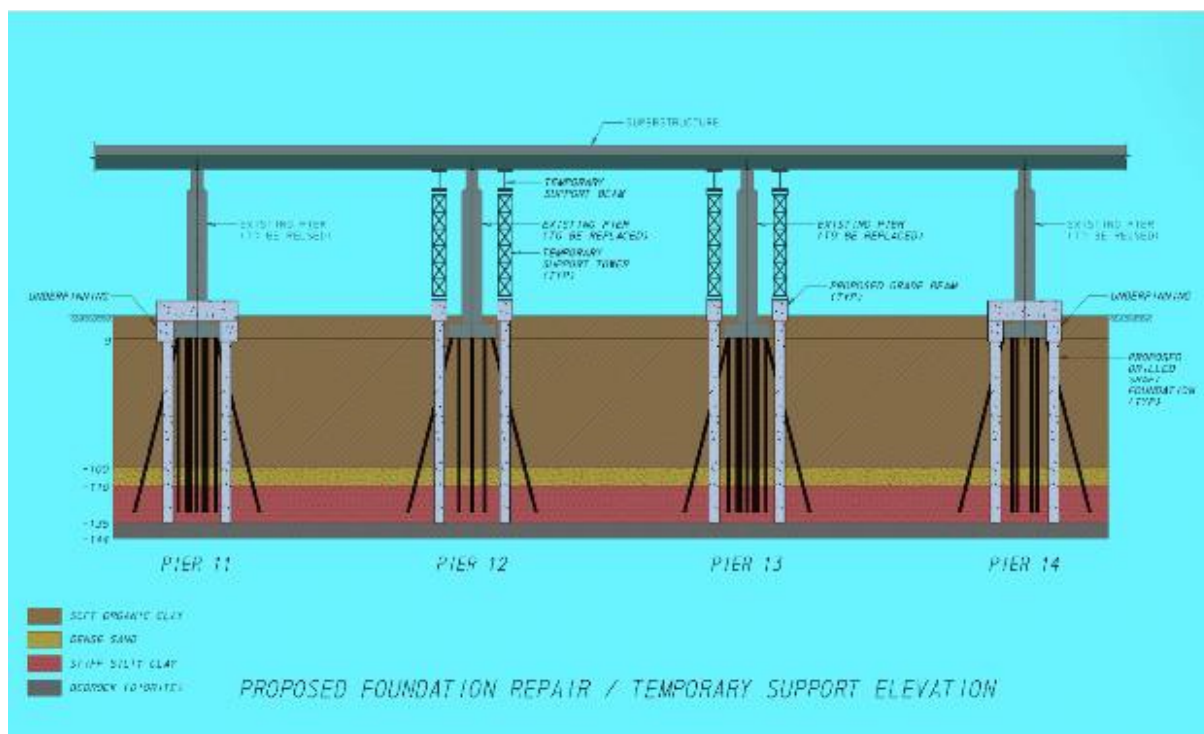
Figure A-7: Repair methods and temporary support (Mohammad and Armfield, 2015)

The southbound lanes of the bridge were opened within 59 days of closure and the northbound lanes were opened 83 days after closure. The total cost of repairs was \$40 million. Temporary repairs were paid completely by Federal funding and 90% of permanent repairs were paid for by Federal funding (O'Shea, 2015). Work was done 24/7 to complete repairs in a timely manner. Investigations and initial design were able to occur simultaneously, also saving time and money (Moffitt and Shelly, 2015). Close communication and cooperation of the client, designer, and contractor, along with the clear vision and leadership of DelDOT and assistance from FHWA, led to quick and successful repairs (Mohammad and Armfield, 2015).

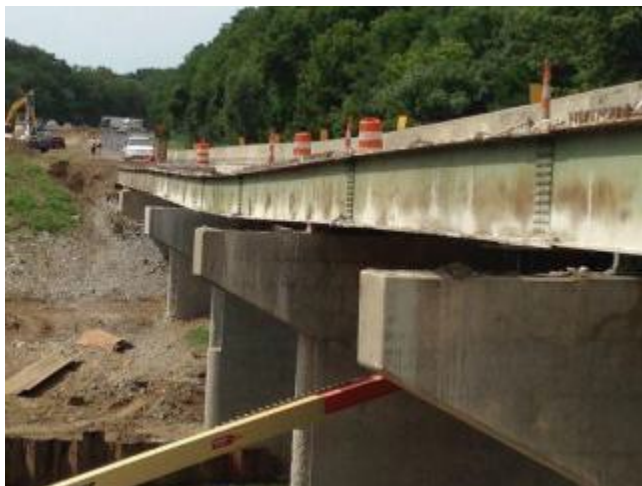
Figure A-8: Post-Failure View, I-65 Bridge, Lafayette, Indiana (McCoy, 2015)

A fracture critical inspection was performed prior to re-opening the bridge. Load tests were also performed, 24 hours after re-establishment of the final elevations. Load tests were performed with varying configurations of truck traffic on the bridge, to observe performance under maximum vertical load, negative moment on the superstructure, braking loads, and an eccentric loading on the restored pier and foundation. The bridge was instrumented with inclinometers and strain gages to observe performance during the load test program. The design-build bridge engineer, in their role as engineer-of-record, reviewed the design considerations associated with leaving the tilt in the existing pier, and confirmed its acceptability. The bridge reopened September 6, 2015, only a month after observed settlement. Continuous work by Indiana DOT and the contractor made the quick turnaround possible (INDOT, 2015). Construction of the remaining portion of the widening project progressed with continuous bridge monitoring by Purdue University, and with design and construction measures to avoid similar settlement of the remaining piers to be widened.

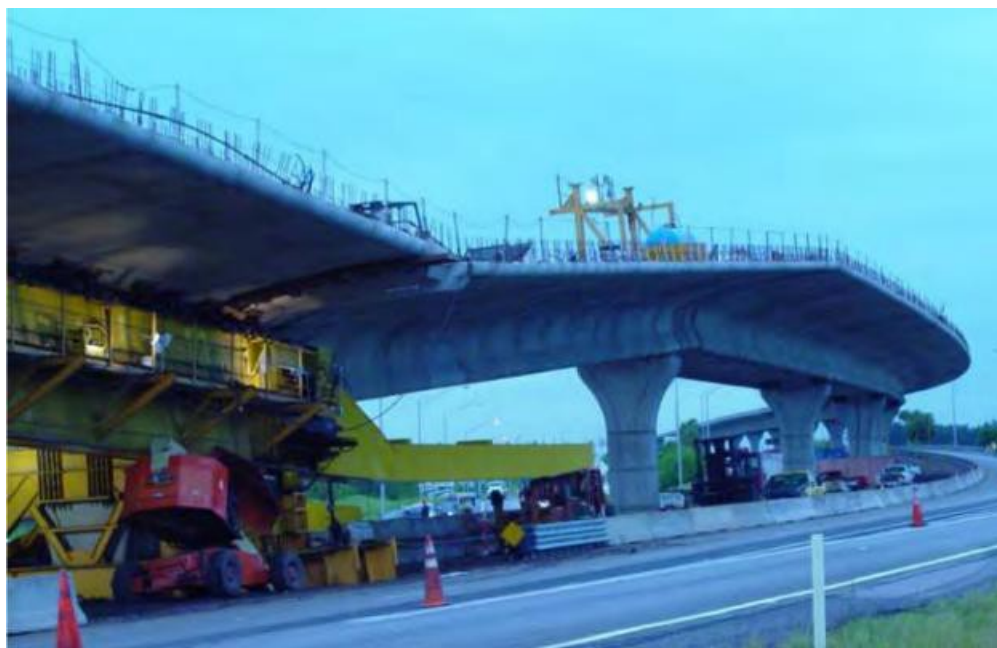
In April 2004, approximately 14 months into construction of the elevated lanes, Pier 97 suddenly settled 11 feet (Samuel, 2009). The photograph in Figure A-10 shows the damage from the sudden settlement.

Figure A-10: Collapse of Pier 97 in April, 2004 (Graham et al., 2014)

The 11 feet of settlement was initially thought to be due to an undetected sinkhole beneath Pier 97. However, a few months later in June, 2004, another pier settled a few inches. As more piers began to settle, further investigations found that only 50 of the 204 piers were designed with adequate foundations for the soil/rock strengths present. (Samuel, 2009; Graham et al., 2014).

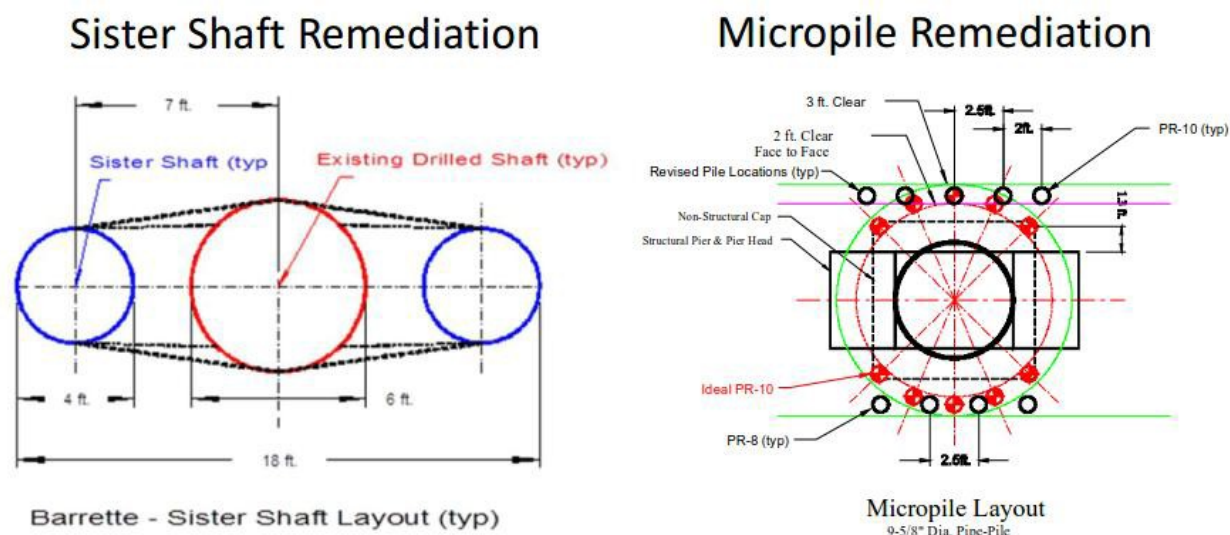
Figure A-11: Remediation techniques selected (Dapp et al., 2013)

Repairs were paid for by the owner, Tampa Hillsboro (Toll) Expressway Authority (THEA), but subsequently were the subject of a claim by THEA for recovery of these costs. Specific information about procurement of the repair work was not found in reviewed literature. Depending on geological conditions, the insufficient piers were either retrofitted with micropiles or drilled shafts. Four to ten micropiles, depending on soil conditions, were installed to augment existing foundations at 87 of the piers. Two 4-foot diameter “sister” drilled shafts were installed for support at each of the remaining 67 drilled shafts that needed remediation. Post-tensioned foundation caps were used to connect the existing foundation with the new drilled shafts. Figure A-11 shows schematics of the two different types of remediation. Multiple borings at each pier were taken and correlated to results from full scale dynamic testing previously done for recently constructed piers to determine if/how much additional support was needed (Samuel, 2009; Graham et al., 2014).

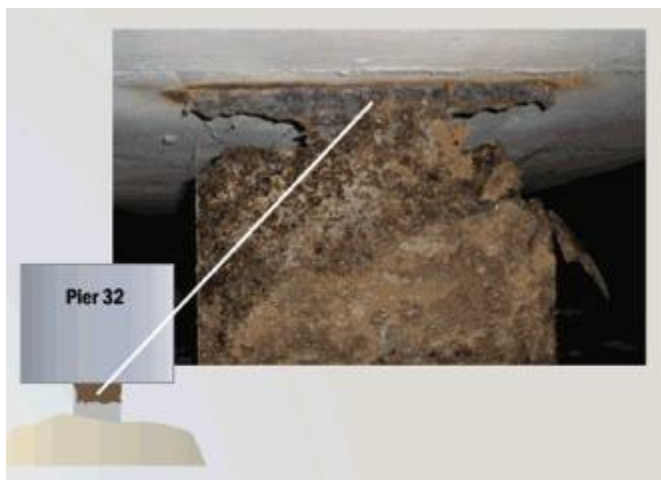
Figure A-14: Pile corrosion under Pier 32 (Paint Square, 2013)

MnDOT started repair work with its internal maintenance crew before hiring a contractor to complete the work. MnDOT awarded an emergency contract with an accelerated schedule for 24/7 work. Concrete collars were installed around the damaged piles at Pier 32 and the bridge was reopened about a month later. (Kraker, 2013; Paint Square, 2013)

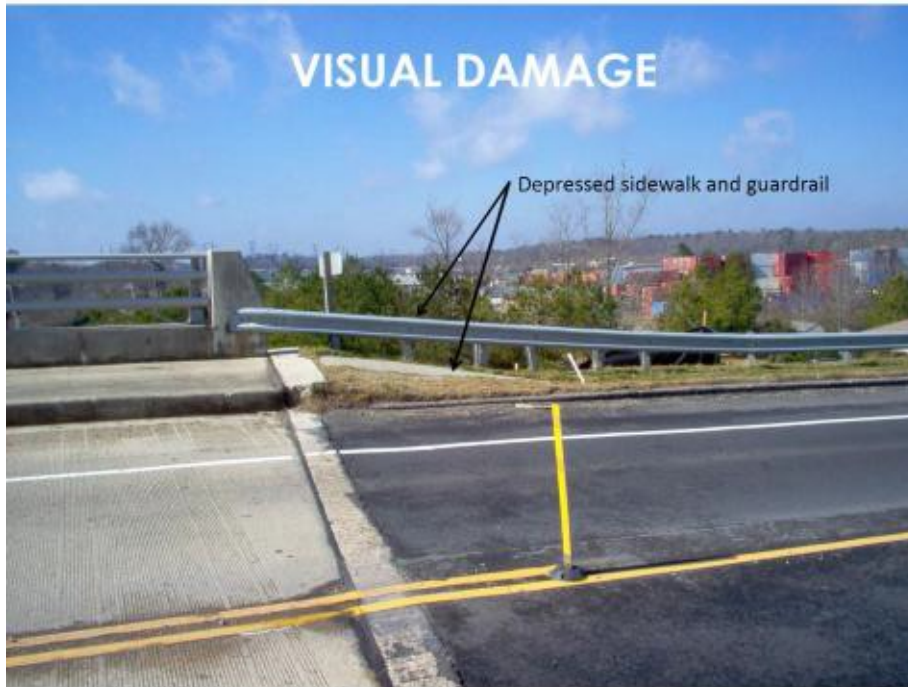
Settlements of 2.5 feet to 3.5 feet were expected from approach embankment loading during the original construction of the bridge. Since eighty percent of this settlement was expected to occur over 3 months, so the embankments were constructed and allowed to settle for 3 months before bridge construction began. However, by 2000, additional settlements of up to 2.5 to 3 feet had occurred at the approach embankments after the end of the bridge construction. Figure A-16 shows sagging of the approach at the surface from excessive embankment settlements. A study conducted in 2003 concluded that original analyses did not properly calculate anticipated settlements or account for downdrag effects on the foundation piles. Up to 22 more inches of consolidation of the soft clay layer under the existing embankment load was possible. Damage to the bridge from settlement included cracked beams, buckling of slope protection, and cracked wing walls. Investigation into the abutment foundations indicated that the piles supporting the abutment were severely damaged. Figure A-17 shows the tensile failure of a pile due to downdrag and the void beneath the abutment foundation. (DeStephen, 2015)

Figure A-16: Damage from Settlements (DeStephen, 2015)

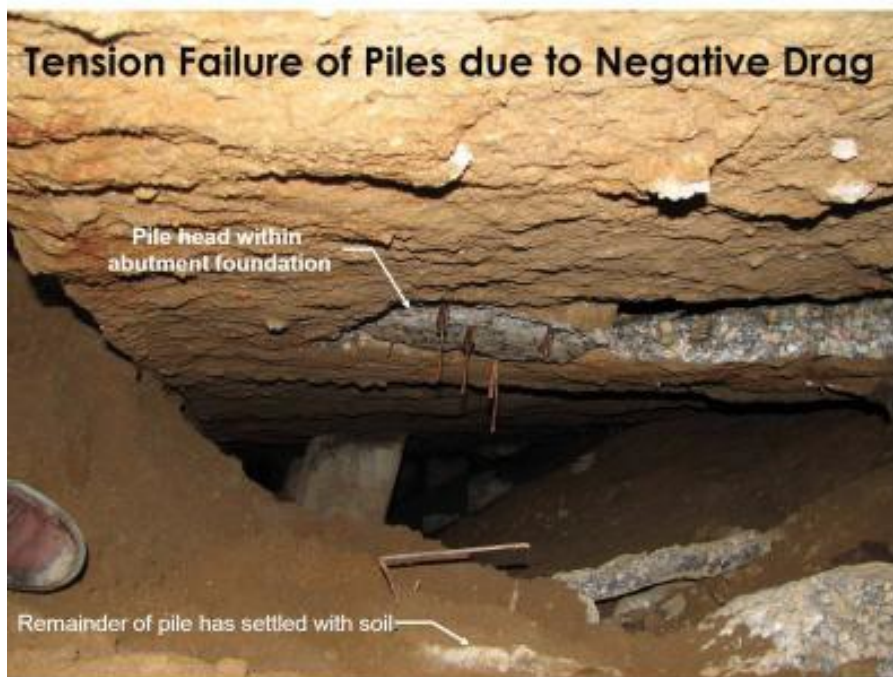
Figure A-17: Settlement Damage from Downdrag (DeStephen, 2015)

As of 2003, the center pier piles had settled up to 1.5 inches, the end pier piles had settled up to 3.5 inches, and the abutment piles settled from 4 to 12 inches. Repair alternatives considered included underpinning with micropiles, underpinning using jet grouting, or partial reconstruction of the bridge. No information on procurement of repairs was found in the reviewed literature. It

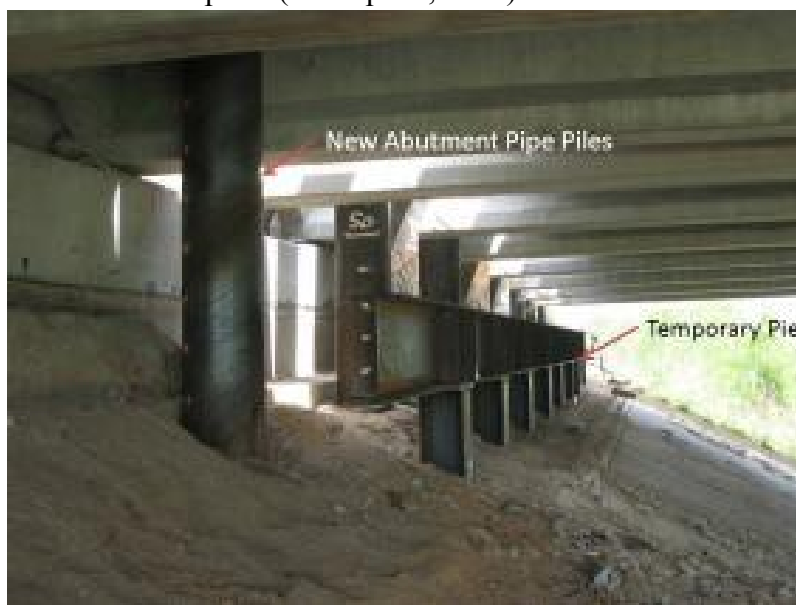
Figure A-18: Repairs and New Foundations (DeStephen, 2015)

was decided to reconstruct the bridge abutments while the piers and bridge spans were left in place. Sixteen-inch diameter steel pipe piles were installed as new foundations for the abutments. The piles were coated to reduce friction. Temporary shoring and steel H-piles were used to support the structure during abutment reconstruction. Square access holes were cut in the bridge deck to install the piles. Figure A-18 shows the temporary and permanent foundation elements replacing the original pre-stressed concrete piles. (DeStephen, 2015)
