Reconstruction Report

May 2, 2014

Incident Date *January 27, 2014*
Incident Place *Hillsborough, NC*

DELTA [v] File *J1442*
DELTA [v] Engineer *Tyler S. Black, M.S., P.E.*

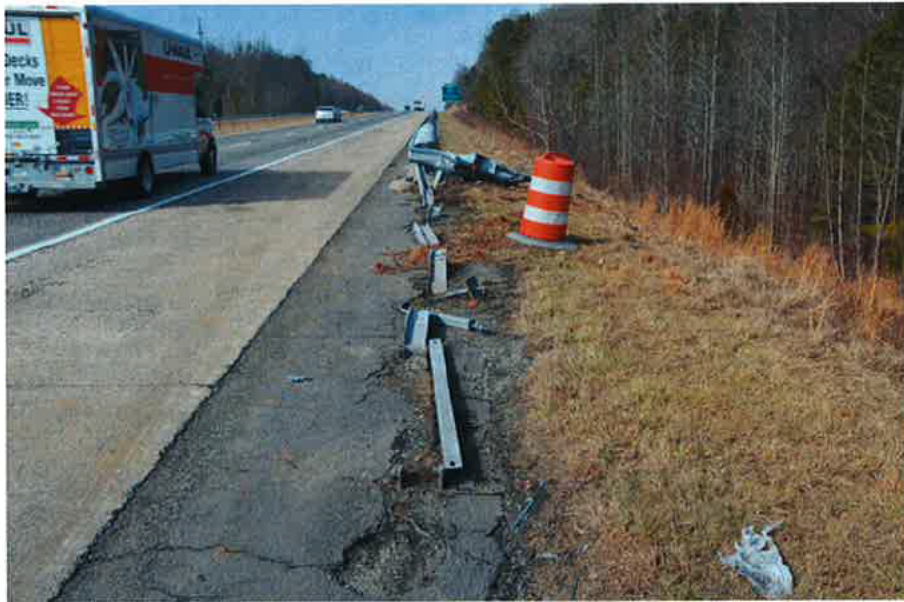
Figure 1 – Collision Site

The guardrail had not been repaired at the time of DELTA [v]'s inspection, and several columns had been separated from the guardrail (Figure 1). Approximately 15 feet of guardrail was bent away from the undamaged guardrail and the remainder was cut and removed from the scene. The end terminal was still located at the scene, and the cut end of the guardrail extended through the window of the end terminal (Figure 2). No pre-impact marks were found in the area leading up to the guardrail end terminal. DELTA [v] drawing J1442.01 of Appendix B shows the collision site during the inspection and shows where the guardrail and end terminal was installed prior to the collision.

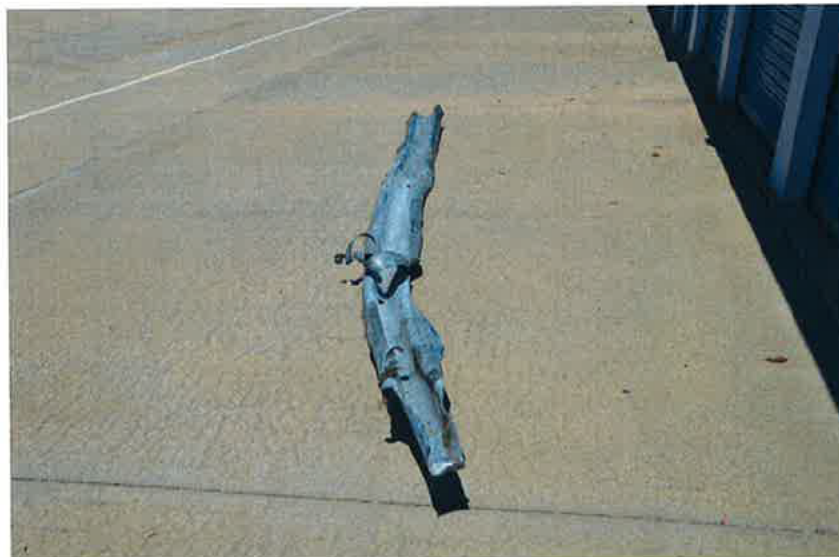
Figure 6 – Guardrail Section

A section of guardrail approximately 17 feet in length (Figure 6) was inspected on April 21, 2014 at America's Storage in Burlington, NC. One end was tapered to a point, and a piece of fabric was lodged in the rail near the pointed end. The other end appeared to be mechanically cut. Lengthwise abrasive marks were present along the length of the rail section. An overlap where two beam sections are bolted together was located from 11'3" to 12'3" from the tapered end of the section.

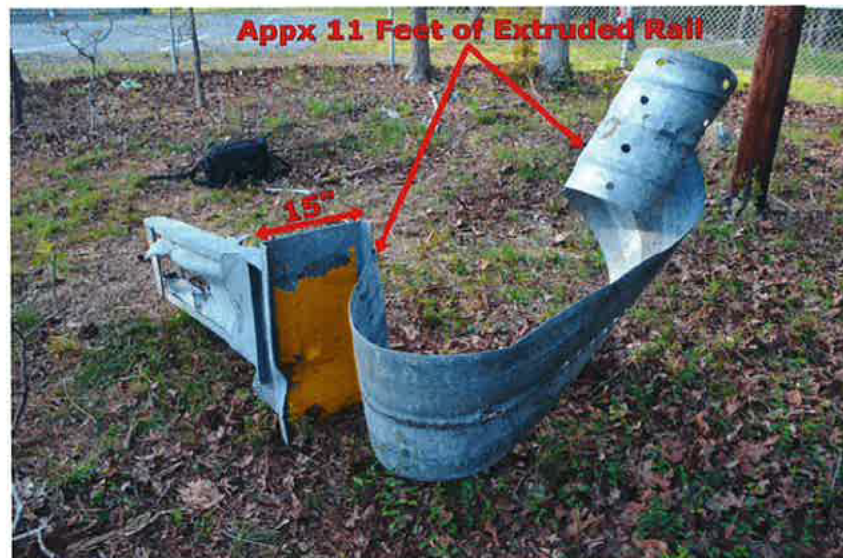
Figure 7 – End Terminal, Overall

The guardrail end terminal (Figure 7) was inspected on April 21, 2014 at Burlington Construction in Oakboro, NC. The face plate measures approximately 15 inches wide. A rectangular indentation is located approximately 7-10 inches from the bottom of the plate and offset toward the left side of the plate. This mark is adjacent to a deformation in the leading edge of the plate. Approximately 11 feet of guardrail is extruded, and a section of rail continues through the sleeve and out of the end of the terminal. The rail section is fractured from the center ridge outward and along a length of the rail, forming a "V" shaped fracture in the rail (Figure 8). The sleeve is approximately four inches in width (Figure 9).
