Reconstruction Report

Missouri State Highway Patrol Reconstruction Report

Level IV Reconstruction: Sergeant David Leitman, #234 C-SS
Major Crash Investigation Team
Troop C
St. Louis, Missouri

Date of Report: October 27, 2003

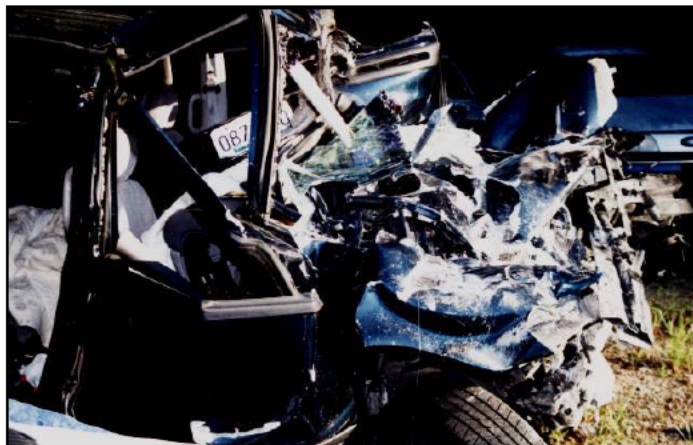
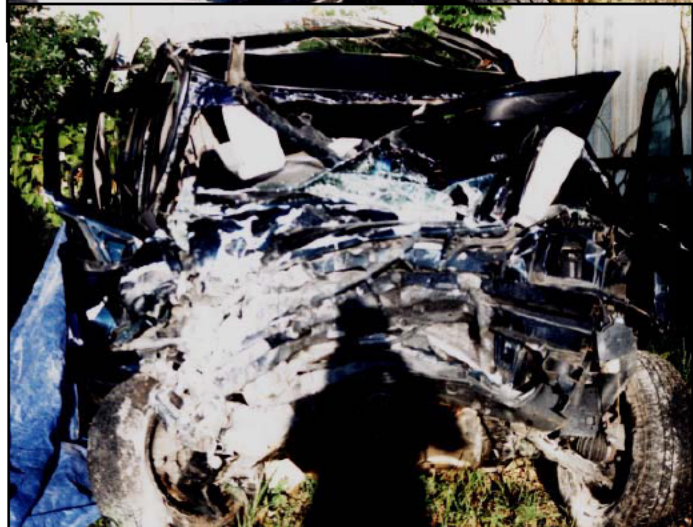
Vehicle #1 was destroyed at impact as it traveled into the rear of Vehicle #2. The adjacent photographs depict the severe devastation caused by impact.

The data in the module indicated the vehicle had sustained a 44 miles per hour change in velocity at impact.

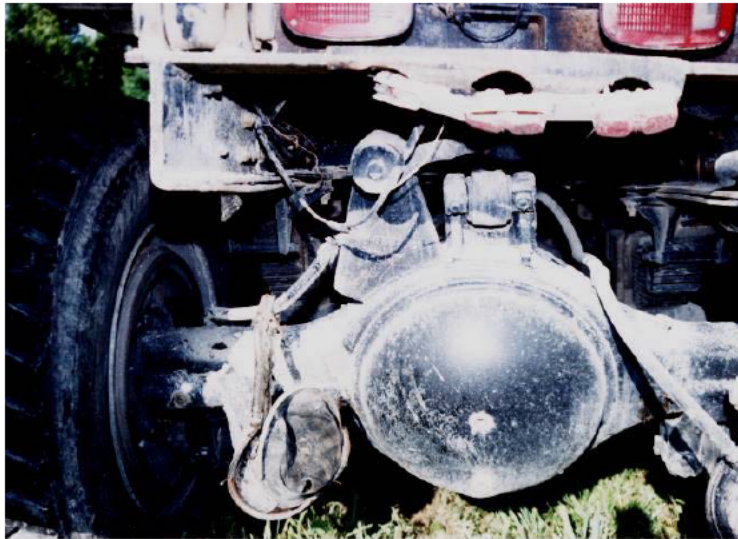
The only observable damage to Vehicle #2 was to the left rear as depicted in the adjacent photograph. The damage includes a flat left rear inside tire, broken axle suspension, damaged tail lamps and marker lamps and the left rear brake canister was destroyed.
