Missouri State Highway Patrol

Reconstruction Report

Date of Report: October 7, 2004

On [REDACTED], at approximately 1140 hours, a single motor vehicle crash occurred on Interstate 55, in Scott County, that resulted in six deaths, and one injury. The seven people involved in the crash were all in a southbound Dodge Grand Caravan. [REDACTED]

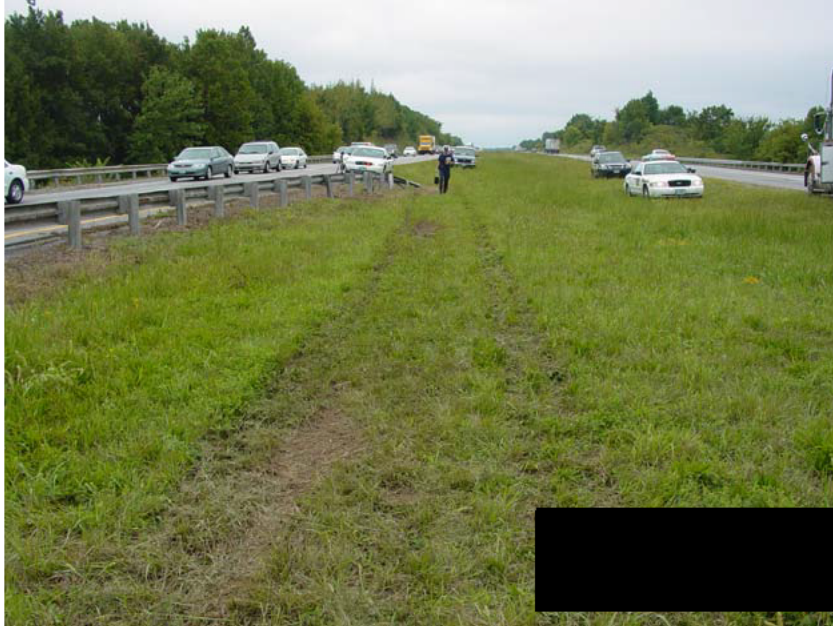
First, looking northbound.

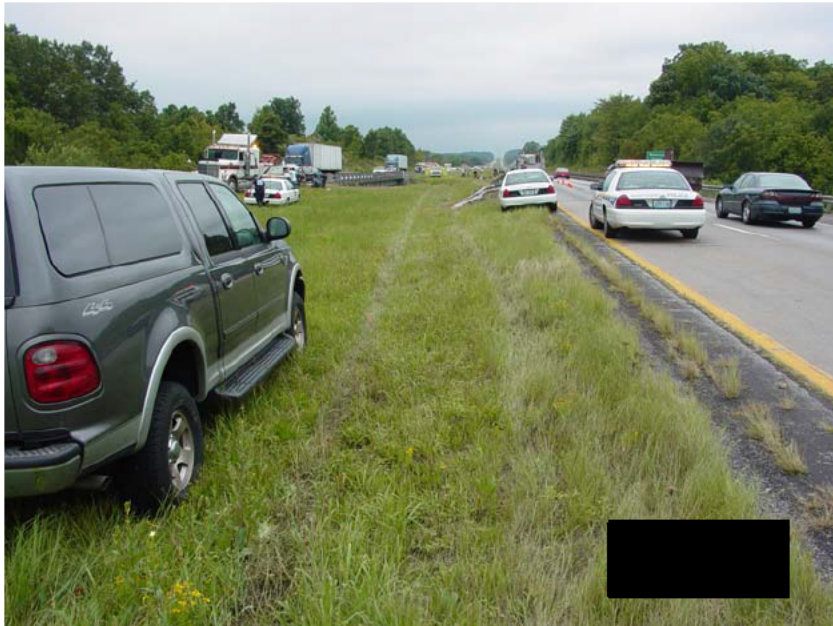
Secondly, looking southbound.

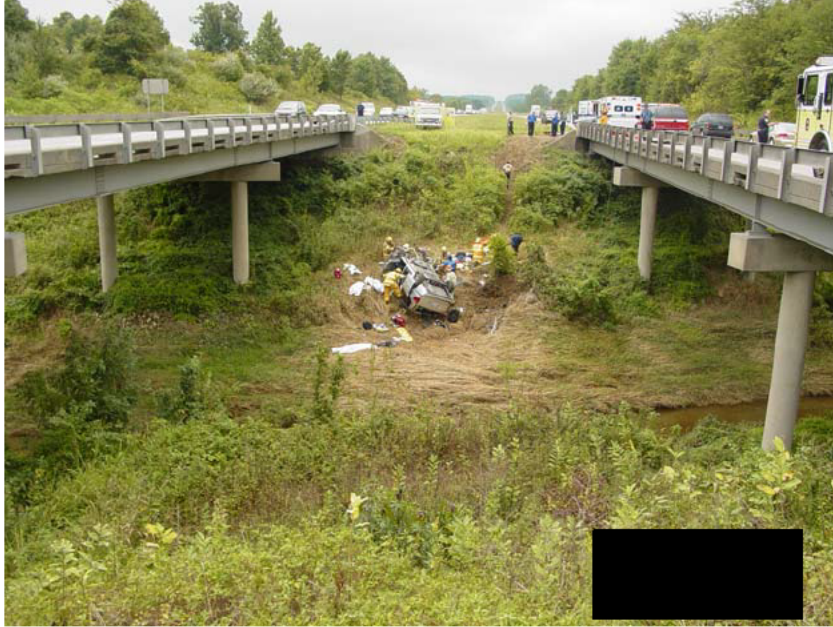
And thirdly, looking down at the final resting position on the creek bank.

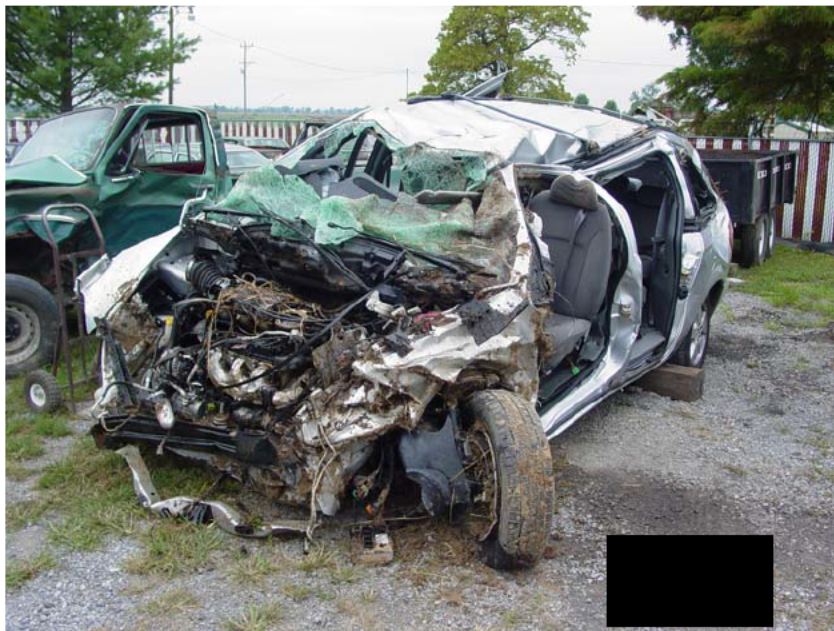
[REDACTED], after we completed our scene investigation, Sergeant Heath and I responded to Carnell's Towing to complete a more thorough examination of vehicle #1. During the examination the following information was noted: The damage to vehicle #1 was consistent with the crash sequence initially reported by Trooper Harrison. The front bumper was torn from the vehicle and the grill was destroyed. Both headlight / parking light assemblies were destroyed. The hood was torn off of the vehicle, and the engine was forced rearward and shifted to the driver's side. The entire front end was forced downward and the windshield was busted out. The middle of the busted windshield had blood evidence on the inside indicating occupant contact. The front left fender was pushed inward and down. The driver's front door and driver's side sliding door had been cut off by the responding fire and rescue squad. The front left rocker panel was bent downward. The driver's

side "A" pillar was bent in and down, and the roof on the driver's side was crushed back and down. The back hatch was sprung open and the glass was broken out. All glass on the driver's side of the vehicle was busted out. The passenger's side sliding door was sprung open and bent up. The passenger's side front door was sprung open, and the passenger's side fender was forced rearward. The glass on the passenger's side of the vehicle was still intact.

The photo below is a photograph of vehicle #1 taken at the tow company storage lot on A [REDACTED] [REDACTED] and represents the damage sustained in the crash.
