STATE OF CONNECTICUT
DEPARTMENT OF TRANSPORTATION

March 5, 2015

RE: Docket No. FHWA-2014-0039, ET-Plus Guardrail End Terminal

The Connecticut Department of Transportation (Department) is providing the following technical data in response to the request for information regarding the ET-Plus Guardrail End Treatment. The Department has performed a statewide inventory of these end treatments, identifying approximately 243 locations where either system ET-Plus/2000 is currently in service.

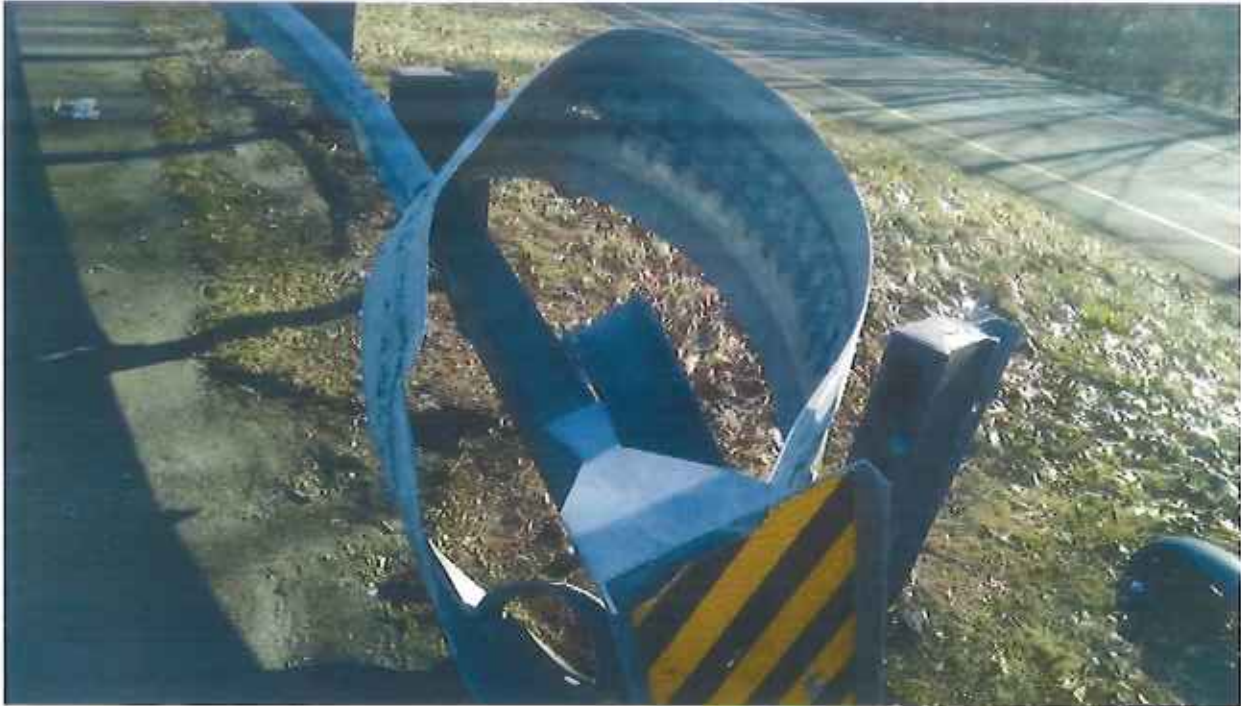
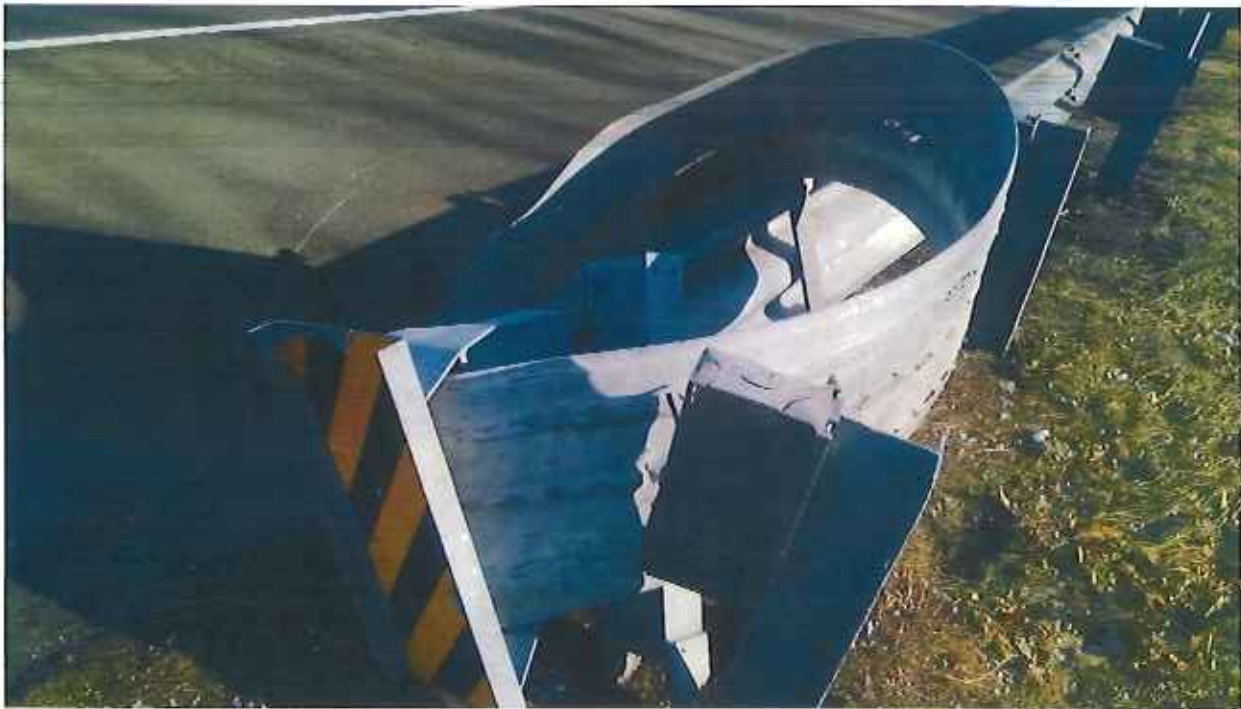
Pictures at time of repair

Connecticut DOT's ET-Plus vehicle crash experience at
Route	Rte 2 EB
Milepost	5.36
Location Description	Rte 2 EB Exit 8 " Rte 94 Hebron Ave" off ramp Gore Area
Roadway type	Limited access highway with an asphalt pavement surface
Date of Accident	1/5/2015
Crash Narratives	No Accident report
Crash Diagrams	No Accident report
Crash Severity	Vehicle drove away - no accident report on file
Vehicle mass	unknown
Vehicle speed	unknown
Angle of impact of the vehicle	unknown
Orientation of vehicle at impact	unknown
Weather	Damage discovered after a snow storm
Condition of shoulder/roadside	unknown
Installation/Maintenance History	System installed in 2009 - Maintenance History unknown
Terminal Condition	Provided image from 2014 state's network collection effort dated July 23, 2014 and pictures of system at time of repair after the non-reported accident

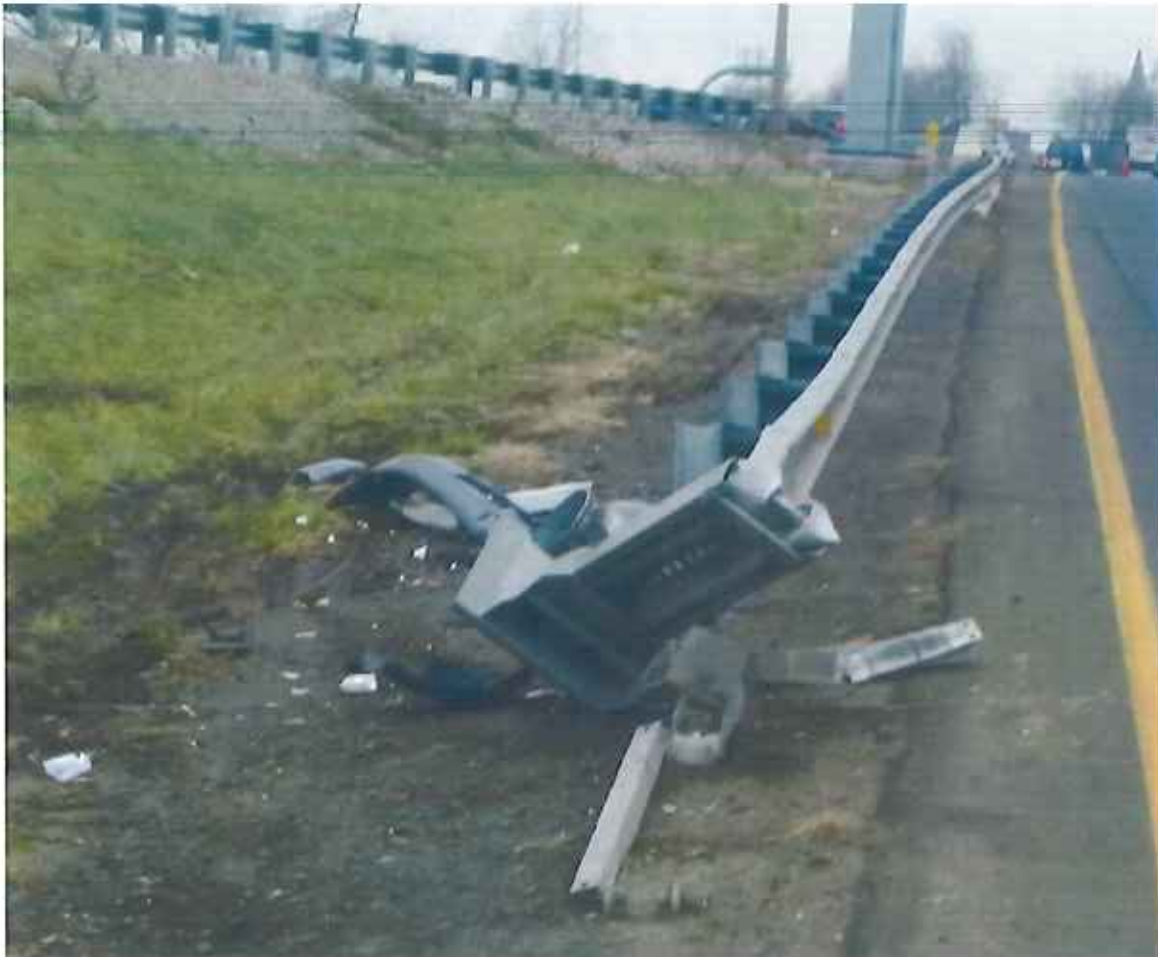
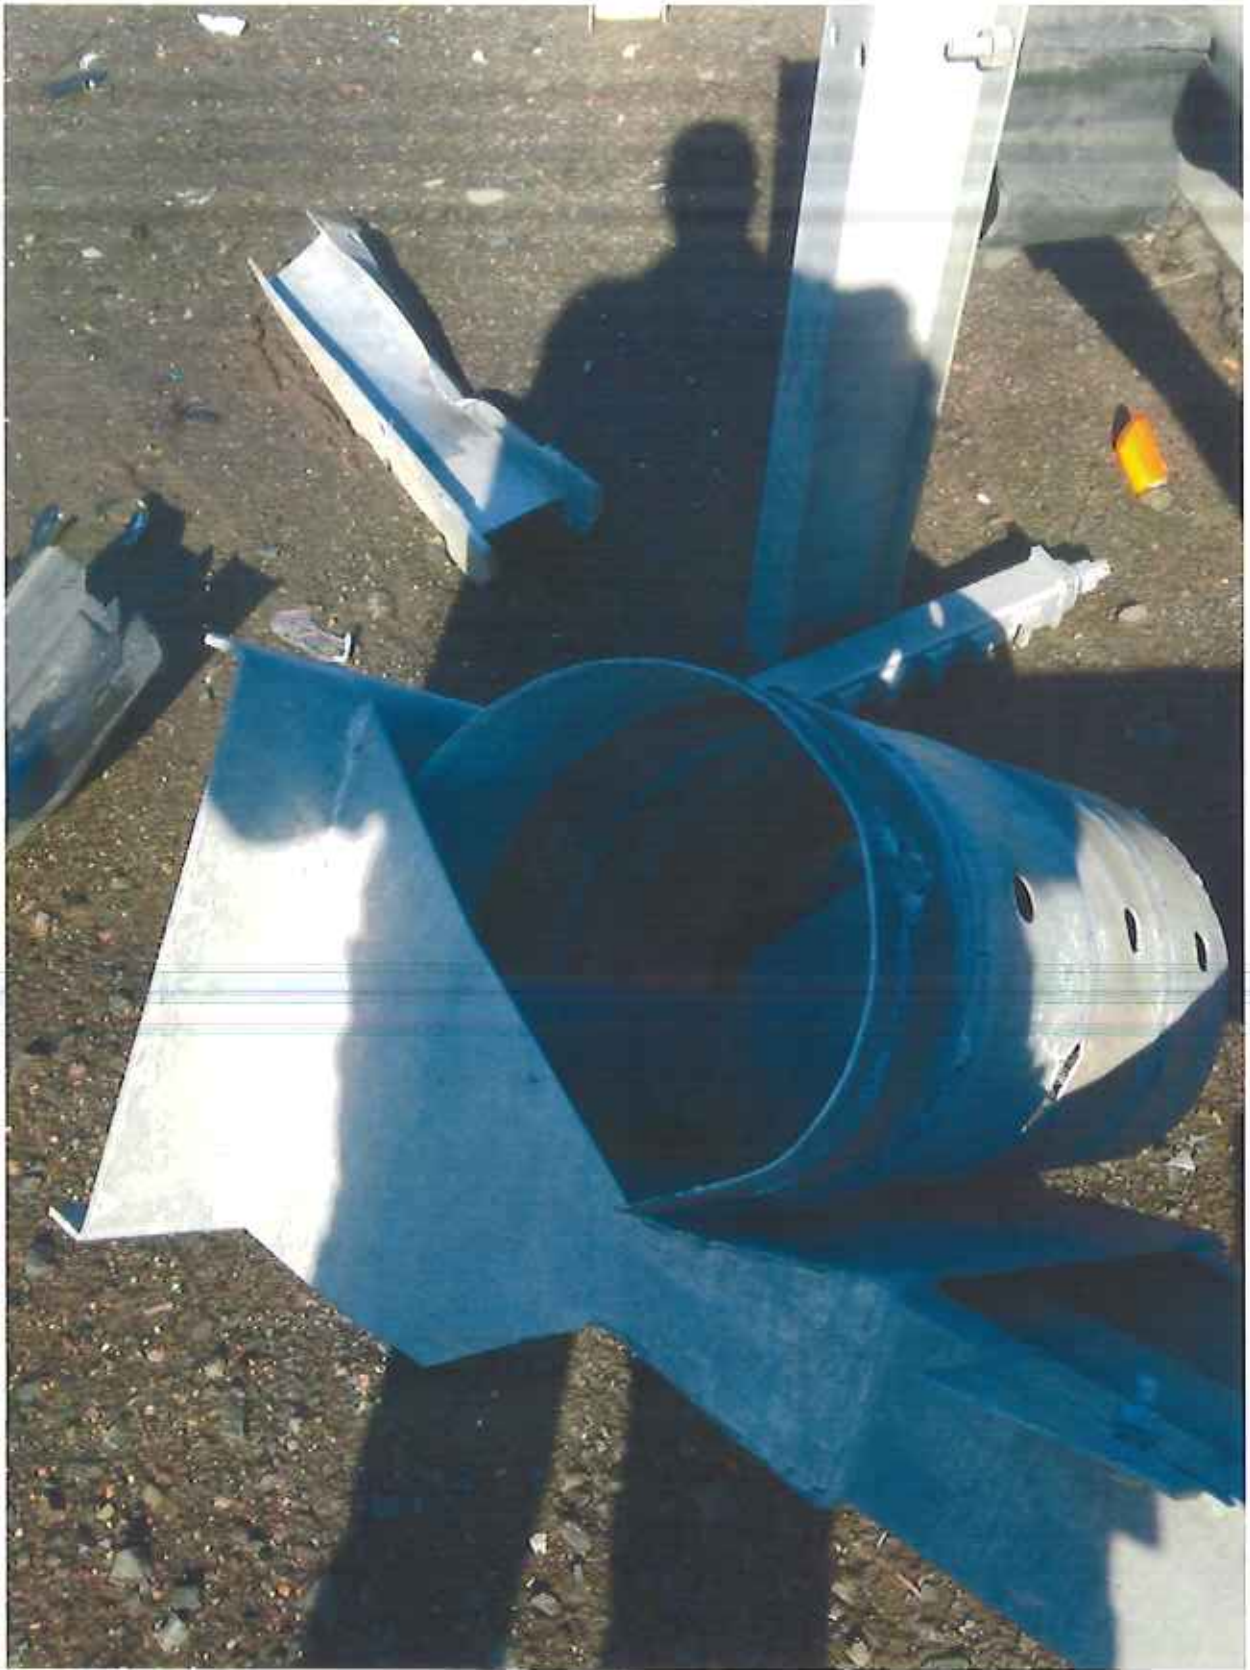
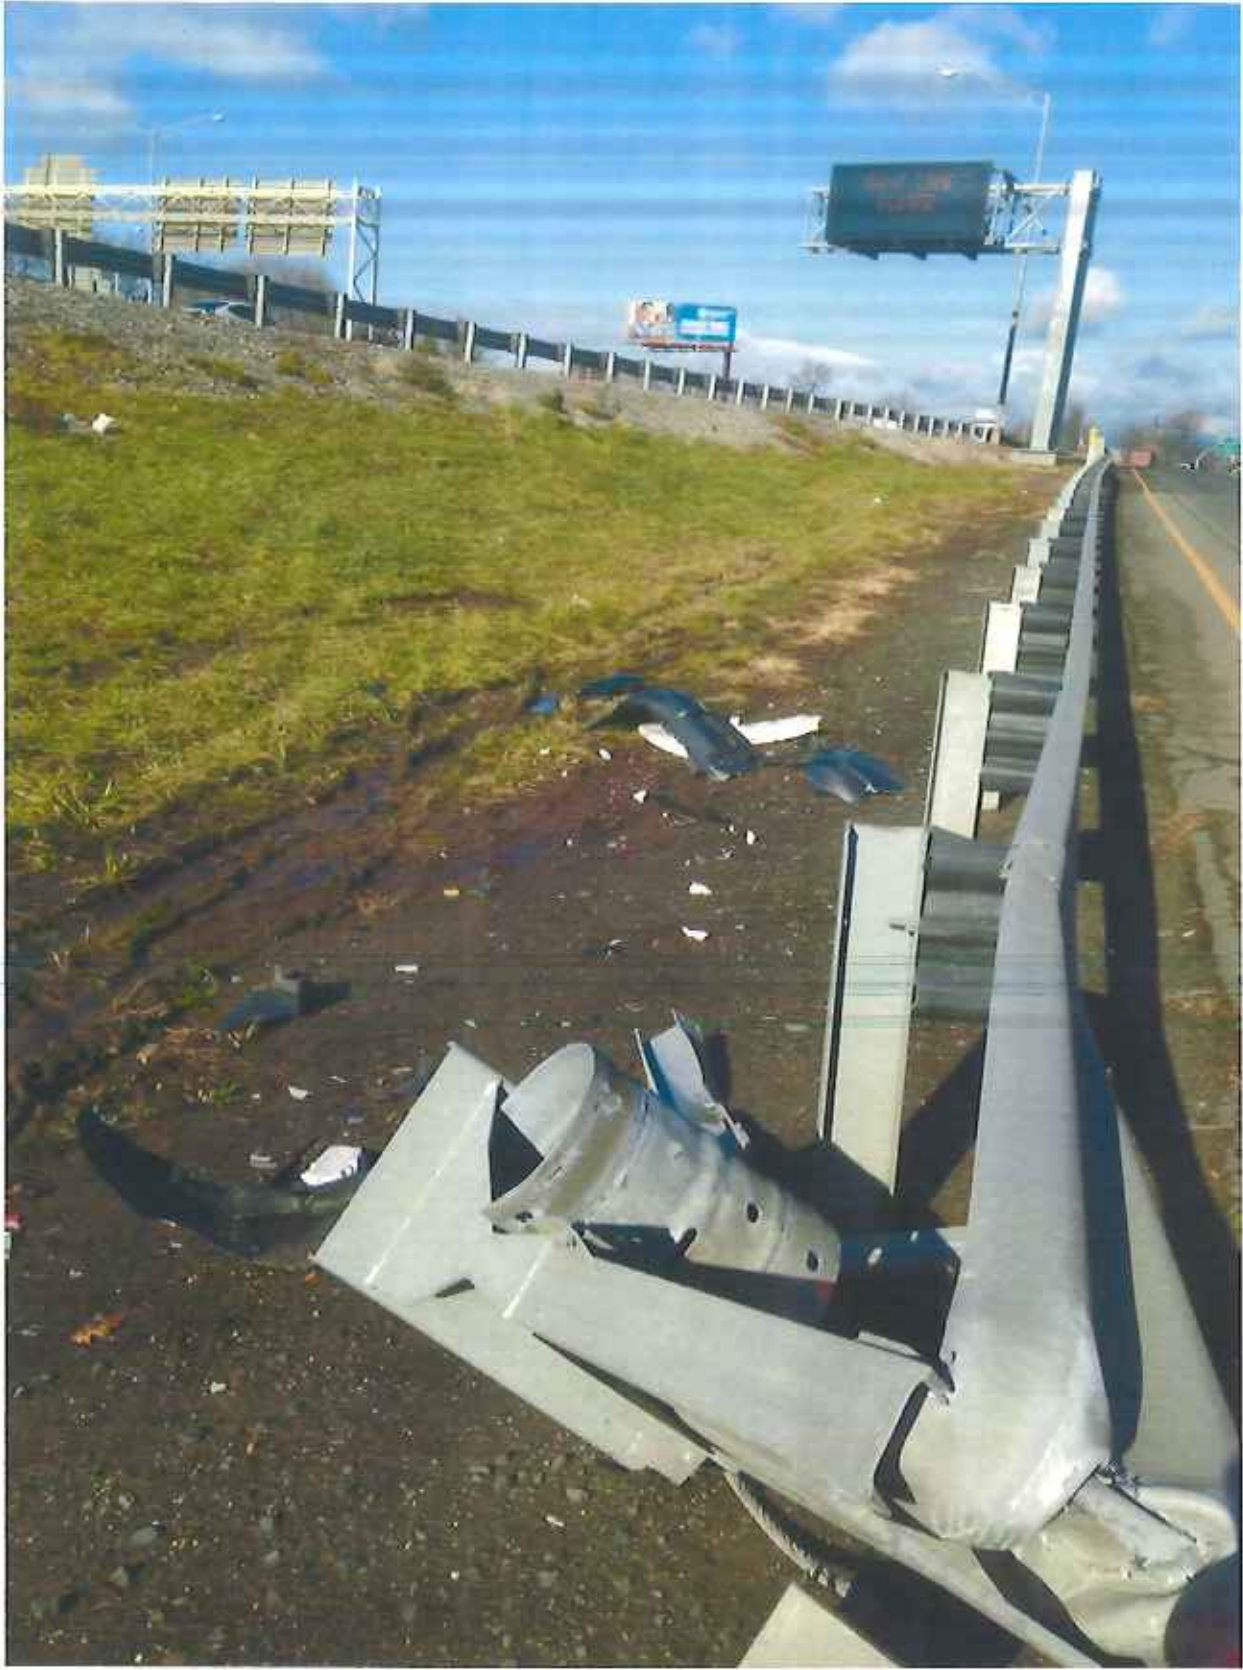
Pictures at time of repair

Connecticut DOT's ET-Plus vehicle crash experience at	
Route	I-91 NB
Milepost	0.49
Location Description	I-95 NB Entrance Ramp 2 - ramp left side
Roadway type	On ramp with Asphalt Pavement surface
Date of Accident	12/16/2014
Crash Narratives	Yes
Crash Diagrams	Yes
Crash Severity	PDO
Vehicle mass	2004 Ford Focus
Vehicle speed	unknown
Angle of impact of the vehicle	vehicle veered of roadway (angle unknown) hitting the impact system and coming to rest passed the attenuator
Orientation of vehicle at impact	Head on
Weather	12:42 pm Weather was clear, road surface slightly wet and Traffic was light
Condition of shoulder/roadside	Unknown
Installation/Maintenance History	System installed in 2014 Construction Season
Terminal Condition	Provided photos of the system after the accident.

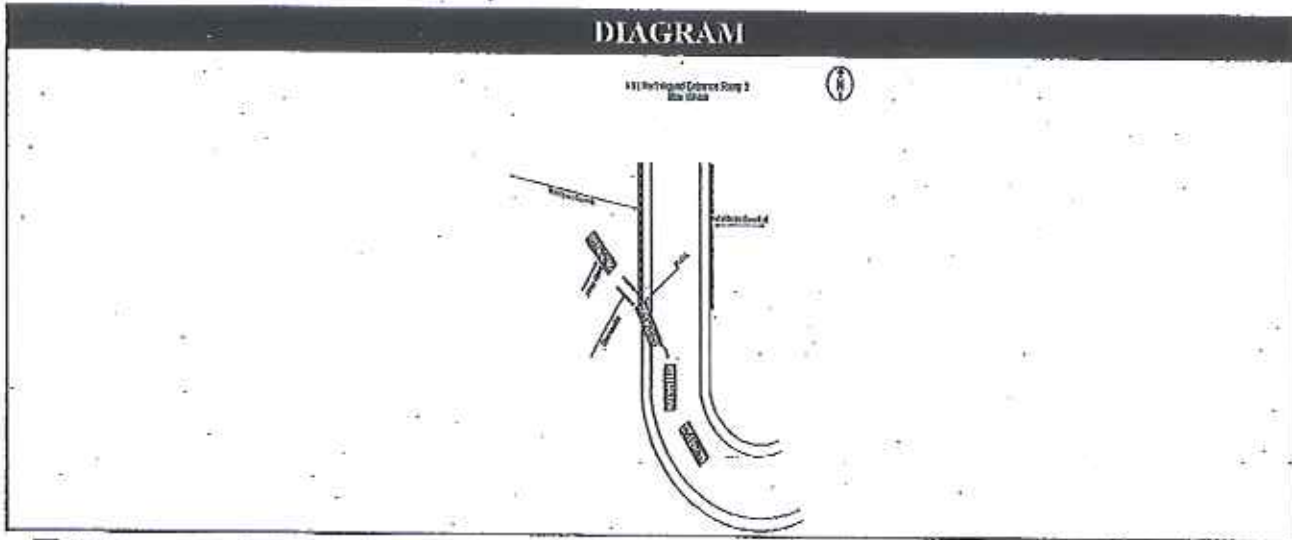
DIAGRAM

Vehicle #1 was travelling North on the I-91 Northbound entrance ramp 2. Vehicle #1 lost control, veered left and struck the metal beam guardrail located on the left shoulder of the entrance ramp. No injuries were reported. At the time of this accident, the roadway slightly wet, traffic was light and the weather was clear.

Upon my arrival, I observed the front end of vehicle #1 to be heavily dented. The front bumper was detached, the right fender metal was torn off by the metal beam guardrail collision. I observed the metal posts and approximately 10 feet of metal beam guardrail damage. I observed tire marks in the left shoulder area where it was muddy. The tire marks did not indicate vehicle #1 negotiating a turn at the time of the collision. All damage was consistent with a vehicle striking a metal beam guardrail.

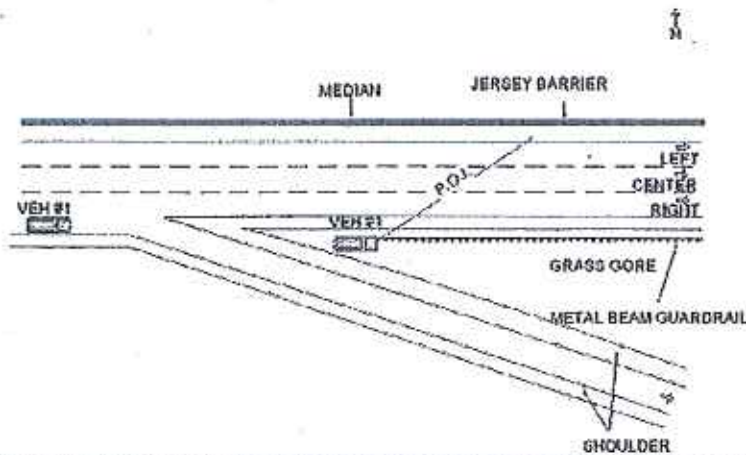
I-95 NORTHBOUND
EXIT 21 OFF RAMP

Vehicle #1 was traveling on the I-95 northbound exit 21 off ramp. Vehicle #1 lost control and struck the metal beam guardrail located on the gore area. No injuries were reported.

Upon arrival there were no adverse weather conditions, the road surface was wet and traffic was light. I observed Vehicle #1 in the grass area of the gore area of the exit 21 off ramp. I observed Vehicle #1 with damage to the front end and damage to the left side. The damage was consistent with a collision with a metal beam guardrail. I observed approximately 20 feet of metal beam guardrail damaged on the gore area of the off ramp. A COLLECT records check revealed that Operator #1 had a suspended license as of 02-09-11.

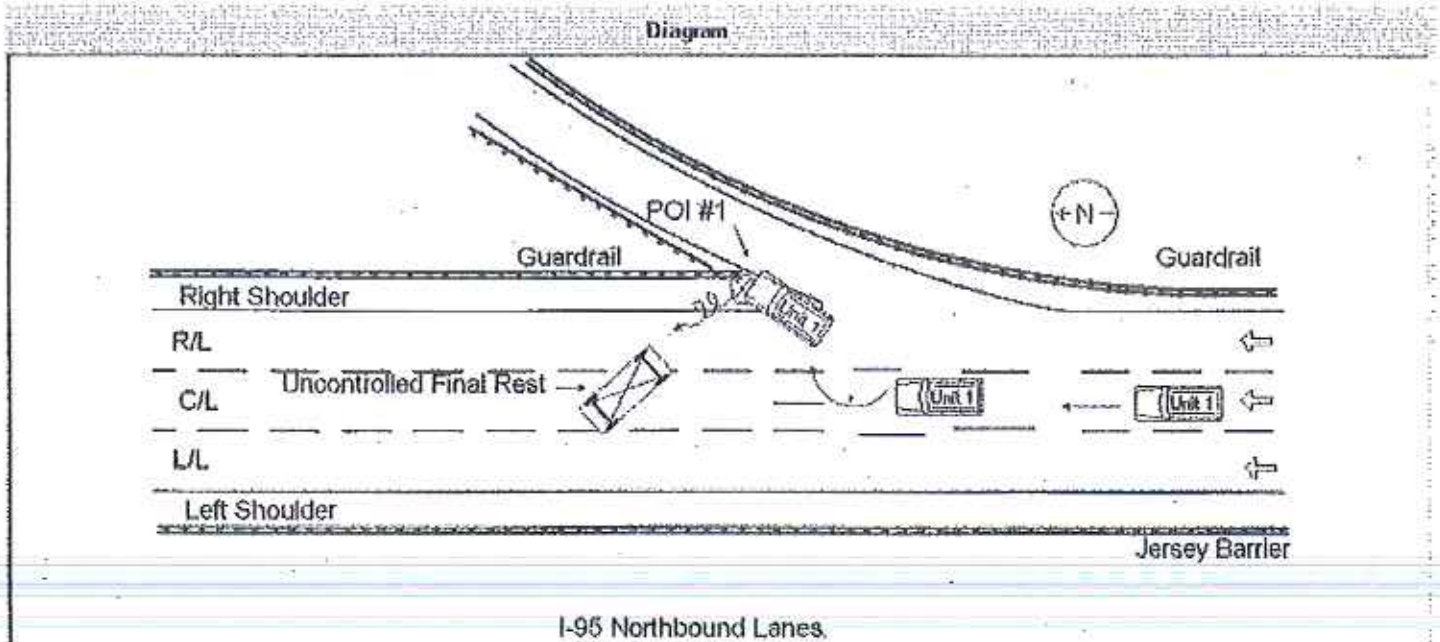
Subject: I-95 NB MP- 24.2 off ramp 3/15/13

Vehicle #1 was traveling northbound on I-95 in the center lane. While in motion, operator #1 swerved from the center lane towards the right shoulder of the roadway. Vehicle #1 struck the Metal beam guard rail in the right shoulder causing vehicle #1 to over turn on its roof sliding back across the highway coming to an uncontrolled final rest in the center lane facing a easterly direction. No injuries were reported during this accident. Vehicle #1 was towed by Star towing due to damage. I-95 northbound in the area of exit 21 is a three lane limited access highway with shoulders on both sides of the roadway. There is a center median divider that separates the south and northbound travel lanes. The weather was clear and traffic flow light due to the time of morning. The roadway was dry and free of obstructions. Operator #1 (Sanchez) said she was traveling northbound on I-95 in the center lane. Operator #1 said she lost control and swerved towards the right shoulder of the roadway. Operator #1 said she struck the metal beam guard rail in the right shoulder and could not remember what happened after that. Prior to my arrival, vehicle #1 was at an uncontrolled rest in the center lane on it's roof facing in a easterly direction. I inspected vehicle #1 for damages caused by the accident heavy damage to the front end and drivers side front tire of vehicle #1 along with heavy crushing damage to the roof. Vehicle #1 had to be towed from the accident scene as a result of the damages. The damage sustained by vehicle #1 is consistent with striking a fixed object and rolling over. I inspected the roadway for physical evidence and located approximately 10 feet of furrow marks in the right shoulder leading to the guard rail. At the point of contact on the metal beam guard rail were fresh paint transfers from vehicle #1. 30 feet of the metal beam guard rail was damaged in the collision and DOT was notified. Based on operator statements and physical evidence, I determined operator #1 to be at fault for the accident and issued her an infraction for failure to maintain proper lane (14-236) in violation of the Connecticut General Statutes. Case Closed.

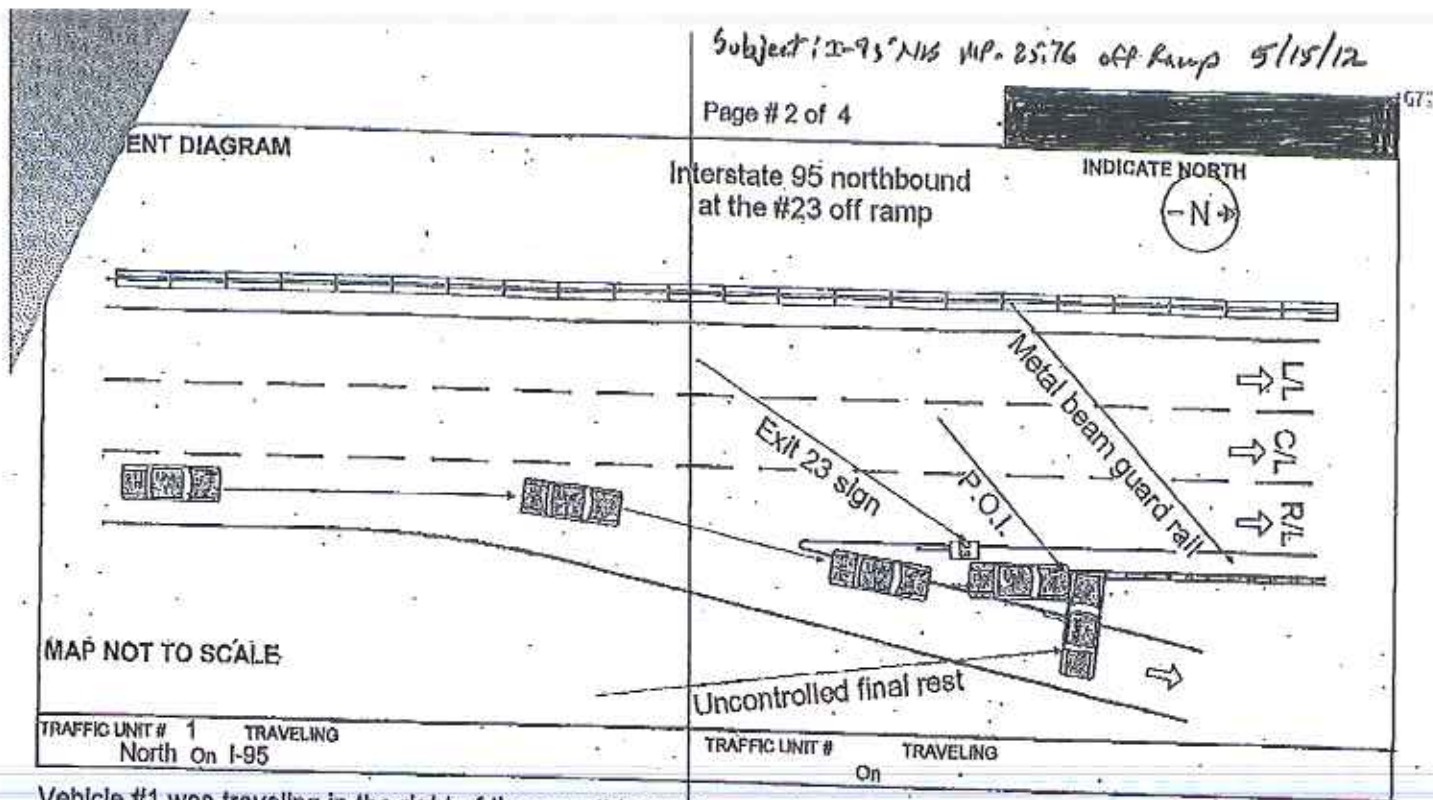
Vehicle #1 was traveling in the right of three northbound lanes when Operator #1 lost control of the vehicle. Vehicle #1 left the travel lanes and entered the #23 exit ramp gore area where it struck the metal beam guard rail.

Upon my arrival at the scene, I observed Interstate 95 is a six lane, divided, limited access highway with three lanes in each direction (north and south). The roadway was wet from earlier rain fall and traffic was light. The roadway also appeared clear of any significant debris or tire marks. Vehicle #1 was at an uncontrolled final rest in contact with the metal beam guard rail. Its rear end extended into the #23 off ramp. Vehicle #1 appeared to have minor front end damage. There was approximately 20 feet of guard rail damaged as a result of this accident. Based upon Operator #1's statements, I inspected Vehicle #1's tires for damage. All four of the vehicles tires appeared to be inflated with adequate tread. The vehicle was towed from the scene by IFT. During the process of towing getting the vehicle on the flatbed, there appeared to be no problems with the steering of the vehicle.

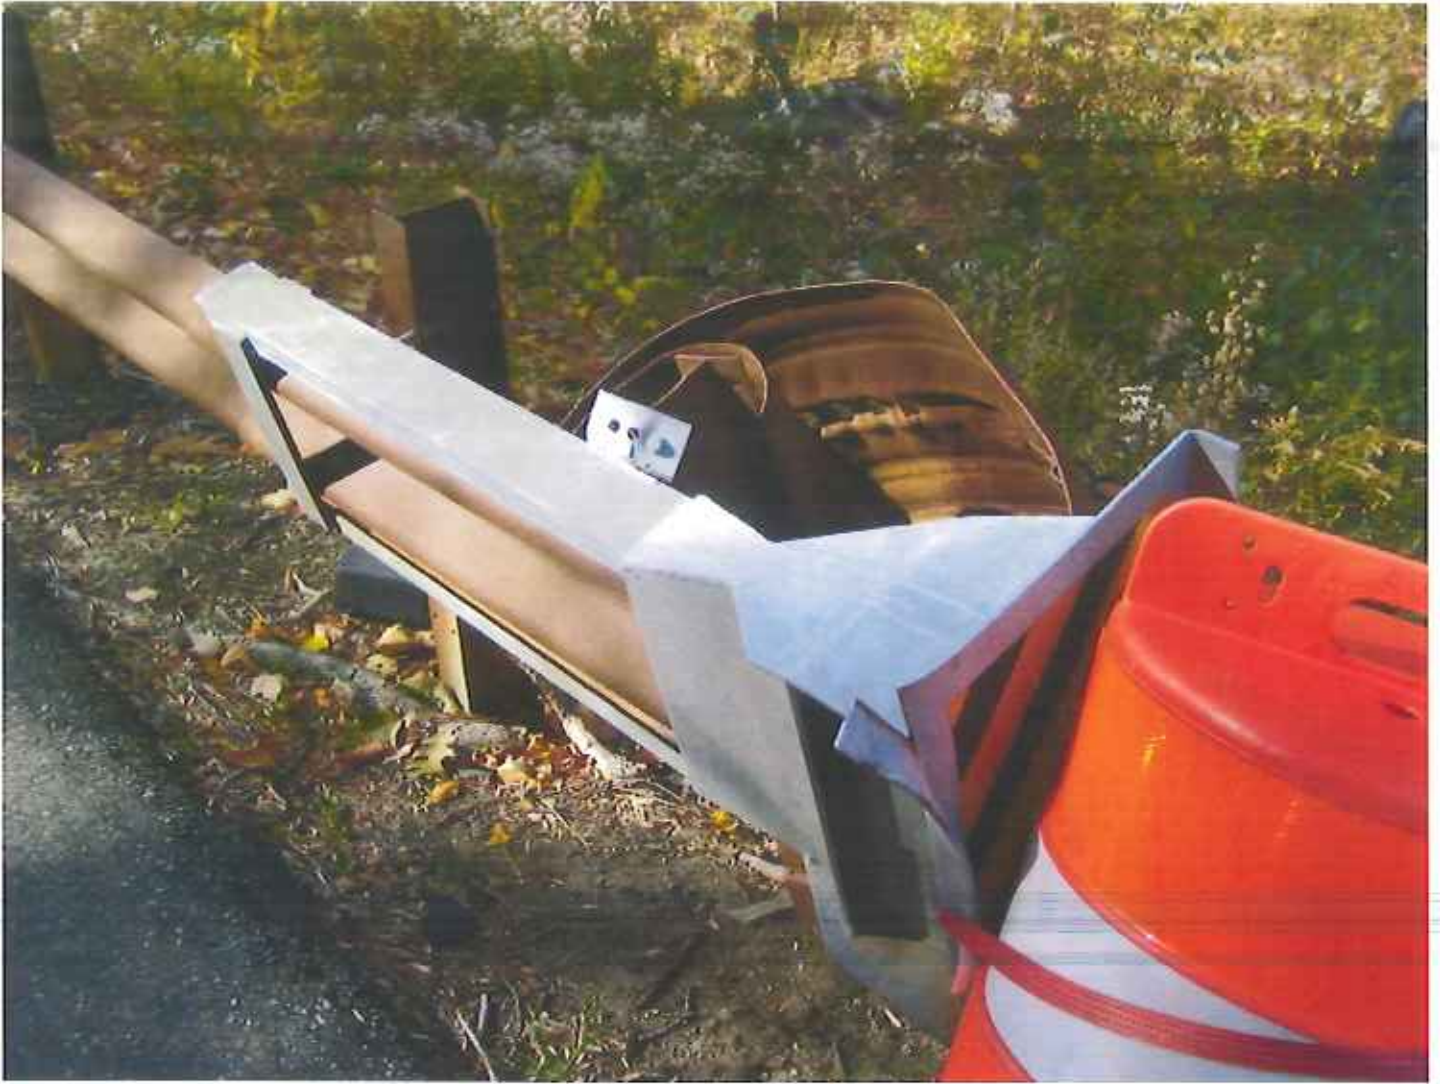
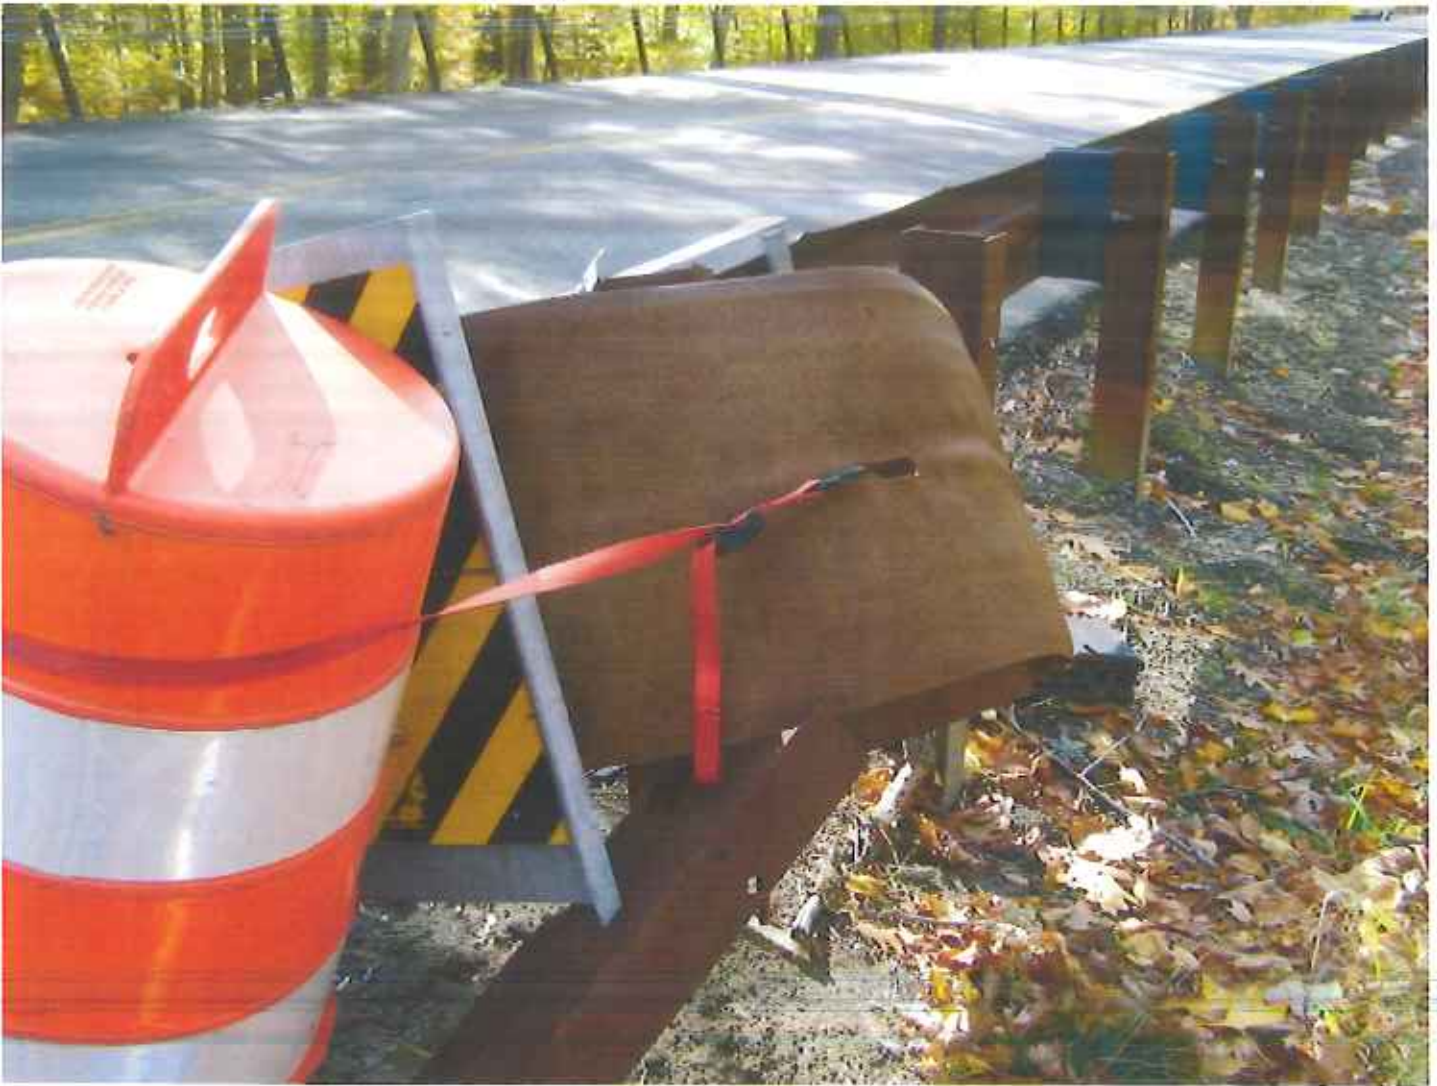
Pictures at time of repair

Connecticut DOT's ET-Plus vehicle crash experience at
Route	Rte 184 WB
Milepost	9.16
Location Description	0.3 of a mile west of the Rte 184/Al Harvey Rd intersection
Roadway type	two lane rural collector
Date of Accident	Approximately 7/1/2014
Crash Narratives	No Accident report
Crash Diagrams	No Accident report
Crash Severity	Vehicle drove away - no accident report on file
Vehicle mass	unknown
Vehicle speed	unknown
Angle of impact of the vehicle	unknown
orientation of vehicle at impact	unknown
Weather	Damage discovered during Maintenance Foremen's roadway review
Condition of shoulder/roadside	unknown
Installation/Maintenance History	System installed in 2006 / Maintenance History - system replaced after 12/10/13 accident
Terminal Condition	Provided image from 2013 state's network collection effort dated June 12, 2013 and pictures of system at time of repair after the non-reported accident.
