I-35 Accident Kills Polo Man

**MISSOURI STATE HIGHWAY PATROL
MISSOURI UNIFORM CRASH REPORT
TECHNICAL SUPPLEMENT**

CRASH DATE 01/17/2014	SUPP RPT DATE 01/17/2014	TRP / DIST / PCT A	COUNTY Clay	REPORT / CASE / INCIDENT NUMBER [REDACTED]
SUPPLEMENT REPORTING OFFICER Cpl. G. D. Ward		DSN / BADGE 1189	SUPPLEMENT REVIEWING OFFICER Sgt. H. A. Sears	
			DSN / BADGE 1200

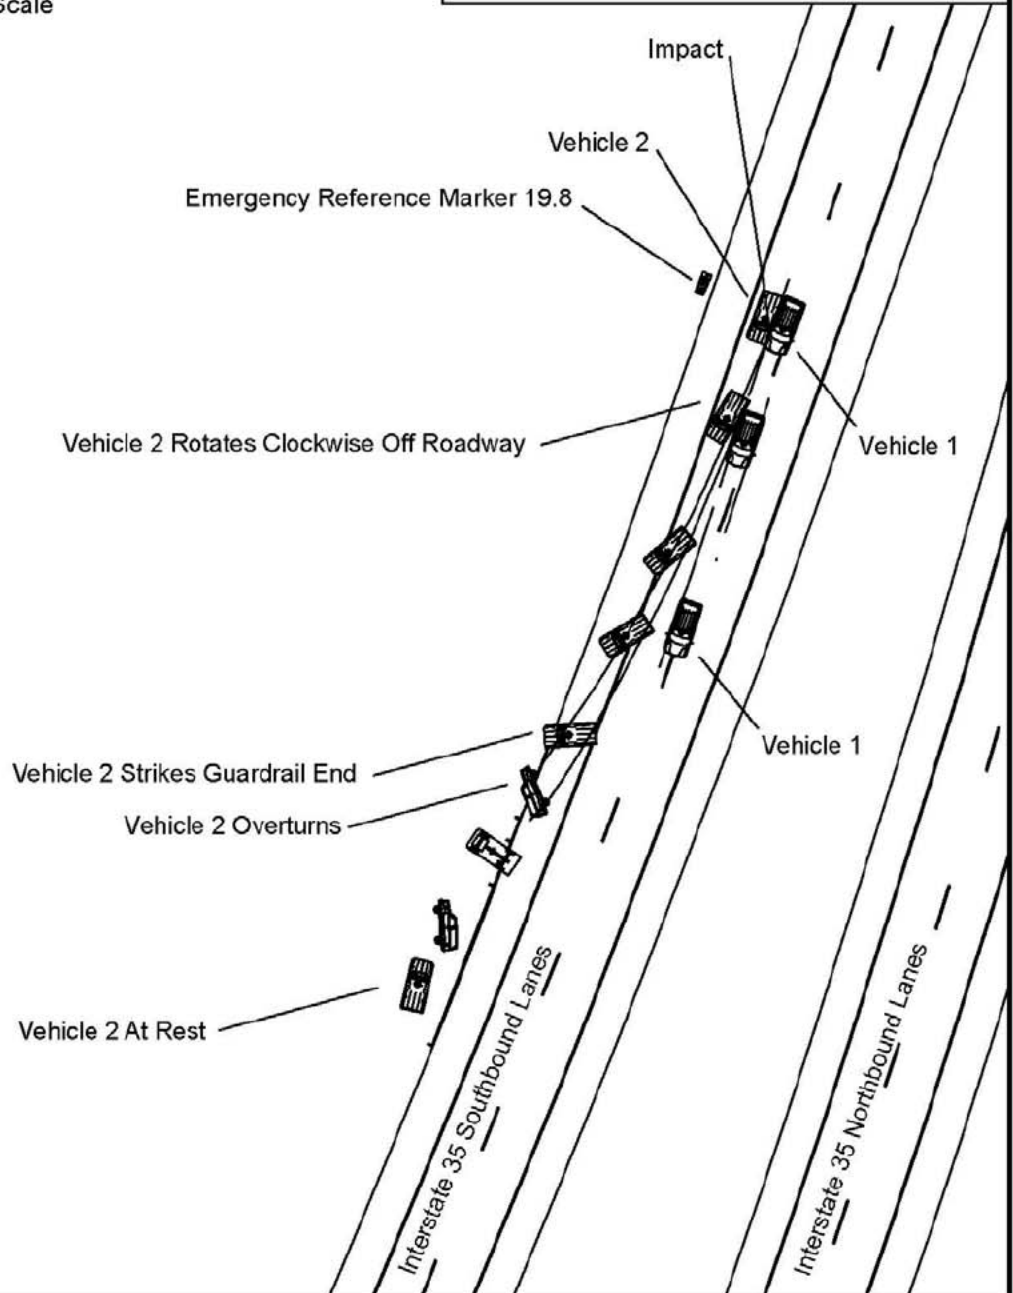
January 17, 2014
0640 Hours
Clay County, Missouri

Using computer generated graphics of the crash scene, along with evidence observed at the scene and damage to the vehicles, determinations were reached concerning the crash situation, also depicted in the attached scale diagram.

Tire mark evidence observed on the roadway indicates Vehicle #1 was facing south when it entered the driving lane, occupied by southbound Vehicle #2, and struck Vehicle #2. Vehicle #2 was facing west when it struck the guardrail end and facing northwest when it began to overturn.
