Federal Highway Administration
Every Day Counts
Innovation Initiative

Safety Edge_{SM}
HMA Demonstration Project
Jasper County, Iowa

Field Report
June 6, 2011

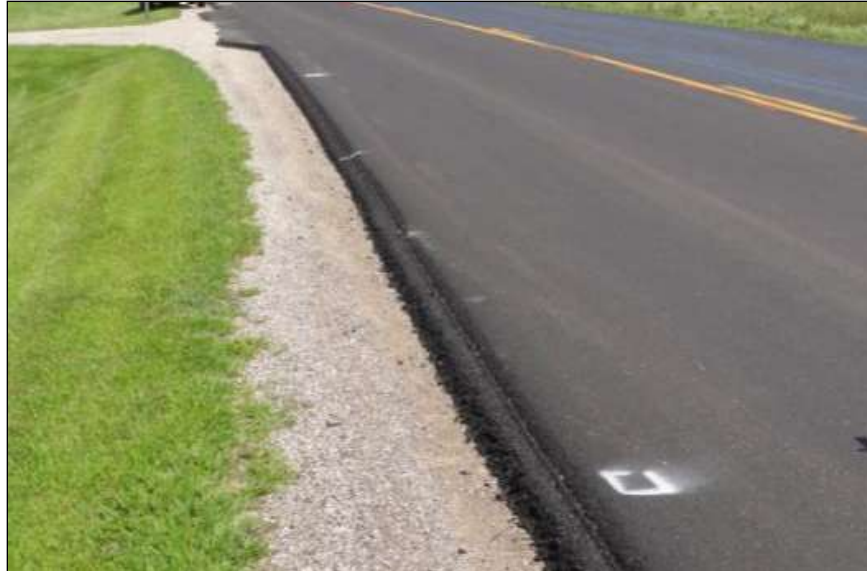
Nearly all of the existing granular shoulder material was free of vegetation or any debris that might interfere with paving operations. At this point in construction before the surface course was paved, new granular shoulder material had not been placed in some areas exposing the Safety Edge_{SM} from the base course upward. The contractor was allowed an extended time frame to pull up the shoulder material because of the use of the Safety Edge_{SM}. Normally the shoulder material would need to be placed in conjunction with each day's mainline paving. Figure 15 is a typical view of the project east of Sully showing the shoulder and the exposed Safety Edge_{SM} of the base and intermediate courses.

Figure 15. Typical view showing the base and intermediate course with Safety Edge_{SM} and granular shoulder material. Image taken east of Sully.
