Federal Highway Administration
Every Day Counts
Innovation Initiative

Safety Edge_{SM}
Demonstration Project
State Route 182
Columbus, Mississippi

Field Report
June 27, 2011

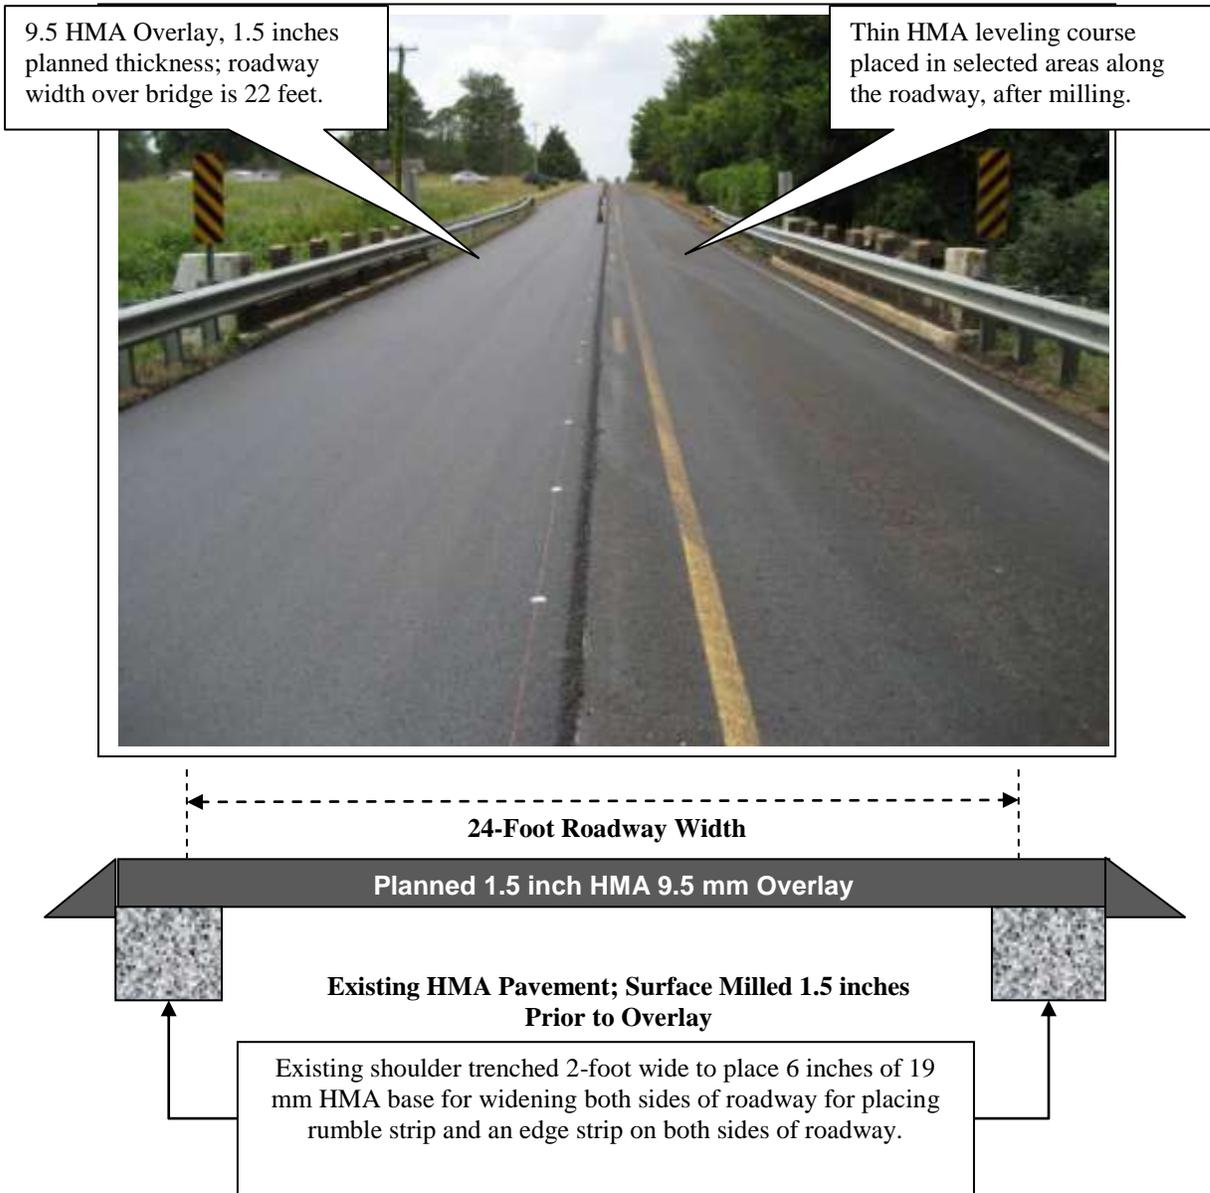
Figure 2. 9.5 mm HMA overlay already placed in one direction and the thin leveling layer placed in opposite direction after milling but prior to overlay placement.

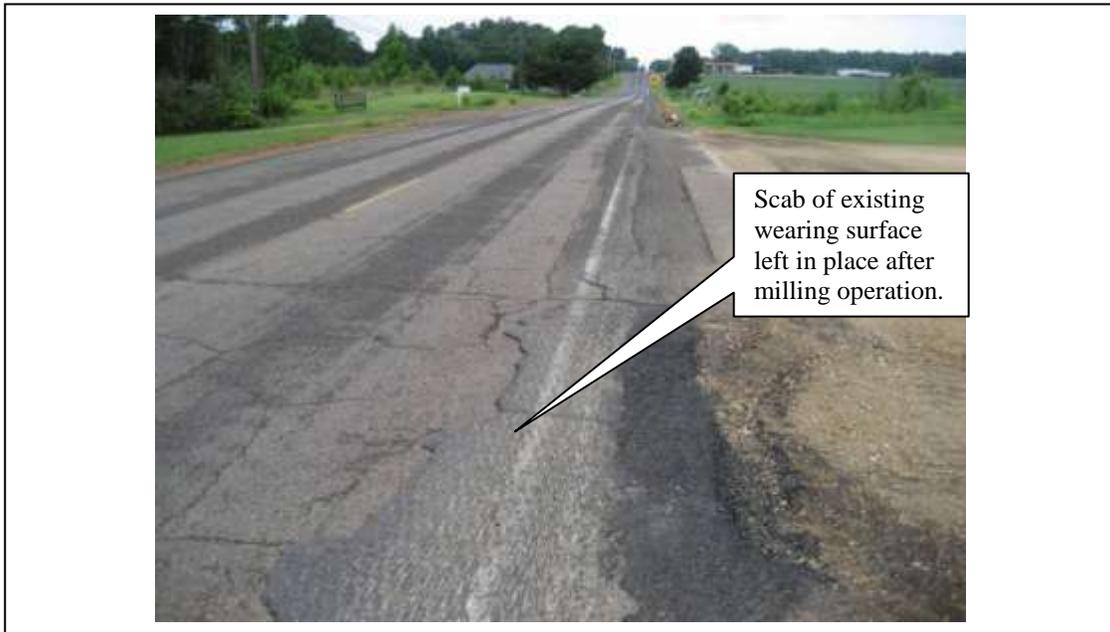
The project consisted of milling the existing surface to a depth of about 1.5 inches (basically removing the existing wearing surface) and placing a 1.5 inch lift of a 9.5 mm HMA mix over the existing HMA pavement. Figure 2 provides a general view of the 1.5 inch HMA overlay and typical cross section of the pavement, while Figures 3 and 4 provide a general view on the condition of the existing pavement after milling. These figures show that a thin layer or scab of the existing wearing surface was left in place. This thin layer may become debonded with time and have a detrimental impact on the performance of the HMA overlay.

Figure 3. General overview of the existing HMA pavement after milling; heavily distressed area with cracking (view is towards the east).

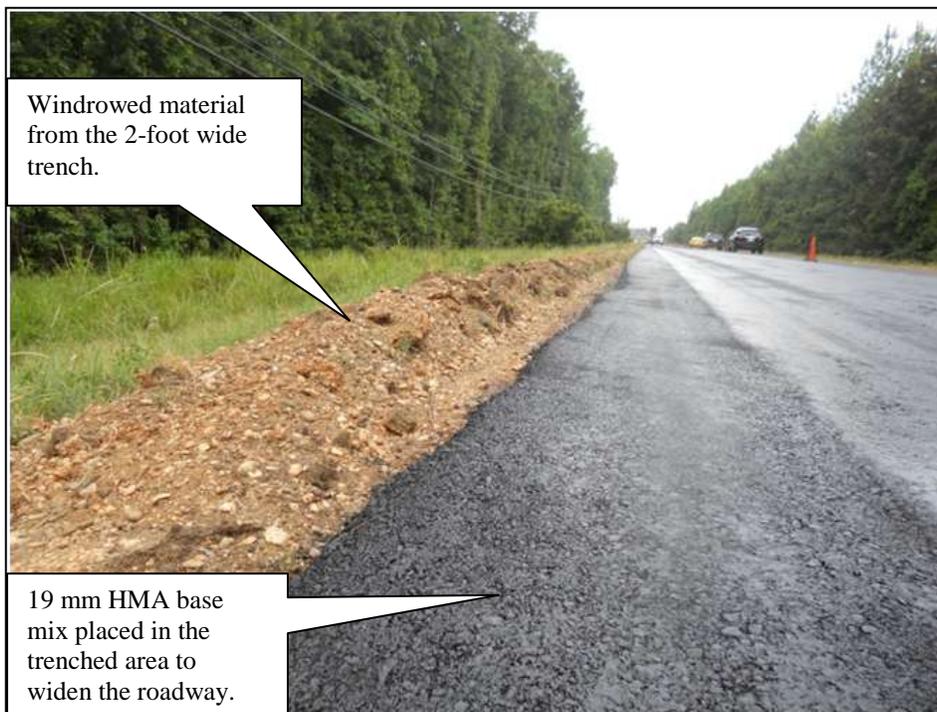
Figure 5. General view of the 19 mm HMA base placed to widen the roadway.

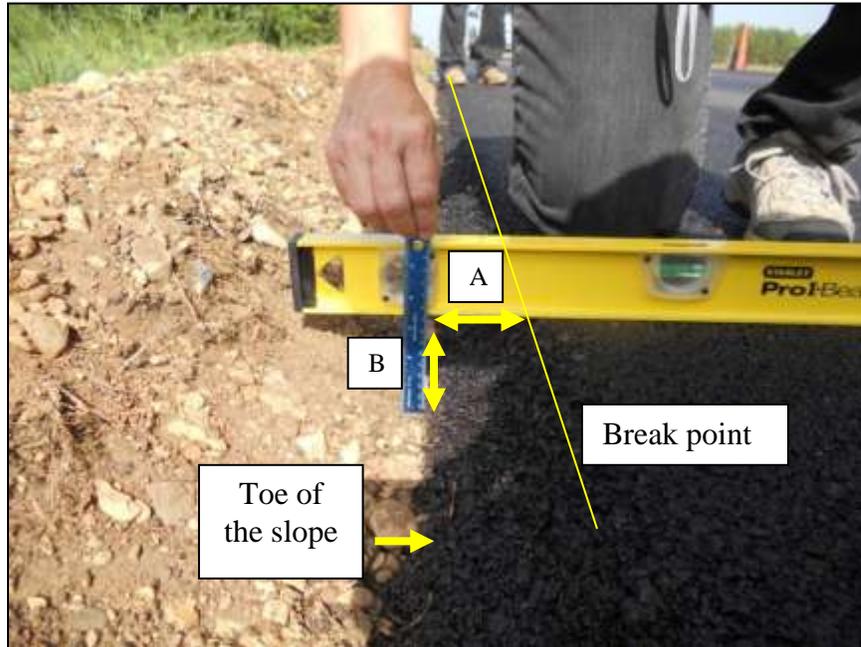
Figure 6. Measurement of the Safety Edges_{SM} angle.

Slope measurements were taken using a straight-edge to measure the width and thickness of the taper of the Safety Edge_{SM} (refer to Figure 6). The average slope of the Safety Edge_{SM} was found to be 37°. All slope measurements are listed in Tables A-1 through A-3 in Appendix A. Only one of the measurements was about 30°. Figure 8 includes a comparison between the slope of the Safety Edge_{SM} after final rolling and thickness of the Safety Edge_{SM} for the two test sections. As shown, there appears to be no correspondence between thickness and the slope of the Safety Edge_{SM}.

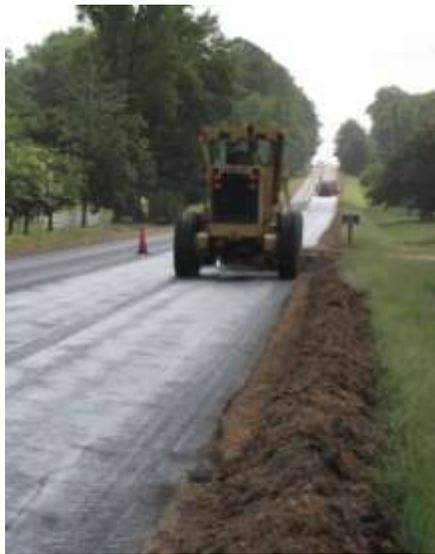
1. The edge of the pavement or shoulder was graded to level out the windrowed material, as shown in Figure 14. The edge of this windrowed material was not compacted prior to placing the Safety Edge_{SM}. In some areas, this material was loose.
2. The motor grader was followed by a broom to clean the surface, as shown in Figure 14. Cleaning the surface is considered good practice prior to placing the tack coat.
3. An emulsion was applied to serve as a tack coat for the HMA overlay. Figure 14 shows the emulsion being placed prior to paving. The application of the tack coat was uniform and covered the entire surface.

Motor grader was used to move and level the windrowed material along the edge of the pavement. In a few areas, the motor grader was used after the tack coat had already been applied.

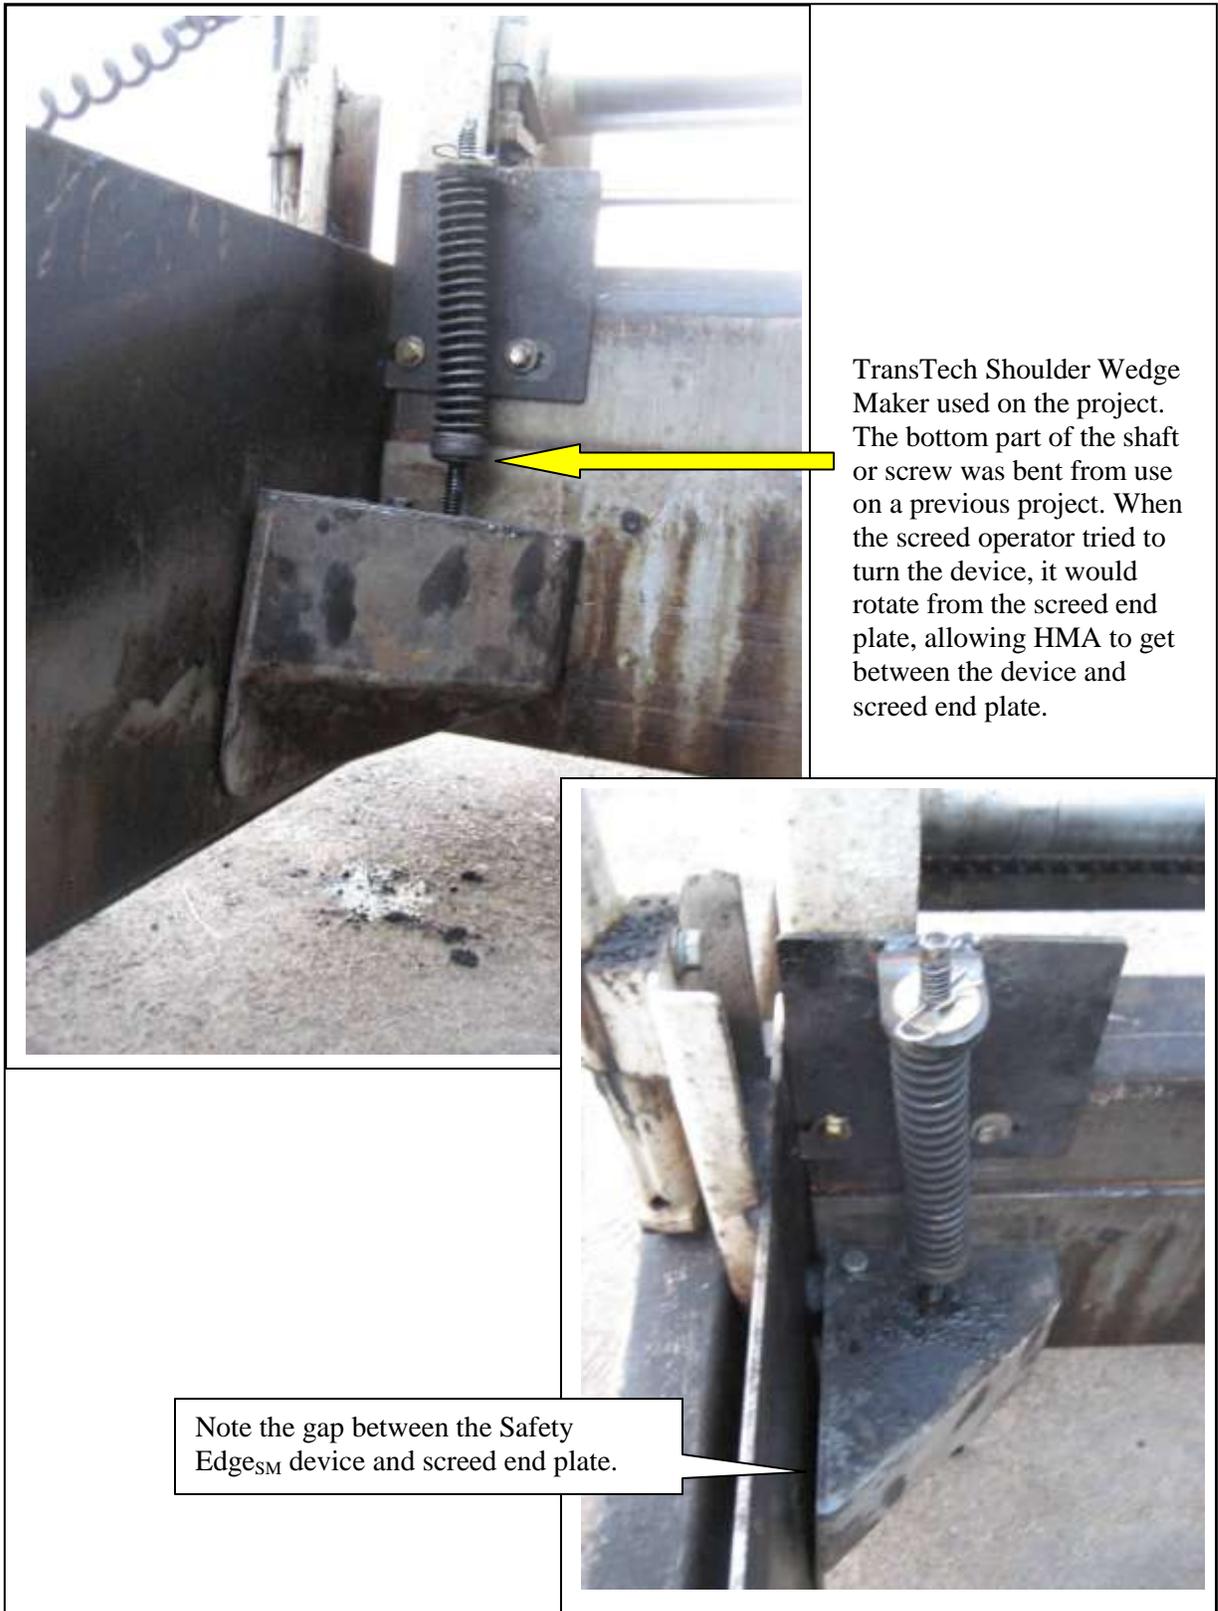
- The screed operator recommended that the Safety Edge_{SM} device be an automated system rather than manually turning the screw to raise and lower the Safety Edge_{SM} device.
- The shaft of the Safety Edge_{SM} device was bent during use on a previous project, such that when the screed operator turned the screw to raise or lower the device, the device would rotate creating a space between the end plate and Safety Edge_{SM} device. HMA material could then become lodged between the screed end plate and the Safety Edge_{SM} device. The screed operator continued to monitor this condition to prevent it from occurring, but in some cases HMA mix would push the device away from the screed end plate – increasing the slope. This condition may have resulted in some of the steeper slopes that were measured within the Safety Edge_{SM} Area #3 (refer to Table A-1 in Appendix A).

TransTech Shoulder Wedge Maker used on the project. The bottom part of the shaft or screw was bent from use on a previous project. When the screed operator tried to turn the device, it would rotate from the screed end plate, allowing HMA to get between the device and screed end plate.

Note the gap between the Safety Edge_{SM} device and screed end plate.

Figure 16. TransTech Shoulder Wedge Maker attached to the screed.

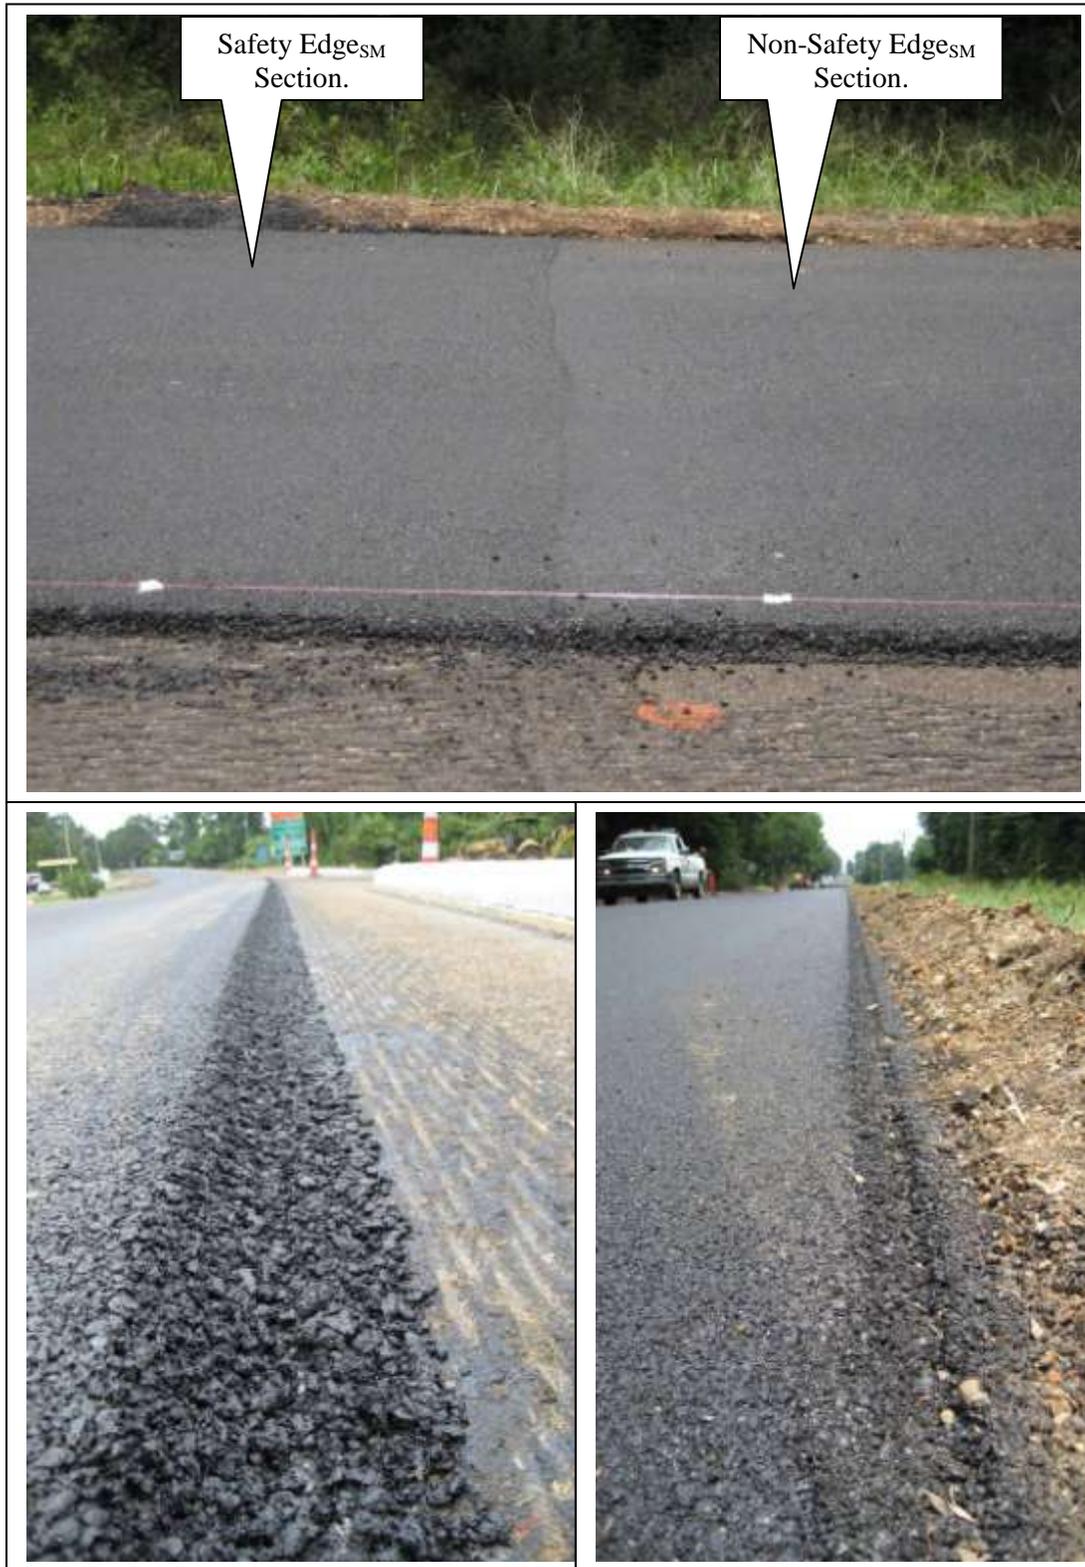
Figure 17 shows the slope and surface texture of the unconfined edge between the Safety Edge_{SM} and non-Safety Edge_{SM} sections.

Figure 17. Safety Edge_{SM} and non-Safety Edge_{SM} sections; different days of paving.

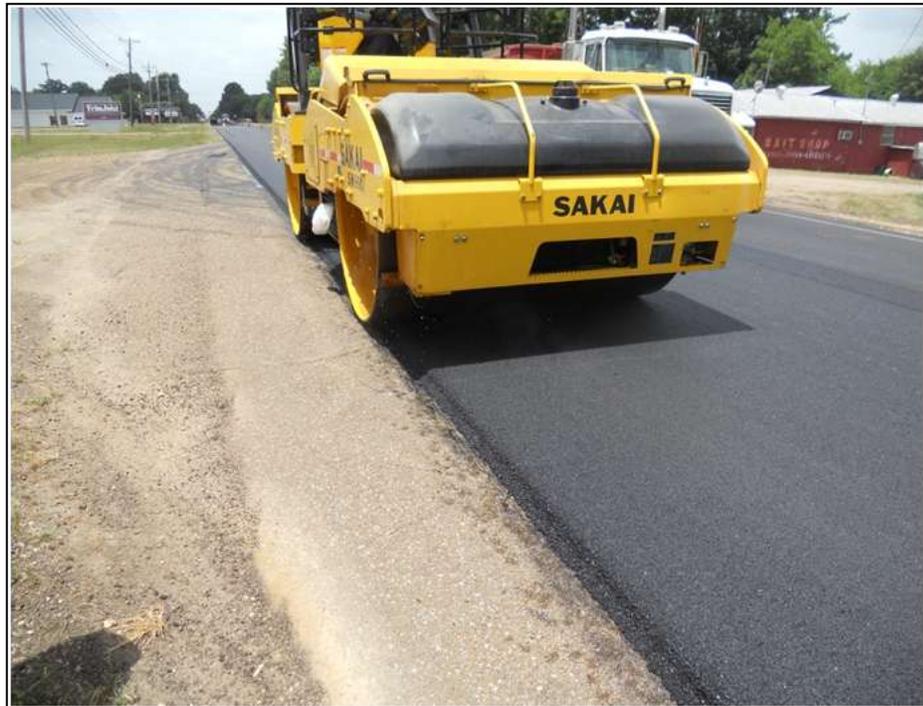
(a) First pass of Sakai roller is 4 to 6 inches over the edge of the mat.

The Safety Edge_{SM} was rolled inconsistently along the project. The rolling pattern used along most of the project, however, was that the first pass of the Sakai breakdown roller was along the Safety Edge_{SM} with the roller extended over the edge of the HMA mat by about 4 to 6 inches (refer to Figures 18 and 20). As noted above, the Sakai roller operator did divert back to initially rolling the mat away from the edge and delayed rolling the edge until the last pass in different locations (refer to Figures 18 and 20). For the initial rolling pattern, the edge of the mat along the Safety Edge_{SM} received only one pass of the breakdown roller. The exact locations of the different rolling patterns were not identified along the project.

- The contractor did obtain adequate density within the interior of the mat, and adjacent to the Safety Edge_{SM} in some areas. The variability in densities adjacent to the Safety Edge_{SM} is believed to be related to the inconsistency in rolling the Safety Edge_{SM}, as explained in the field report. Although the rolling pattern of the Safety Edge_{SM} will be dependent on the mixture properties, it is recommended that the Safety Edge_{SM} be rolled first and not delayed, as recommended in some of the literature for rolling the Safety Edge_{SM}. It is believed that the air voids adjacent to the Safety Edge_{SM} would have been less than 10 percent if the edge was rolled consistently by overhanging the roller over the mat's edge by 4 to 6 inches.

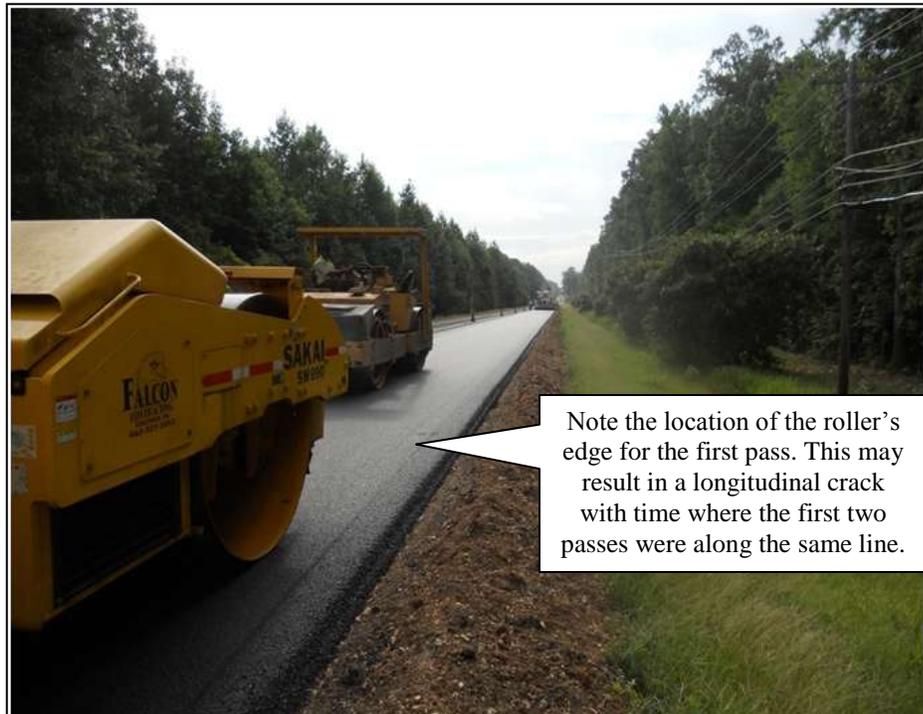
(b) First pass of Sakai roller is about 6 to 12 inches away from edge of the mat.

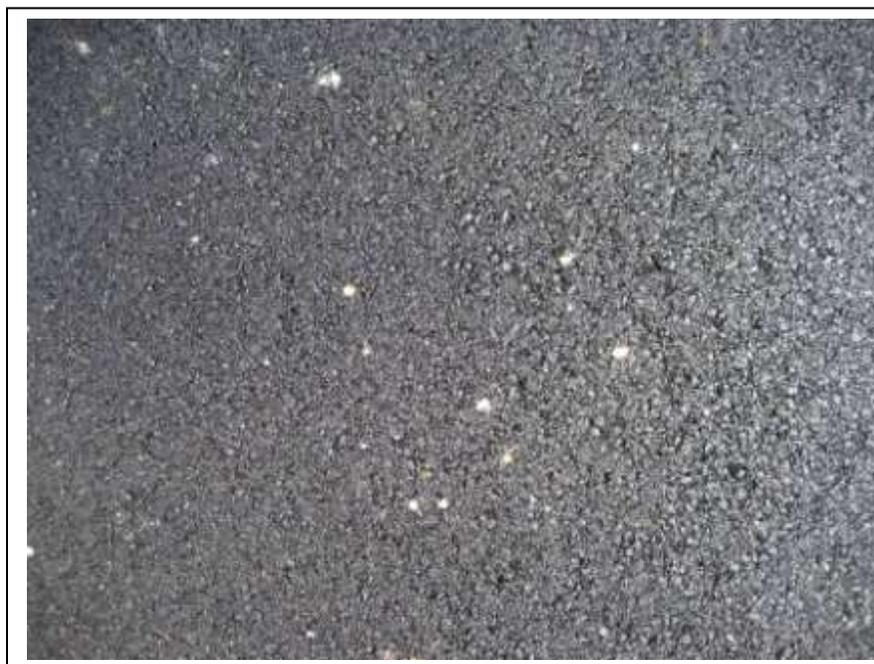
Figure 21. Surface texture of the 9.5 mm HMA overlay after final rolling.

- The 9.5 mm HMA mixture is considered a relatively fine aggregate mixture, and the surface texture was dense. Water beads were observed on the surface after rains that occurred during one of the evenings during the paving operation. This observation indicates that permeability of the HMA overlay is low.

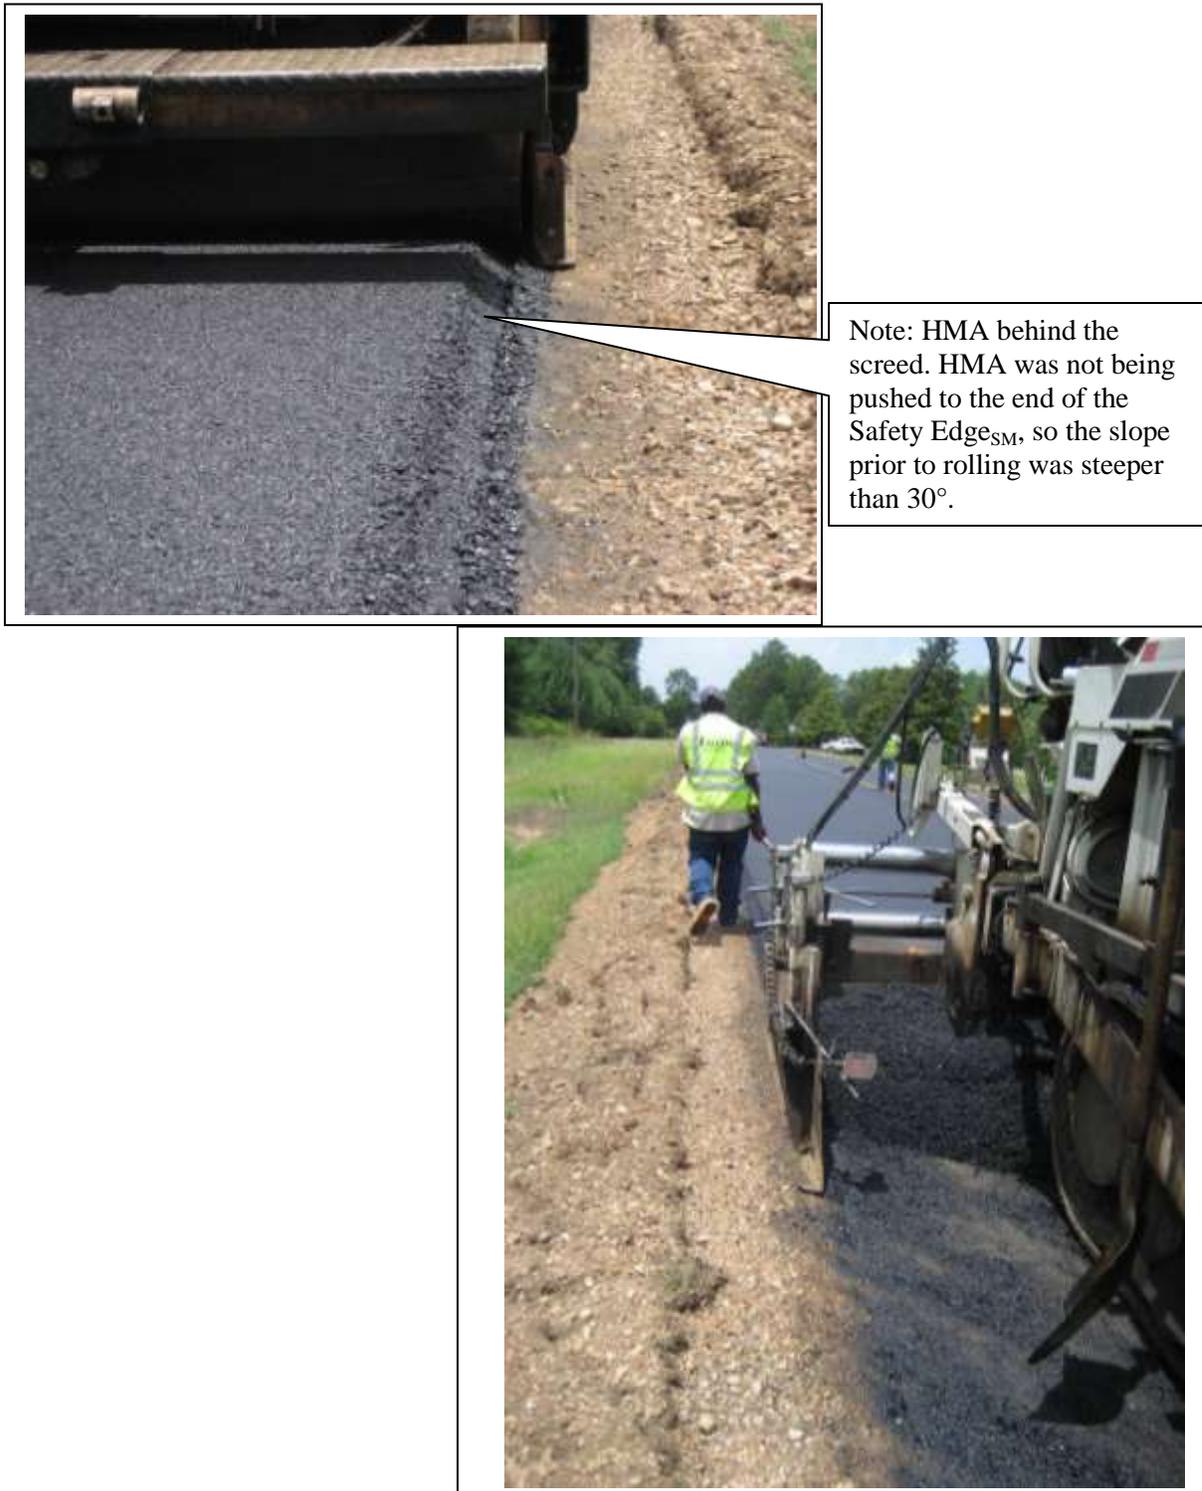
The distance between the end of the auger and screed end plate was about 18 to 24 inches. This distance should be less than 18 inches. The temperature of the HMA being delivered to the project site was reported to be 295 to 305 °F. Mix temperature and the distance between the end of the auger and screed end plate, however, are not believed to be contributing factors to the steeper slopes.

Observations made during paving showed that the HMA mixture was not being pushed to the end of the Safety Edge_{SM} device. Figure 22 shows HMA behind the screed and the Safety Edge_{SM} slope prior to rolling. The slope of the Safety Edge_{SM} was steeper than planned prior to rolling. A reason for the steeper slope, however, could be related to the bent shaft of the Safety Edge_{SM} device.

Figure 22. HMA under and behind the screed; the HMA was not being pushed to the end of the Safety Edge_{SM}, which resulted in a steeper slope prior to rolling.

- The average slope of the Safety Edge_{SM} was 37°, exceeding the target value of 30°. The shaft or screw of the Safety Edge_{SM} was bent. The bend in the rod or shaft may have resulted in a steeper angle because HMA was observed between the screed end plate and Safety Edge_{SM} device.
- The density of the HMA mixture adjacent to the Safety Edge_{SM} was found to be higher than along the unconfined edge in the areas placed without the Safety Edge_{SM} – a positive benefit from the Safety Edge_{SM} device.

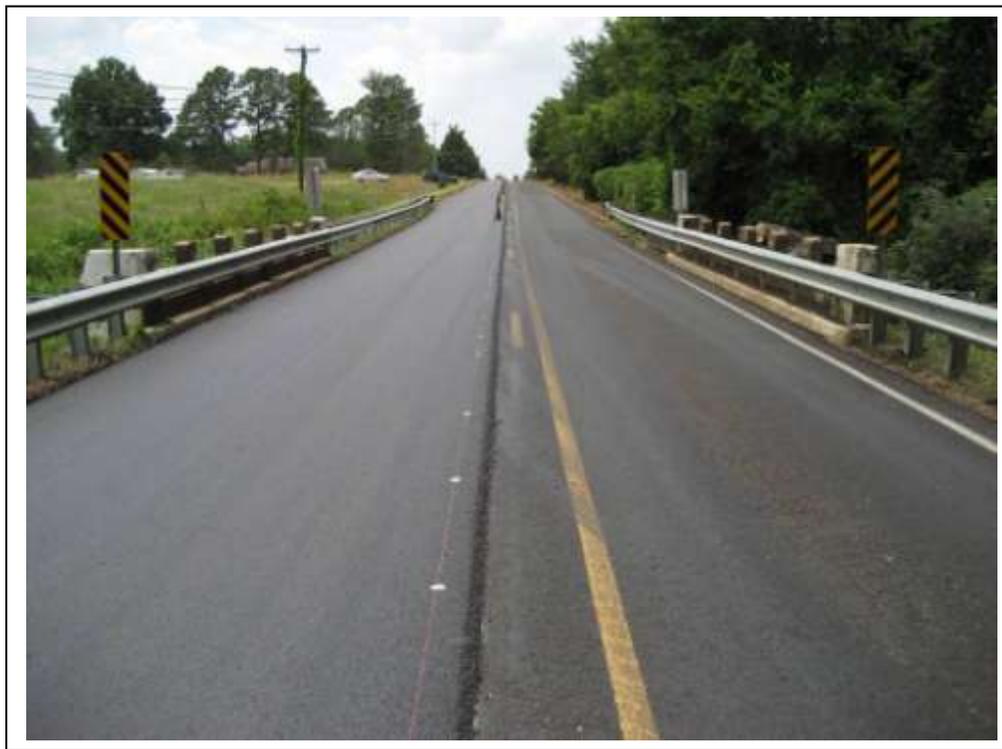
The contractor voiced a concern about being unable to retract the extension on the shoulder side of the paver sufficiently, so that the paver operator would not have to steer the paver closer to the centerline and retract the other extension. Steering the paver closer to the centerline and retracting the other extension could potentially create a longitudinal joint that would be difficult to match and compact (refer to Figure 23).

Figure 23. One of the narrow bridges located on the project (about 22-feet wide).
