Federal Highway Administration
Every Day Counts
Innovation Initiative

Safety Edge_{SM}
Demonstration Project
Kearney, Nebraska

Field Report
May 24, 2011

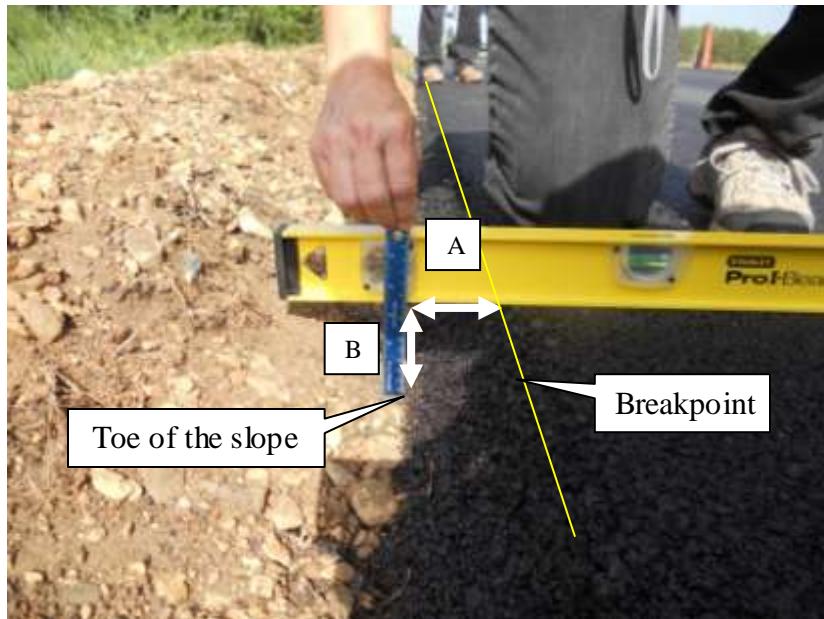
Slope measurements were taken using a straight-edge to measure the width and thickness of the taper of the Safety Edge_{SM} (refer to Figure 6). The average slope of the Safety Edge_{SM} for all four test sections was found to be 34°. Table A-1 in Appendix A contains slope measurements recorded at each individual measurement location. Figure 8 includes a comparison between the slope of the Safety Edge_{SM} after final rolling and thickness of the

Figure 6. Measurement of the Safety Edge_{SM} slope angle.

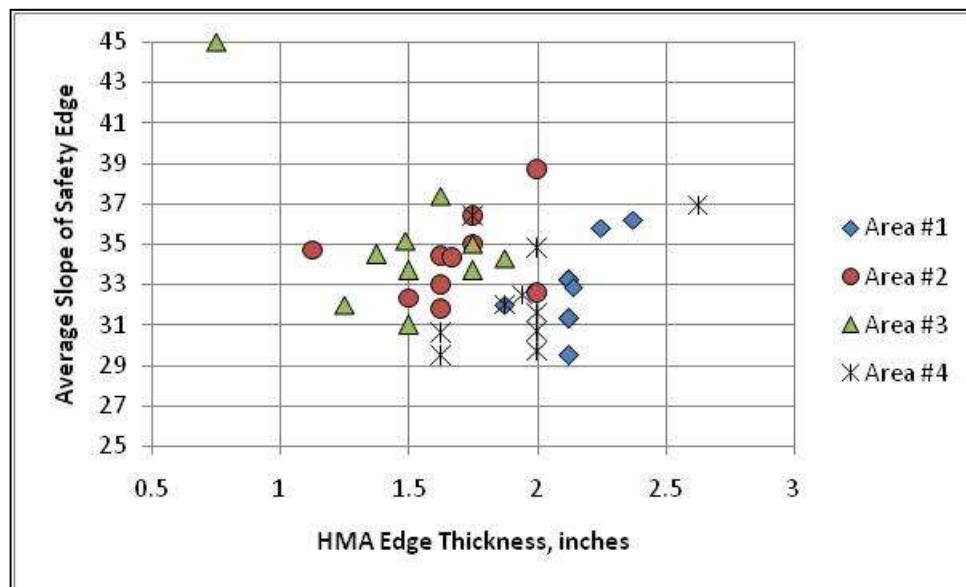
Safety Edge_{SM} for the four test sections. As shown, there appears to be no correspondence between thickness and the slope of the Safety Edge_{SM}.

Figure 8. Comparison of the Safety Edge_{SM} slope and thickness of the HMA adjacent to edge of the HMA overlay.

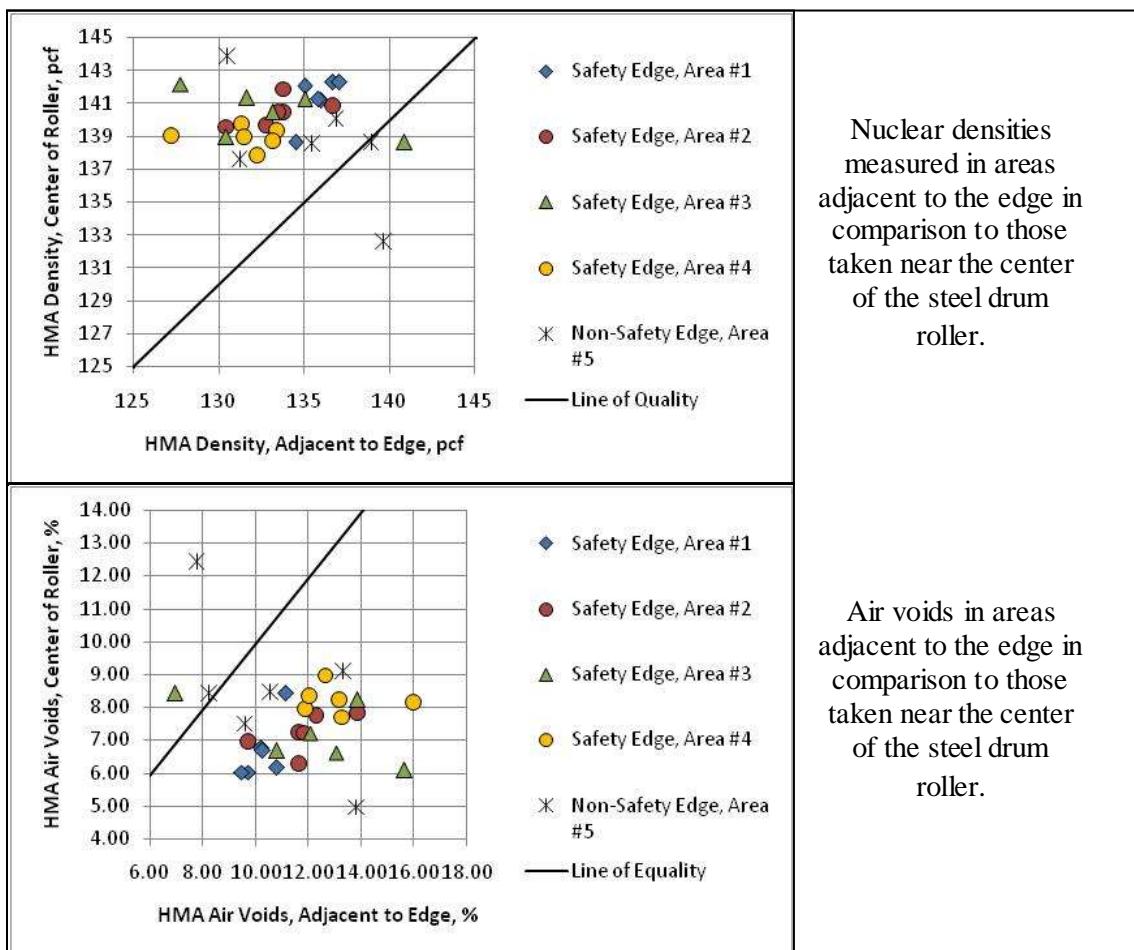
Figure 12 shows a comparison of the adjusted nuclear density gauge readings taken adjacent to the Safety Edge_{SM} and in the center of the vibratory steel wheel roller. Figure 12 also includes a comparison of the HMA air voids between both of these areas. As expected, the air voids are higher adjacent to the Safety Edge_{SM} in comparison to 3-feet from the Safety Edge_{SM}. The other observation from this data and comparison is that the densities and air voids are similar between the Safety Edge_{SM} and non-Safety Edge_{SM} measurements adjacent to the edge of the HMA mat.

Figure 12. Comparison of the adjusted nuclear density readings and air voids between the areas adjacent to the edge and center of the steel drum roller.

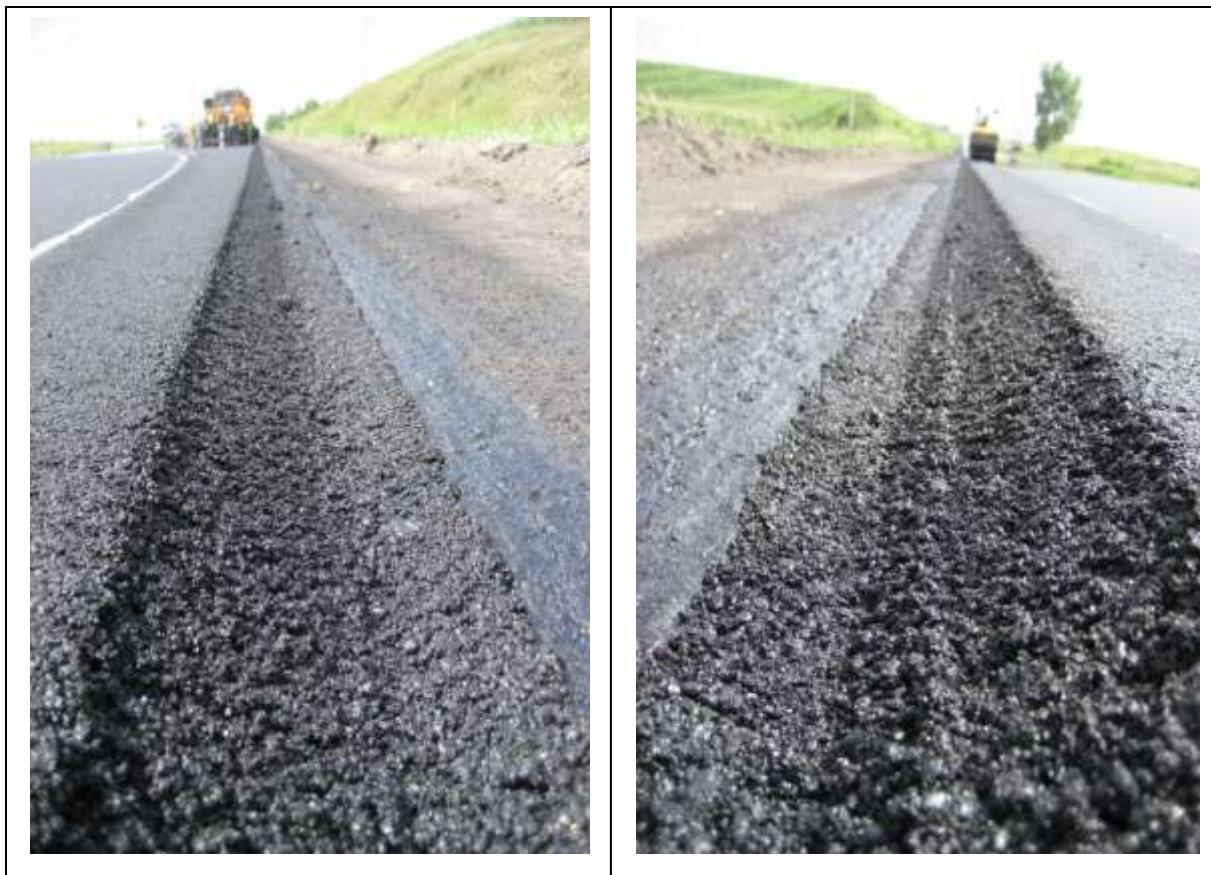
Figure 16. Typical surface texture and slope of the Safety Edge_{SM} sections.

Figure 16 shows the slope and surface texture of the Safety Edge_{SM}. The contractor superintendent/owner recommended that the Safety Edge_{SM} device be an automated system rather than manually turning the screw to raise and lower the Safety Edge_{SM} device.

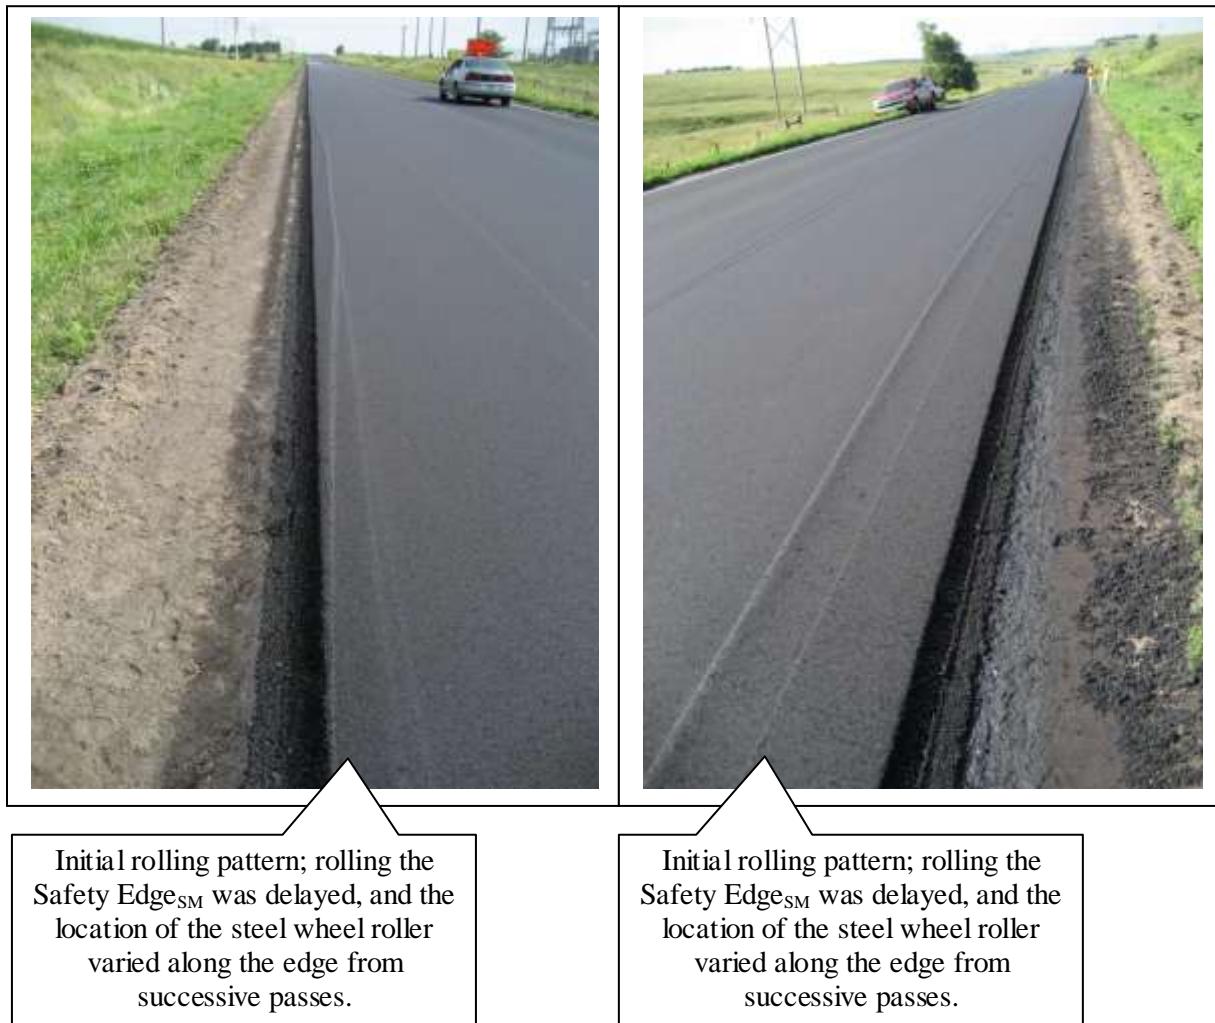
adequate HMA production. Figure 18 shows the variation in the location of the roller's edge along the Safety Edge_{SM}.

Figure 18. Initial rolling pattern; edge of the breakdown roller varied along the Safety Edge_{SM}, prior to finish rolling.

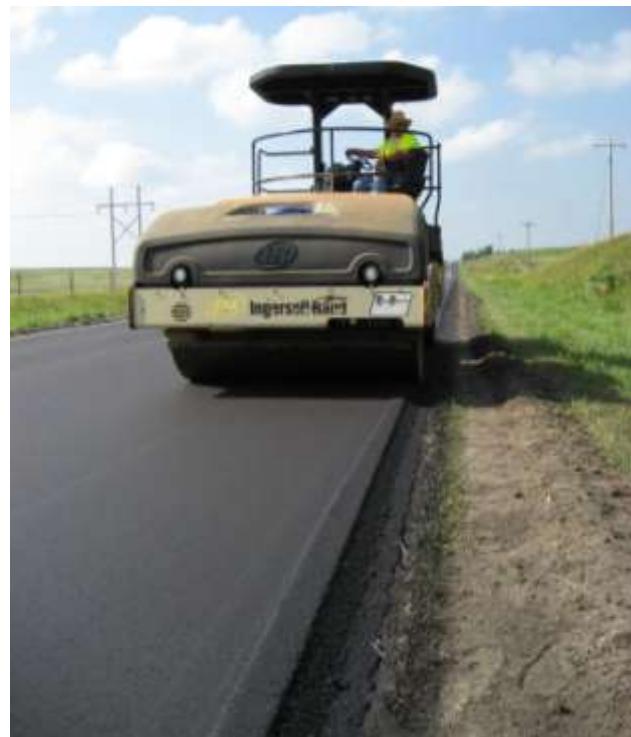
The delay in rolling the Safety Edge_{SM} caused the roller operator to increase the speed of the breakdown roller to keep up with the paver. The increase in speed resulted in chatter in localized areas of the mat surface (roller being operated too fast for the frequency selected). The other important point is that the outer edge of the mat (6 to 12 inches from the Safety Edge_{SM}) only received one pass of the breakdown roller in some areas prior to the first pass of the Ingersoll-Rand roller (refer to Figure 21).

Figure 21. First pass of the Ingersoll-Rand finish roller along the Safety Edge_{SM}.

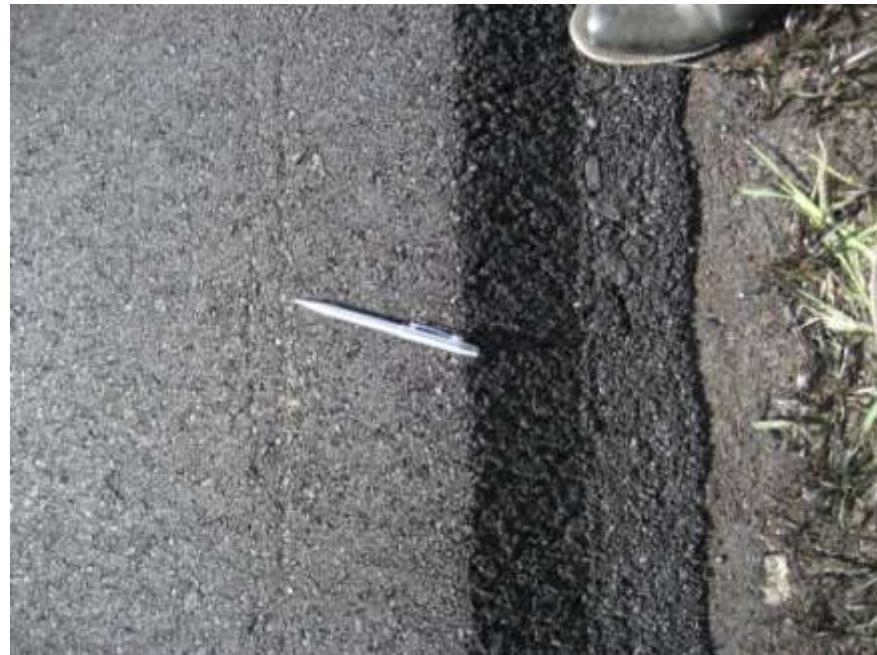
The finish roller appeared to remove most of the chatter caused by the breakdown roller. The finish roller did not eliminate the longitudinal roller mark left by delaying the breakdown roller along the outside edge of the mat (refer to Figure 22). It is expected that this mark will eventually result in a longitudinal crack along the edge of the mat.

Figure 22. Longitudinal mark left by delaying the breakdown rolling of the Safety Edge_{SM}; image taken after finish rolling.

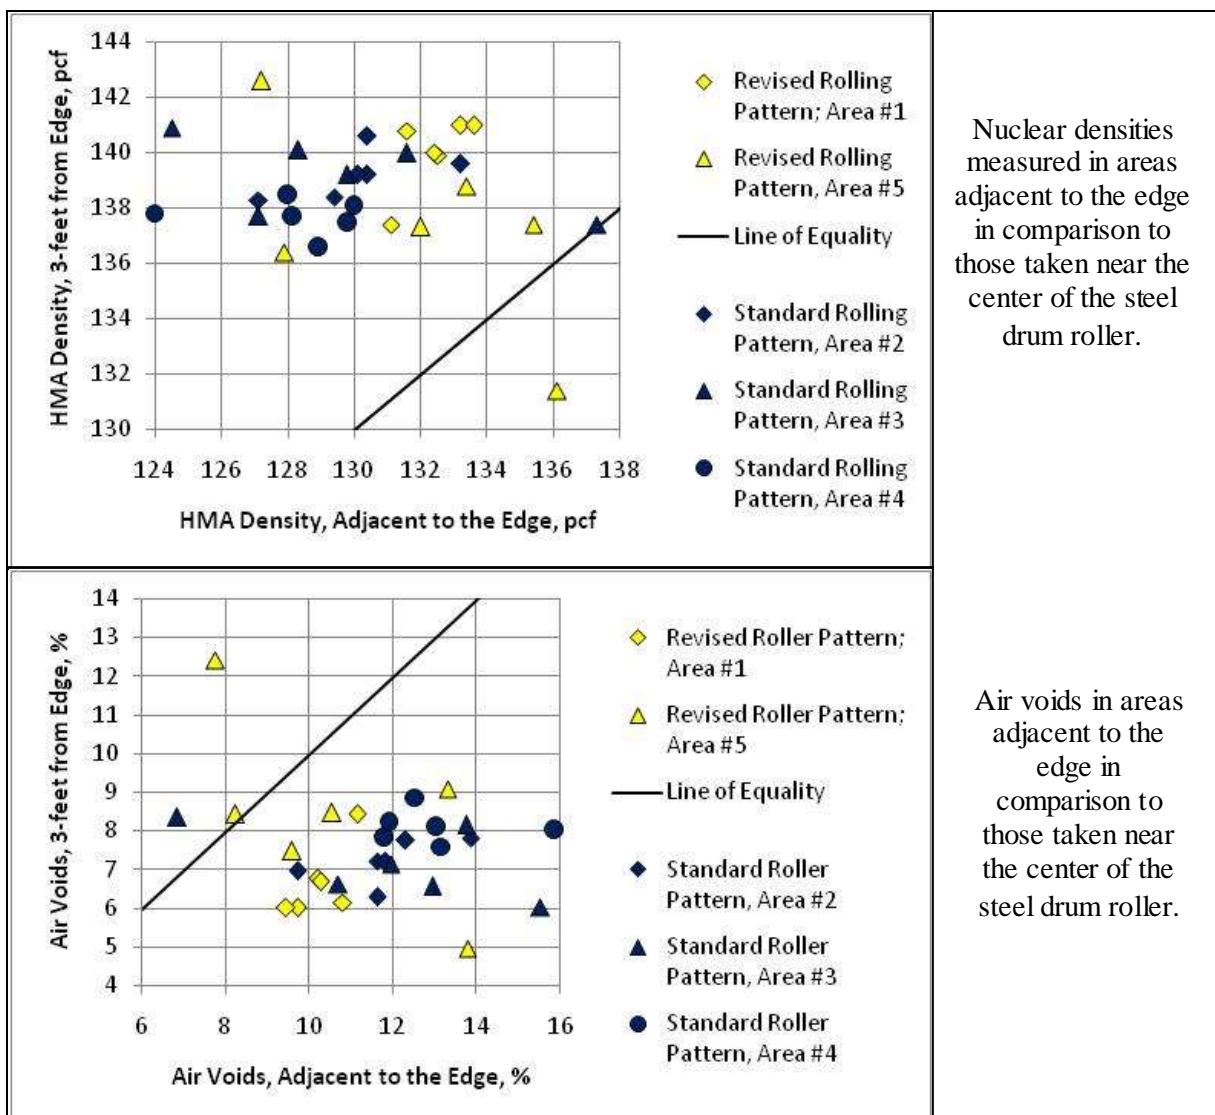
As tabulated above and shown in Figure 23, rolling the Safety Edge_{SM} first without delay and extending the edge of the breakdown roller over the Safety Edge_{SM} by 4 to 6 inches resulted in lower air voids and higher densities without significantly steepening the average slope of the Safety Edge_{SM}, as compared to delaying rolling of the Safety Edge_{SM}.

Figure 23. Comparison of volumetric properties between the areas adjacent to the edge and center of the steel drum roller for the two different rolling patterns.

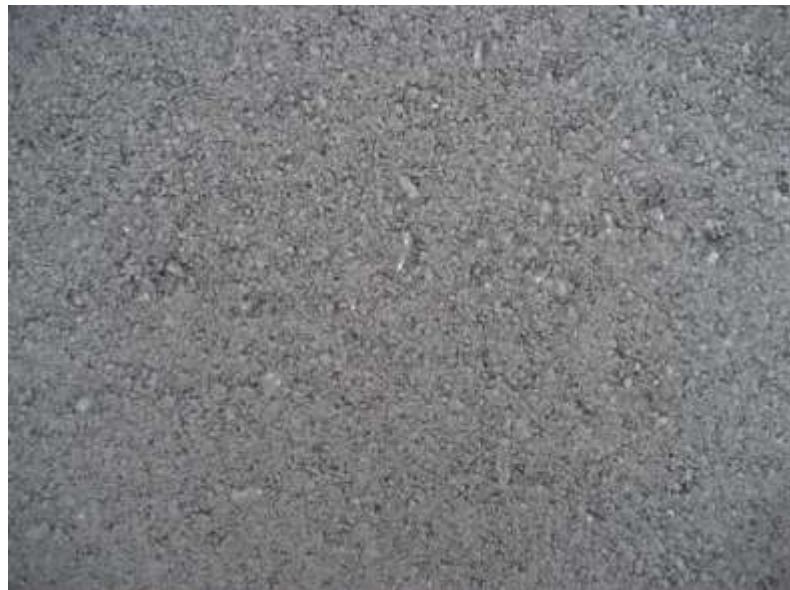
Figure 24. Surface texture of the 12.5 mm HMA overlay after final rolling.

- The 12.5 mm HMA mixture is considered a relatively fine aggregate mixture, and the surface texture was dense. Water beads were observed on the surface after rains that occurred just prior to the demonstration project. This observation indicates that permeability of the HMA overlay is low.

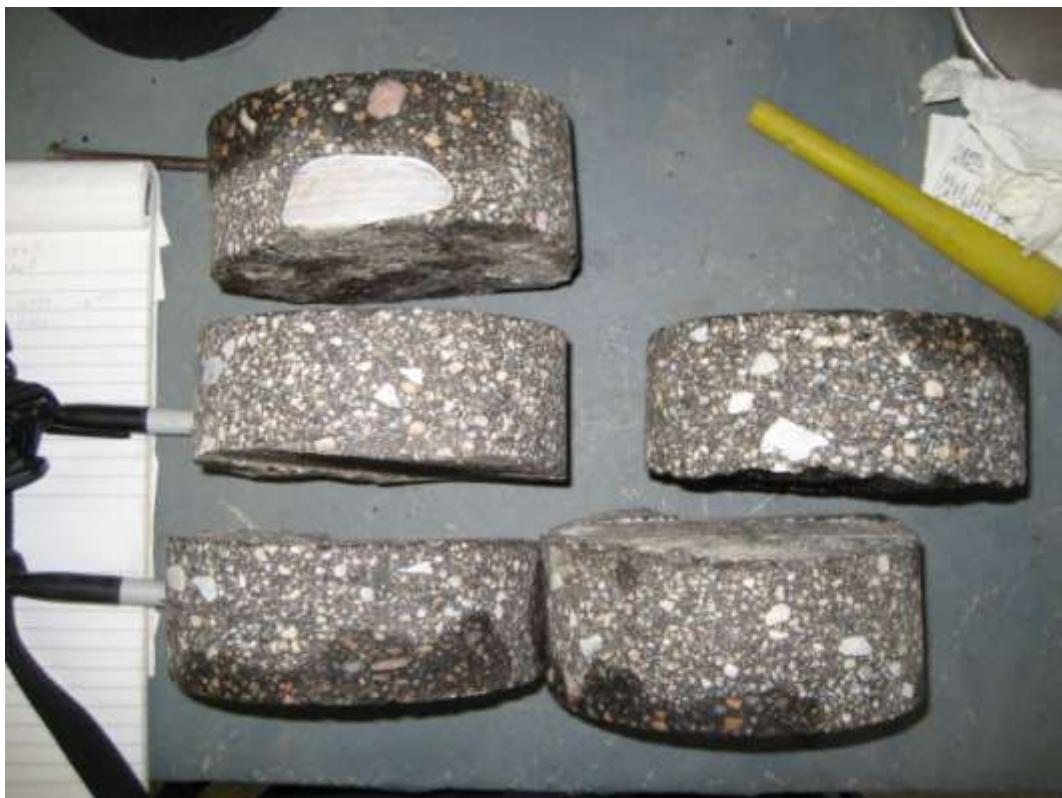
This section of the field report provides a photograph of five of the cores that were recovered for laboratory density testing and visual observations of the mixture along the edge and 3 feet from the edge. No systematic visual differences were noted between the different core sets. Some of the cores did exhibit much larger aggregate than included in the test results for mixture design, quality control and other tests, as shown in the picture for two of the five cores. Larger aggregate would tend to steepen the slope of the Safety Edge_{SM}, because those larger aggregate would prevent the finer aggregate particles being nearer the bottom of the slope. Based on visual observations of the Safety Edge_{SM}, this is not believed to be the case, with the possible exception in a few localized areas.

Figure A-1. Cores recovered for laboratory density testing.
