Evaluation of Bibb Graves Bridge Arch in Wetumpka, Alabama

Petrographic Evaluation and Recommendations

ASR Development and Deployment Program
Field Application and Demonstration Projects

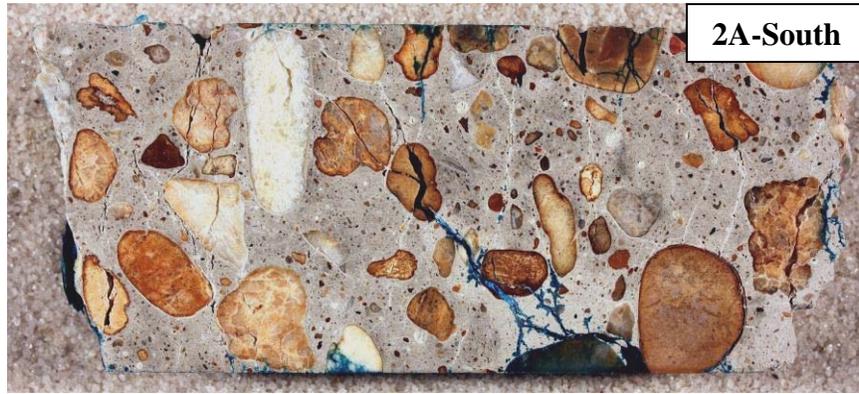
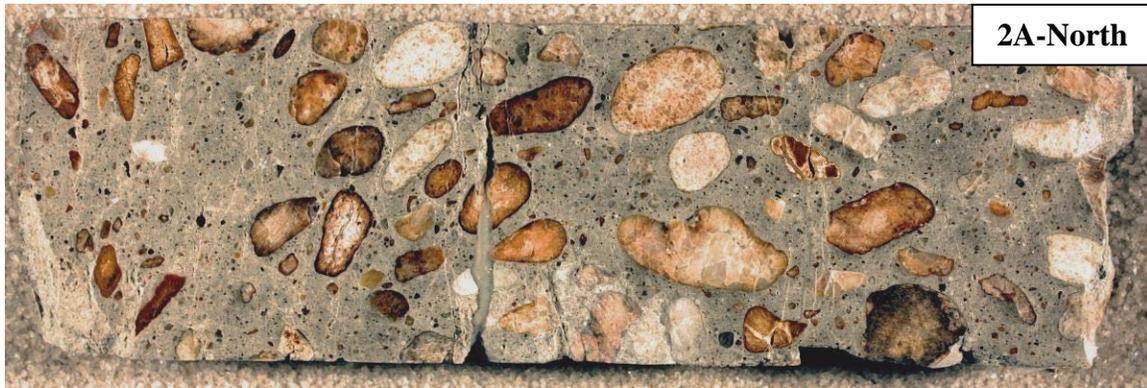
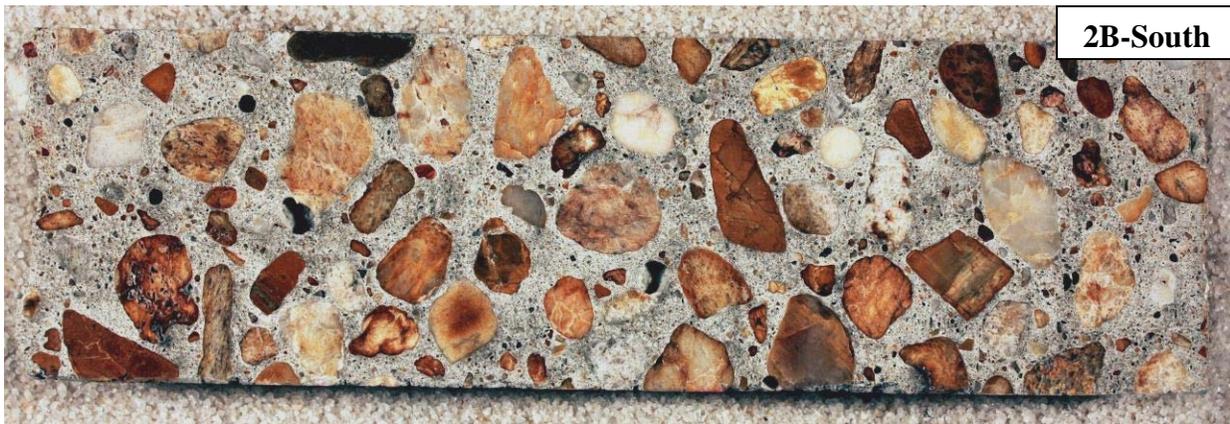
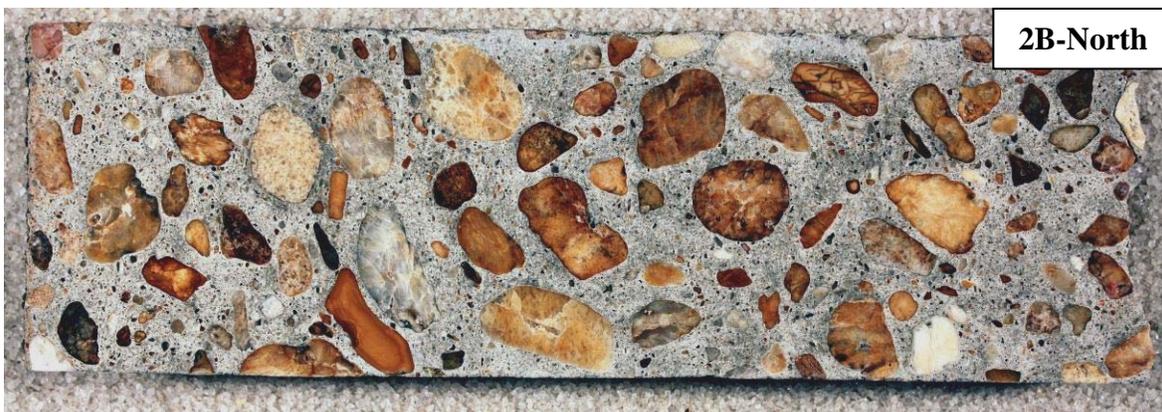
Globally, the polished concrete section 2A-South shows several large cracks (up to 1mm in size) that run through the cement paste and the coarse aggregate particles (Figures 1 and B1). The core had

Similar to the Core 2A-South, the polished concrete section 2A-North shows several large cracks (up to 1mm in size) that run through the cement paste and the coarse aggregate particles (Figures 1 and B5). The core had also to be glued with epoxy to allow the cutting and polishing processes to take place.

Figure 1. Polished concrete sections from the Gibb Graves Bridge, Wetumpka, Alabama.

The polished concrete section 2B-South shows neither significant cracking nor deterioration (Figures 1 and B8). The DRI value of **141** is the lowest for the set of cores obtained from the Bibb Graves Bridge (Figures 2 and B8). It is indicative of a very low degree of damage in the concrete. As indicated in Figure 2, the highest contributor to the DRI for this core is *Cracks in the aggregate particles (without reaction products)* (73% - 103/141; Figure B9), followed by *Open cracks within the aggregate particles* (22% - 31/141). The coarse aggregate is similar to that of the set of 2A cores and mainly consist of quartzite (Qtz) (also possibly quartzitic sandstone) and chert (Ch) (sometimes partially leached/weathered) particles (Figure B9-D). Several quartzite aggregate particles show extensive internal cracking and/or grain joints, thus giving a sort of “mosaic” macrotexture (e.g. Figures B9-B and C). Dark reaction rims were observed around only a few of the above coarse aggregate particles (~4% of the DRI value). The fine aggregate mainly consist of angular to sub-angular quartz grains, with possible fragments of quartzite; the sand is however coarser than in the cores of the 2A series. No significant cracking, at least at the magnification used for the DRI (16X), was observed in the cement paste. Concrete is not air entrained and the few voids observed are generally empty (no secondary/reaction products).

Similar Core 2B-South, the polished concrete section 2B-North shows neither significant cracking nor deterioration (Figures 1 and B10). The DRI value of **205** is the second lowest for the set of cores obtained from the Bibb Graves Bridge (Figures 2 and B10). It is indicative of a very-low to low degree of damage in the concrete. As indicated in Figure 2, the highest contributor to the DRI for this core is *Cracks in the aggregate particles (without reaction products)* (76% - 155/205; Figure B11), followed by *Open cracks within the aggregate particles* (15% - 31/205). The coarse aggregate is similar to that

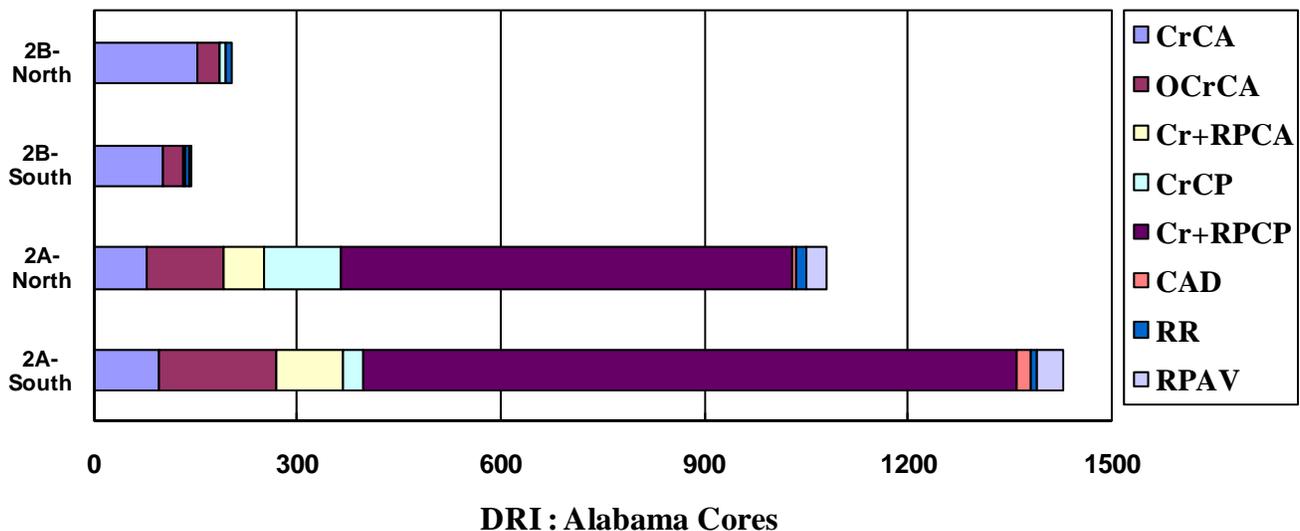
There is currently no rating system for the DRI values that correspond to concrete affected to a low, moderate or severe degree by ASR. However, our experience is such that values below 200-250 are indicative of a low degree of reaction / deterioration, DRIs in excess of about 500-600 represent a high to very high (DRI > 1000) degree of ASR. It is important to mention, however, that since the DRI is not a standardized method, values can vary significantly from one petrographer to another.

Figure 2. Results of the Damage Rating Index (DRI) for the Alabama cores

Two sets of cores were obtained from the Bibb Graves Bridge (AL Route 111 over Coosa River), Wetumpka, and Alabama. Cores extracted from the arch # 4 (2B-South and 2B-North) are in very good condition and the concrete shows no significant signs of deterioration, as indicated by the low DRI values of 141 and 205. On the other hand, cores extracted from the arch # 5 (2A-South and 2A-North) show several large cracks (up to 1mm in size) that run through the cement paste and the coarse aggregate particles. The DRI values of 1430 and 1081 are indicative of a very high degree of damage in the concrete.

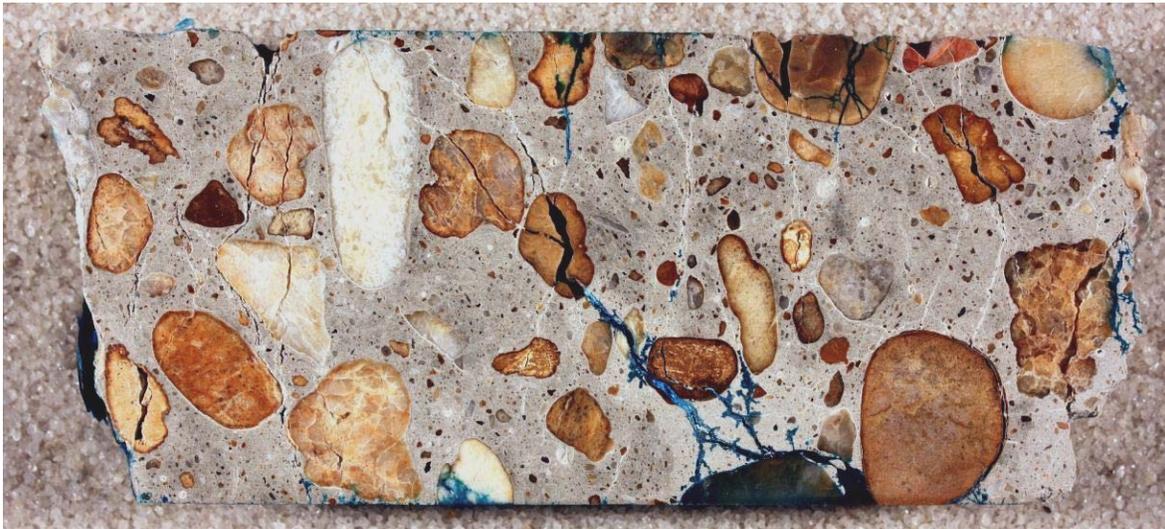
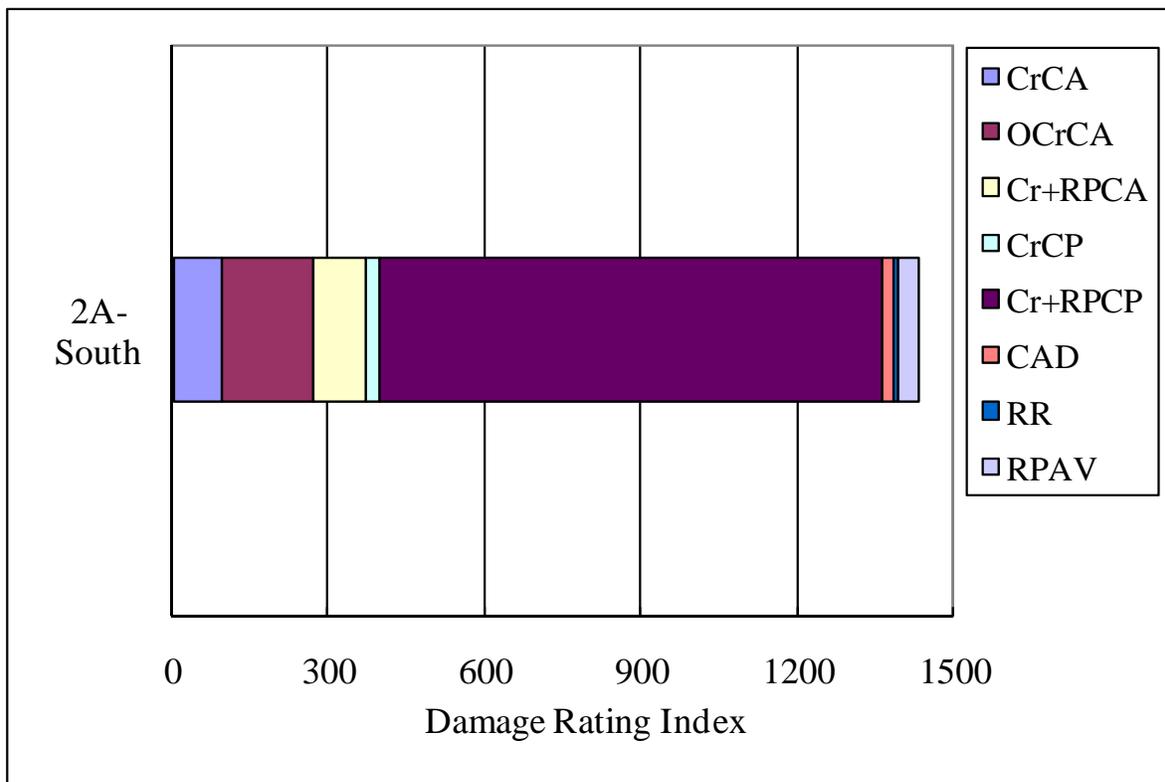
Figure B1: Polished core section 2A-South and DRI results

The DRI value of **1430** is the highest for the set of cores obtained from the Bibb Graves Bridge (Figures 2 and B1). It is indicative of a very high degree of damage in the concrete. The micrographs in Figure B2 show extensive cracking in the coarse aggregate particles and in the cement paste. As indicated in Figure 2, the highest contributor to the DRI for this core is *Cracks in the cement paste with reaction products* (67% - 964/1430; Figure B2), followed by *Open cracks within the aggregate particles* (12% - 173/1430; e.g. Figure B2-E) and *Cracks with reaction products in the coarse aggregate particles* (7% - 100/1430; Figure B2-B). The coarse aggregates mainly consist of quartzite (Qtz) and chert (Ch) (sometimes partially leached/weathered) particles. Several quartzite aggregate particles show extensive internal cracking and/or grain joints, thus giving a sort of “mosaic” macrotexture (e.g. Figures B2-B and F). Dark reaction rims are observed around some of the above coarse aggregate particles (Figures B2-C and F). The fine aggregate mainly consist of angular to sub-angular quartz grains, with possible fragments of quartzite; it probably has a fairly low modulus of fineness.

With regards to suppressing future expansion it is our recommendation that the damaged portions of the arch be treated with a suitable hydrophobic sealer such as a silane. Before application of the silane it is recommend that the concrete surface be cleaned by sand blasting and that the larger cracks be filled with a suitable flexible sealant.

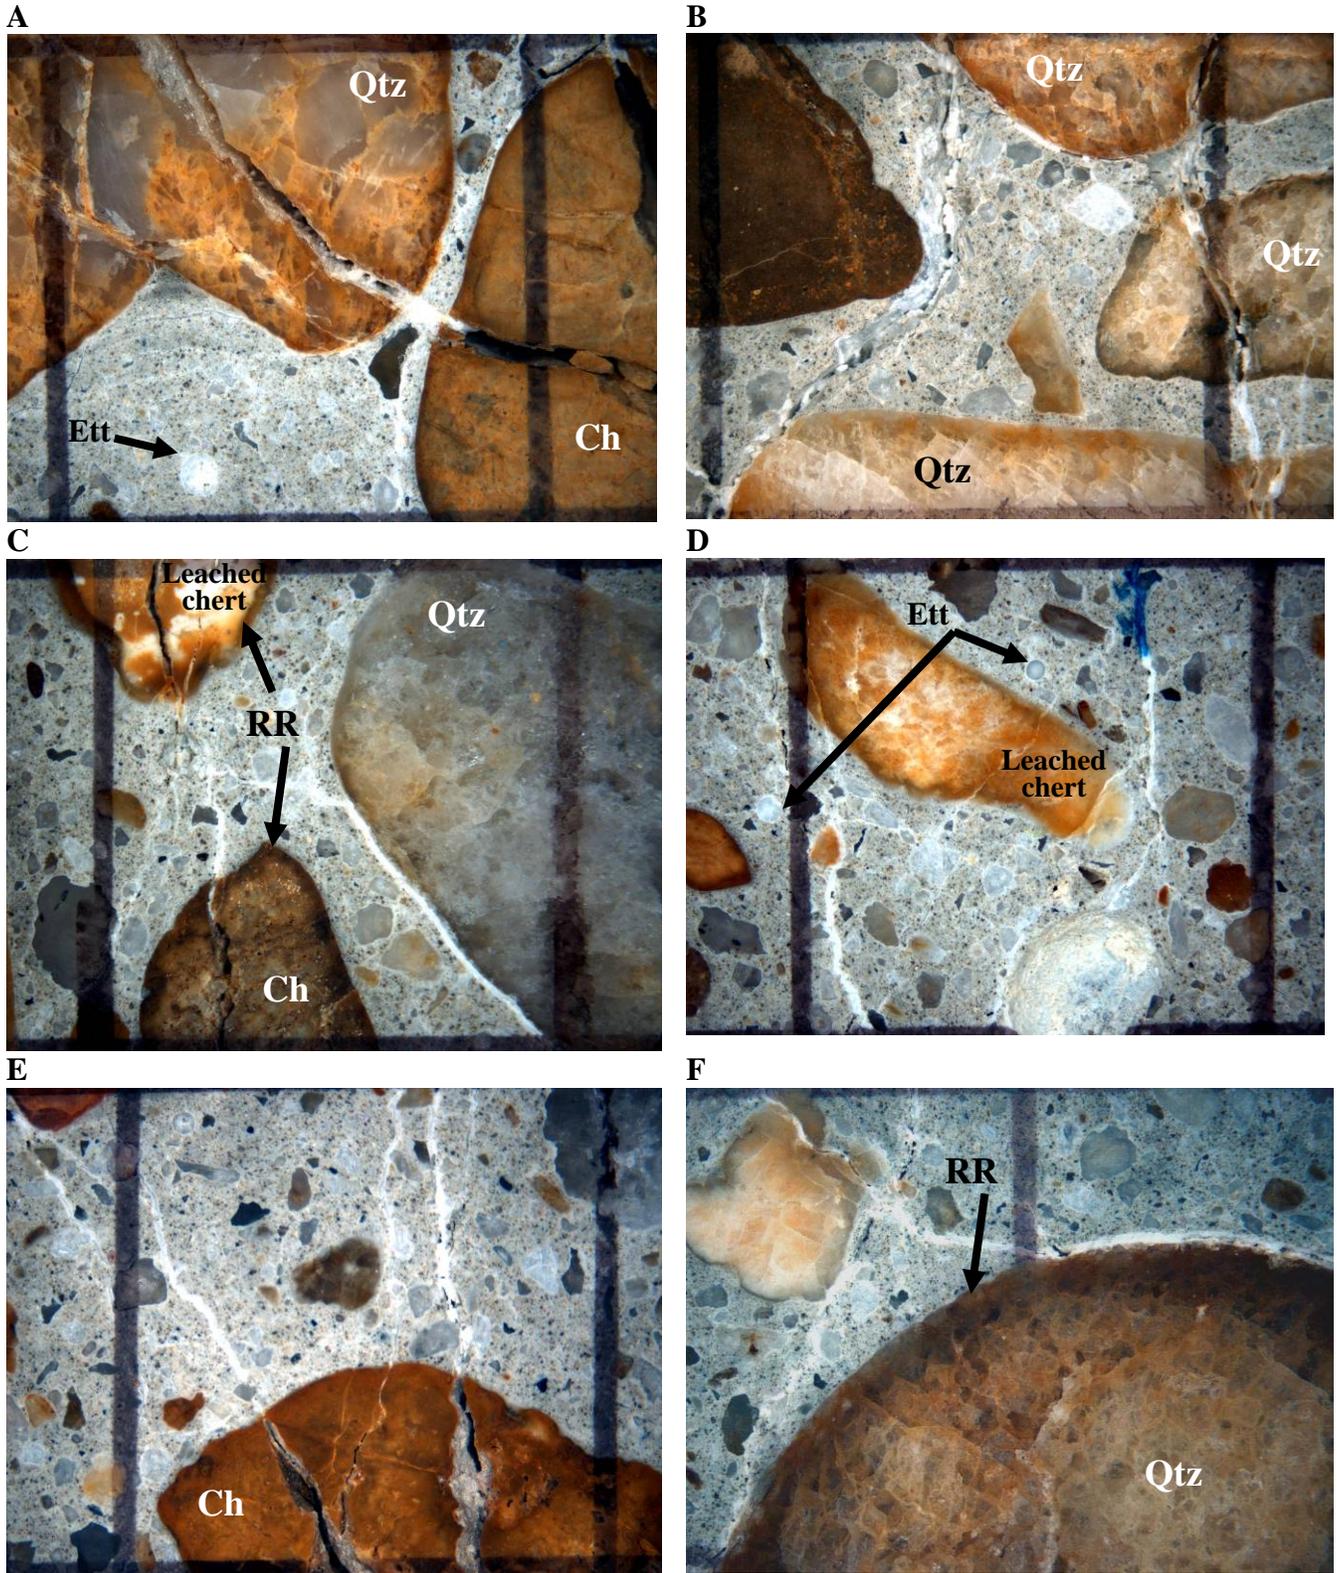
Cracks in the cement paste are often filled with whitish/powdery, glassy and/or clear (with a “waxy” luster) secondary reaction products. The examination of concrete fragments under the stereomicroscope (Figure B3) and the scanning electron microscope (SEM) (Figure B4) indicates that the reaction products consist of ettringite (present as clear and “waxy” secondary products under the stereomicroscope as well as in whitish powdery deposits) (Figures B3, B4-B and C; B4-I to K) and alkali-silica gel (Figure B3) that closely co-exist in the deteriorated concrete. Fractured surfaces of the concrete cores reveal a typical arrangement of ASR products (Figures B3-A to C) (i.e. cracks within the aggregate particles and that extend into the cement paste are often filled with alkali-silica gel that gives the typical “mud-crack” texture on such fractured surfaces (Figures B3-G to J)) along with large deposits of ettringite (Figures B3-D to F). Concrete is not air entrained but some voids are filled with ettringite with a clear but “waxy” luster (*ett* on Figures B2-A and D).

Figure B2: Micrographs of the polished core section 2A-South (distance between vertical lines = 1 cm)
 The micrographs show extensive cracking in the coarse aggregate particles and in the cement paste. The coarse aggregates mainly consist of chert (Ch) (sometimes partially leached/weathered) and quartzite particles (Qtz). Dark reaction rims (RR) are observed around some coarse aggregate particles. Concrete is not air entrained but some air voids are filled with ettringite (ett) (e.g. D). Cracks in the cement paste are often filled by ettringite (whitish and powdery deposits; also clear and waxy in luster) and alkali-silica reaction products, as illustrated in more details in Figure B3.

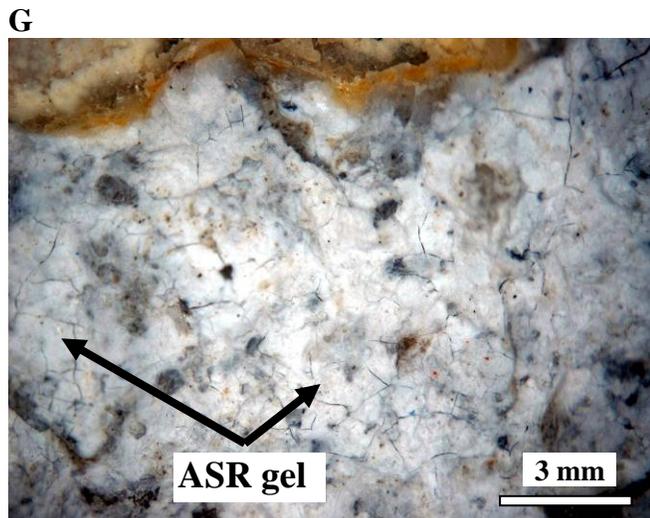
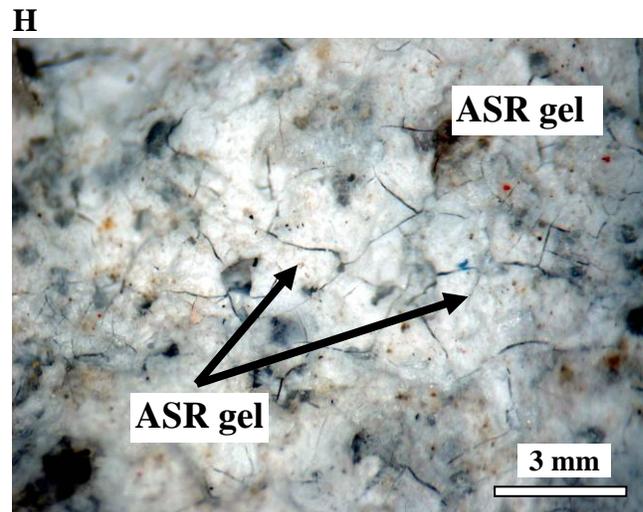
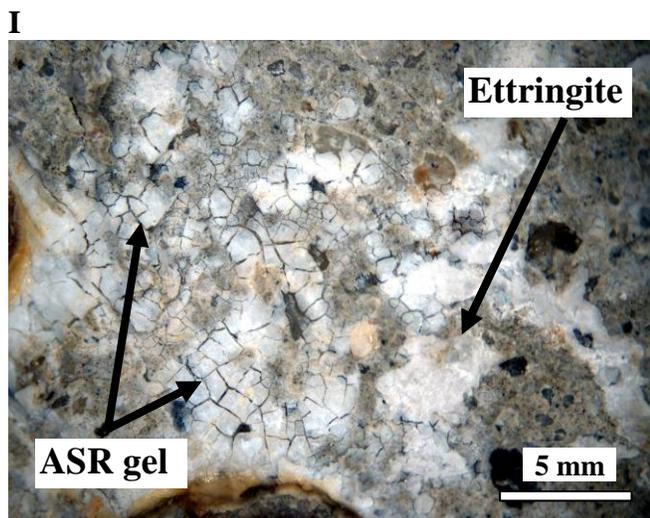
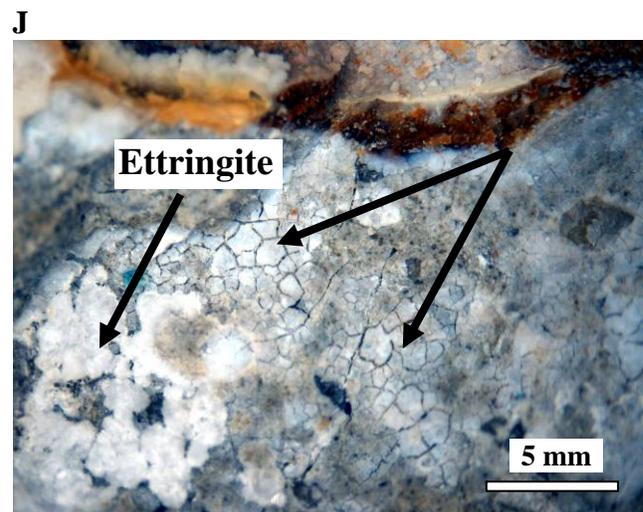
Figure B3: Micrographs of broken surfaces of the core 2A-South, as examined under the stereomicroscope. Figures B3-A and B3-B. Concrete surfaces broken along major cracks in the cement paste (core diameter = 3 inches (75mm)). Figure B3-C. The core broke along large cracks in the cement paste, thus exposing surfaces, both along cracks in the aggregates and the cement paste, largely covered by whitish secondary reaction products. Such products consist of ettringite and ASR gel (18x magnification). Figure B3-D. Whitish (powdery) reaction products (ettringite) covering large areas of the cement paste (20x magnification). Figure B3-E: Magnification (30x) of the reaction products illustrated in B3-D showing the needle-type microtexture of ettringite. Figure B3-F. Deposit of ettringite covering an aggregate particle. The deposit was found at the interface between an aggregate particle and the cement paste (as in Figure B2-C) and caused debonding of the aggregate particle when the concrete was broken for petrographic examination (20x magnification). Figures B3-G and B3-H. Deposits of ASR gel (showing typical “mud-crack” microtexture) covering large areas of the cracked cement paste (25x magnification). Figures B3-I and B3-J. Deposits of ASR gel and ettringite co-existing in the deteriorated concrete sample (18x magnification).

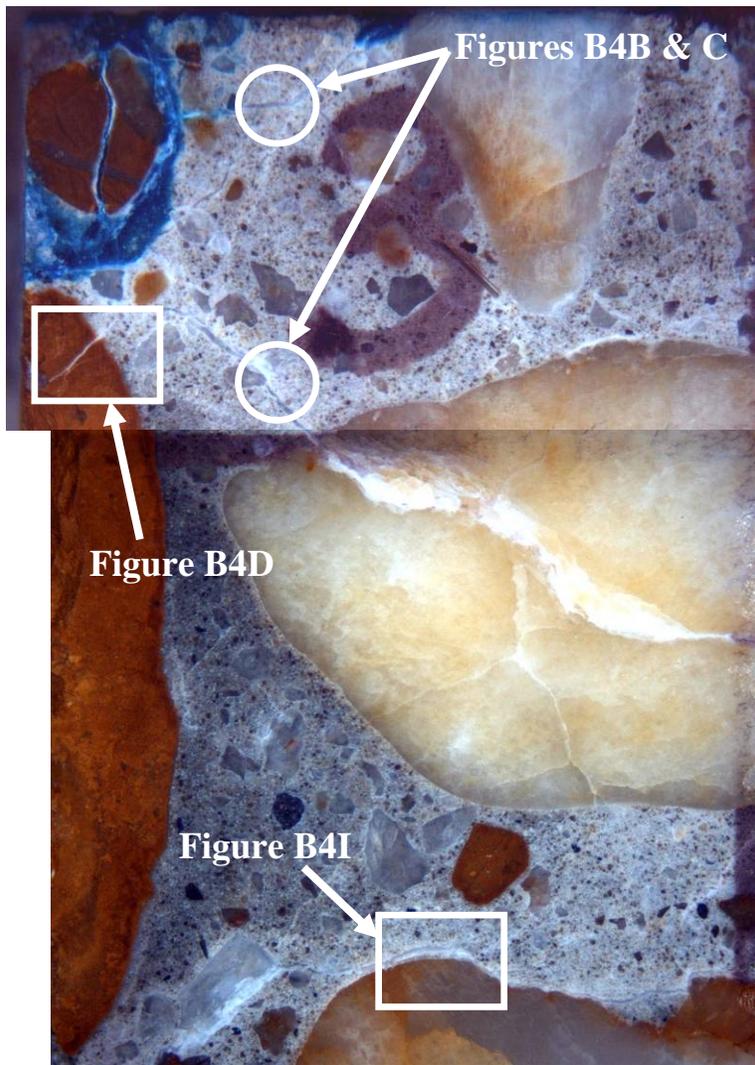
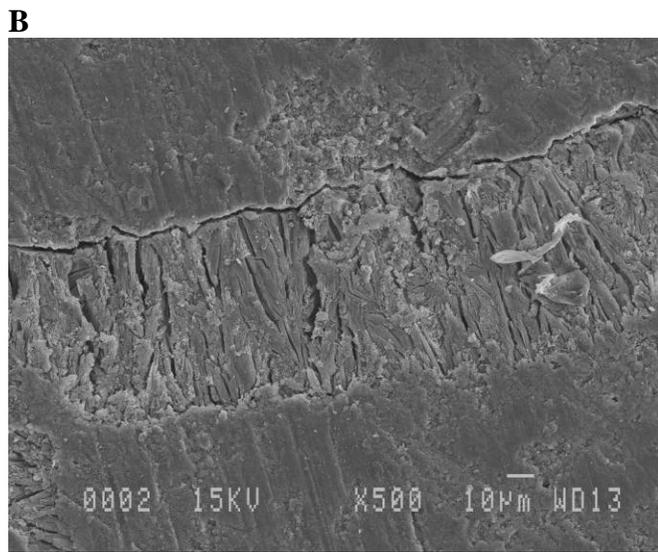
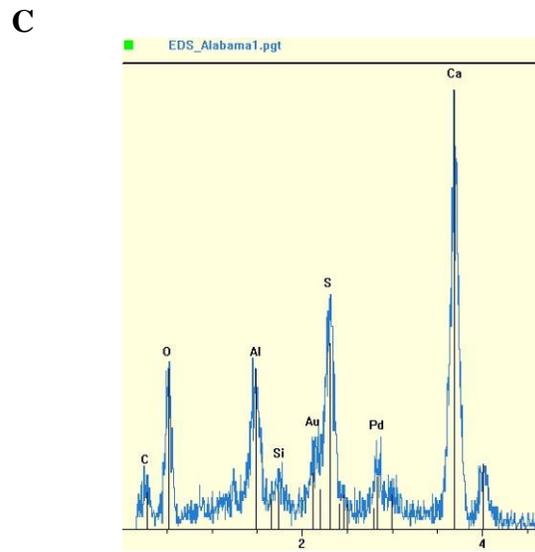
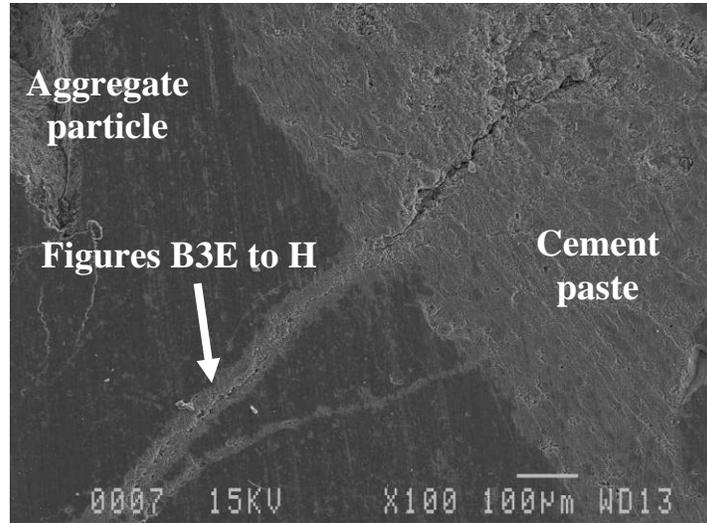
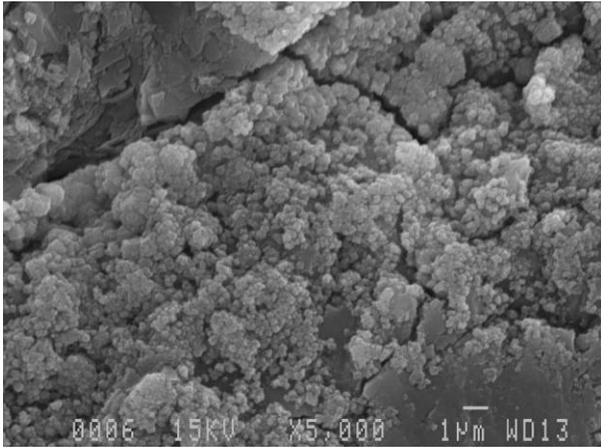
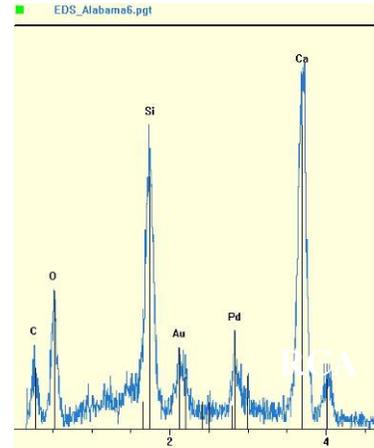
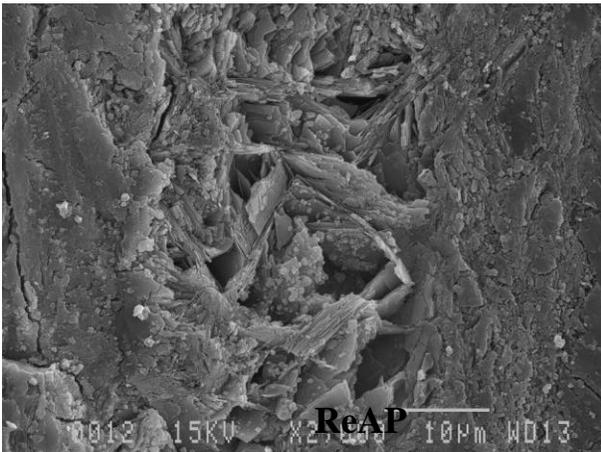
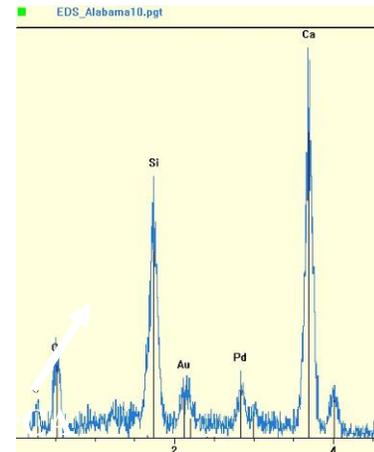
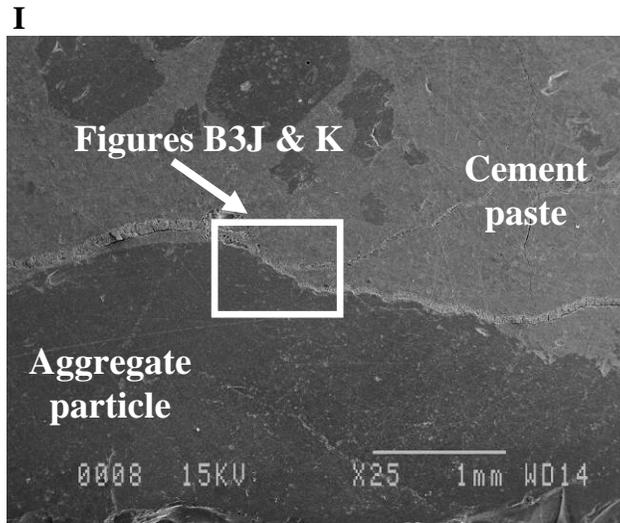
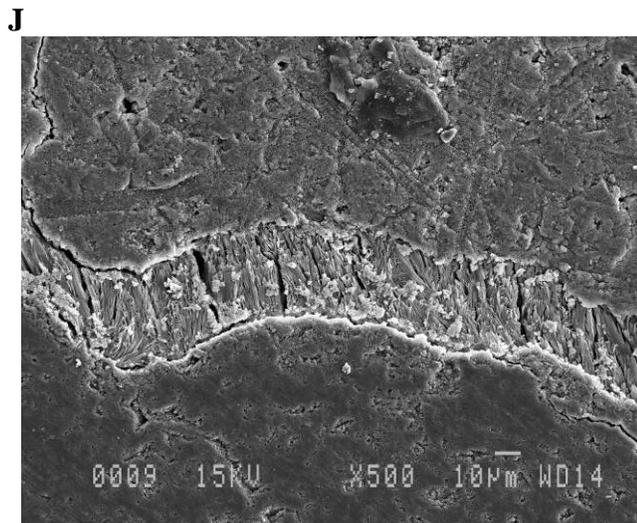
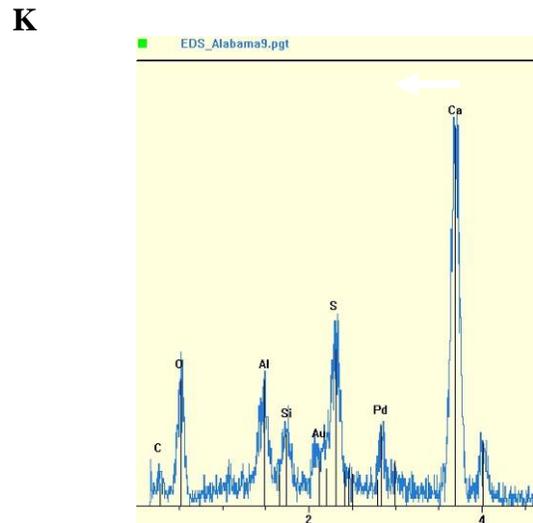
Figure B4 (cont'd): Micrographs of a polished core sample examined under the SEM (2A-South). Figure B4-A. Sample examined under the stereomicroscope. Figure B4-B. Crack filled by compacted ettringite material. Under the stereomicroscope, the ettringite shows a clear but “waxy” luster that differs from that of “glassy” alkali-silica gel. Figure B4-C. Energy dispersive X-Ray analysis of the material (compacted ettringite) filling the crack in micrograph B4-B (typical composition of ettringite including Ca, Al, S; note: the Au and Pd peaks correspond to the conductive metallic deposit at the surface of the sample required for SEM observations). Figure B4-D. Crack extending from the aggregate particle into the cement paste. Figure B4-E. Microtexture of secondary products filling the crack in the aggregate particle illustrated in micrograph B4-D. Figure B4-F. Energy dispersive X-Ray analysis of the material (recrystallized ASR product !?) in micrograph B4-E. Figure B4-G. Microtexture of secondary products filling the crack in the aggregate particle illustrated in micrograph B4-D. Figure B4-H. Energy dispersive X-Ray analysis of the material (recrystallized ASR product !?) in micrograph B4-G. Figure B4-I. Crack in the cement paste above an aggregate particle. Figure B4-J. Microtexture of secondary products filling the crack in the aggregate particle illustrated in micrograph B4-I. Figure B4-K. Energy dispersive X-Ray analysis of the material (compacted ettringite) in micrograph B4-J.

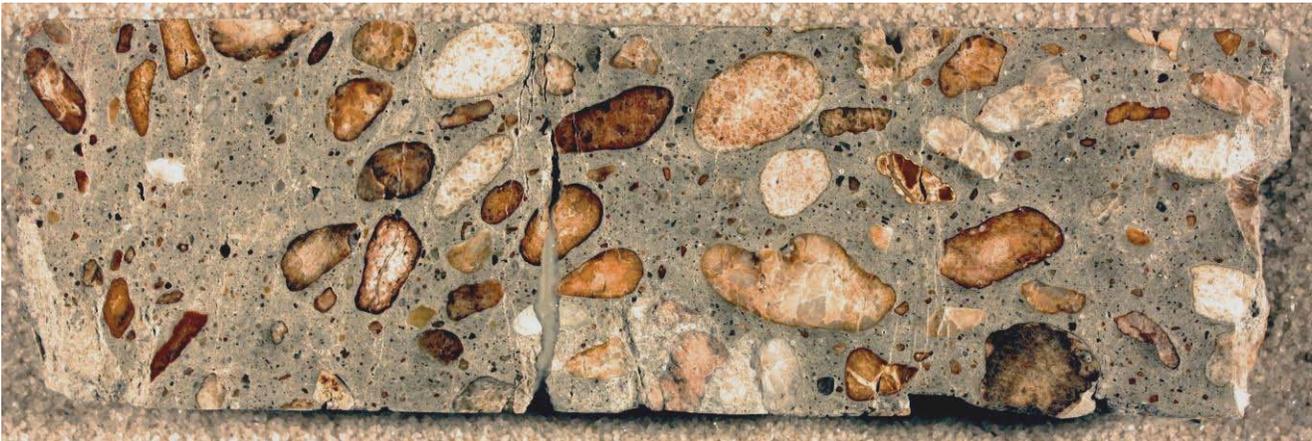
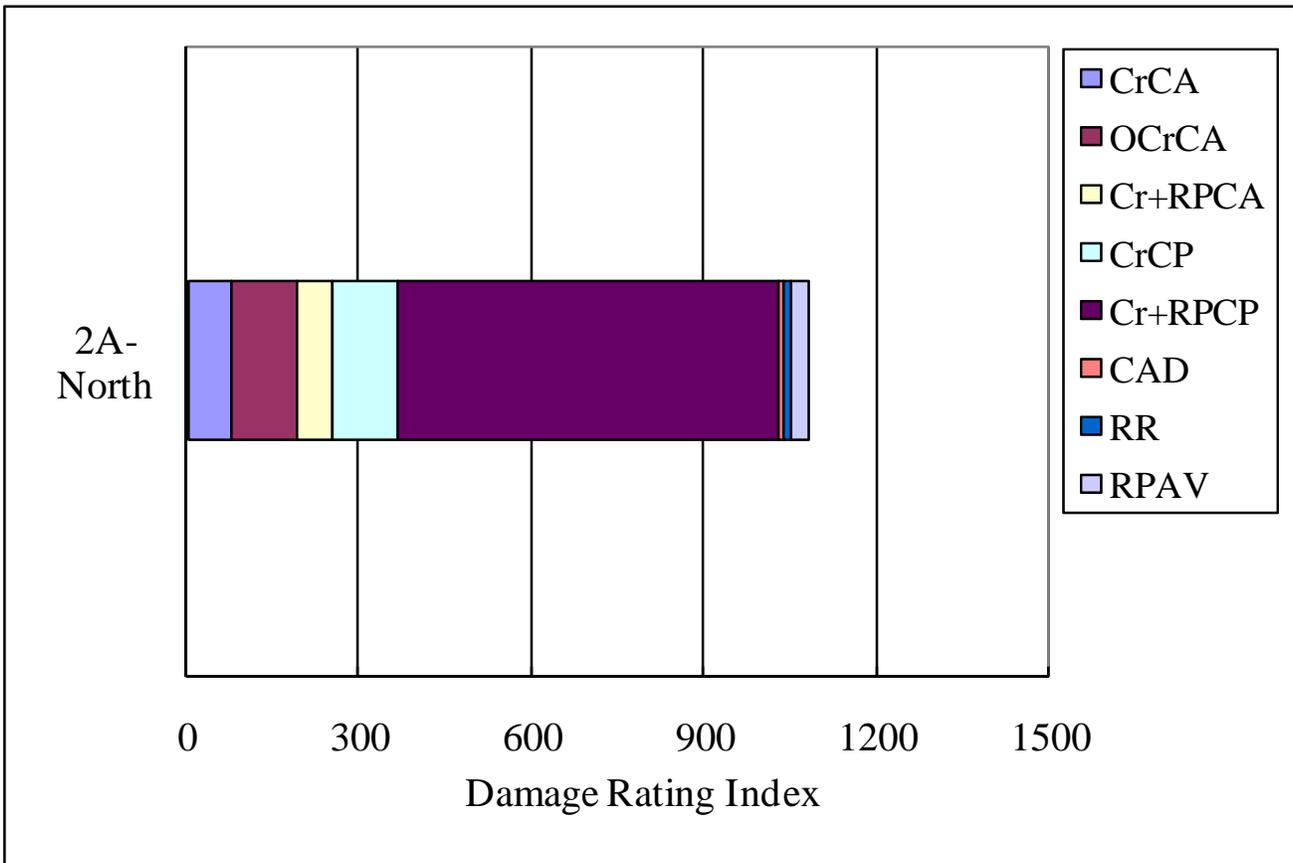
Figure B5: Polished core section 2A-North and DRI results

The DRI value of **1081** is the second highest for the set of cores obtained from the Bibb Graves Bridge (Figures 2 and B5). It is indicative of a very high degree of damage in the concrete. The micrographs in Figure B6 show extensive cracking in the coarse aggregate particles and in the cement paste. As indicated in Figures 2 and B5, the highest contributor to the DRI for this core is *Cracks in the cement paste with reaction products* (61% - 664/1081; Figure B6), followed by *Open cracks within the aggregate particles* (11% - 114/1081; e.g. Figure B6-D) and *Cracks in the cement paste (without reaction products)* (10% - 112/1081; Figure B6). The coarse aggregate particles are similar to that in the Core 2A-South and mainly consist of quartzite (Qtz) (possibly some quartzitic sandstone) and chert (Ch) (sometimes partially leached/weathered) particles (Figures B6-A and D). Several quartzite aggregate particles show extensive internal cracking and/or grain joints, thus giving a sort of “mosaic” macrotexture (e.g. Figure B6-F). Dark reaction rims are observed around some of the above coarse aggregate particles (Figures B6-A and B). The fine aggregate mainly consist of angular to sub-angular quartz grains, with possible fragments of quartzite; it probably has a fairly low modulus of fineness.

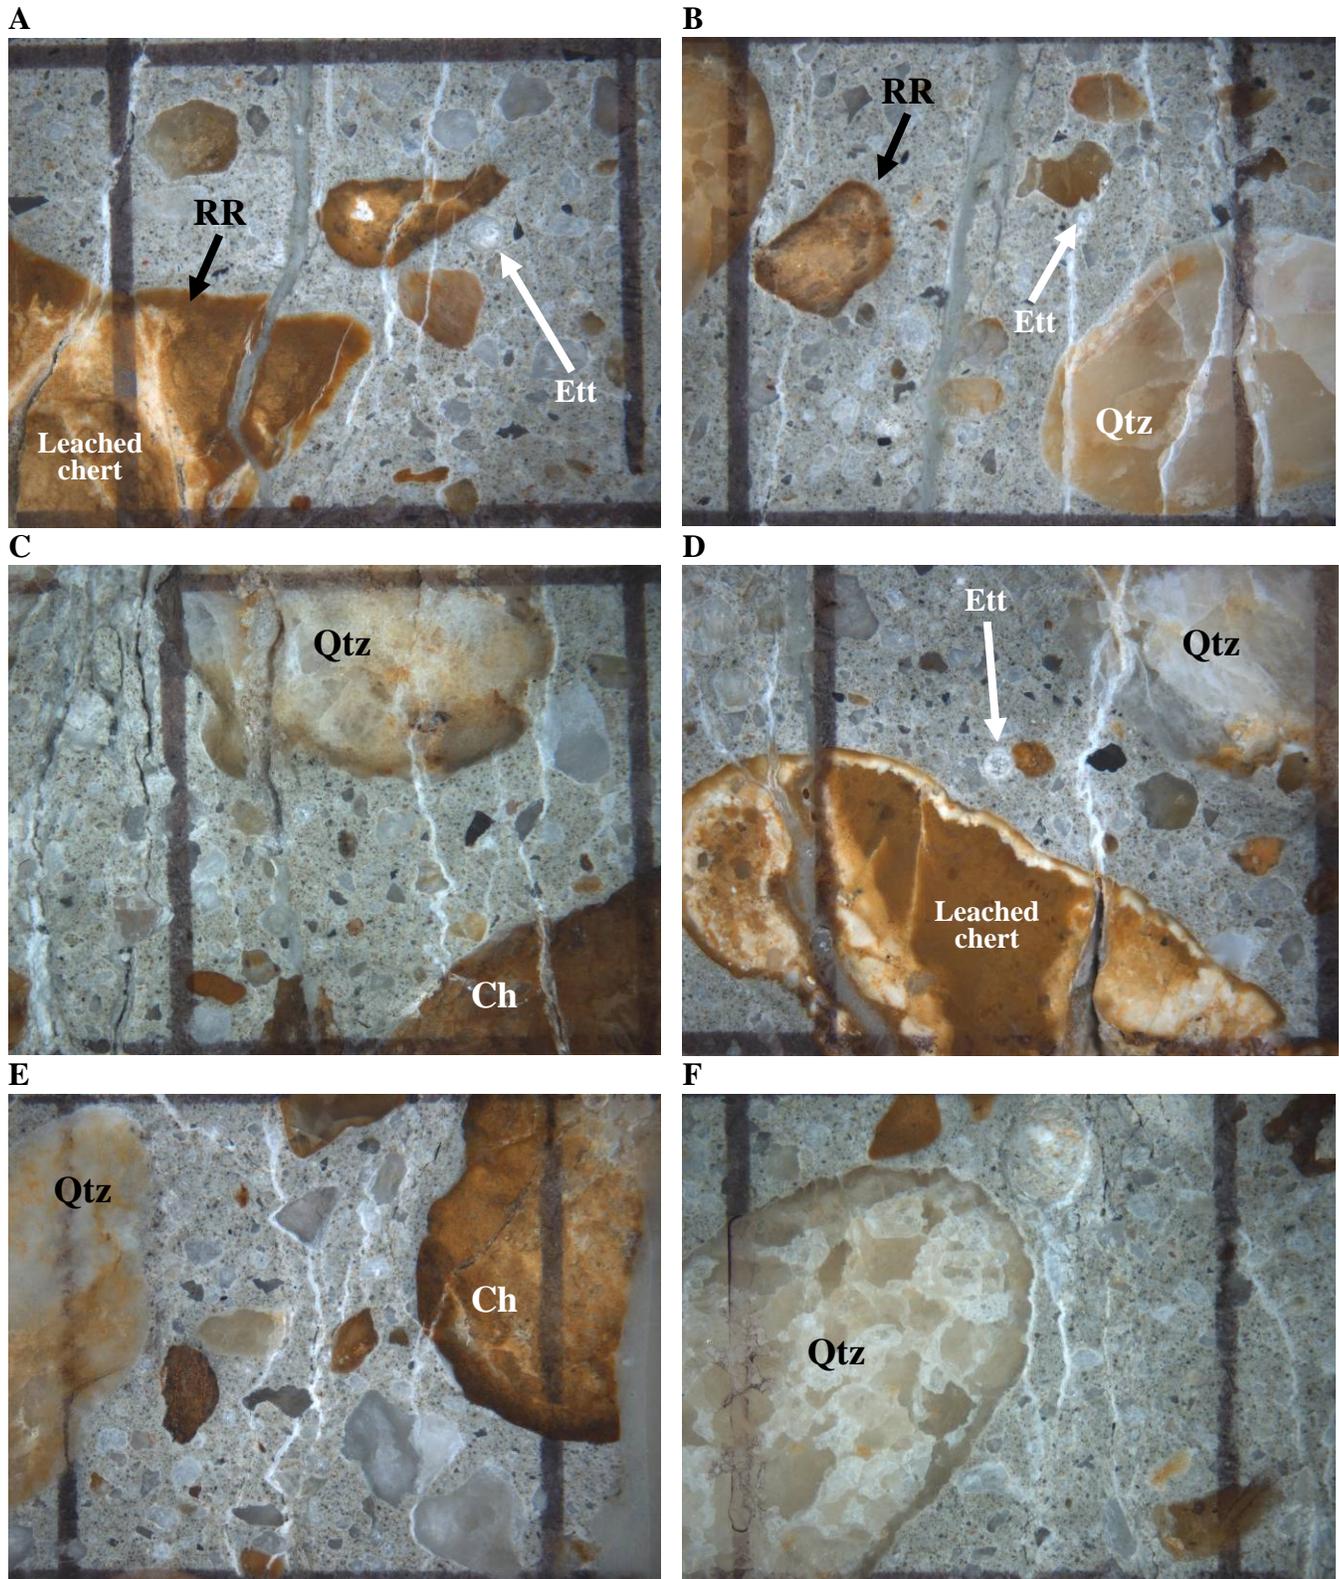
Similar to Core 2A-South, cracks in the cement paste are often filled with whitish/powdery, glassy and/or clear (with a “waxy” luster) secondary reaction products; some of those cracks are very fine (~0.02-0.03mm). Examination of concrete fragments under the stereomicroscope (Figure B7) indicate that the reaction products consist of ettringite (present as clear and “waxy” secondary products under the stereomicroscope as well as in whitish powdery deposits) (Figure B7-D) and alkali-silica gel (Figures B7-A to C) that co-exist in the deteriorated concrete. Concrete is not air entrained but some voids are filled with ettringite (*ett* in Figures B6-A, B and D).

Figure B6: Micrographs of the polished core section 2A-North (distance between vertical lines = 1 cm). The micrographs show extensive cracking in the coarse aggregate particles and in the cement paste. The coarse aggregates mainly consist of chert (Ch)(sometimes partially leached/weathered) and quartzite particles (Qtz). Dark rims (RR) are observed around some coarse aggregate particles. Concrete is not air entrained but some air voids are filled with ettringite (ett) (e.g. B6-A, B6-B and B6-D). Cracks in the cement paste are often filled by ettringite (whitish and powdery deposits; also clear and waxy in luster) and alkali-silica reaction products, as illustrated in more details in Figure B7.

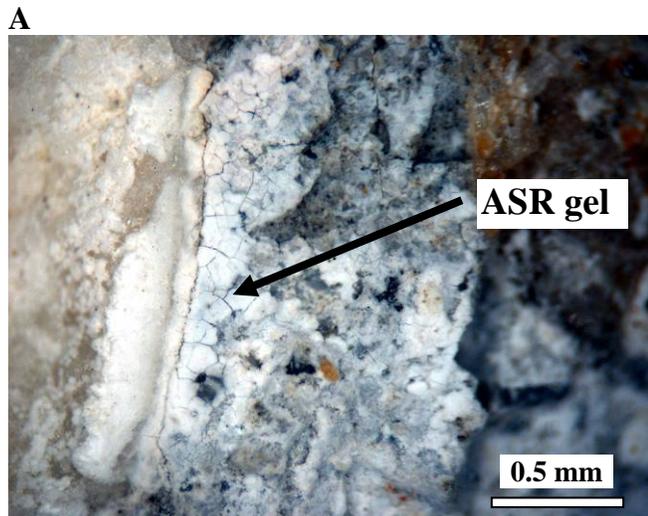
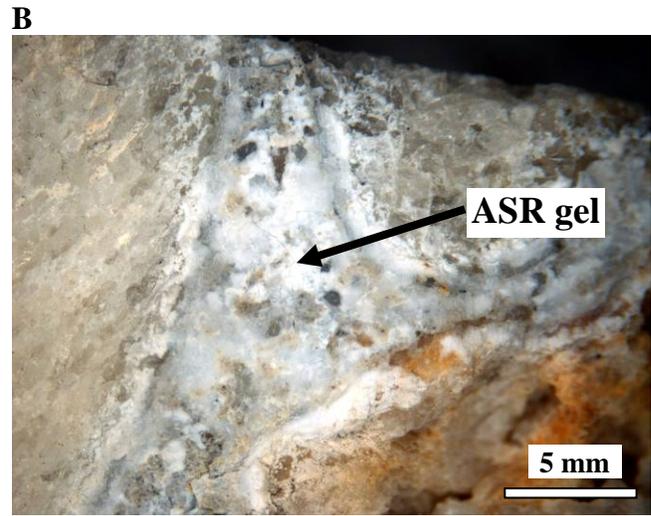
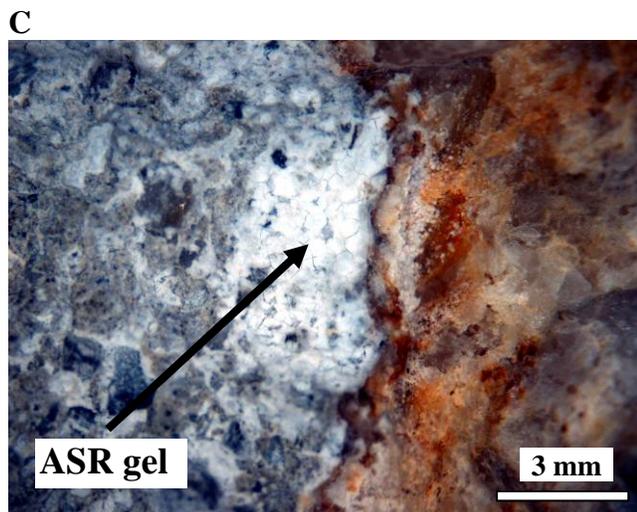
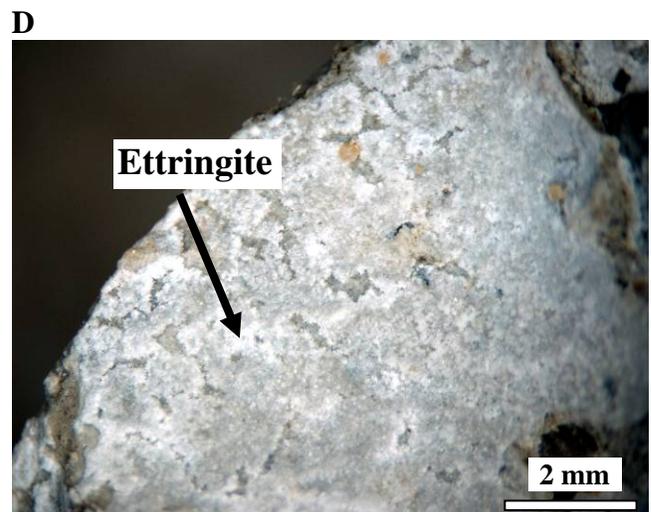
Figure B7: Micrographs of broken surfaces of the core 2A-North, as examined under the stereomicroscope. Figure B7-A to B7-C. Deposits of ASR gel (showing typical “mud-crack” microtexture) covering large areas of the cracked cement paste between aggregate particles. Figure B7-D. Deposit of ettringite in the mold of a debonded aggregate particle. The deposit was found at the interface between the aggregate particle and the cement paste (as in Figure B2-C) and caused debonding of the aggregate particle when the concrete was broken for petrographic examination.

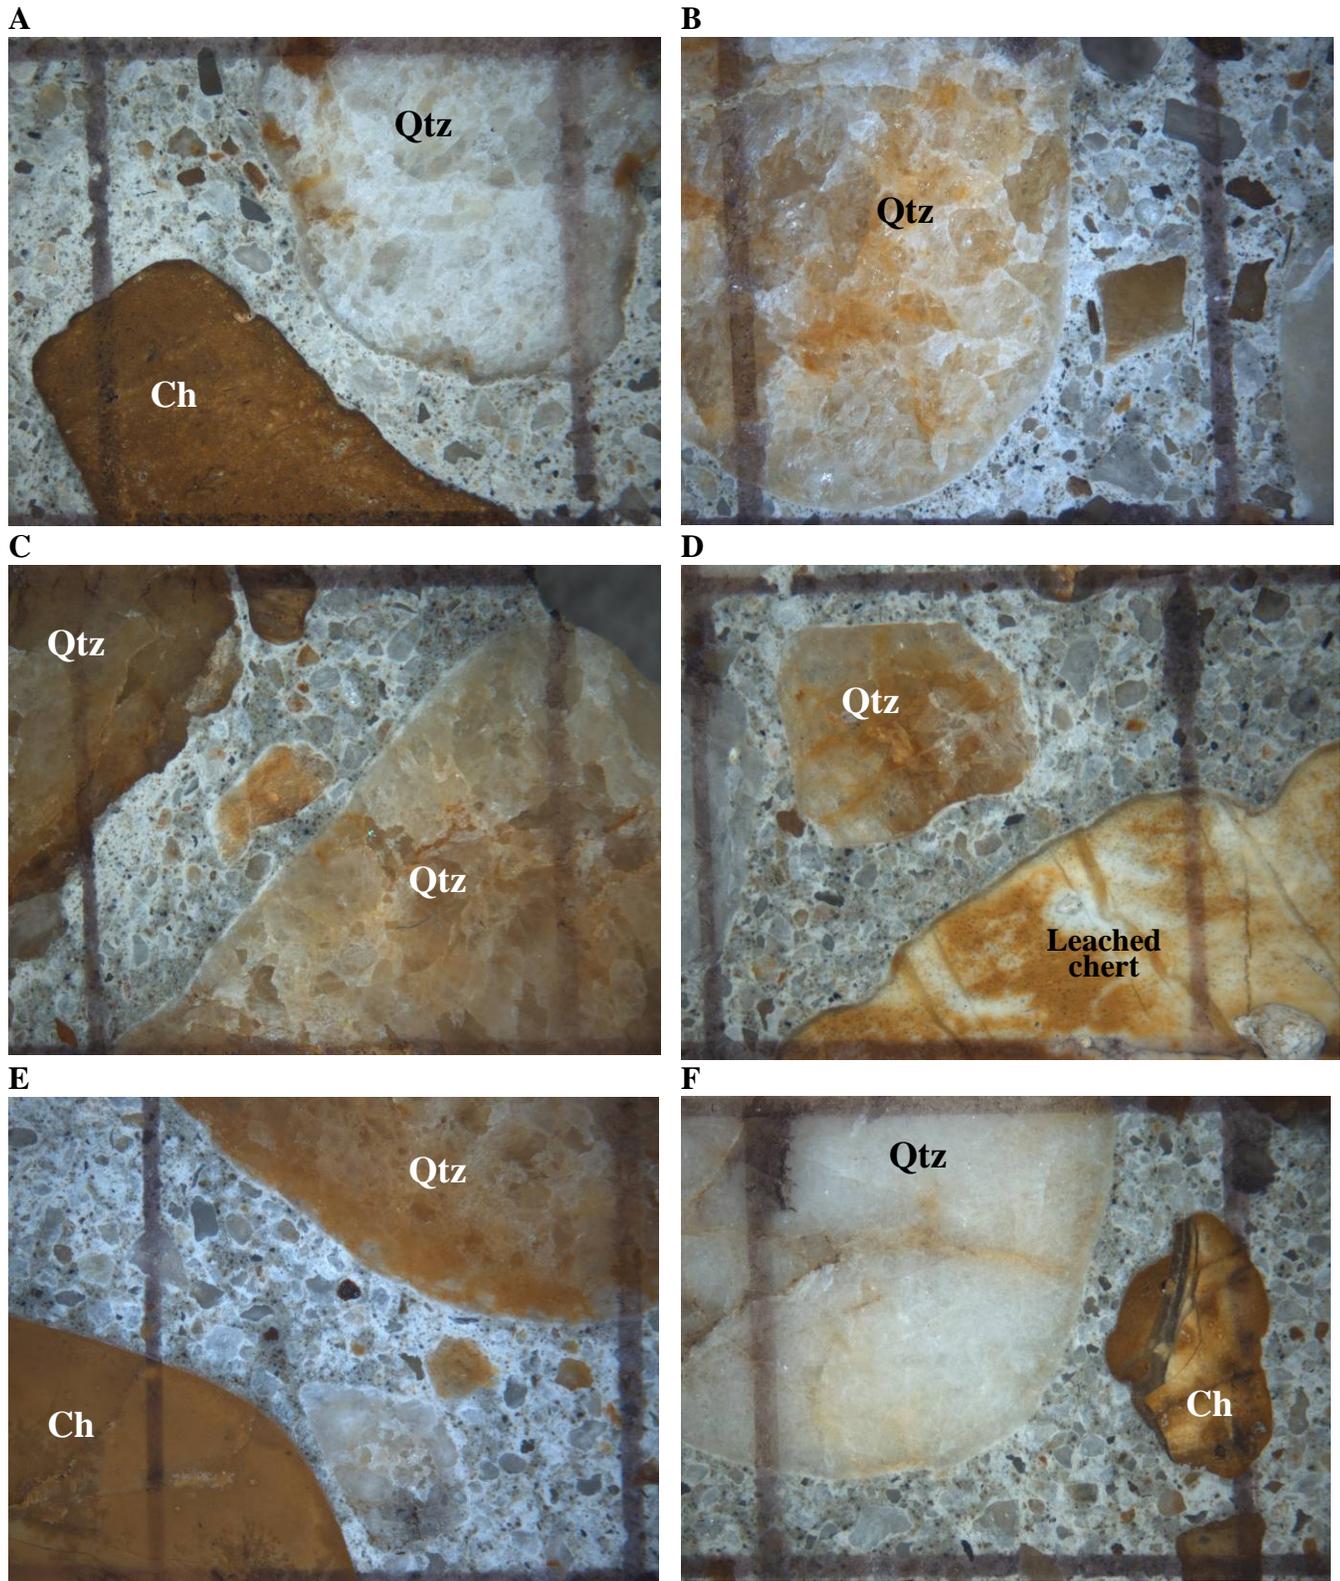
Figure B9: Micrographs of the polished core section 2B-South (distance between vertical lines = 1 cm). The micrographs show coarse aggregate particles that mainly consist of chert (Ch)(sometimes partially leached/weathered) and quartzite particles (Qtz). Very limited cracking is noticed in the cement paste.
