Evaluation of Bibb Graves Bridge Arch in Wetumpka, Alabama

Petrographic Evaluation and Recommendations

ASR Development and Deployment Program
Field Application and Demonstration Projects

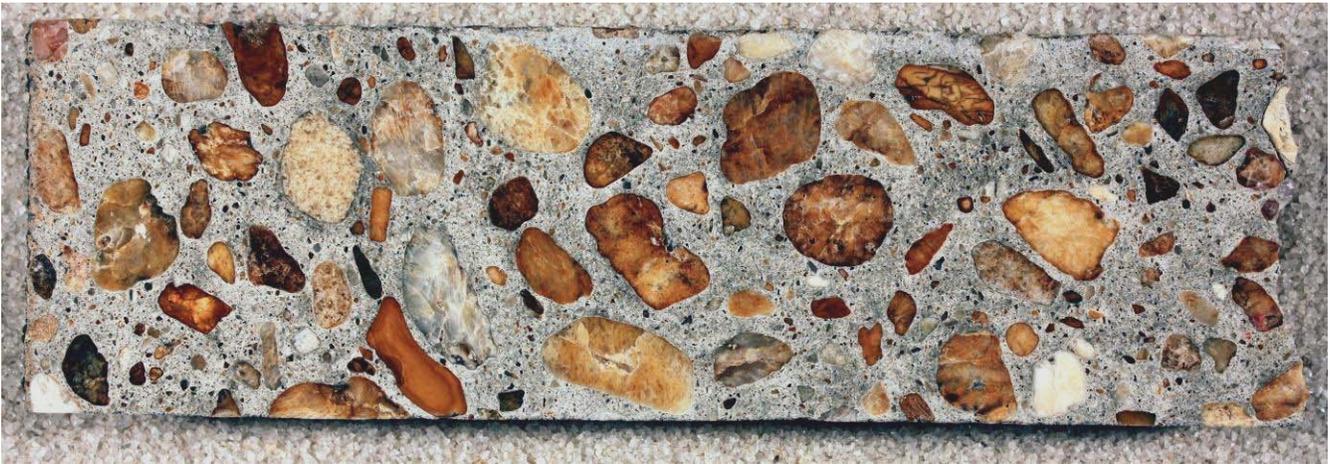
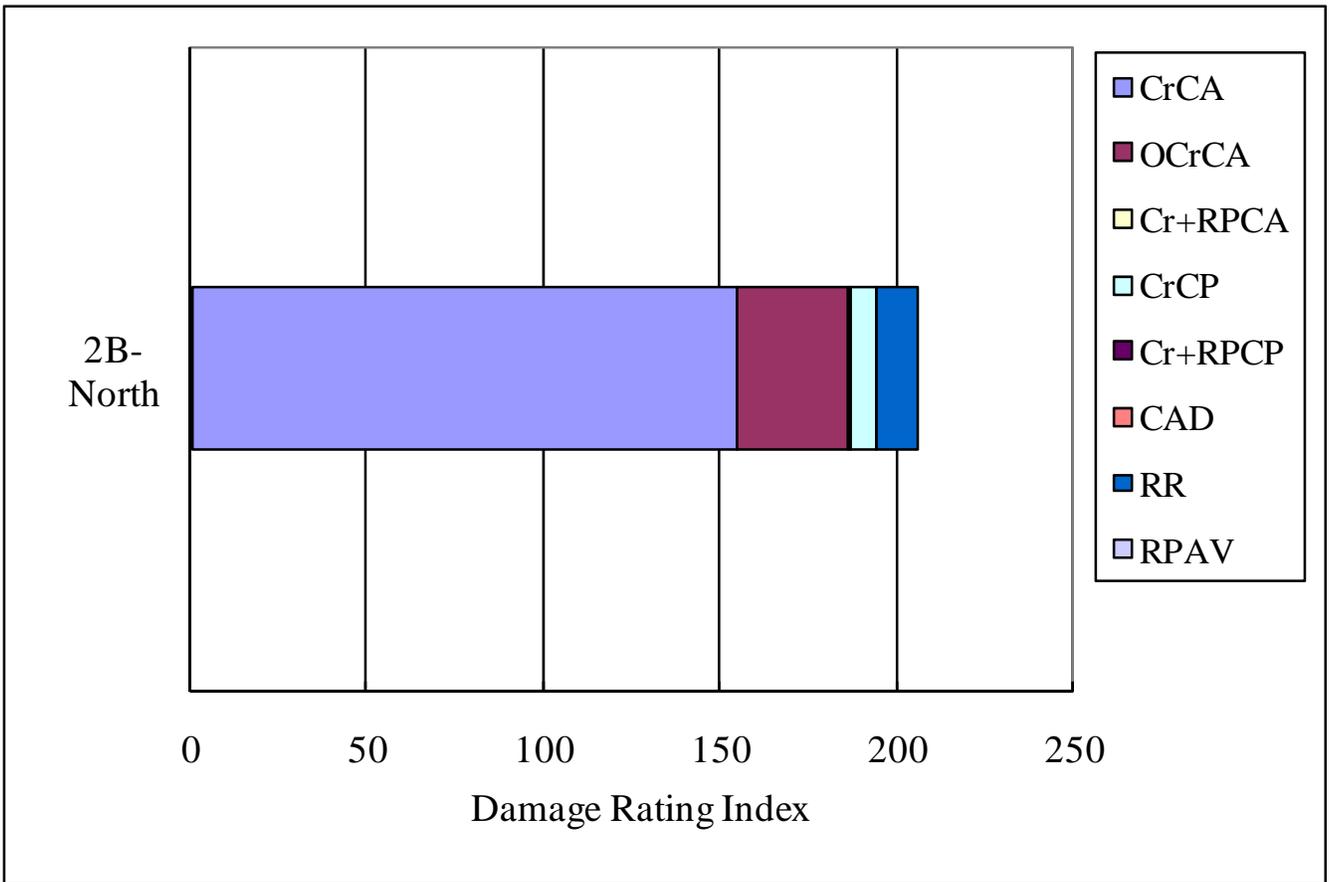
Figure B10: Polished 2B-North core section and DRI results

Similar Core 2B-South, the polished concrete section 2B-North shows neither significant cracking nor deterioration (Figures 1 and B10). The DRI value of **205** is the second lowest for the set of cores obtained from the Bibb Graves Bridge (Figures 2 and B10). It is indicative of a very-low to low degree of damage in the concrete. As indicated in Figure 2, the highest contributor to the DRI for this core is *Cracks in the aggregate particles (without reaction products)* (76% - 155/205; Figure B11), followed by *Open cracks within the aggregate particles* (15% - 31/205). The coarse aggregate is similar to that

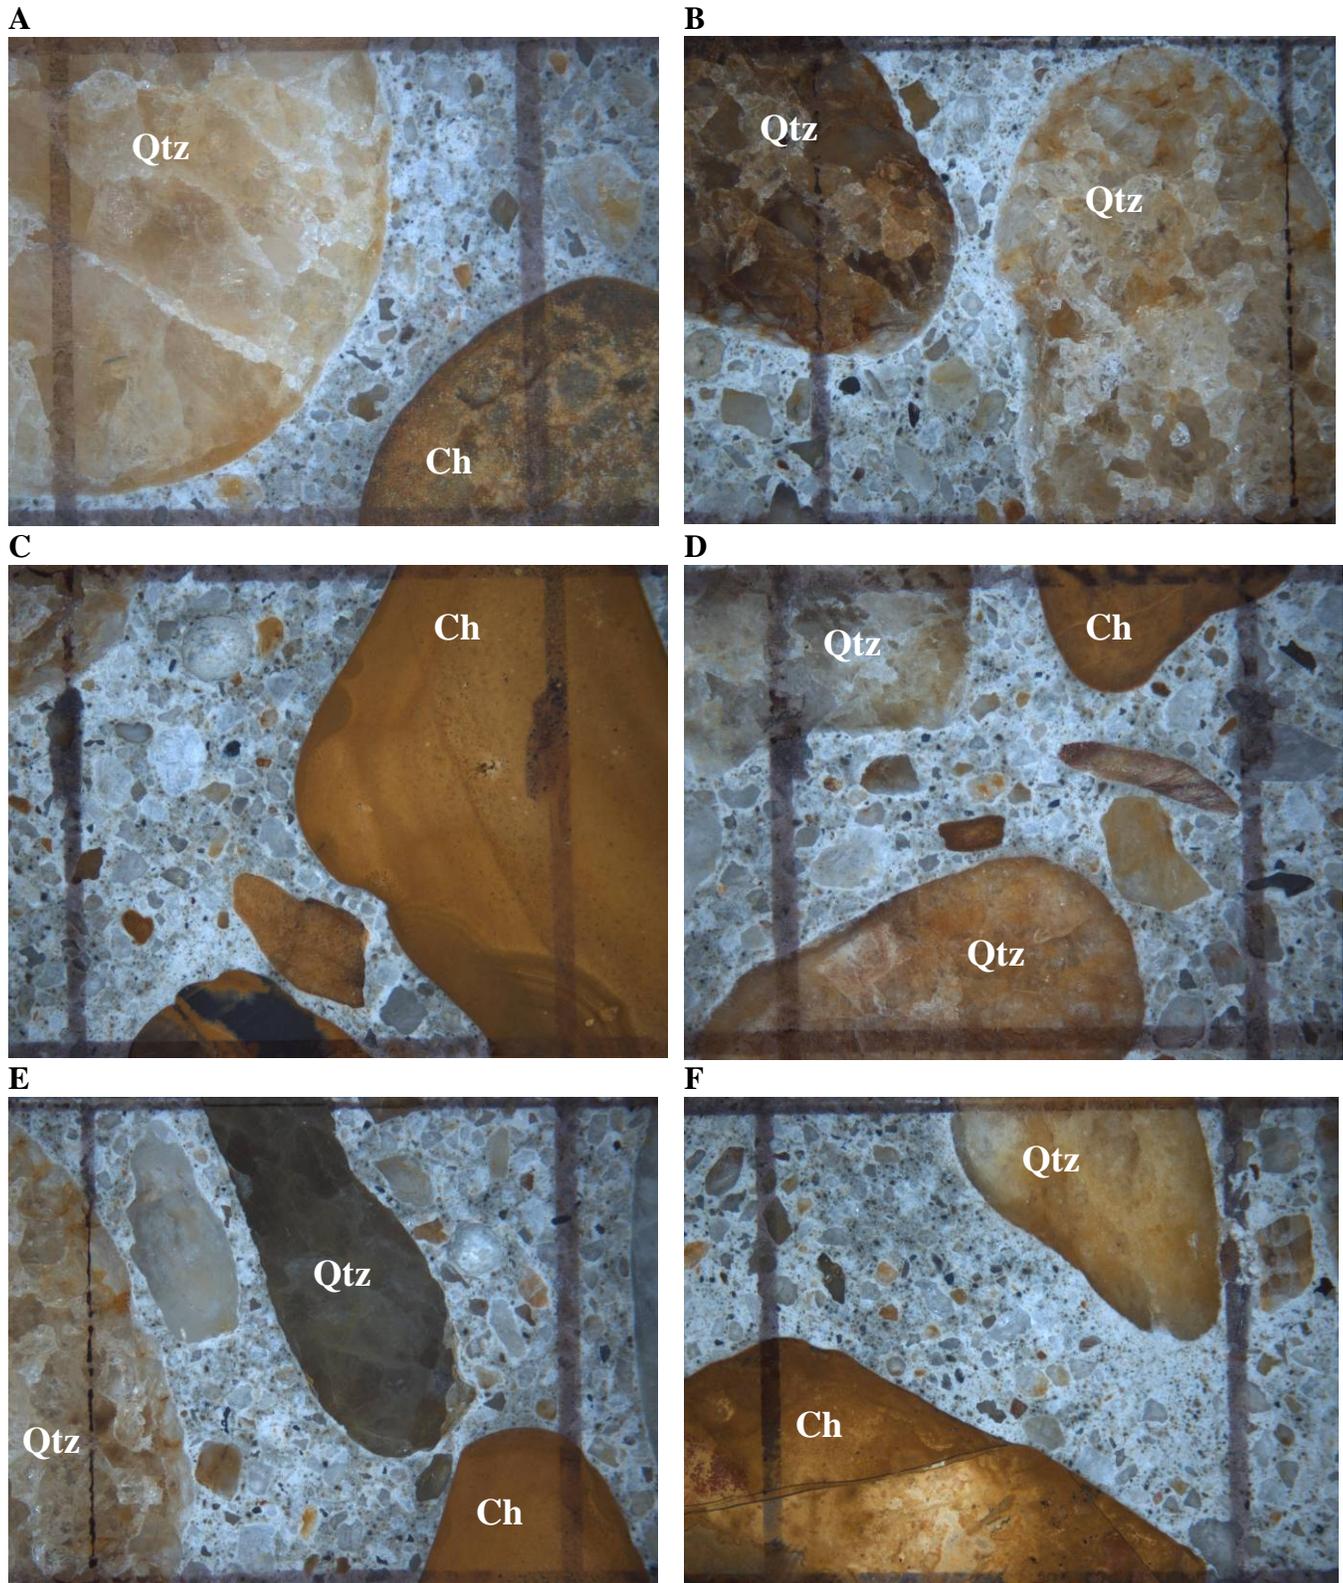
of the set of 2A cores and mainly consist of quartzite (Qtz) (also possibly quartzitic sandstone) and chert (Ch) particles (Figure B11). Several quartzite aggregate particles show extensive internal cracking and/or grain joints (e.g. Figures B11-B and E). Dark reaction rims were observed around a few of the above coarse aggregate particles (~5% of the DRI value). The fine aggregate mainly consist of angular to sub-angular quartz grains, with possible fragments of quartzite; the sand is coarser than in the cores of the 2A series. No significant cracking, at least at the magnification used for the DRI (16X) was observed in the cement paste. Concrete is not air entrained but the few voids observed are generally empty (no secondary products).

Figure B11: Micrographs of the polished core section 2B-North (distance between vertical lines = 1 cm).The micrographs show coarse aggregate particles that mainly consist of chert (Ch)(sometimes partially leached/weathered) and quartzite particles (Qtz). Very limited cracking is noticed in the cement paste.
