Evaluation of Six Bridge Structures along Interstate 395 in Bangor, Maine

Field Site and Petrographic Evaluation

U.S. Department of Transportation
Federal Highway Administration

1. Report No. FHWA-HIF-13-066		2. Government Accession No.		3. Recipient's Catalog No.	
4. Title and Subtitle Evaluation of Six Bridge Structures along Interstate 395 in Bangor, Maine: Field Site and Petrographic Evaluation				5. Report Date September 2009

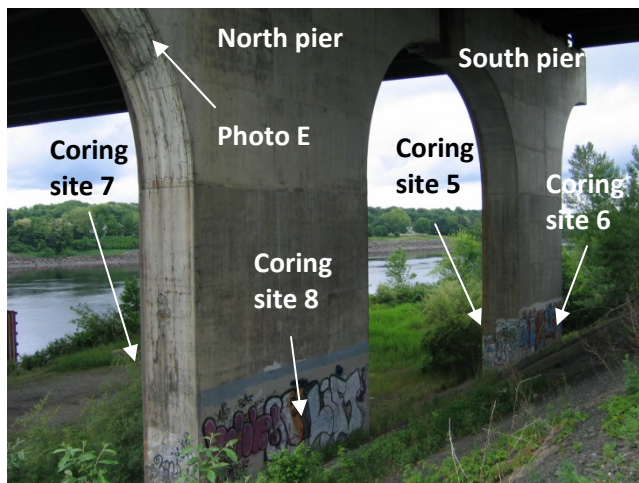
Figure B3: I395 over Penobscot River

Cores extracted from that structure can be separated in two sets. Cores PR1 and PR2 were extracted from the abutment located on the east shore of the river (Figure B2). Cores 3 to 8 were extracted from large reinforced concrete columns on the west shore of the river (Figure B3).

A: General view of the bridge from the west shore of the river. B: Coring site no. 3 and 4 (first row of piers). C: Coring site no.4. D: Coring sites no. 5 to 8 (2nd row of piers). E: Closer view of cracking in the arch of the north pier, 2nd row of piers (coring sites 7 and 8).

Most of the piers appear to be in reasonable condition with little visible cracking. The exception is the two land-based piers supporting the 2nd and 3rd spans counting from the west abutment. It is proposed that one of these piers is treated with silane and that the other is left untreated as a control.

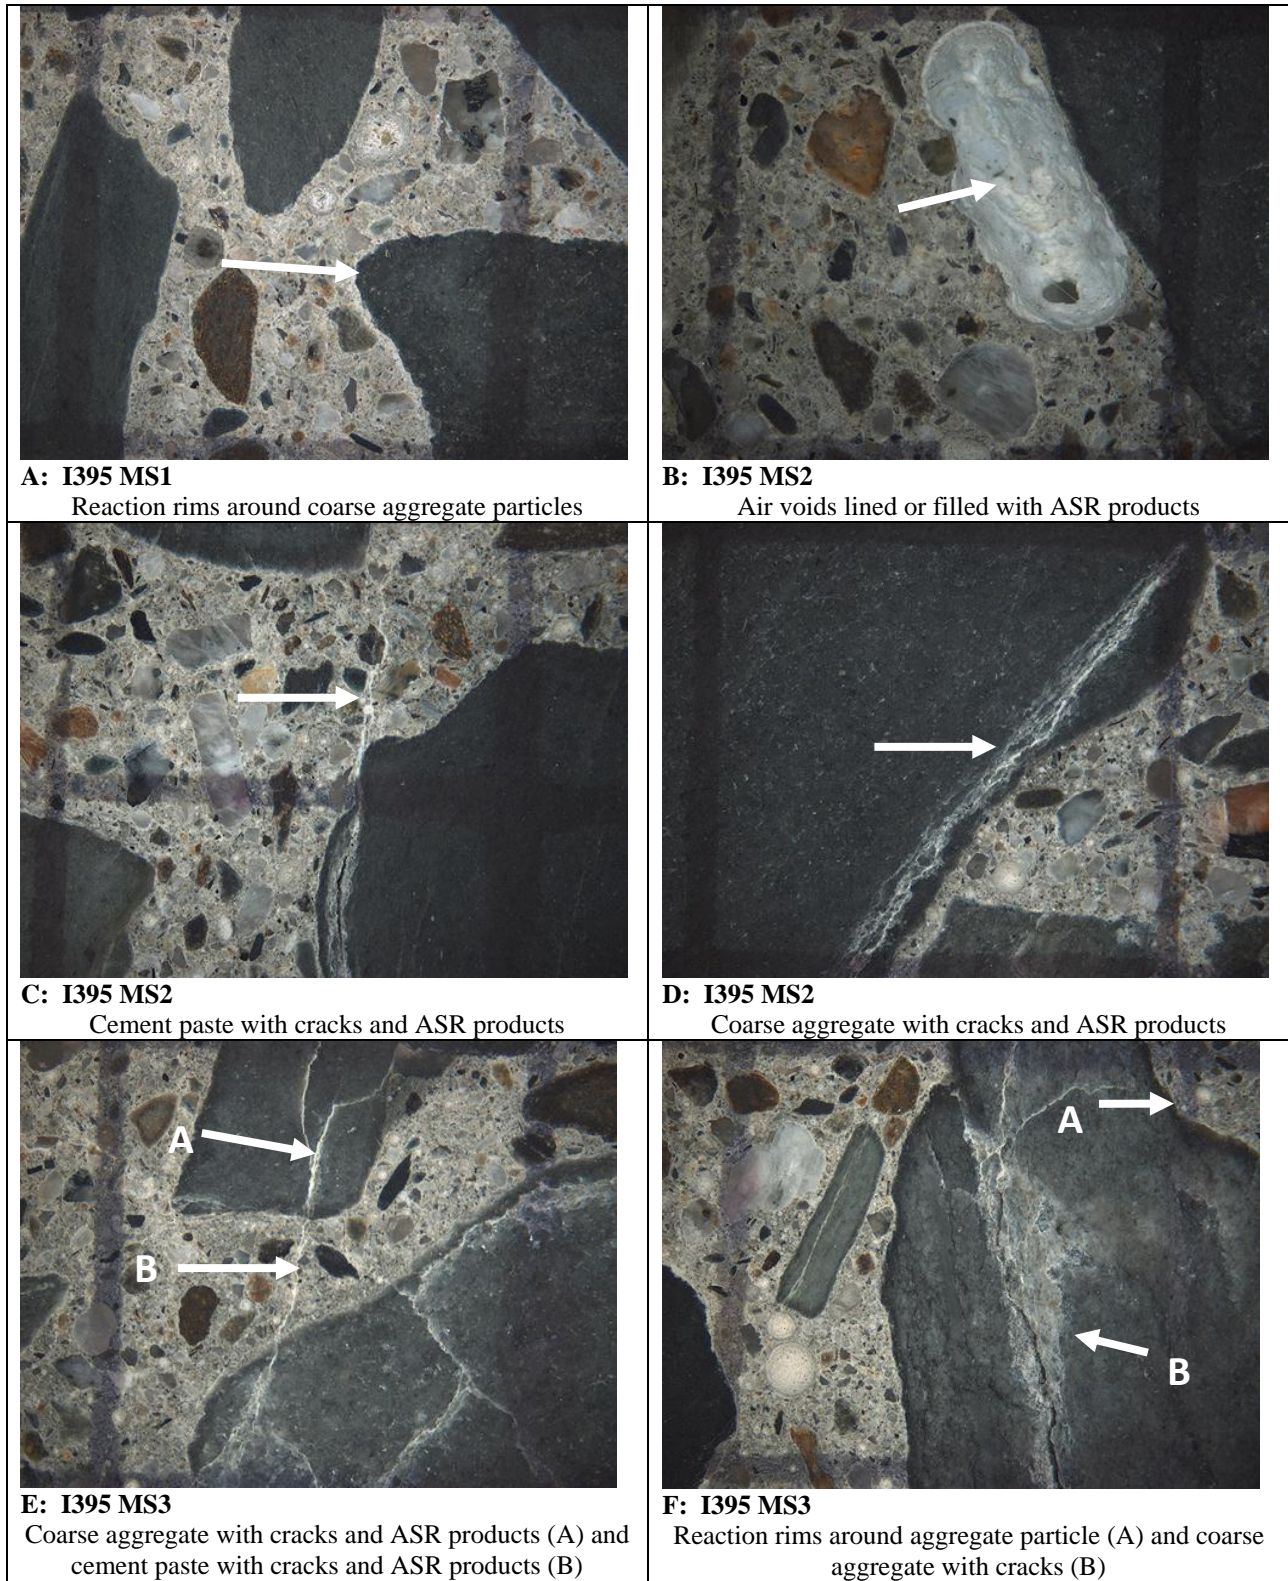
Figure C4: Micrographs illustrating petrographic features of deterioration in cores from the structure I395 over Main Street.

The DRI values for this set of cores range from 133 (I395 MS-1) to 528 (I395 MS-3). Signs of ASR are observed in all cores; however, the extent of ASR ranges from low, for core MS-1 that was extracted in the abutment under the bridge deck (sheltered) (Figure B1-B), to moderate for core MS-3 that came from the exposed and cracked wing wall (Figure B1-E). The core MS-3 shows fairly extensive cracking in the coarse aggregate particles and in the cement paste (with and without ASR products) (Figures C3, C4-E and C4-F). Reaction rims were observed around a large number of coarse aggregate particles (Figure C4-F).

Core MS-2, which was extracted from the exposed part of the abutment, shows significant cracking with ASR products in the coarse aggregates and the cement paste (Figures C2, C4-C and C4-D); however, the extent of ASR in that core is considered low despite a fairly severe pattern of surface cracking on the exposed abutment (Figure B1-D).

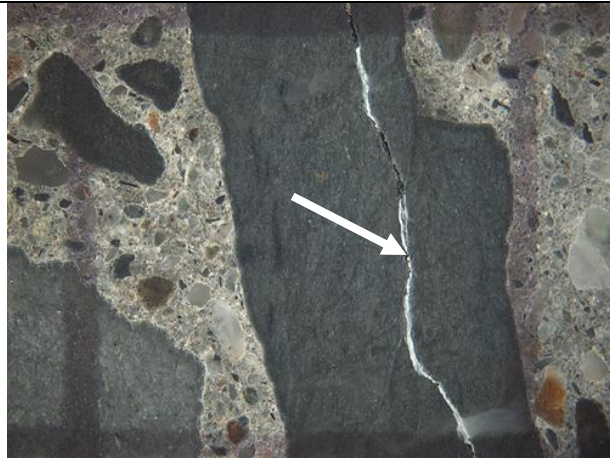
A: I395 PR1a
Coarse aggregate particle with crack and ASR products

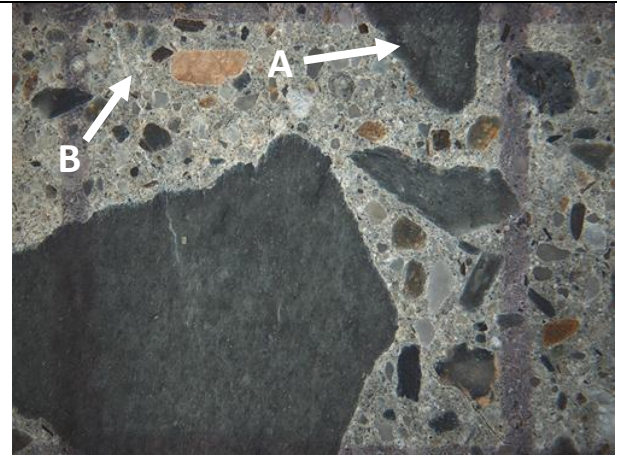
B: I395 PR1a
Reaction rims around aggregate particle (A) and cement paste with cracks (B)

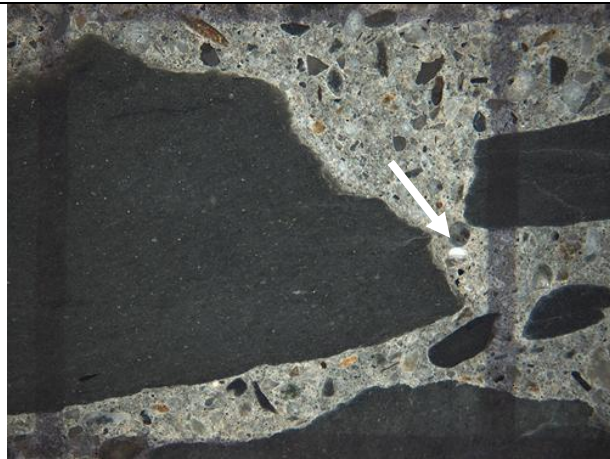
C: I395 PR1b
Air void partially filled with ASR products

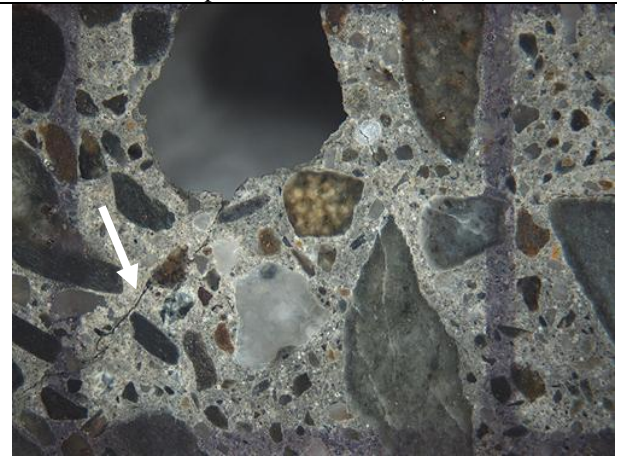
D: I395 PR2
Cement paste with cracks

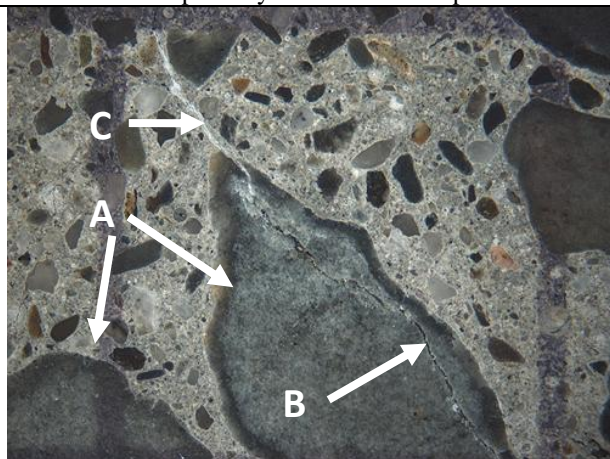
E: I395 PR2
Coarse aggregate with reaction rims (A), cracks and ASR products (B) and cement paste with cracks and ASR products (C)

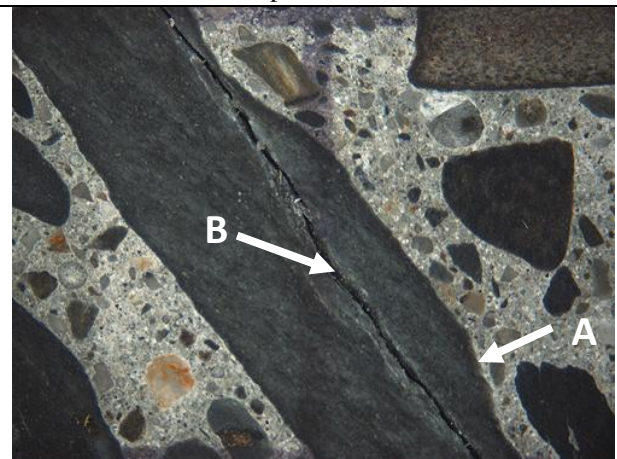
F: I395 PR2
Coarse aggregate particle with reaction rim (A) and open crack (B)

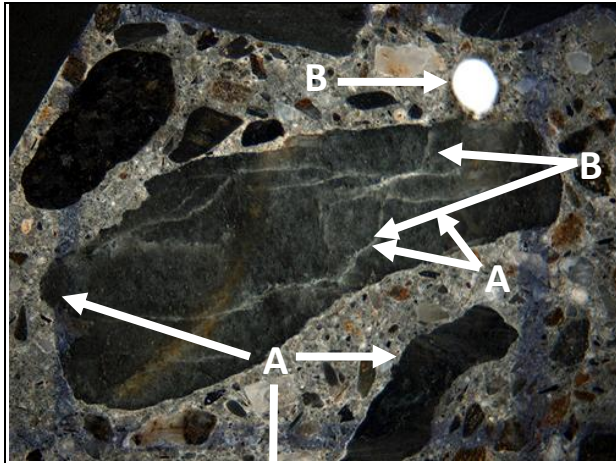
A: I395 5th-1: Coarse aggregate particle with cracks (A) and air void with ASR products (B)

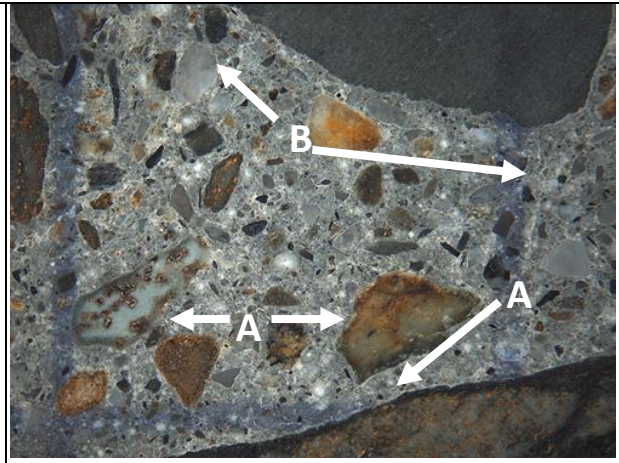
B: I395 5th-1
Reaction rims (A) and cement paste with cracks (B)

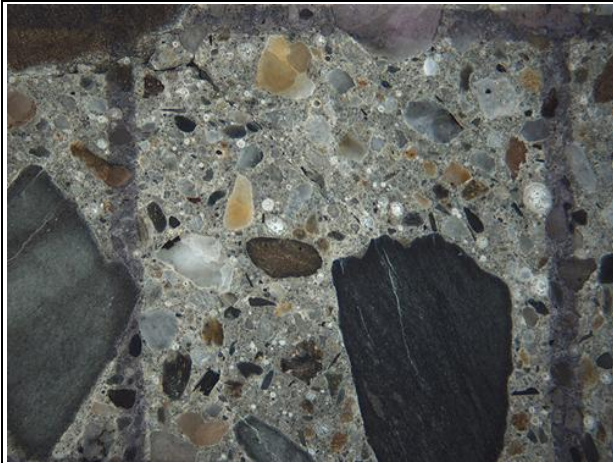
C: I395 5th-2
Coarse aggregate particles with cracks (A) and cement paste with cracks (B)

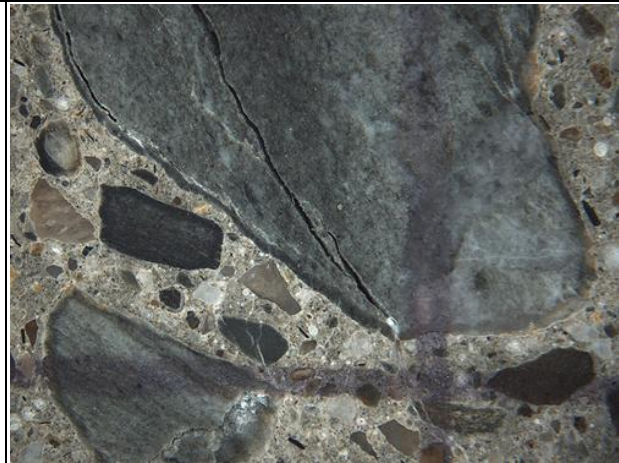
D: I395 5th-2
Coarse aggregate with cracks and ASR products (A) and cement paste with cracks and ASR products (B)

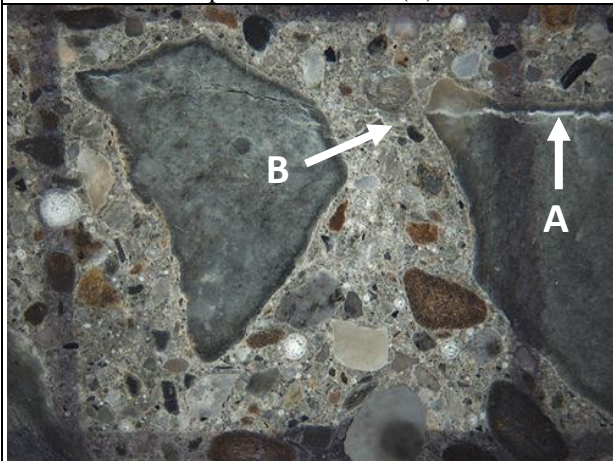
E: I395 5th-2
Coarse aggregate with cracks and ASR products (A) and cement paste with cracks and ASR products (B)

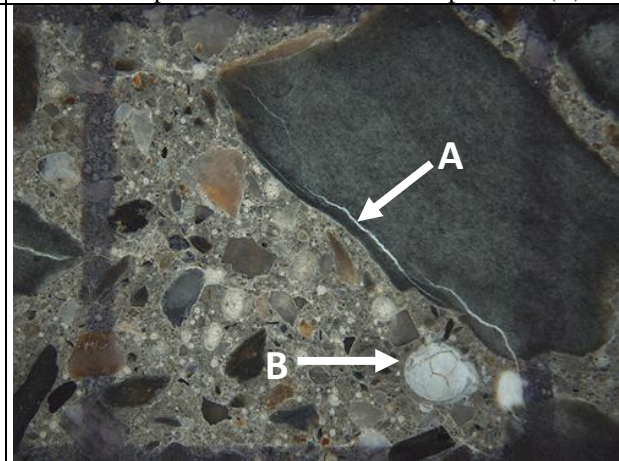
F: I395 5th-3
Coarse aggregate with cracks and ASR products (A) and an air void filled with ASR products (B)

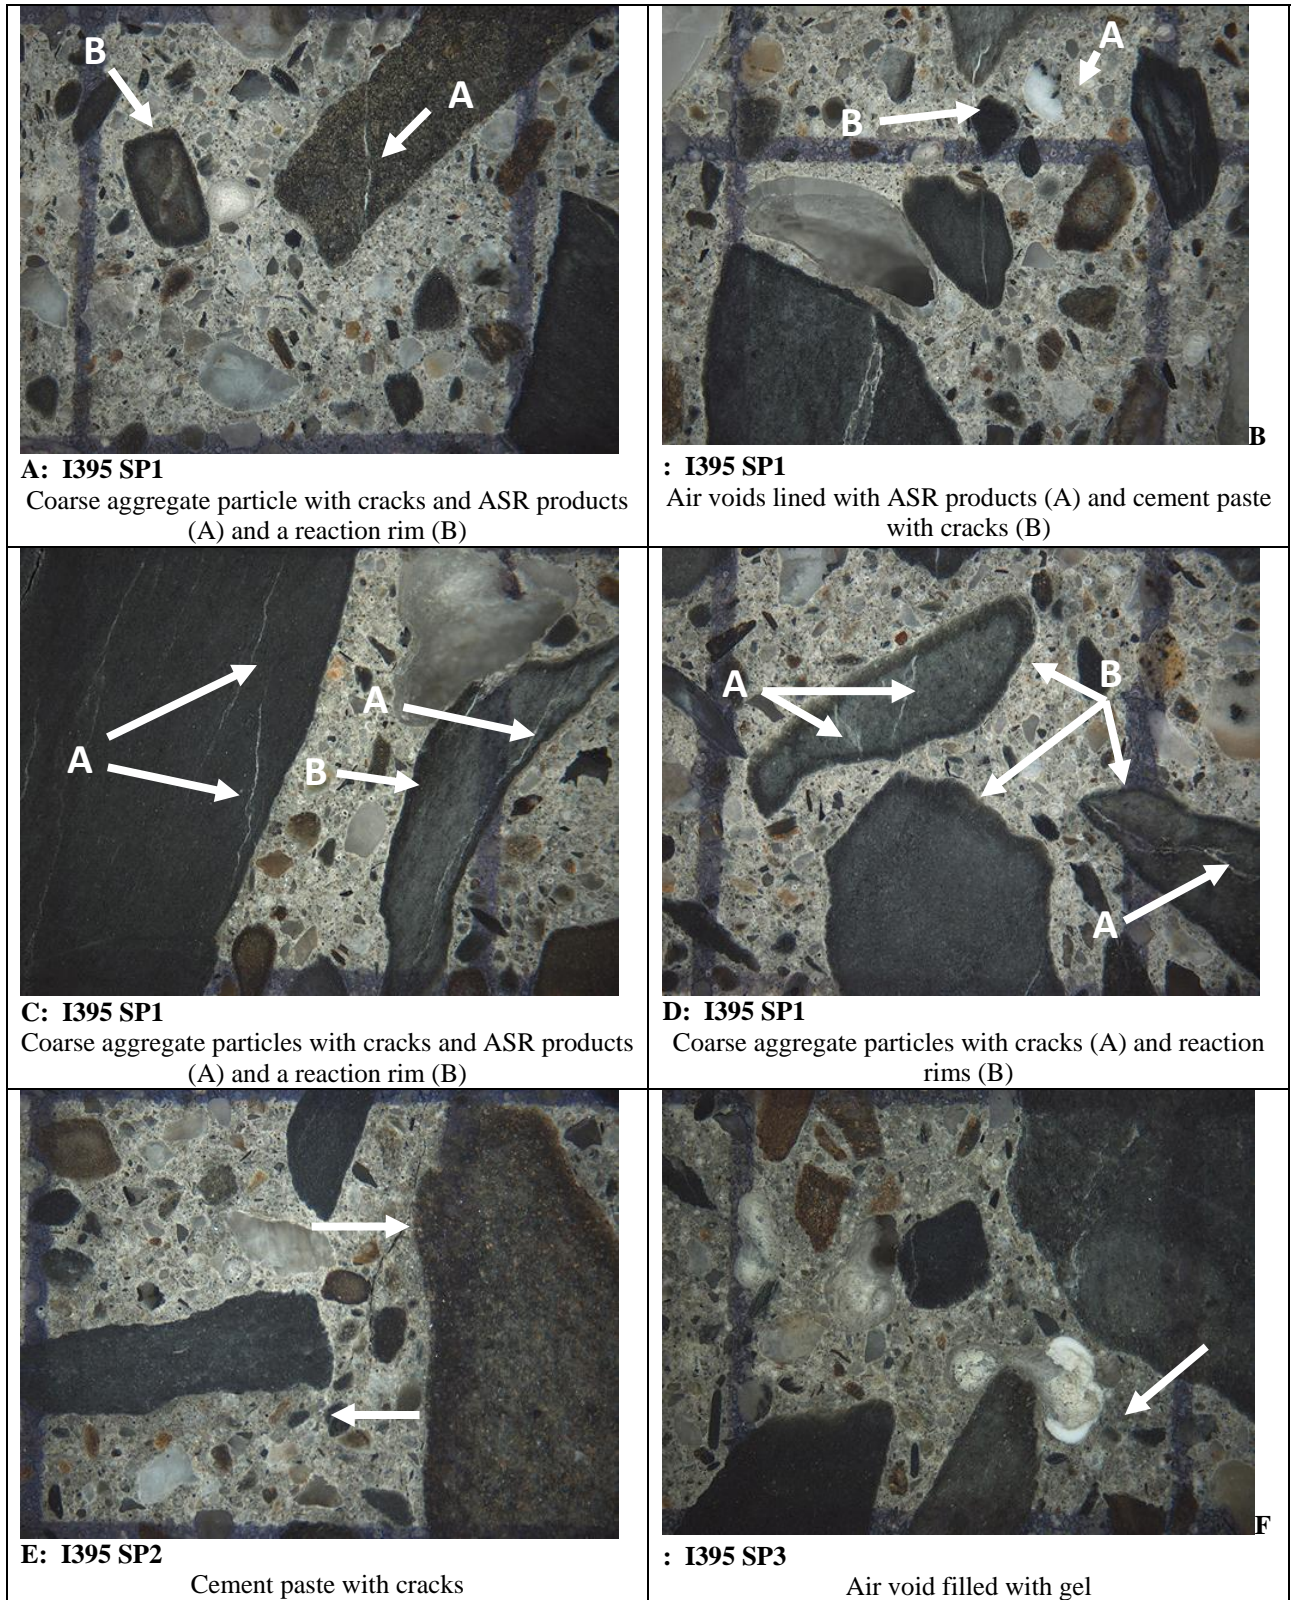
Figure C23: Micrographs illustrating petrographic features of deterioration in cores from the structure South Parkway over I395.

The DRI values for this set of cores range from 152 (I395 SP-3) to 531 (I395 SP-1). Signs of ASR, including extensive cracking in the coarse aggregate particles and in the cement paste (with ASR products), as well as reaction rims around coarse aggregate particles, are most abundant in the core SP-1 (Figures C20, C23-A to C23-D). This core was taken in the external/exposed column on the eastern side. ASR is observed, but at a low degree, in cores SP2 and SP3 (Figure C23-E and C23-F). Typical crack widths in the cement paste range from about 0.02 to 0.05mm, with some high values up to 0.10mm in the case of the core SP-1 (Table 4).

The six columns at mid-span provide an excellent opportunity to compare three different treatments of columns exhibiting different levels of ASR. Numbering the columns from 1 to 6 starting from the west, we recommend the following treatment:

<u>Column #</u>	<u>ASR Severity (DRI)</u>	<u>Repair</u>
1	Severe (531)	FRP Wrap
2	Moderate (203)	Electrochemical Lithium Impregnation
3	Mild (152)	Silane
4 - 6	Not tested	Controls

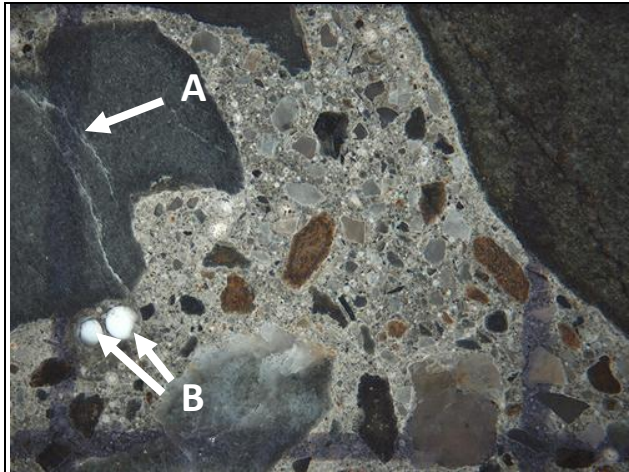
A: I395 GPR1
Coarse aggregate particle with cracks and ASR products (A) and air voids filled with ASR products (B)

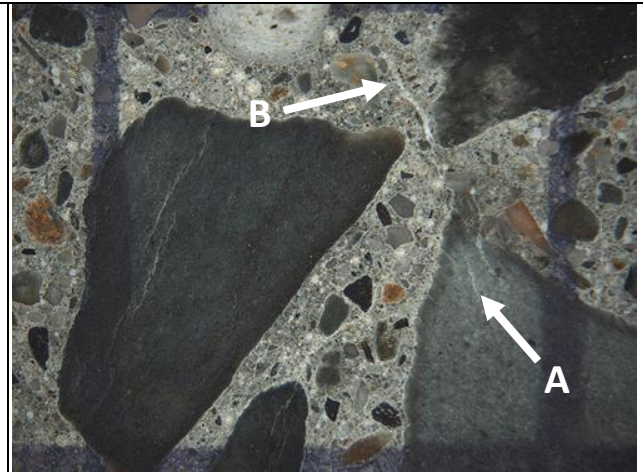
B: I395 GPR1
Coarse aggregate with cracks and ASR products (A) and cement paste with cracks and ASR products (B)

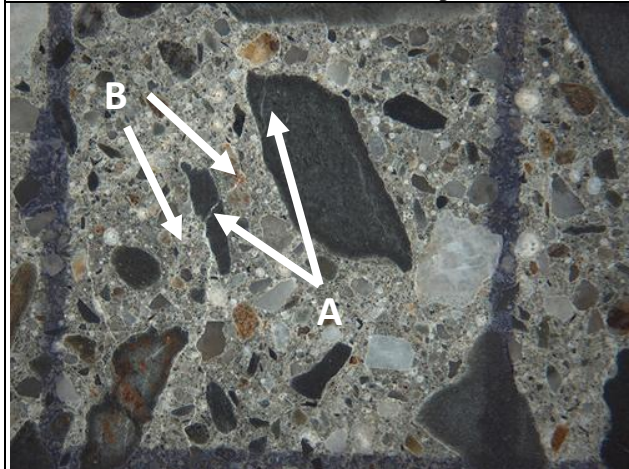
C: I395 GPR1
Coarse aggregate (A) and cement paste (B) with cracks

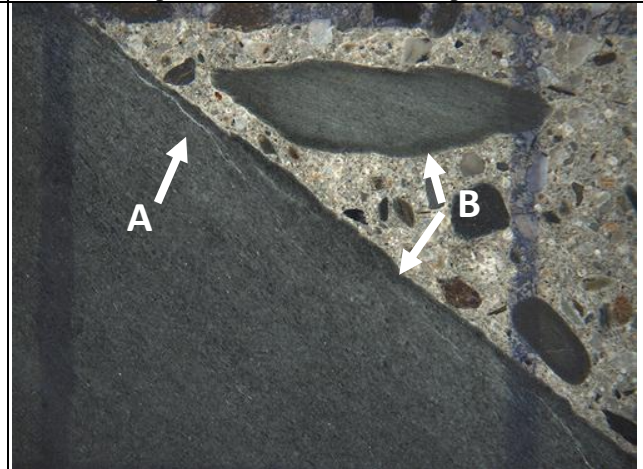
D: I395 GPR2
Coarse aggregates with cracks (A) and reaction rims (B)

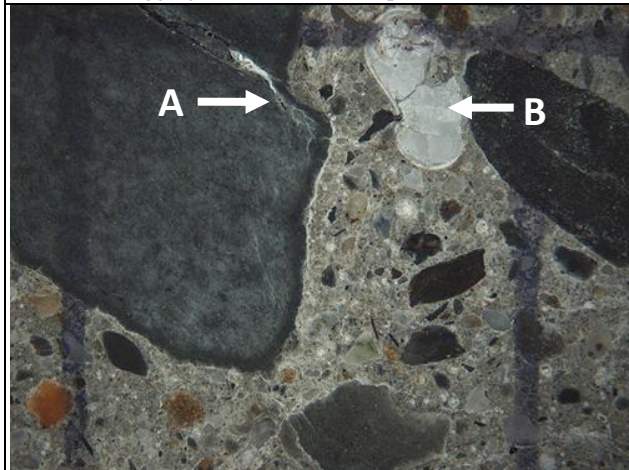
E: I395 GPR2
Coarse aggregate particle with cracks and ASR products (A) and air void filled with ASR products (B)

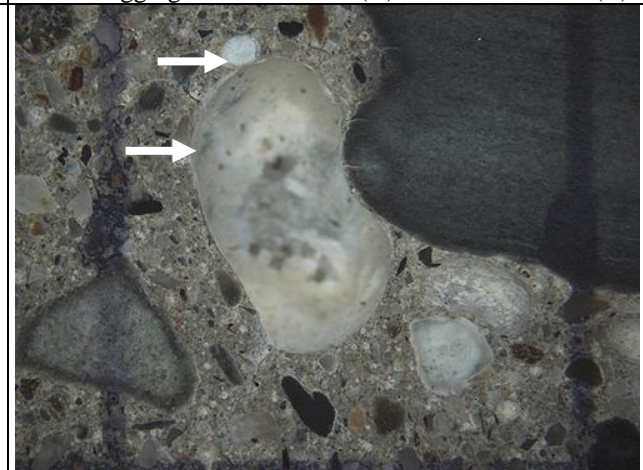
F: I395 GPR2
Air voids filled with ASR products

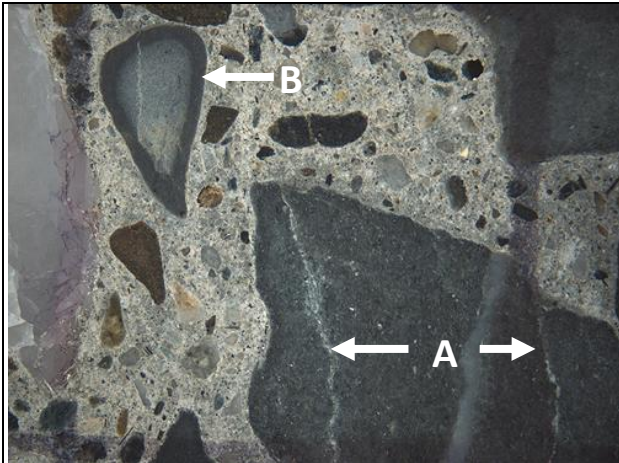
A: I395 R1A1
Coarse aggregate with cracks (A) and a reaction rims (B)

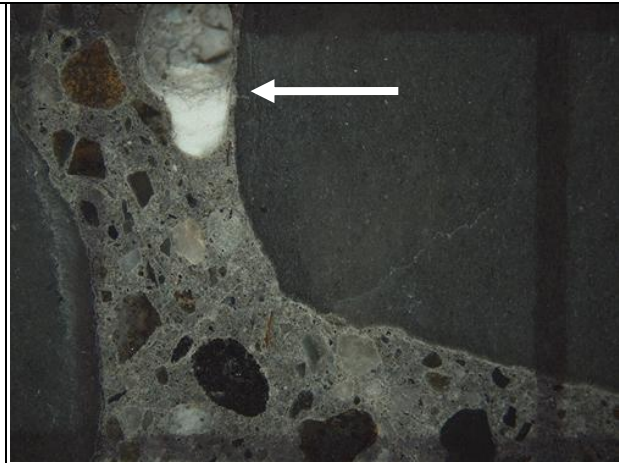
B: I395 R1A1
Air void filled with ASR products

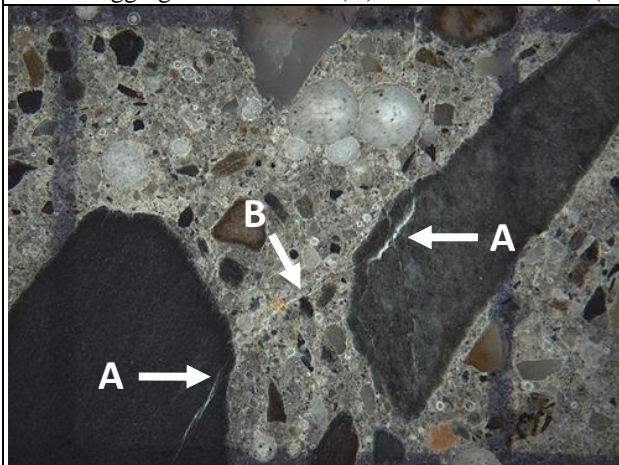
C: I395 R1A2
Coarse aggregate with cracks and ASR products (A) and cement paste with cracks and ASR products (B)

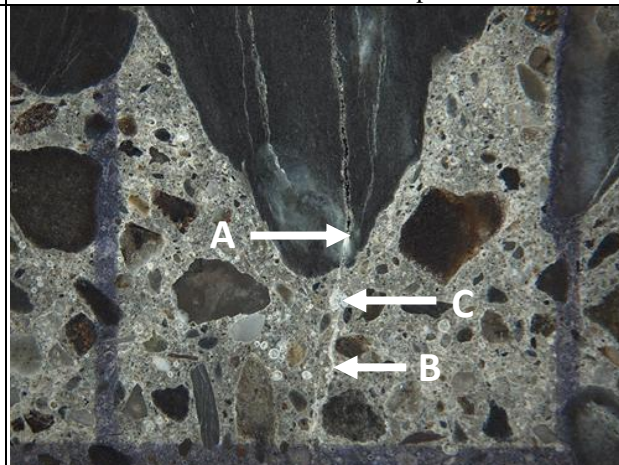
D: I395 R1A2
Coarse aggregate with cracks and ASR products (A), cement paste with cracks and ASR products (B) and an air void filled with ASR products (C)

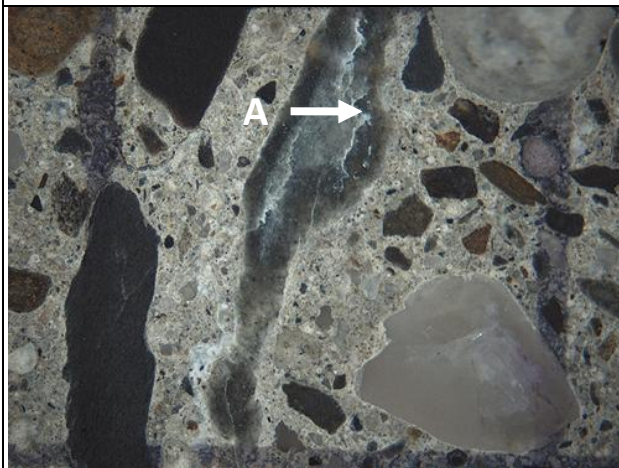
E: I395 R1A3
Coarse aggregate with cracks and ASR products (A)

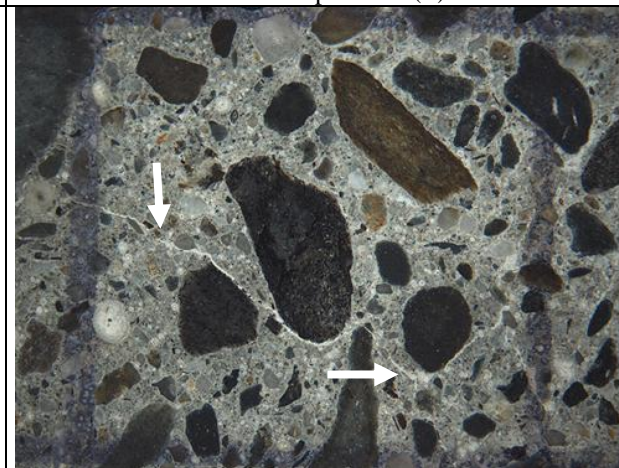
F: I395 R1A3
Cement paste with cracks
