*Tech Brief*

# Precast Concrete Panels for Rapid Full-Depth Repair of CRC Pavement to Maintain Continuity of Longitudinal Reinforcement

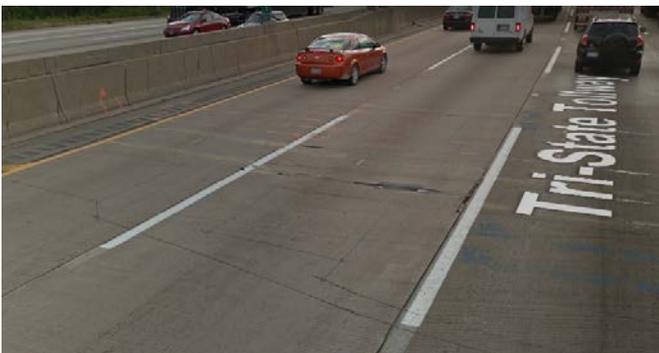
This pavement section remains in excellent condition; however, a retrofitted weigh-in-motion (WIM) system in all four lanes at one location in the westbound direction resulted in the saw cutting of the longitudinal steel reinforcement in the CRC. This ultimately resulted in localized failure of the CRC pavements in all four lanes, as well as within an adjacent CRC ramp lane. The Tollway needed a repair strategy that would have minimal impact to traffic while maintaining a safe work zone for the contractor and traveling public. Figure 1 shows the distressed pavement before implementation of the full-depth CRC repairs using PCP described in this Tech Brief.

**Figure 1. Photo. Distressed section of I-80/I-294 CRC pavement.**

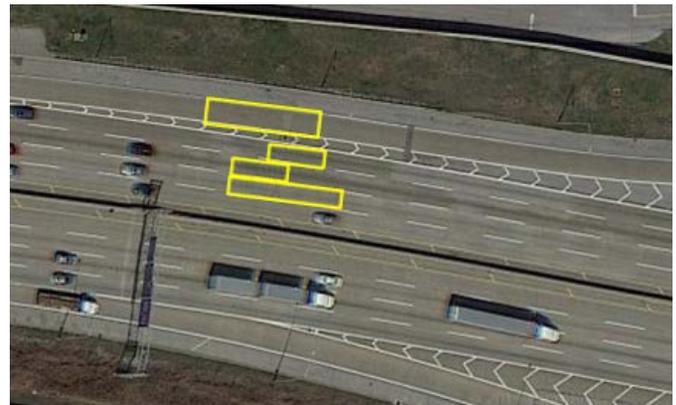
The existing CRC pavements for westbound I-80/I-294 and for most of the rest of the Tollway system are designed with 12-inch (300-mm) slab thickness, with 0.8 percent steel content using No. 7 size longitudinal bars at a 3.5-inch (90-mm) depth below the surface, and with No. 4 transverse support bars every 4 ft (1.2 m). Figure 2 shows the multiple lane repair areas for this project.

**Figure 2. Photo. Repair areas along a section of I-80/I-294 CRC pavement.**

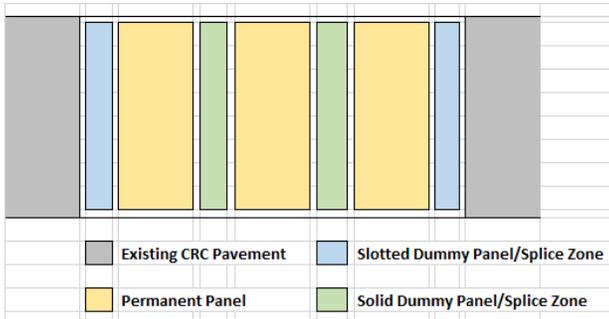
**Figure 4. Illustration. Plan view of a repair area with multiple PCP panels.**

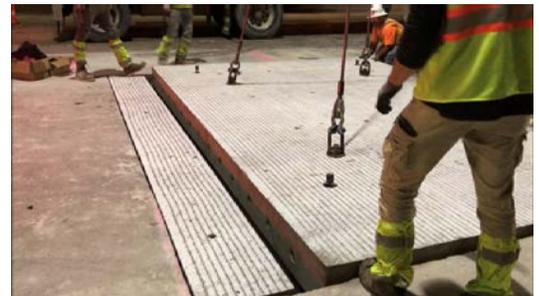
**Figure 5. Photo. Permanent precast panel placement showing corner leveling bolts.**

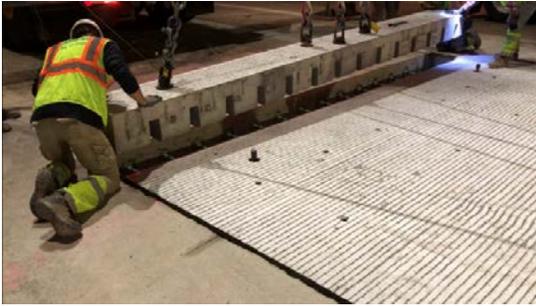
**Figure 6. Photo. Resetting of the slotted temporary panel.**

- c. After all panels were placed and leveled, each temporary precast panel was lifted to allow for leveling sand to be placed over the base so that, when the temporary panel was reset, the surface of the panel was within 0.25 inch (6 mm) of the surrounding concrete pavement or adjacent permanent panel. All temporary panels were designed 0.5 inch (12 mm) thicker than permanent precast panels, and the thickness of the leveling sand was not allowed to exceed 0.25 inch (6 mm). Figure 6 shows the first slotted temporary panel being reset between the existing pavement and the first permanent panel in the ramp lane.

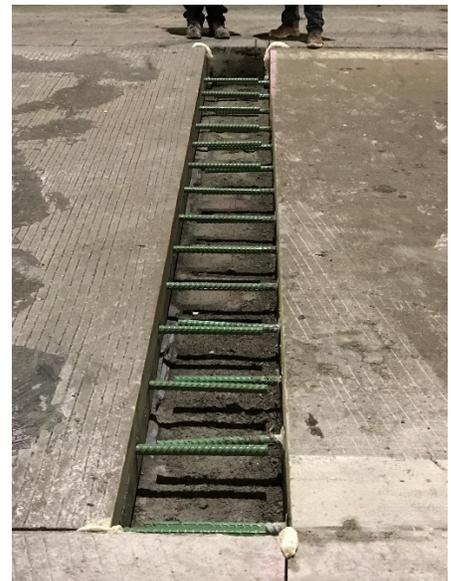
**Figure 7. Photo. A splice zone with the threaded No. 10 bars in the precast panel splicers.**

- b. Leveling sand that was placed under temporary precast panels was removed, and the base was restored if damaged.
- c. All protective duct tape over couplers embedded within the permanent precast panels was removed, and the No. 10 threaded reinforcement bars were inserted into each of the couplers. Because of the length of threading on the bars and because the length of the splice zones had to be reduced slightly to accommodate the adjusted precast panel lengths, the overall length of the bars had to be shortened slightly to fit within the 18-inch (450-mm) long splice zones. This resulted in reducing the overlap of the splice zone longitudinal bars from 14 inches (355 mm) to about 13 inches (330 mm). Figure 7 shows the splice zone with the threaded No. 10 bars in the splicers of the permanent precast panels.

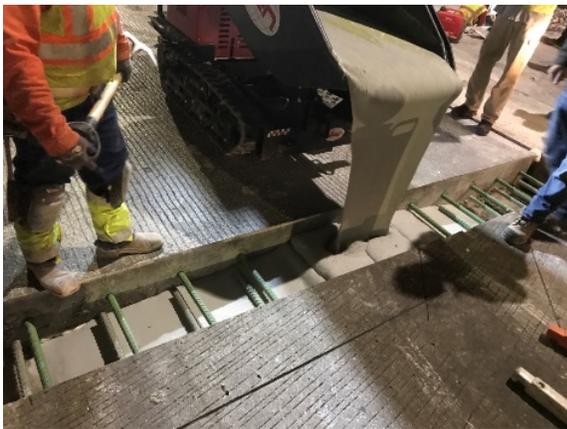
**Figure 8. Photo. UHPC placement into the splice zone.**

- d. Backer rods or polyurethane foam were used as gaskets to fill joint gaps that surrounded each splice zone so that the UHPC material did not seep into the longitudinal joints.
5. The UHPC material was produced and placed within each splice zone in accordance with the manufacturer's specifications and finished flush with the adjacent pavements or panels. Figure 8

shows the placement of the material within a prepared splice zone. Placement of UHPC within the splice zones was completed no less than 4 hours before the work zone was to be reopened to traffic. Two of the five splice zones for the ramp lane repairs were backfilled with an experimental proprietary steel fiber-reinforced high-early-strength concrete material. Compressive strength for the UHPC averaged about 4,000 psi (27 MPa) at 4 hours, and compressive strength for the HESC averaged about 6,300 psi (43 MPa) at 3 hours. Since the UHPC product was very flowable, the backfilled splice zones had to be confined at the surface with plywood cover to provide a flush surface, as the pavements had a 1.5 percent cross slope. The HESC did not require surface confinement when placed within the splice zones and was relatively easier for the contractor to produce on-site and place.

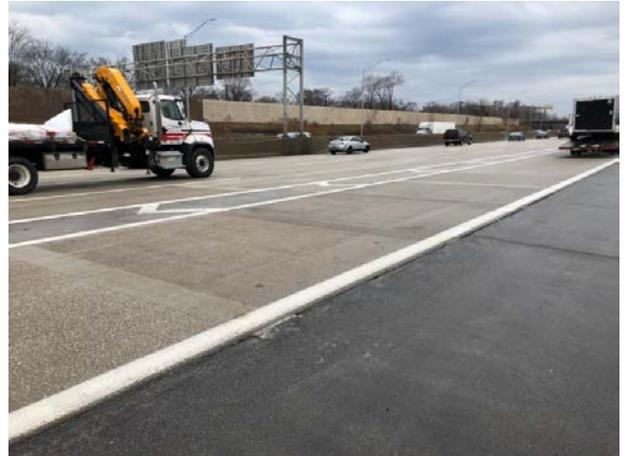
**Figure 9. Photo. Completed repair of the ramp lane.**

The CRC precast repair area on the I-80/I-294 Tollway project was observed immediately after the installation work was completed in October 2017, then in mid-December 2017 and in mid-February 2018. The repairs have been exposed to extremely high truck traffic and cold temperatures over the 4-month observation period. The only distresses seen so far are micro shrinkage cracks that were observed the morning after placement in a few of the splice zone backfills, with both the UHPC product and with the HESC product. The cracks are hardly observable and have not propagated or widened since placement occurred. Also, slight debonding and separation of the backfill material from one of the vertical faces of the adjacent precast panel has been observed at most splice zones.

No settlement of the precast panels had been observed, and the rideability of the repair area surfaces remains excellent. The transverse cracking in the existing CRC pavements that are adjacent to the repair areas appears to be unaffected. No widening of these cracks is evident, and no new cracking has been observed in the adjacent existing CRC pavement.

The last step for the contractor to carry out was to diamond grind 100 percent of the repaired area of the CRC pavement to provide for good rideability. The diamond grinding occurred during nighttime hours after most of the pavement repair or rehabilitation work was completed. Figure 9 shows the repaired ramp lane as of mid-February 2018.
