Ohio Route 50 Joint Sealant Experiment

State Job No.: 14668(0)

FINAL REPORT

April 2002

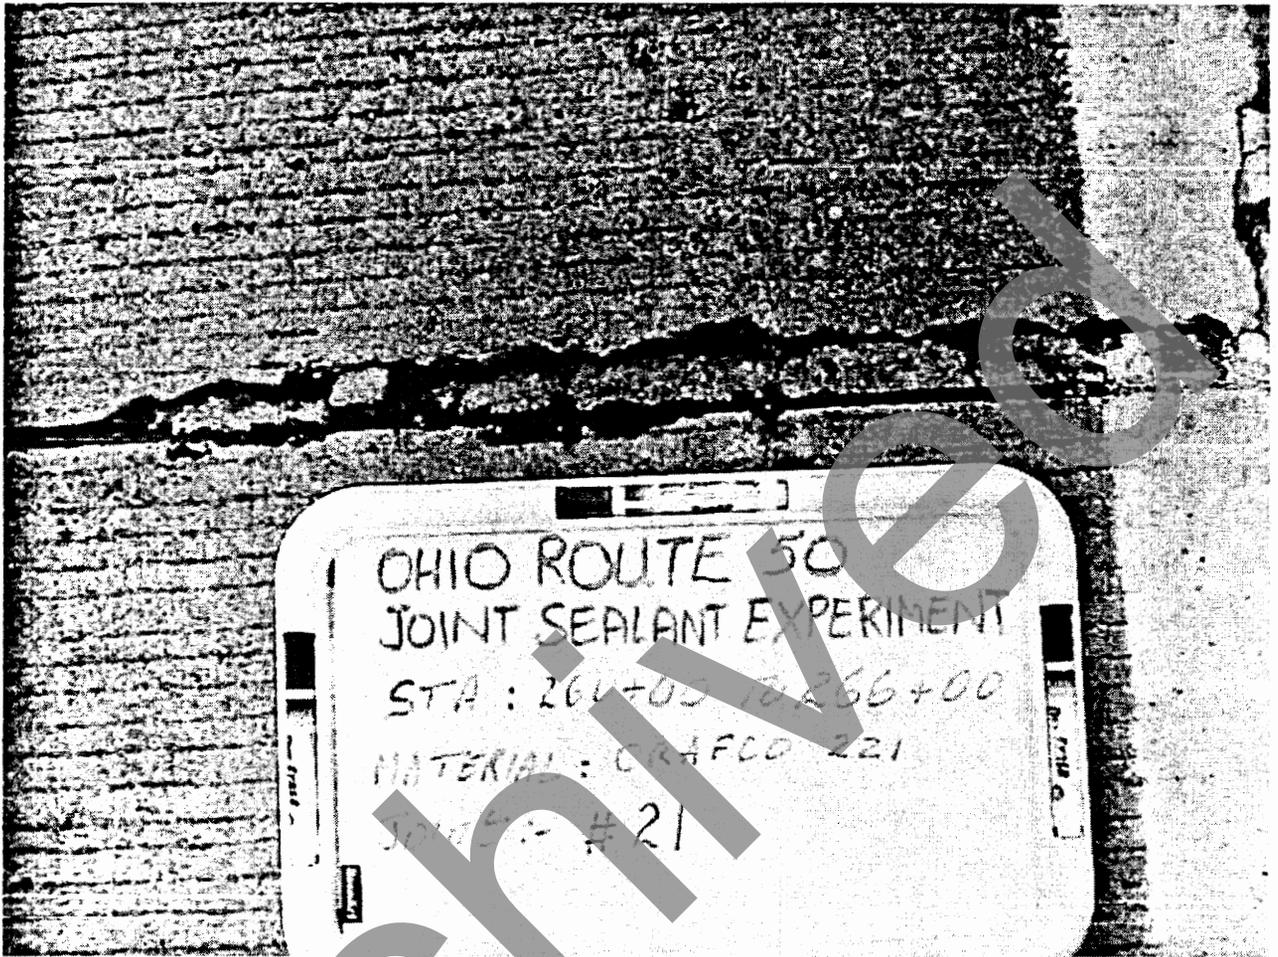
Figure 4.2 Severe cracking and spalling in Joint 21 of the eastbound Crafcoc 221 (1) section

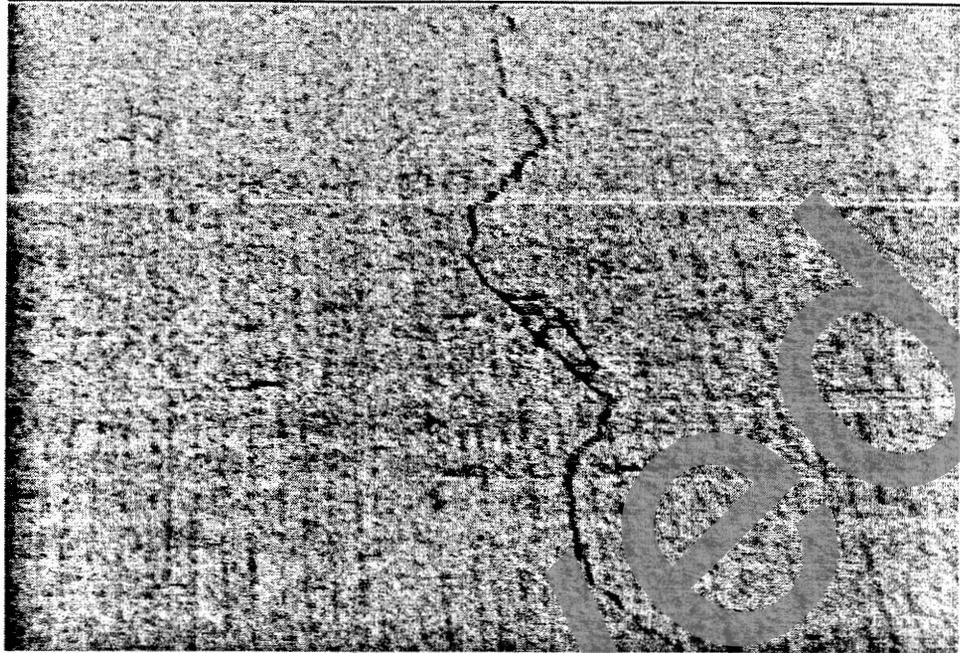
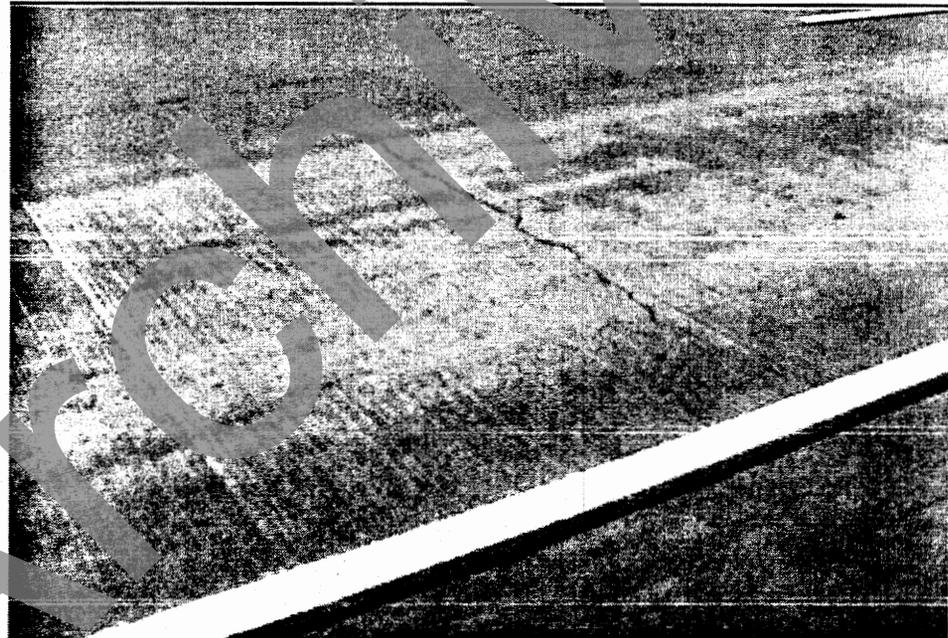
Figure 5.46 Examples of transverse cracks

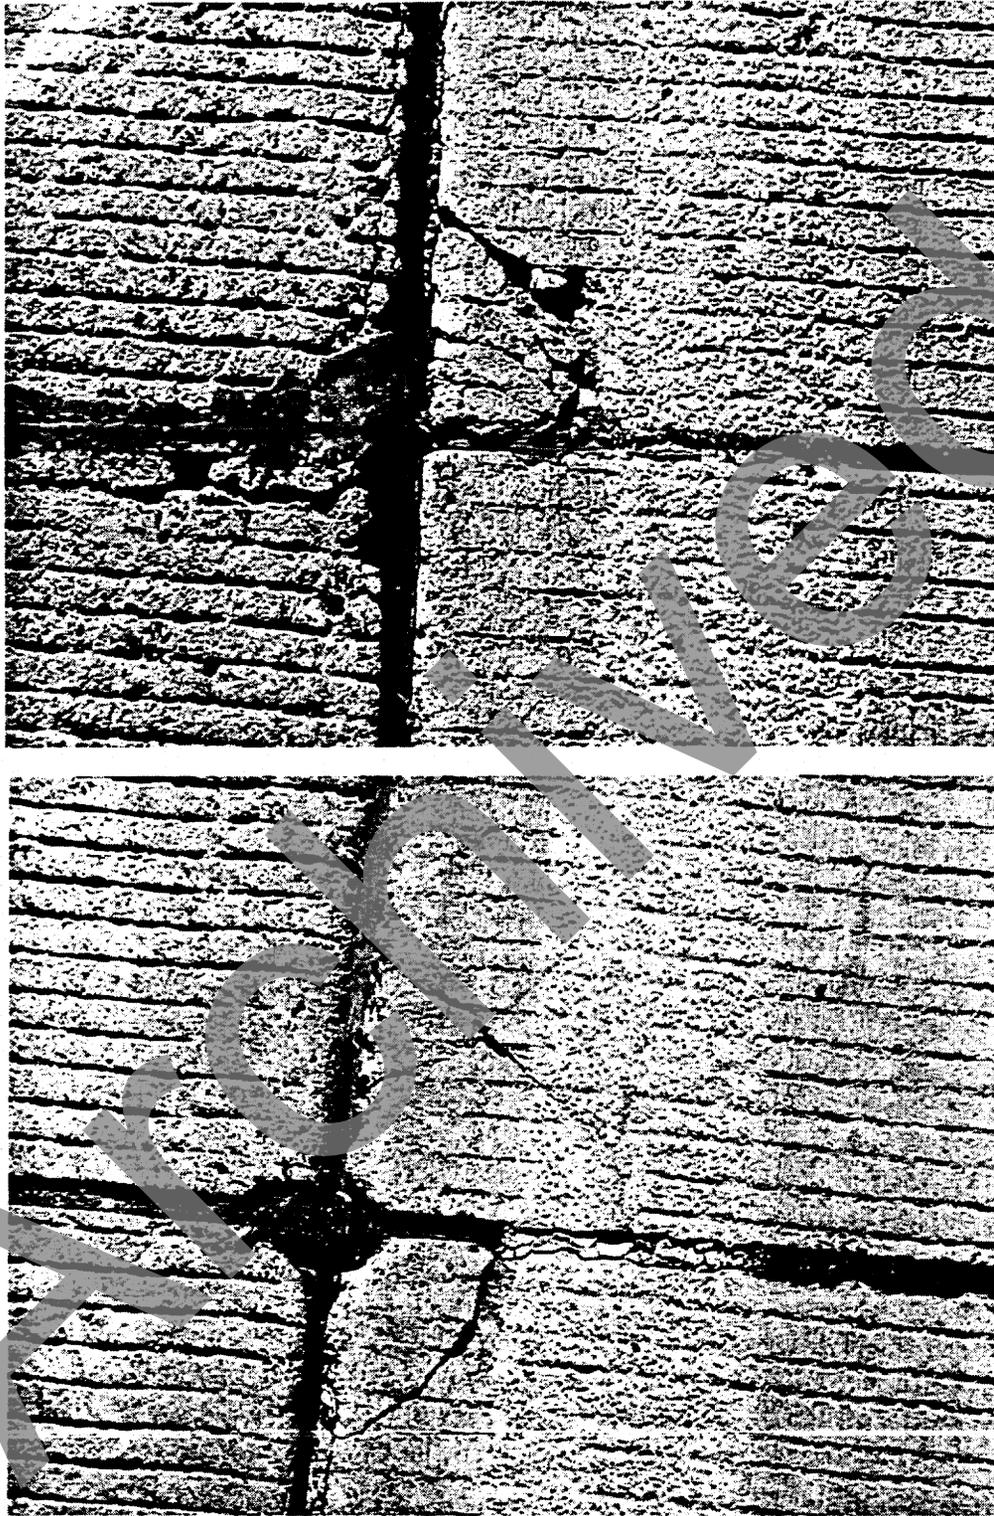
Figure 5.47 Examples of corner breaks

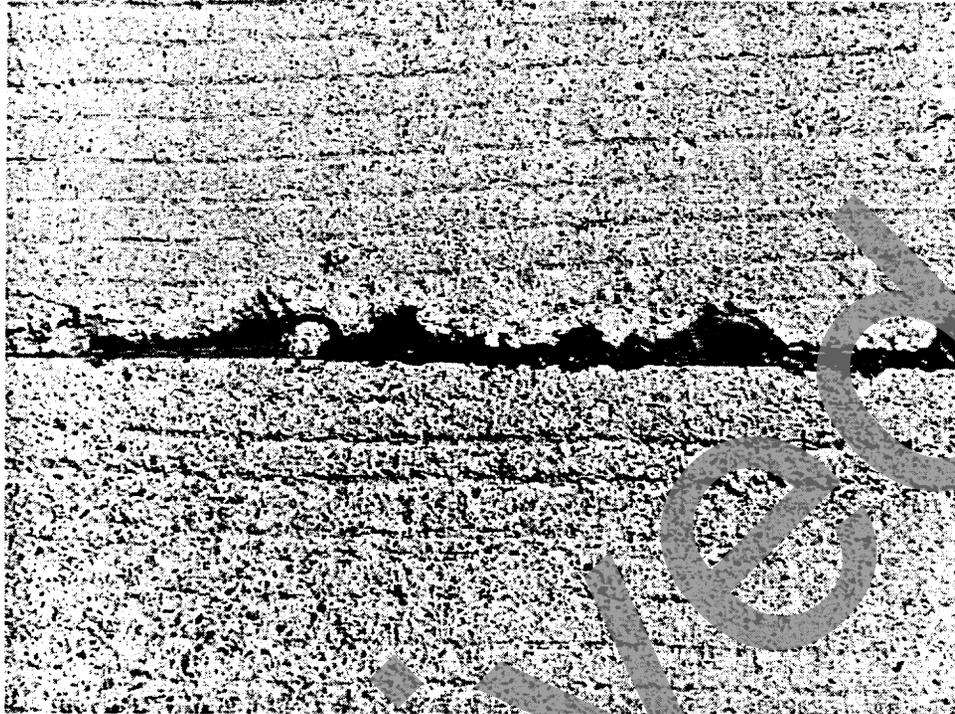
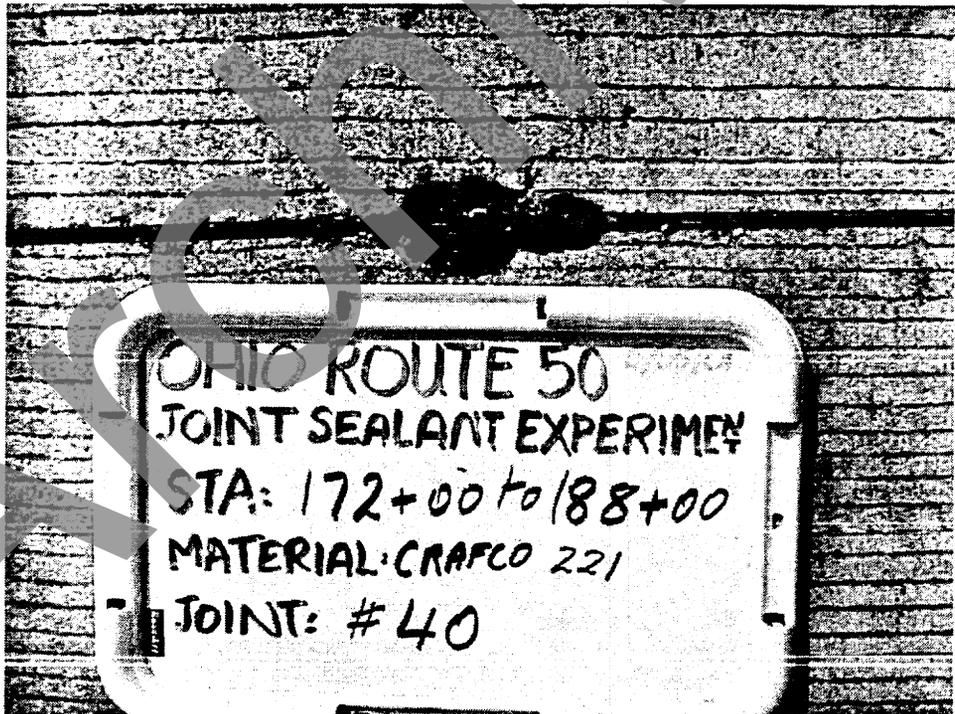
Figure 5.48 Examples of spalling failures

[Top: Joint 7 of WB Dow 890 (4); Bottom: Joint 40 of WB Crafcro 221 (1); both appear to be created at the time of joint sawing]

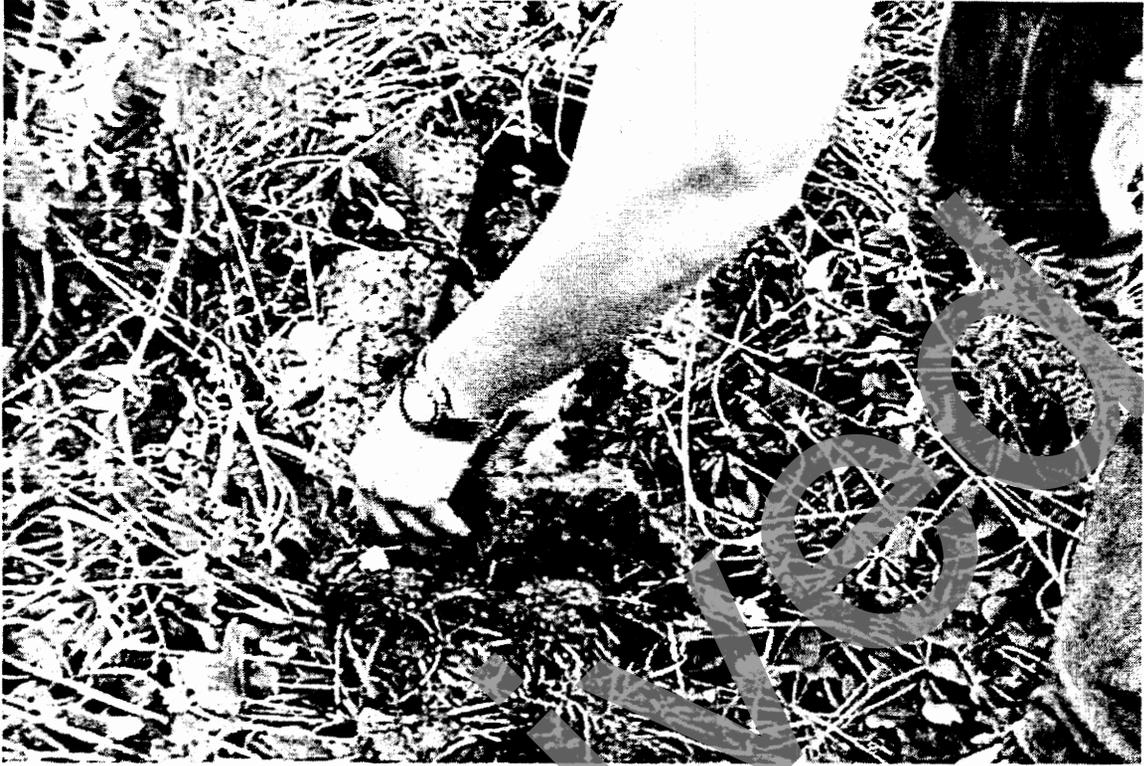
Figure 6.14 An older concrete outlet, which appears to have been recycled
