Durability Analysis of Aluminized Type 2 Corrugated Metal Pipe

PUBLICATION NO. FHWA-RD-97-140

JANUARY 2000

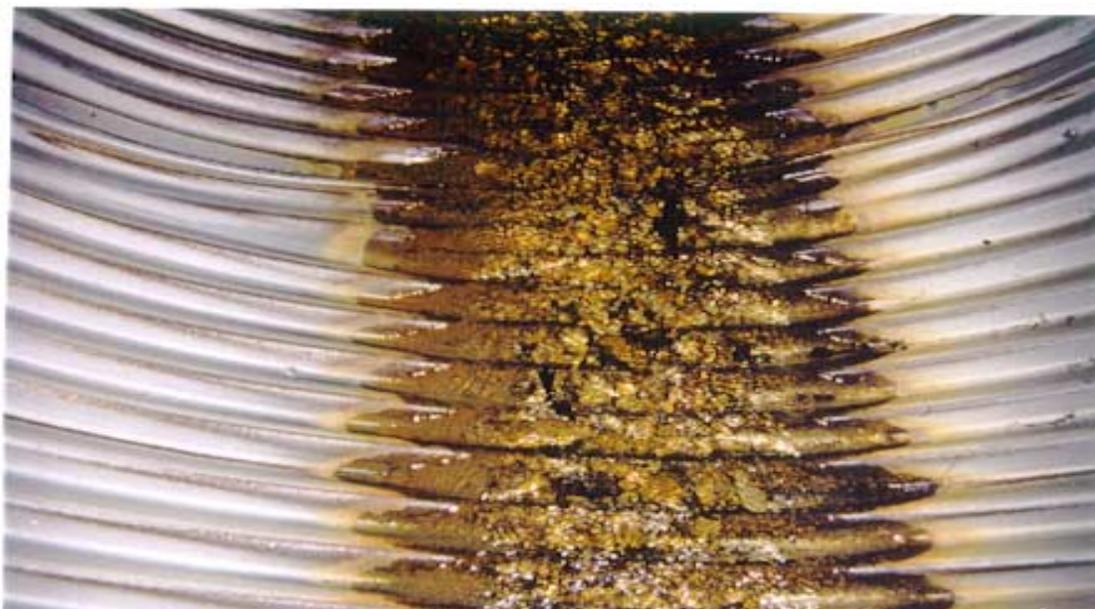
Locations 310.0 and 310.1 were the only two culverts at the Natchez Trace Parkway that were experiencing any kind of flow conditions at the time of the inspection. A possible alternative explanation for the advanced deterioration is a synergistic effect of the potentially corrosive Alabama soils and incidence of abrasion. The wear pattern on these culverts is indicative of the type of deterioration that occurs as a result of abrasive wear. This wear occurs predominantly on the upstream tangents of the corrugations. Figure 4 shows the interior of 310.0. Figure 5 shows a close-up of the invert of this culvert. Notice in both photos that the exposed steel and apparent rusting is more significant on the upstream side of the corrugation. This is consistent with

Figure 4. Culvert at 310.0 (flow is from bottom of photo to the top).

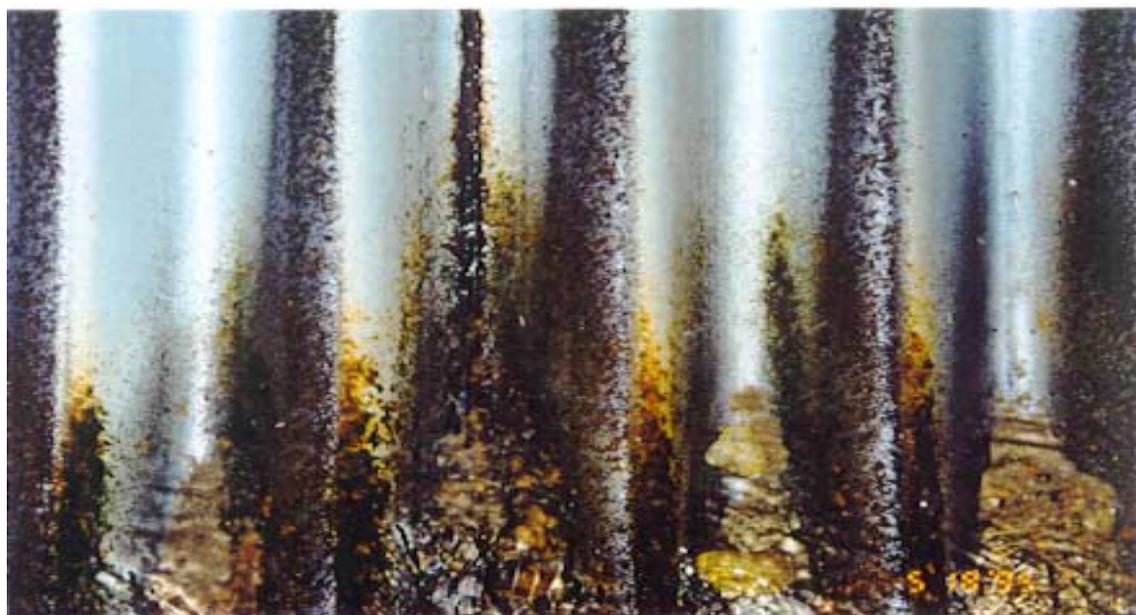
abrasive damage. Chemical attack would be expected to affect both sides equally, as shown in figure 6, which is a photo of an Aluminized Type 2 pipe (not in this study) exposed to an aggressive environment in the absence of abrasion.

Figure 5. Close-up of 310.0 (flow is from left of photo to right).
Note: Wear and corrosion predominate on upstream side of corrugation.

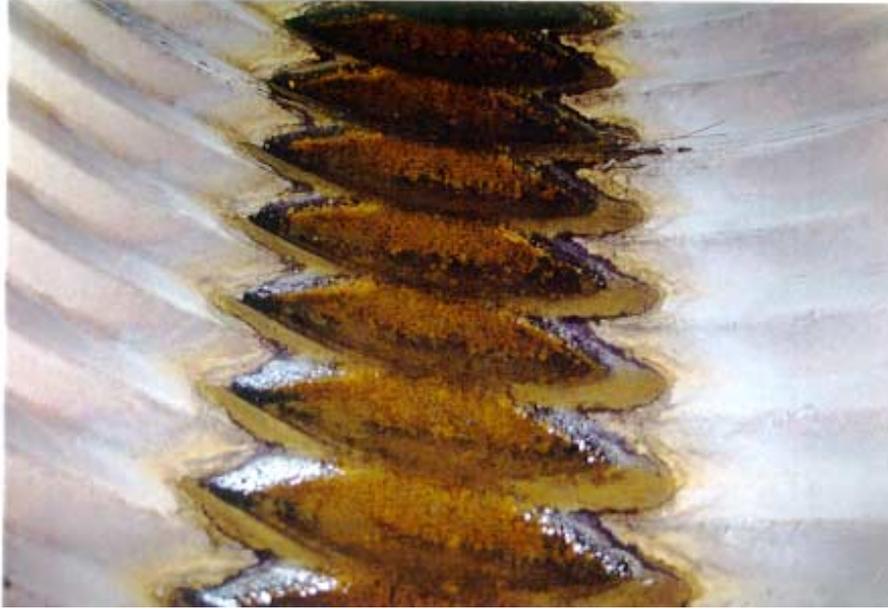
Figure 6. Aluminized Type 2 culvert after 5.5 years exposed to runoff with a pH of 2.5 to 3.5 (not from this study).

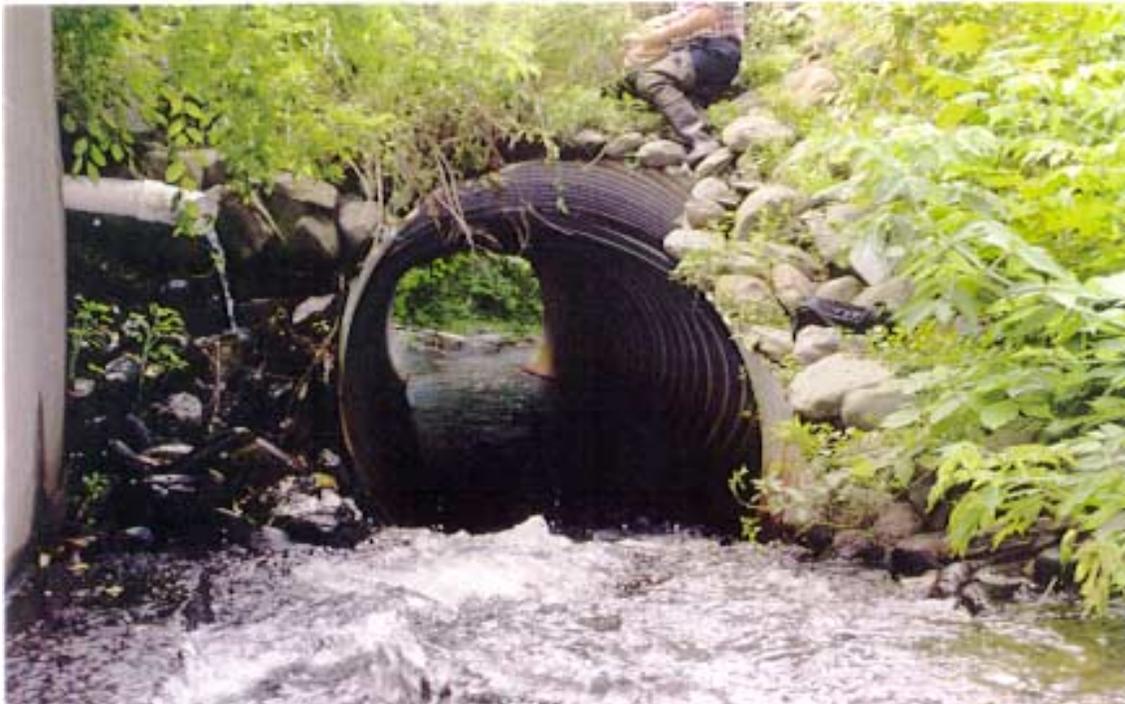
The third data outlier is that from the location in Dexter, Maine. This culvert is experiencing the highest abrasion of any of the Aluminized Type 2 pipes in this investigation. A high-velocity flow passes through this culvert carrying a rock bed load. Figure 7 shows an overview of the Dexter culvert.

Figure 7. Culvert at Dexter, Maine, experiencing high-velocity flow.
