Highway Concrete Pavement Technology Development and Testing: Volume IV— Field Evaluation of Strategic Highway Research Program (SHRP) C-206 Test Sites (Early Opening of Full-Depth Pavement Repairs)

PUBLICATION NO. FHWA-RD-02-085

AUGUST 2006

U.S. Department of Transportation
Federal Highway Administration

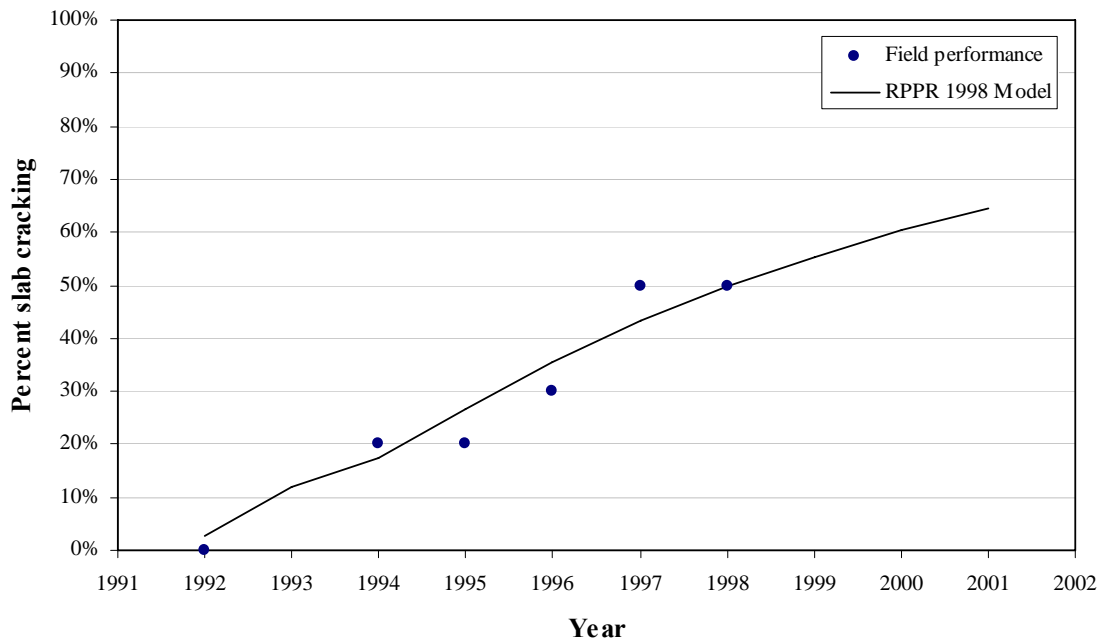
The cracking of the longer (4.6-m) repairs in the GADOT section is consistent with expectations. The Georgia sections were placed at night and opened to traffic at 6 a.m. At the time of concrete hardening, there was no difference in the temperature between the top and bottom of the PCC slab. Thus, the repair slabs were built flat with no built-in temperature gradients. Although an excessive built-in negative temperature gradient is undesirable because it contributes to top-down cracking, a moderate amount of built-in negative curling is beneficial because it moderates the effects of high daytime temperature gradients (Yu et al., 1998). Without any built-in curling, the 4.6-m repair length is excessive for a 230-mm repair slab. Differential shrinkage does provide equivalent built-in temperature of about $-2.2\text{ }^{\circ}\text{C}$ ($28.04\text{ }^{\circ}\text{F}$), but that is not enough to counter sufficiently the effects of high daytime temperature gradients.

The results of fatigue analysis are shown in figure 4, along with the observed slab cracking. The model was run with built-in curling of $-2.2\text{ }^{\circ}\text{C}$ ($28.04\text{ }^{\circ}\text{F}$), which accounts for differential shrinkage. The effects of damage due to early opening are illustrated in figure 5. As shown in table B1 in appendix B, the amount of fatigue damage attributable to early opening was minimal (Miner's damage of 0 to 0.07, except for 0.10 for the last patch). The damage due to early opening has the effect of shifting the time (or traffic) versus cracking curve upward, as illustrated in figure 5. However, for the Georgia sections, early opening to traffic had a negligible effect on the fatigue life of the repairs, even for the 4.6-m repairs. In fact, the last three 4.6-m repairs placed in the GADOT section (i.e., the repairs that were opened to traffic at the lowest strength) did not crack. For shorter repairs, the effects of early opening (and fatigue damage in general) are inconsequential.

Figure 4. Comparison of field performance of 4.6-m repairs in the GADOT section and predicted cracking using the rigid pavement performance/rehabilitation (RPPR) 1998 model (Yu et al., 1998).

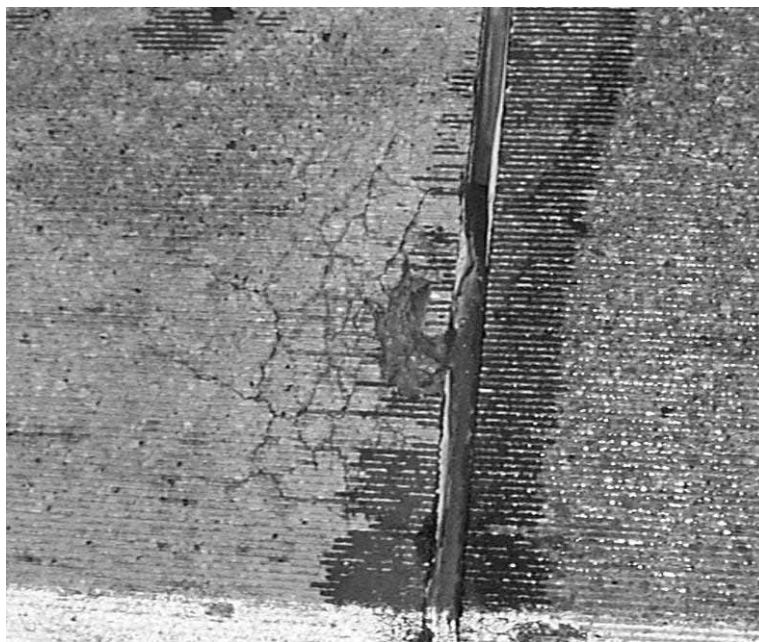
As mentioned in appendix A, the VES and FS sections started to show map cracking in 1997 (figure 7). The suspected cause of the map cracking is delayed ettringite formation (DEF). DEF is possible if the concrete temperature during hydration exceeds about 70 °C. The peak temperature in the VES section was just above this threshold temperature, and that in the FS section was significantly higher (80.6 °C). Core testing confirmed DEF in these sections.

Figure 7. Map cracking observed in FS section in 1997.

- Extremely high PCC temperatures during curing should be avoided. If the PCC temperature during curing exceed 70 °C, DEF is possible. Two of the Ohio sections (VES and FS) showed map cracking characteristic of DEF, and core testing confirmed DEF in those sections.

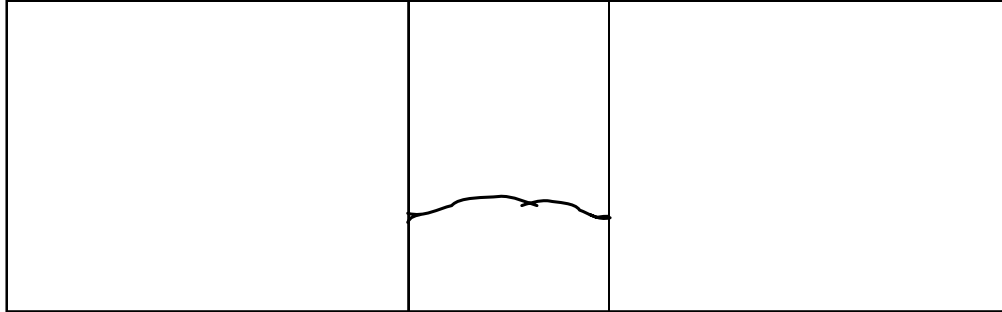
By far the most significant distress in the Ohio test sections is the early development of longitudinal cracking in nearly all repairs. Typical longitudinal cracking at this site is illustrated in figure 8. These cracks typically occurred in about the outer one-third of the slab. The rate of development of longitudinal cracking in Ohio sections is shown in figure 9. By the 2-month follow-up survey conducted under SHRP C-206, 100 percent of the FS section and 90 percent of the RSC 1 section had developed longitudinal cracking. By the time of first survey under this project in 1994, five of the eight sections had developed additional longitudinal cracking. Under SHRP C-206, the following were identified as possible causes of the cracking problem:

- The restriction of horizontal movement in the transverse direction caused by dowels.
- Excessive curling stress.
- Excessive compressive force exerted on the repairs by surrounding concrete.

Figure 8. Illustration of typical longitudinal cracking in Ohio sections.

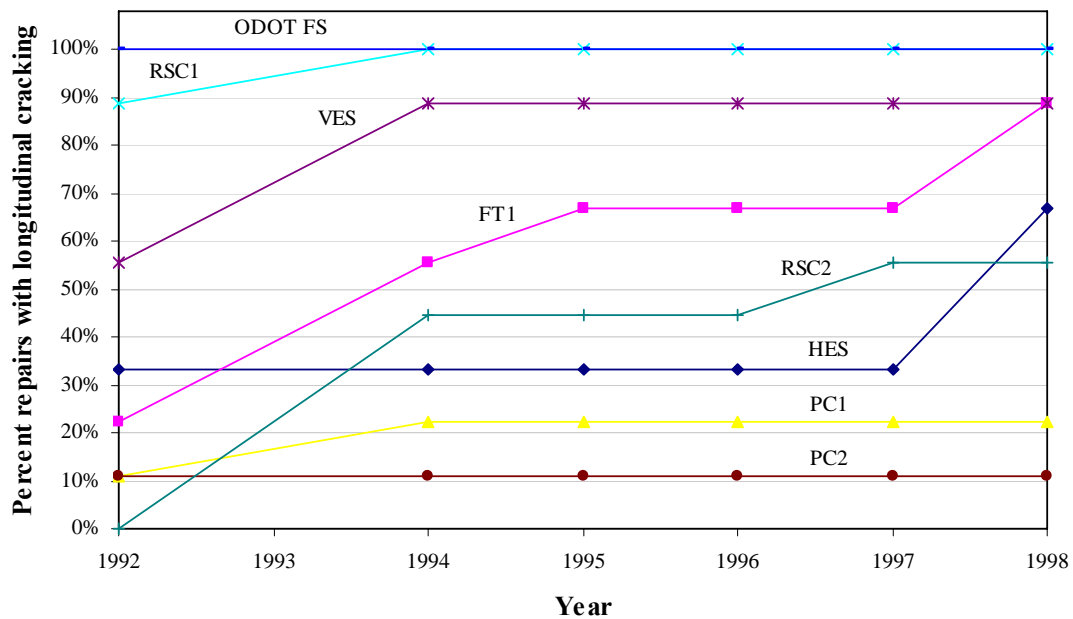
The performance of Ohio sections was plagued by the longitudinal cracking that developed in the majority of repairs shortly after construction. The cracks appeared within weeks of construction. Three sections also developed transverse cracks and corner breaks, but those distresses are secondary cracking that is unlikely to have occurred had the longitudinal cracking not occurred. Transverse fatigue cracking is not an issue for short (1.8-m) repairs.

Figure 9. Development of longitudinal cracking in Ohio sections.

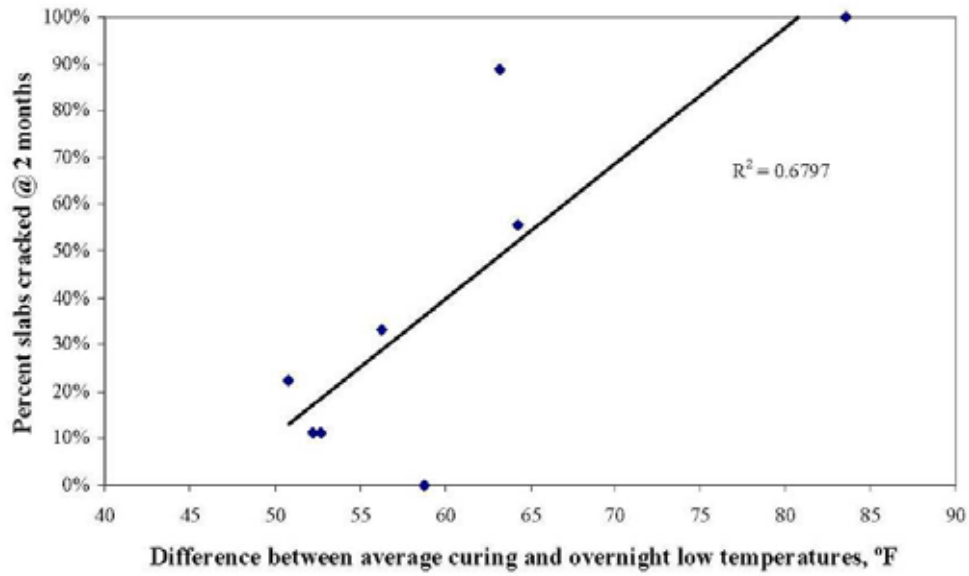
correlation between this parameter and longitudinal cracking in Ohio sections is shown in figures 10, 11, and 12 for the correlation at 2 months, 2 years, and 6 years of age. Figure 10 shows excellent correlation between this parameter and longitudinal cracking. If the cracking is caused by dowel restraint (of the horizontal movement in the transverse direction), this should be an effect that mostly influences the early-life behavior. Various factors would alleviate this effect at later ages, including creep and higher material strength. This is consistent with the trends shown in figures 10, 11, and 12. The best correlation is exhibited in figure 10 at 2 months of age, and the correlation becomes progressively worse for later ages.

Figure 10. Correlation between the difference of average curing and overnight low temperatures and longitudinal cracking in Ohio sections at 2 months.

The results shown in table 9 and figures 10 through 12 strongly suggest that the climatic conditions during construction played a major role in early development of longitudinal cracking in the Ohio sections. Figure 10 shows that if the difference between average curing temperature and overnight low temperature is less than about 10 °C (50 °F), the risk of developing longitudinal cracking due to dowel restraint is relatively low. That difference was less than 5 °C (41 °F) for all the Georgia sections, and none of the Georgia sections developed longitudinal cracking.

The risk of early age cracking can be evaluated using FHWA’s software HIPERPAV (McCullough and Rasmussen 1999; Forster 1998). The software takes key environmental, structural design, mix design, and construction inputs and generates a graph showing the development of PCC strength and stress over the first 72 hours after placement. If the stress exceeds the strength at any time, a high potential for uncontrolled cracking is indicated. For such cases, adjustments can be made to mixes, curing practice, or time of PCC placement to reduce the potential for cracking. Where a significant difference between the average curing temperature and overnight low temperature is possible (i.e., greater than 10 °C (50 °F)), the use of HIPERPAV is recommended.

- The temperature data from the Ohio site suggest that the risk of longitudinal cracking is high if the difference in average curing temperature and nighttime low temperatures exceeds about 10 °C (50 °F). The use of HIPERPAV is recommended in adverse conditions to avoid premature failures.

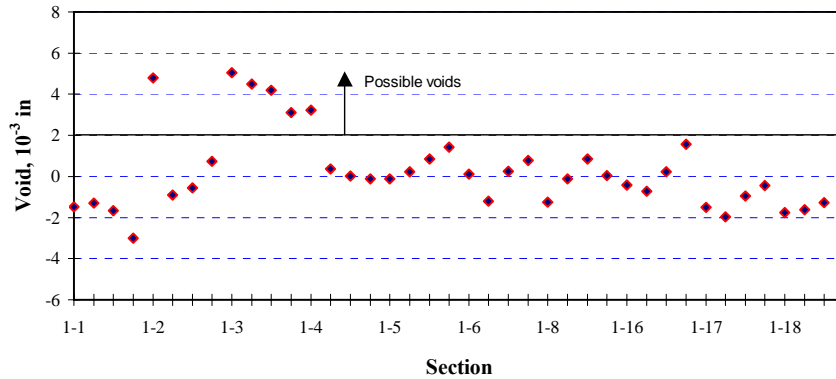
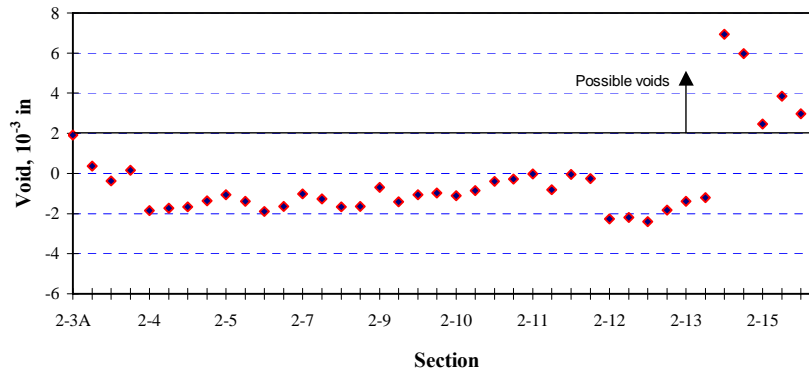
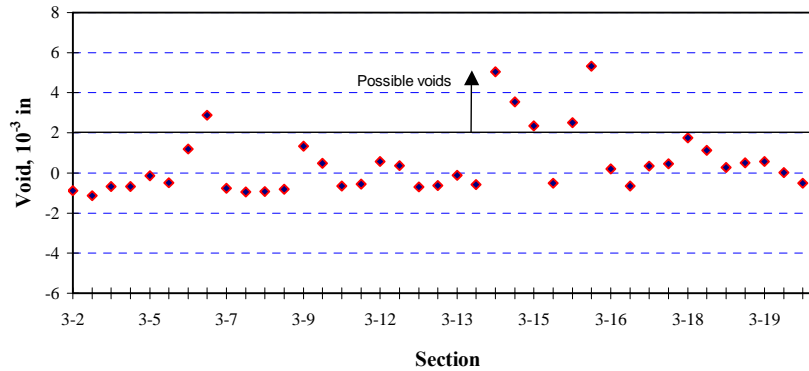
The intercept values from the load-deflection plots are shown in figures A4, A5, and A6. The figures show possible voids under the repairs 1-3, 2-13, 2-15, 3-13, and 3-15, but most joints tested show good support under the joints. These results show that the slabs were not curled up at the time of testing.
