Highway Concrete Pavement Technology Development and Testing: Volume IV— Field Evaluation of Strategic Highway Research Program (SHRP) C-206 Test Sites (Early Opening of Full-Depth Pavement Repairs)

PUBLICATION NO. FHWA-RD-02-085

AUGUST 2006

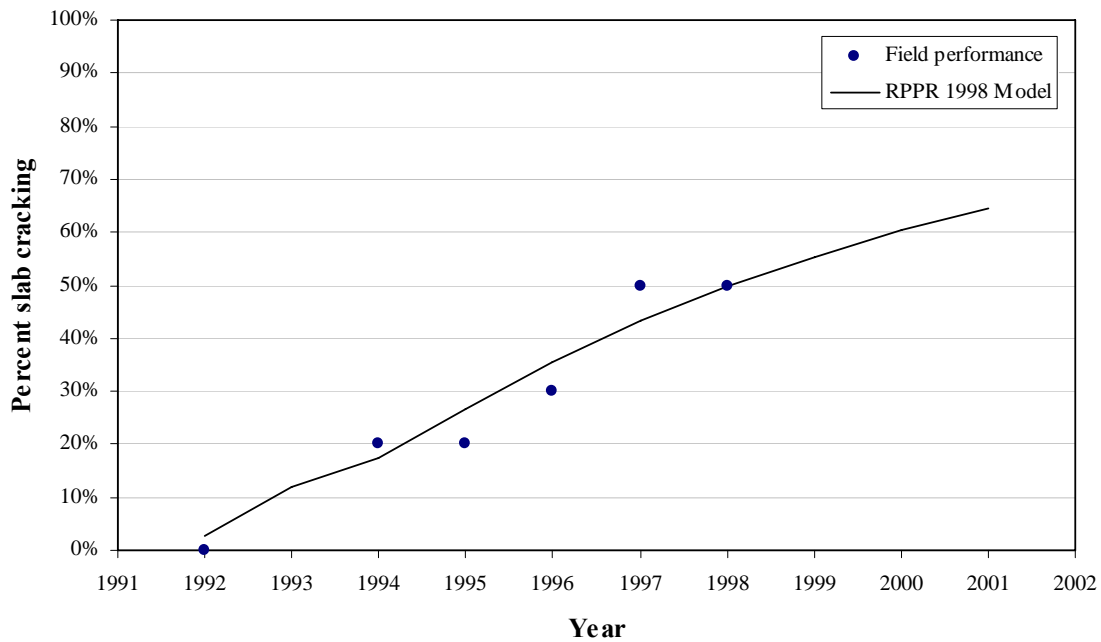
Figure 4. Comparison of field performance of 4.6-m repairs in the GADOT section and predicted cracking using the rigid pavement performance/rehabilitation (RPPR) 1998 model (Yu et al., 1998).

The cracking of the longer (4.6-m) repairs in the GADOT section is consistent with expectations. The Georgia sections were placed at night and opened to traffic at 6 a.m. At the time of concrete hardening, there was no difference in the temperature between the top and bottom of the PCC slab. Thus, the repair slabs were built flat with no built-in temperature gradients. Although an excessive built-in negative temperature gradient is undesirable because it contributes to top-down cracking, a moderate amount of built-in negative curling is beneficial because it moderates the effects of high daytime temperature gradients (Yu et al., 1998). Without any built-in curling, the 4.6-m repair length is excessive for a 230-mm repair slab. Differential shrinkage does provide equivalent built-in temperature of about $-2.2\text{ }^{\circ}\text{C}$ ($28.04\text{ }^{\circ}\text{F}$), but that is not enough to counter sufficiently the effects of high daytime temperature gradients.

The results of fatigue analysis are shown in figure 4, along with the observed slab cracking. The model was run with built-in curling of $-2.2\text{ }^{\circ}\text{C}$ ($28.04\text{ }^{\circ}\text{F}$), which accounts for differential shrinkage. The effects of damage due to early opening are illustrated in figure 5. As shown in table B1 in appendix B, the amount of fatigue damage attributable to early opening was minimal (Miner's damage of 0 to 0.07, except for 0.10 for the last patch). The damage due to early opening has the effect of shifting the time (or traffic) versus cracking curve upward, as illustrated in figure 5. However, for the Georgia sections, early opening to traffic had a negligible effect on the fatigue life of the repairs, even for the 4.6-m repairs. In fact, the last three 4.6-m repairs placed in the GADOT section (i.e., the repairs that were opened to traffic at the lowest strength) did not crack. For shorter repairs, the effects of early opening (and fatigue damage in general) are inconsequential.

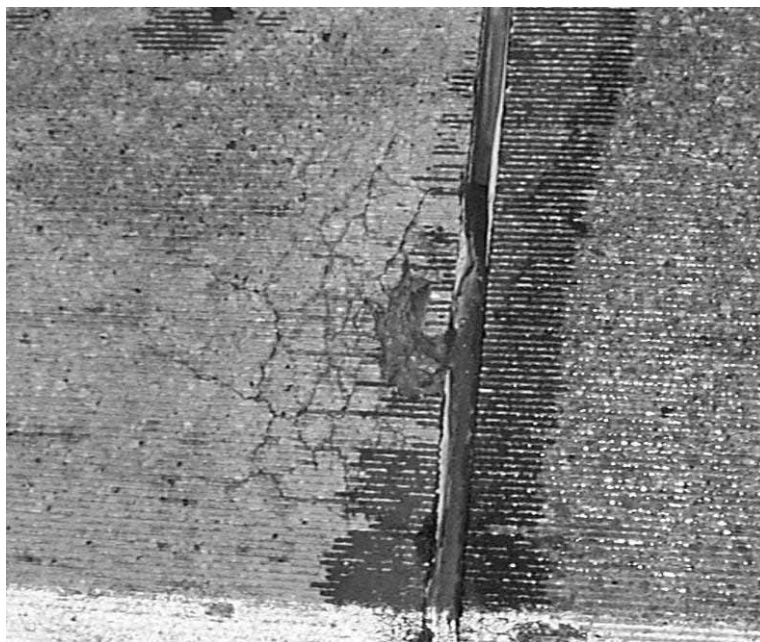
Figure 7. Map cracking observed in FS section in 1997.

As mentioned in appendix A, the VES and FS sections started to show map cracking in 1997 (figure 7). The suspected cause of the map cracking is delayed ettringite formation (DEF). DEF is possible if the concrete temperature during hydration exceeds about 70 °C. The peak temperature in the VES section was just above this threshold temperature, and that in the FS section was significantly higher (80.6 °C). Core testing confirmed DEF in these sections.

- Extremely high PCC temperatures during curing should be avoided. If the PCC temperature during curing exceed 70 °C, DEF is possible. Two of the Ohio sections (VES and FS) showed map cracking characteristic of DEF, and core testing confirmed DEF in those sections.

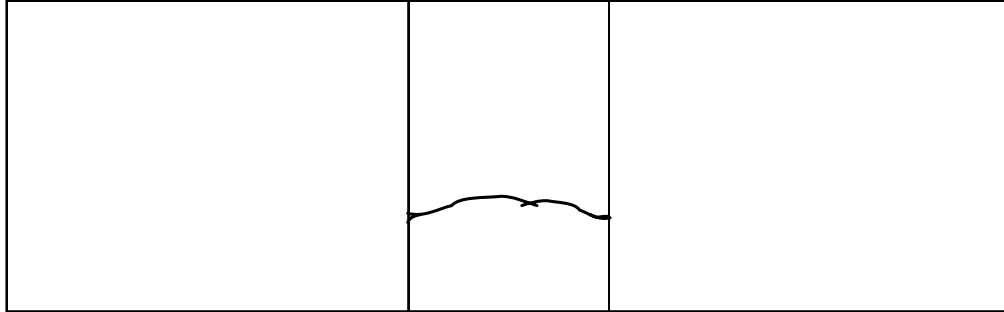
Figure 8. Illustration of typical longitudinal cracking in Ohio sections.

By far the most significant distress in the Ohio test sections is the early development of longitudinal cracking in nearly all repairs. Typical longitudinal cracking at this site is illustrated in figure 8. These cracks typically occurred in about the outer one-third of the slab. The rate of development of longitudinal cracking in Ohio sections is shown in figure 9. By the 2-month follow-up survey conducted under SHRP C-206, 100 percent of the FS section and 90 percent of the RSC 1 section had developed longitudinal cracking. By the time of first survey under this project in 1994, five of the eight sections had developed additional longitudinal cracking. Under SHRP C-206, the following were identified as possible causes of the cracking problem:

- The restriction of horizontal movement in the transverse direction caused by dowels.
- Excessive curling stress.
- Excessive compressive force exerted on the repairs by surrounding concrete.

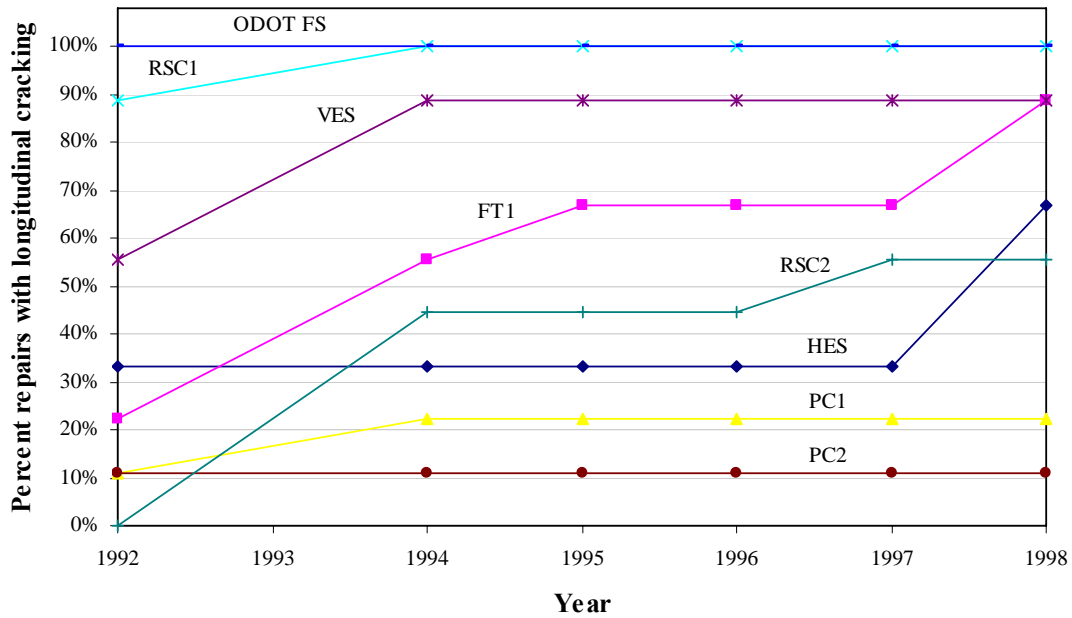
Figure 9. Development of longitudinal cracking in Ohio sections.

The performance of Ohio sections was plagued by the longitudinal cracking that developed in the majority of repairs shortly after construction. The cracks appeared within weeks of construction. Three sections also developed transverse cracks and corner breaks, but those distresses are secondary cracking that is unlikely to have occurred had the longitudinal cracking not occurred. Transverse fatigue cracking is not an issue for short (1.8-m) repairs.
