# RECYCLING ASPHALT PAVEMENTS

Elkhart County, Indiane

FINAL REPORT

EVALUATION OF RECYCLED BITUMINOUS PAVEMENTS.

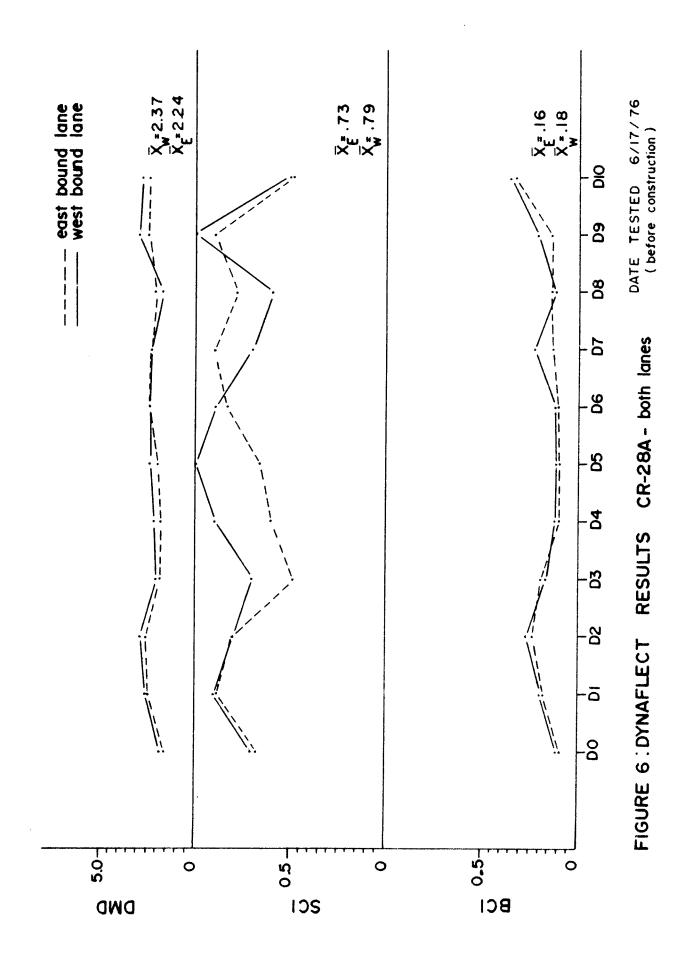
The three characteristics obtained from initial dynaflect measurements on CR-28A are shown in Figure 6 for test obtained on June 17, 1976. The maximum deflection or the deflection of Sensor 1 for all sites in both the east and west bound lanes is represented by the uppermost plot. The Surface Curvature Index, SCI, is plotted in the middle and the Base Curvature Index, BCI, is the bottom plot. It is readily seen that the average deflection in mils for the east and west bound lanes of CR-28A is very similar - 2.24 and 2.37, respectively. Very uniform values were obtained at all of the individual test locations and it is also readily seen that variations in both lanes were quite similar for the most part. These values, however, are quite high and indicate that the pavement is not capable of transmitting the load down through the pavement system. The large maximum deflections is supported by the plot of the SCI values for both lanes. The average SCI value for the westbound lane is .79 mils, while the average for the eastbound lane is .73, both of which are quite a bit higher than the maximum allowable SCI for a suitable pavement which is generally accepted as being .48 mils. (4) The bottom plot shows the BCI for both lanes and again uniform results were obtained. The westbound average value is .18 and the eastbound average is .16 mils. A comparison of these values with a maximum allowable BCI of .11 indicates that the base is not suitable - not strong enough to properly distribute the load. In fact, the

overall analysis based on the limiting values for the maximum deflection, the maximum SCI, and the maximum BCI indicates that both the pavement and the subgrade are weak.

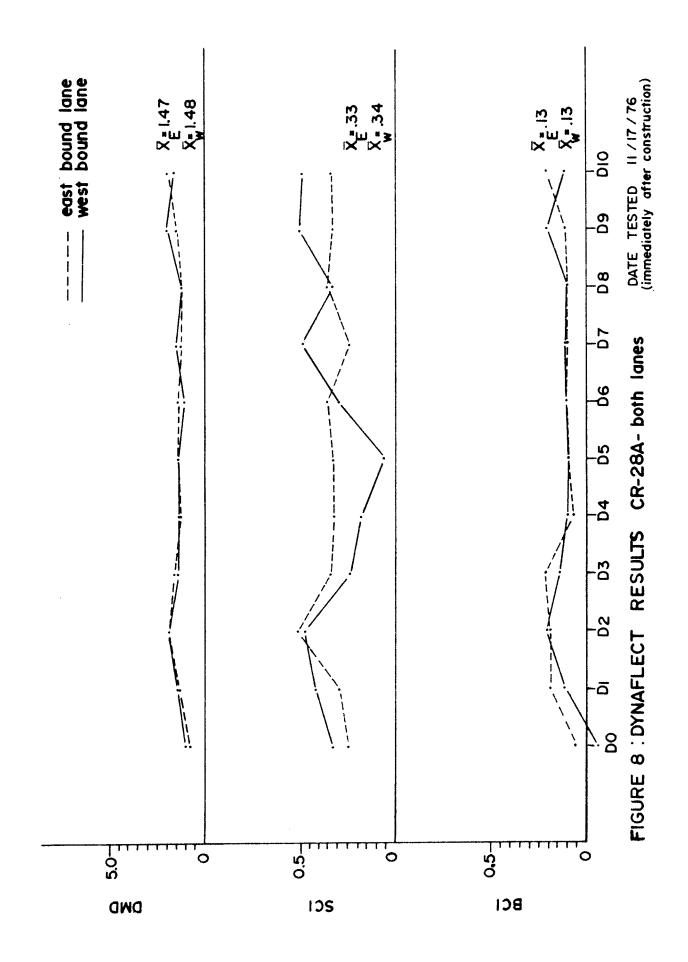
The results of the Dynaflect testing performed on CR-28A immediately after construction on November 17, 1976, as shown in Figure 8, indicate that the average maximum deflection in the westbound lane was 1.48 mils while the eastbound maximum was 1.47 mils. The results appear to be very uniform and very similar for both the eastbound and the westbound readings. The average SCI for both east and west bound lanes of CR-28A was very similar and within the allowable SCI limit. The individual values are somewhat erratic. The plot of the BCI values for both east and west bound lanes shows both average values to be .13 mils compared to the maximum allowable BCI of .11 mils for a satisfactory base course. The BCI for CR-28A immediately after construction appears to be fairly uniform. The overall indication of the Dynaflect descriptors is that the subgrade was weak and the pavement marginal immediately following construction.

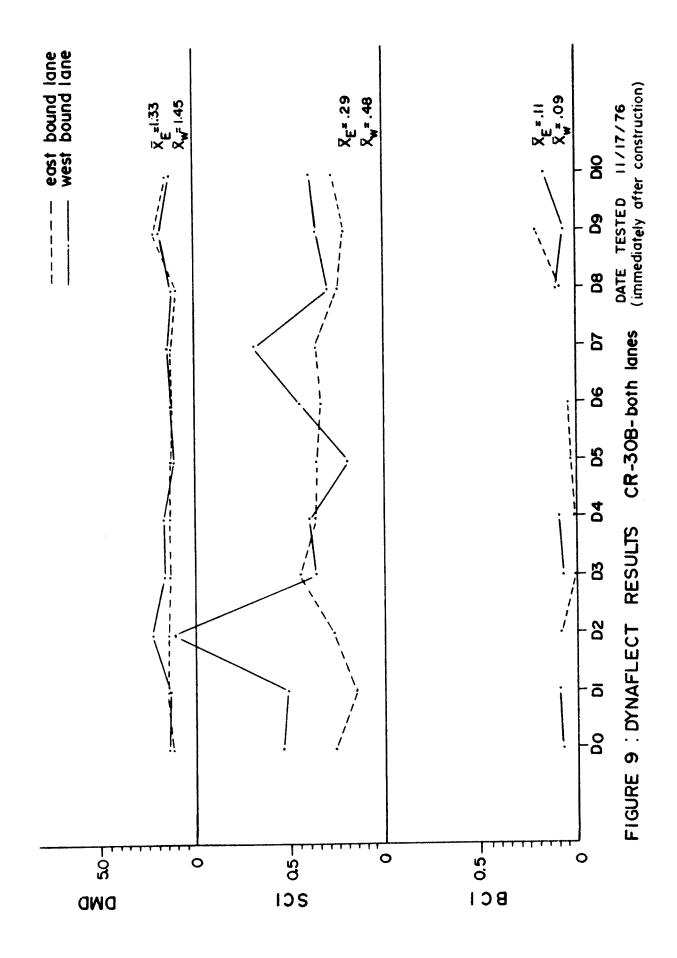
Dynaflect tests performed on CR-30B immediately after construction on November 17, 1976, produced the plots which are shown in Figure 9. This series of plots shows quite an improvement for all three of the Dynaflect descriptors. First, the maximum deflection shown at the top of the figure indicates fairly uniform results within the lane and between the east and west bound lanes. The average maximum deflection of the westbound lane was 1.45 mils and the average in the eastbound lane was 1.33 mils. The SCI plot indicates a continued variation between the lanes which is fairly extreme in the case of at least four of the test sites. The average SCI value for the westbound lane was .43 mils while the average SCI in the eastbound lane was .29 mils. The BCI values for CR-30B were very spotty. The plots are not continuous because some of the values were not meaningful. The average BCI value of the plots shown was .09 mils for the westbound lane and .11 mils for the eastbound lane.

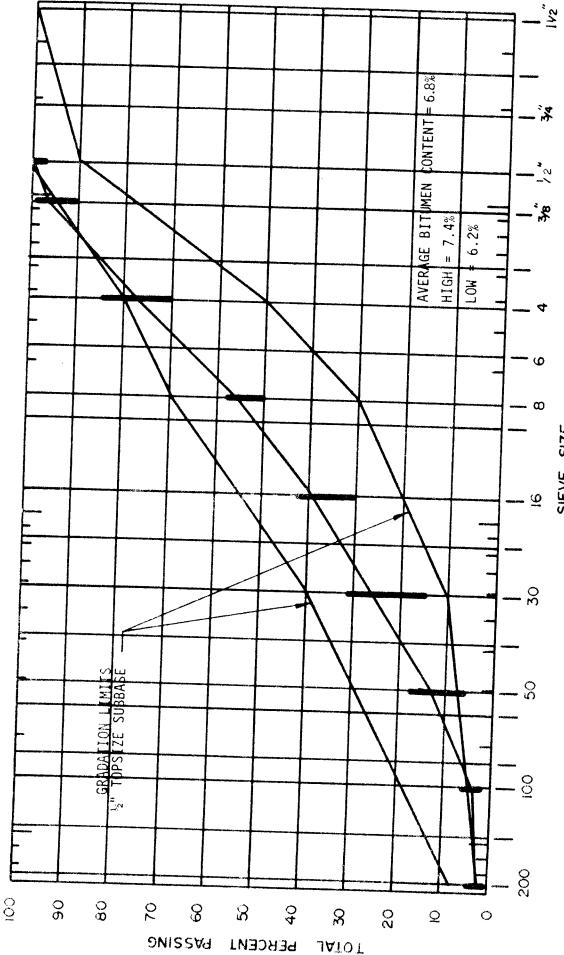
FIGURE 19 : GRADATION OF EXTRACTED AGGREGATE CR-30B - INITIAL SAMPLES (0"-3") SIEVE SIZE

The gradation of the extracted aggregate and asphalt content of the material sampled from the top three inches of the existing pavement at the five sampling sites is shown in Figure 19. The average asphalt content of the material taken from these sites was 6.8%. The range was from 6.2% to 7.4% which is very uniform considering the condition of the surface. The average gradation of this material was similar to that designated for ½" top size subbase by the Indiana Specifications except for the very top and the very bottom. The maximum top size is actually one-half inch and approximately 96% of the material passed the 3/8" sieve. The bottom most portion of the gradation from the #100 to the #200 sieve falls on the clean side of 1/2" top size material. Considerable variability is evident on most of the sieves. The material sampled from the three inch to the six inch depth follows the mean gradation of the top size subbase very closely as seen in Figure 20. The average asphalt content dropped to 3.7% as would be expected for material sampled 3" below the surface.

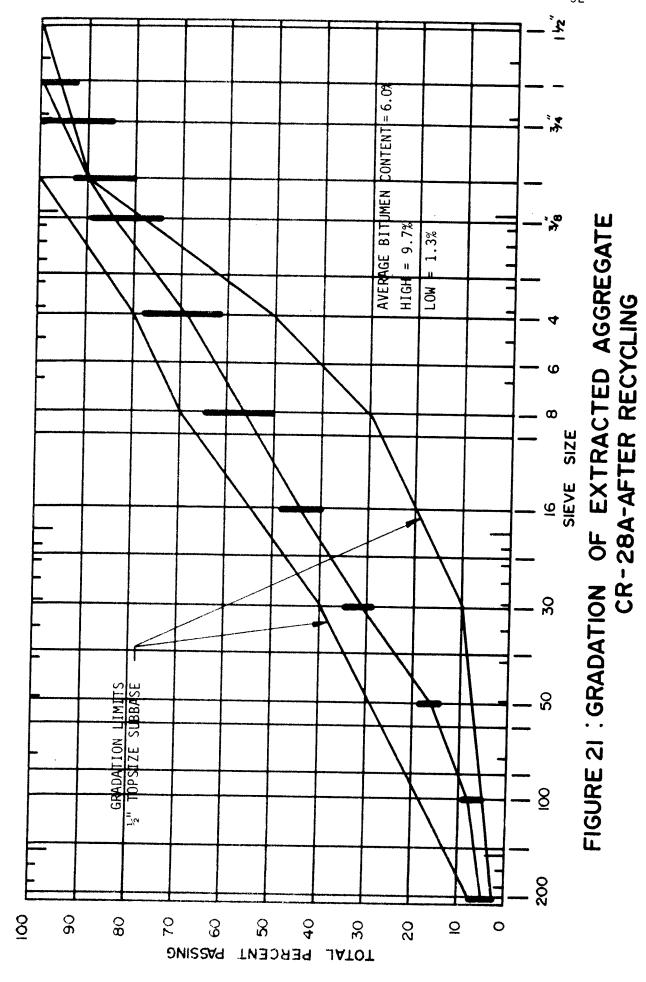
The results of the gradation and asphalt content determination for the recycled material as shown in Figure 21 indicates that the material remains somewhat finer than is specified and expected for the top range of material to be used as a base. The gradation is very comparable to the material sampled from the top three inches of the existing pavement except for a few sizes in the middle range - from the #8 sieve to the #50 sieve. A comparison of the gradations of the surface portion of the initial samples and the recycled samples shows the maximum differential is 9% on the #16 sieve and overall the recycled material is somewhat finer. The average asphalt content of the recycled material was 6.0%. The range of the 10 samples was from 1.3 to 9.7 percent which was unexpectedly high. This is an indication that the distribution of the

added bituminous material is non-uniform. The fineness of the material is an indication that some degradation of the aggregate occurred during the processing which is to be expected. The degree of degradation does not appear to be significant and probably is not critical for this particular section of roadway. Over an extended period of service the road might become prematurely unstable in the wheelpaths as indicated by some degree of rutting.

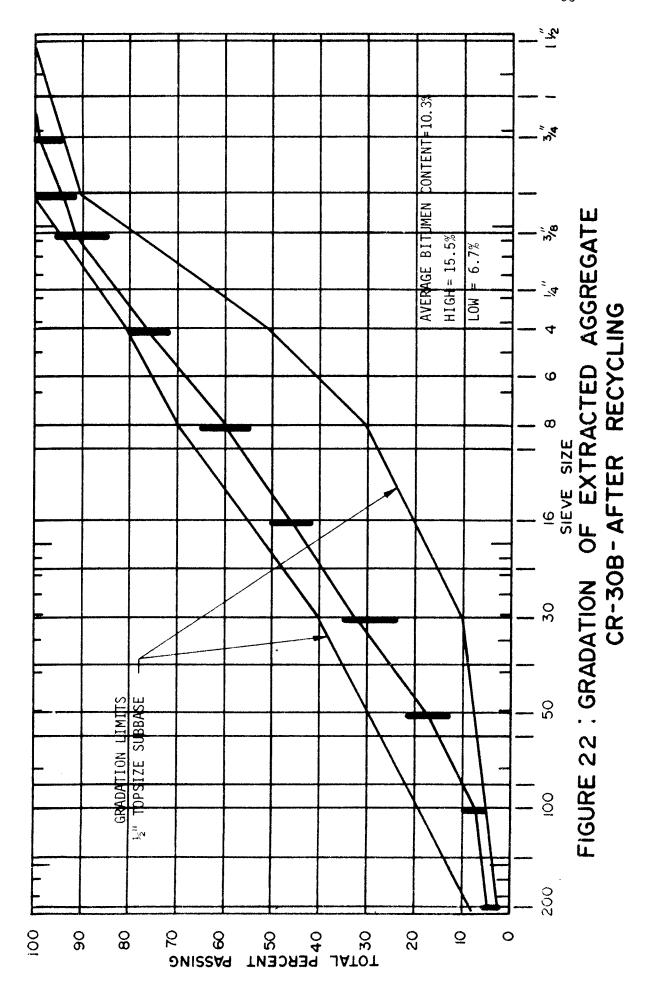
The average gradation curve of the samples of the recycled material from CR-30B, Figure 22, is very similar to the curve shown in Figure 20 for the initial samples taken from the three to six inch level. The

average asphalt content of the recycled material was 10.3% with a range of 6.7% to 15.5%. The asphalt content appears to be quite high and while this may provide for a very durable roadway it will no doubt exhibit rutting in a very short period of time.
