The November 1999 Duzce Earthquake: Post-Earthquake Investigation of the Structures on the TEM

Publication No. FHWA-RD-00-146

Hamid Ghasemi, James D. Cooper, Roy Imbsen,
Hasan Piskin, Fulya Inal, and Azmi Tiras

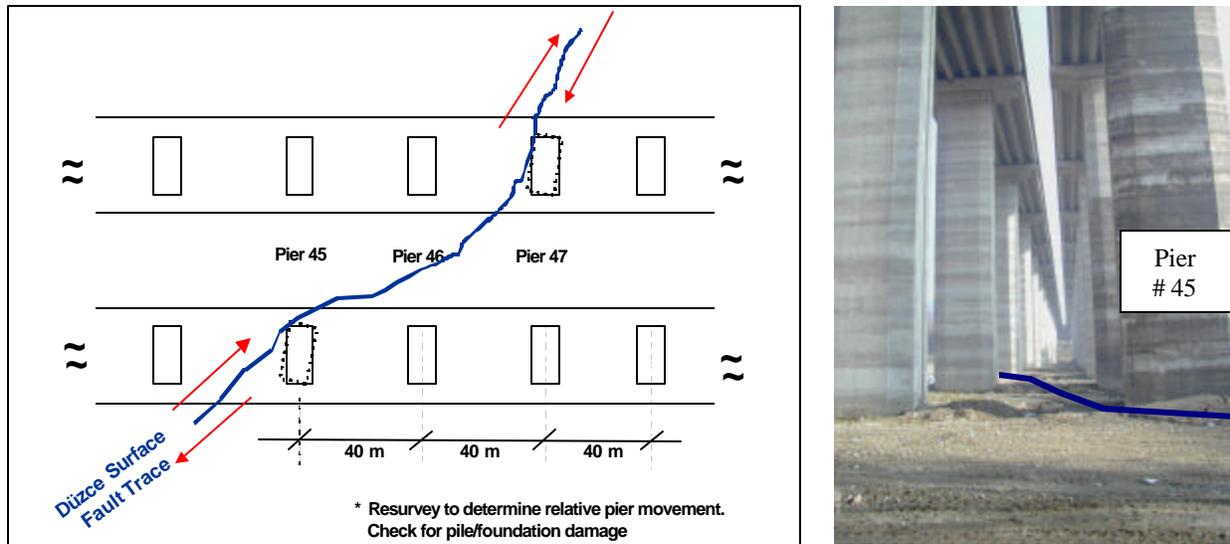
1. The surface fault trace was visible sporadically in the valley town of Kaynasli, where Viaduct #1 is located. Faulting caused major destruction of buildings, residential housing, and other facilities. The fault trace was also observed at Viaduct #1, where it intersected Pier #45 (eastbound), then continued between the two #46 piers before intersecting Pier #47 (westbound) as shown in Figure 15. Fault rupture movement, estimated to be about 2.5 to 3 m at this location, resulted in a rotation of nearly 13 degrees at Pile Caps #45 (eastbound) and #47 (westbound) about their vertical axes.

Figure 15. Fault trace at Viaduct #1.

1. The viaduct was first subjected to a low-frequency vibratory motion, which was then followed by a high-velocity impulse or "fling" resulting from the near-field effect. The surface fault trace was visible at Piers #45, #46, and #47 (Figure 15).

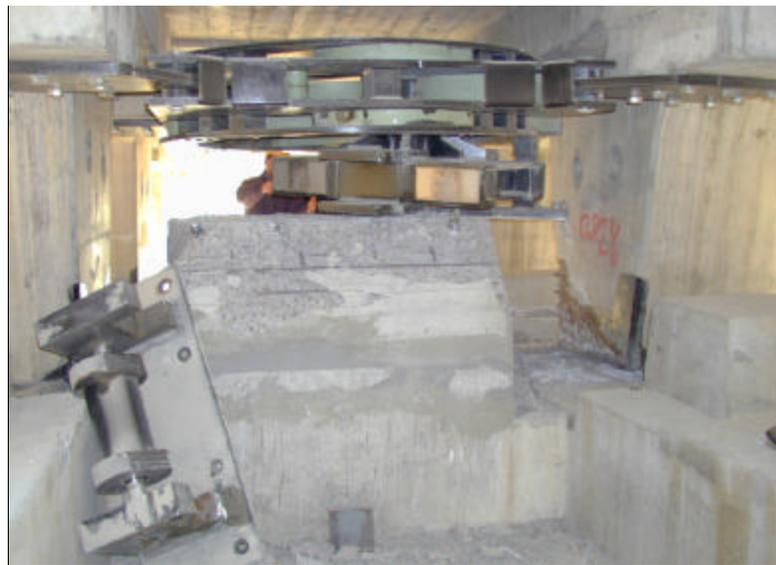
2. Significant damage did occur to the EDUs and bearings from surface-rupture displacement and ground shaking, which then caused the superstructure girders to translate on their pier tables, narrowly avoiding total collapse (Figures 16 through 18).

Figure 16. Dislodged EDU, Pier #5.

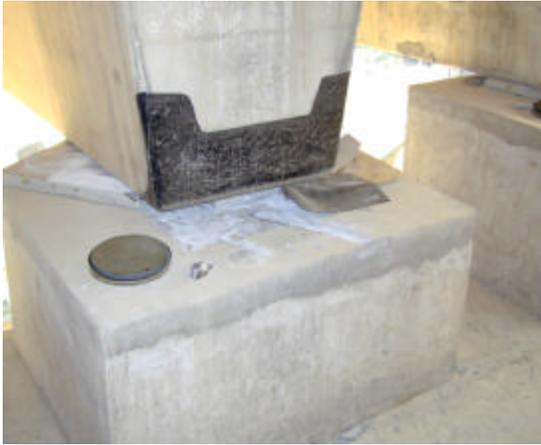
Figure 17. Typical dislodgment of bearing systems.

2. The fling caused the bearings to be ejected from underneath the box girders after the bearing sliding plate interface area was exceeded (Figure 17).

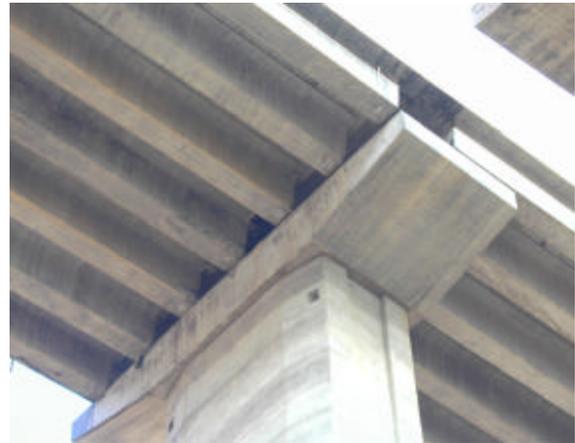
Figure 18. End of fascia girder extending beyond pier table.

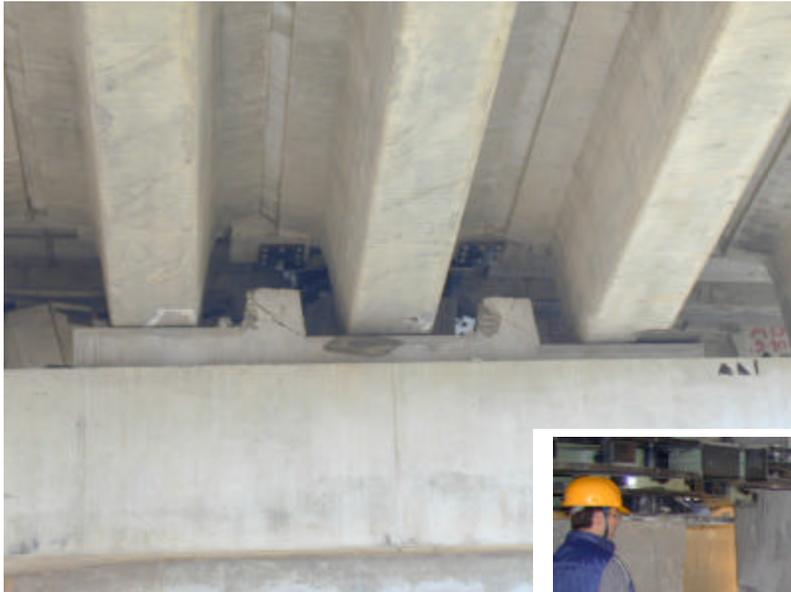
3. Shear keys or blocks used to control transverse girder movement, although severely damaged, have functioned as intended appear to (Figure 19).

Figure 19. Shear block damage (translational restraint).

- Shear keys or blocks used to control transverse girder movement of Bolu Viaduct #1, although severely damaged, appear to have functioned as intended.

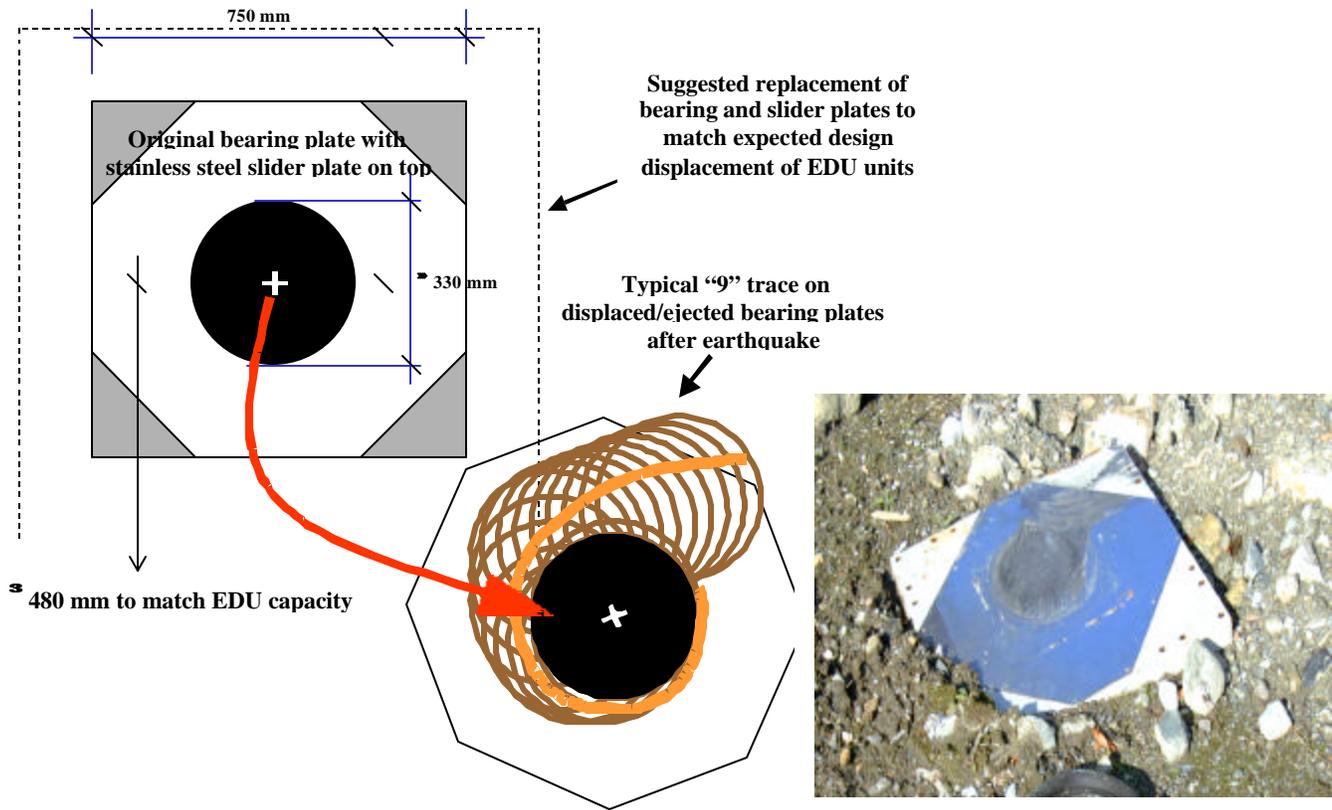
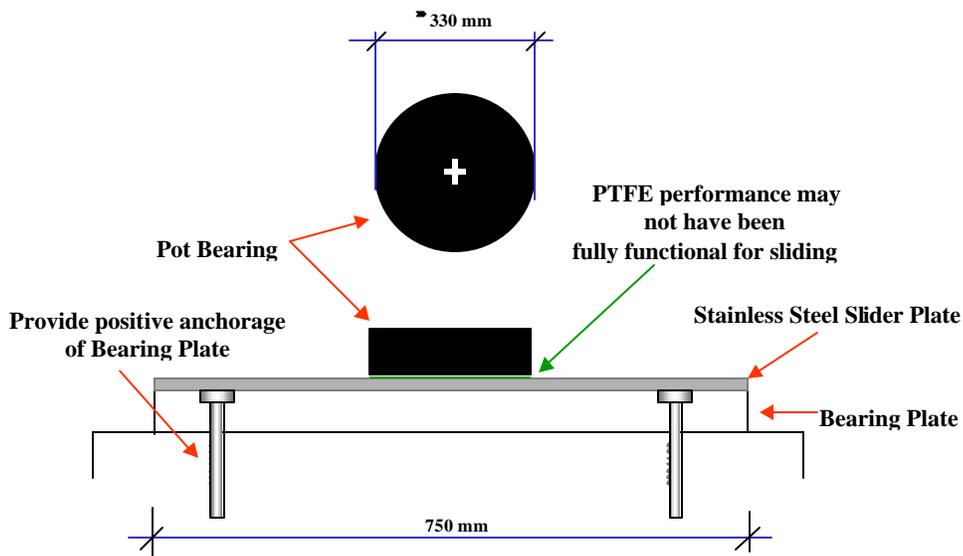
5. Almost all of the stainless steel interface plates had distinct scoring that resembled the number "9". The "9" trace may validate a scenario of large cyclic motion resulting from the fling effect (Figure 20). Also included in Figure 20 are the authors suggestions for remediation that were made at the time of the site investigation.

Figure 20. Viaduct #1 bearing damage scenario (based on the site review on November 30, 1999).

Recommendation: Expand to 1000 mm in redesign, but check pot bearing / EDU system performance for maximum credible earthquake

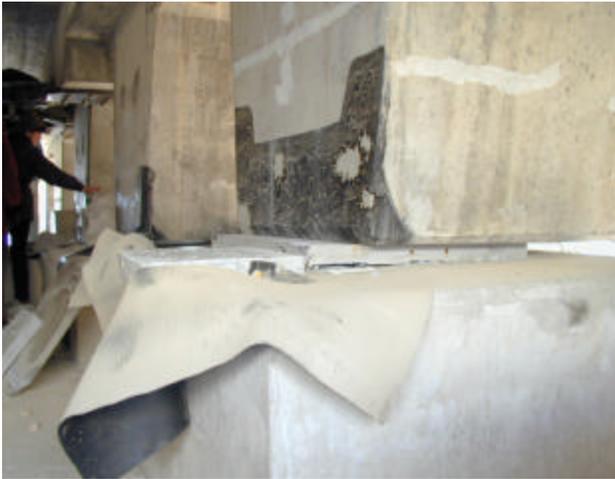
6. Upon the loss of the bearings from underneath the girders (and in some instances, the steel bearing plates, too), the superstructure then dropped approximately 5 cm to rest on the pier caps. That caused an excessive bending moment at the EDU connection to the deck, which resulted in the partial to total binding of the C-element ring plates (Figures 21 through 23). The binding action prevented the EDUs from functioning properly.

Figure 21. Bearing failure.

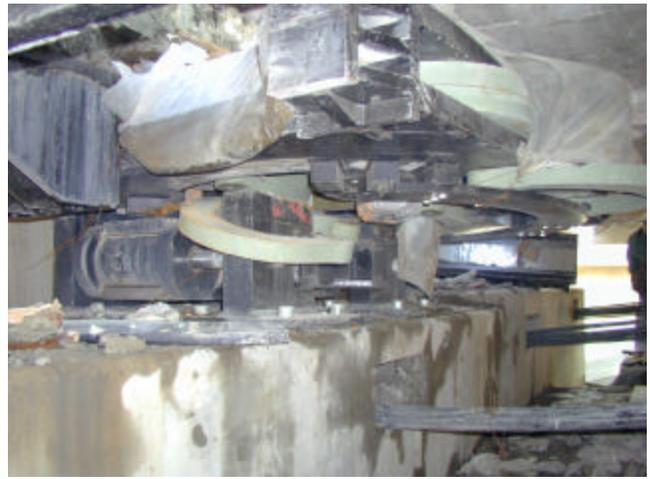
7. The fling effect possibly sheared off the connection between the EDU and its pier cap, as well as the connection to the deck. It is believed that the design of the EDU connections to the super- and substructure was based on the elastic limits of the C-element. The connections for the bearings plates were designed for a force level equal to the dynamic coefficient of friction of the PTFE-sliding bearing (4%).

Figure 22. EDU failure.

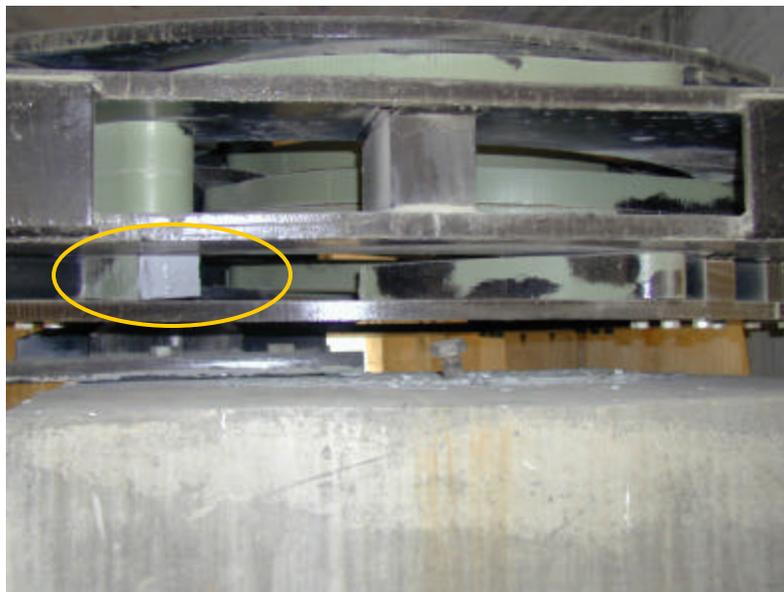
Figure 23. Fractured EDU C-element

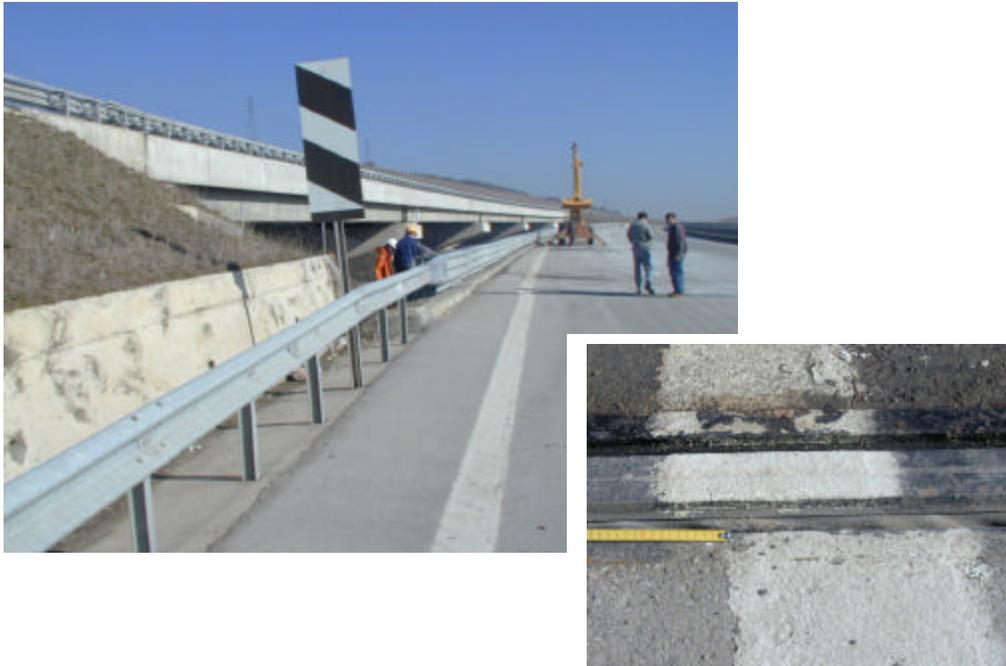
1. Moderate structural damage occurred to the concrete box girders of Bridge #2. The west end of the eastbound span translated approximately 3.5 in (88.9 mm) to the north relative to the west abutment, as evidenced by the misalignment of lane striping at the west abutment (Figure 24).

Figure 24. Translation of the eastbound span at the west abutment.

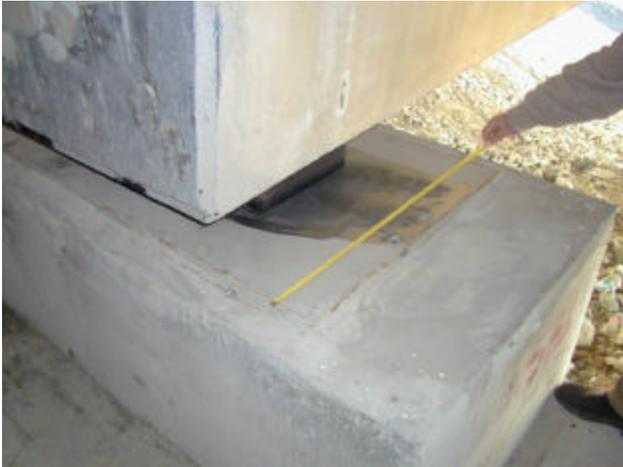
2. Examination at the abutment seat revealed a set of well-proportioned, steel-reinforced, rectangular elastomeric bearing pads (Figure 25) and an EDU device that had functioned properly during the Duzce Earthquake (Figure 26). One C-element had compressed to a 23.5-in (596.9-mm) opening from center of pin to center of pin, while the other C-element extended to an opening of 31 in (787.4 mm). Markings on a bearing plate indicated that the 12-in by 27.5-in by 4.5-in- (304.8-mm by 698.5-mm by 114.3-mm-) thick bearing pad had translated about 6.5 in (165.1 mm) to the north and about 3.75 in (95.3 mm) to the west. Movement of the elastomeric bearings allowed the EDU to function and dissipate energy as conceptually designed.

Figure 25. Well-proportioned, steel-reinforced elastomeric bearing pad showing evidence of translation.

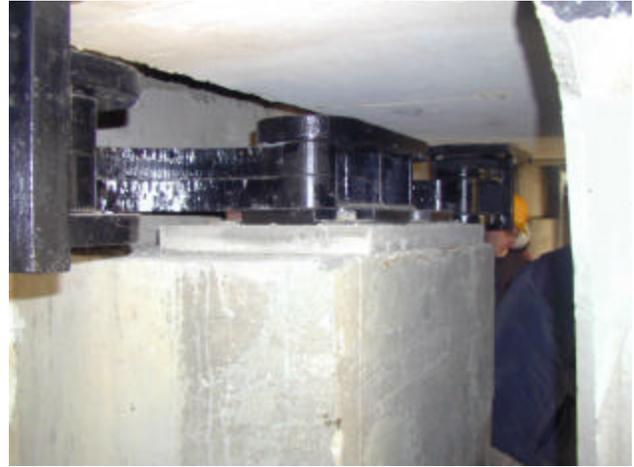
Figure 26. Flaked-off paint of an EDU C-element that had functioned properly.

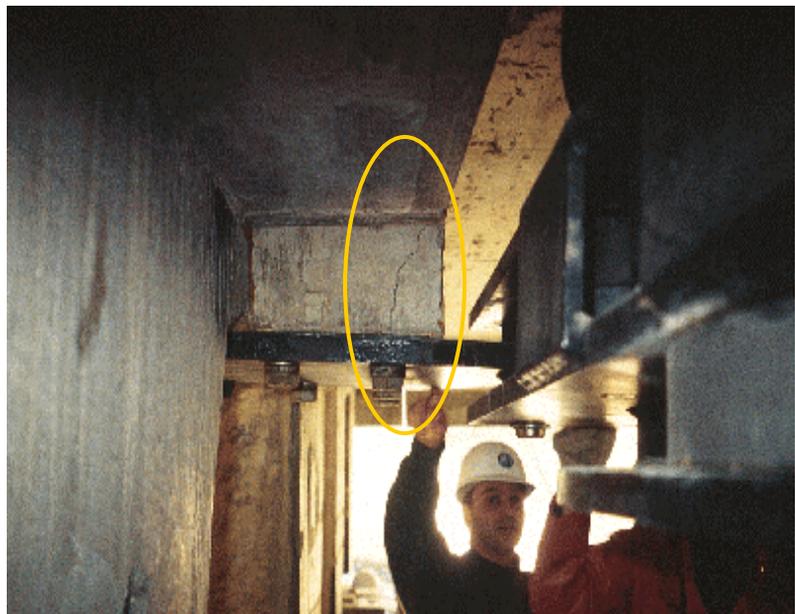
3. Inspection of the eastbound span at the first pier table of the western abutment indicated that the bearings allowed the EDU to function properly. It was also noted that one of the anchorages of the EDU brackets that was attached to the superstructure appeared to be at incipient failure, i.e., cracking of the concrete at the EDU anchorage point was noted (Figure 27).

Figure 27. Incipient failure of EDU anchorage point.

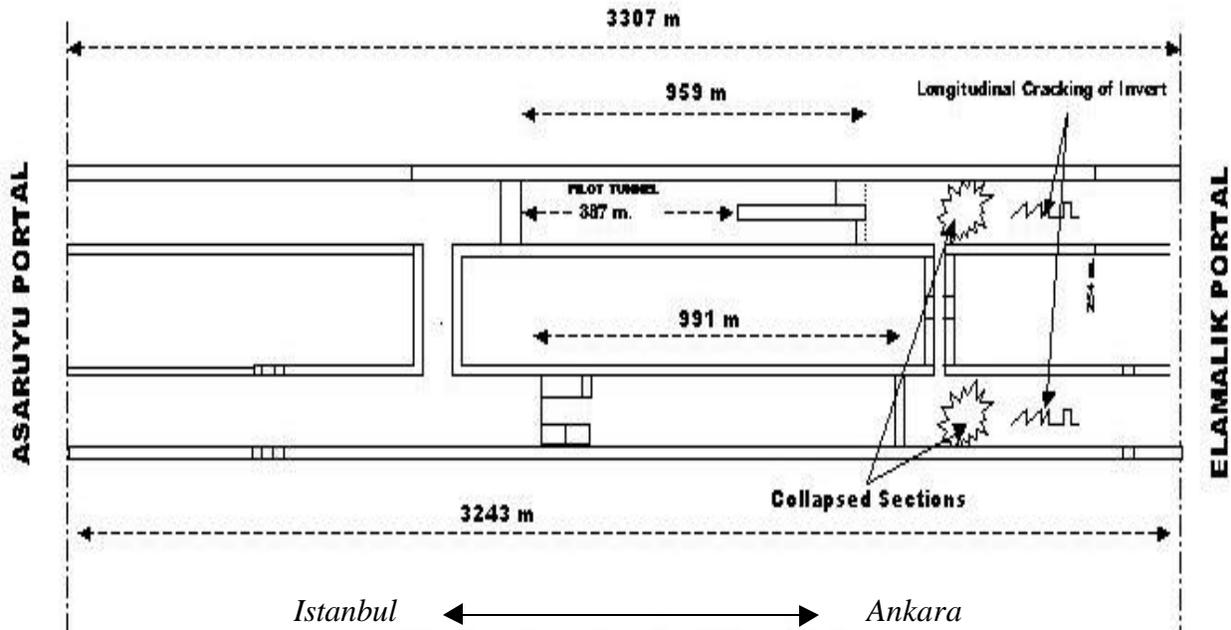
1. A very brief visual inspection of the Bolu tunnels was made on December 2, 1999. The inspection consisted of driving through both bores, from the Elmalik portal to the collapsed sections, approximately 300 m from the portal entrance, with limited time spent at the face of the collapse and in the structurally incomplete segment leading to the collapse. The incomplete section had only a shotcrete liner system in place.
2. Complete closure of both tunnel bores was noted about 200 to 300 m from the Elmalik portal entrances (Figure 30).

Figure 30. Approximate location of Tunnel collapse.

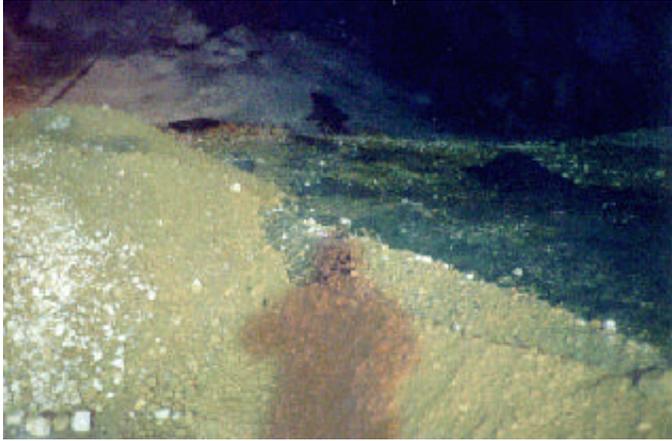
3. The collapses occurred in a section of tunnel passing through a clay/weak rock zone where a temporary shotcrete lining system was in place (Figures 31 and 32). The collapses occurred about 50 to 75 m beyond a structurally complete tunnel liner system.
4. Severe shotcrete spalling was noted between sets and at the sets along the tunnel wall (Figures 33 and 34).

Figure 31. View looking head-on at the collapse of the westbound tunnel.

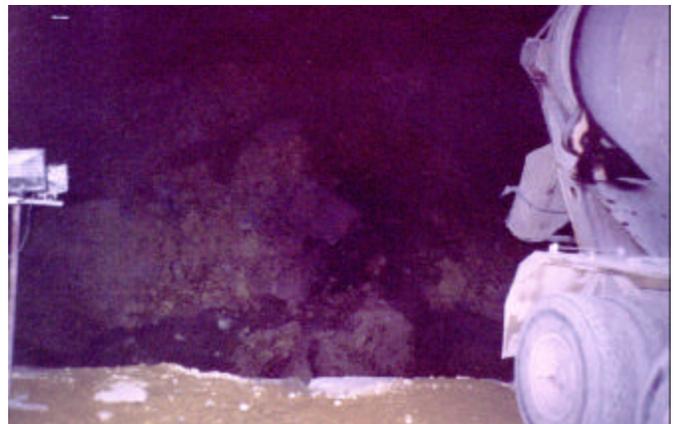
Figure 32. View looking at the collapse of the eastbound tunnel.

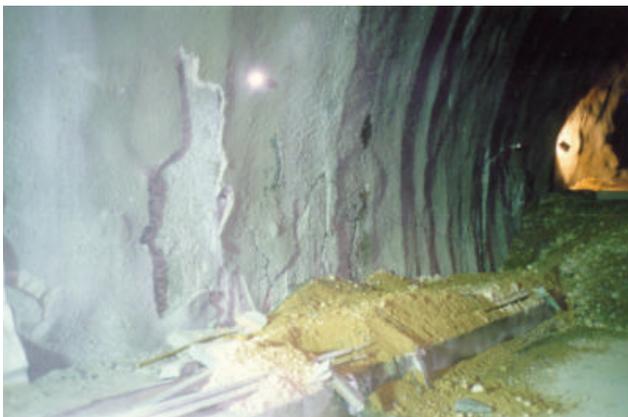
Figure 33. Spalled shotcrete liner segment.

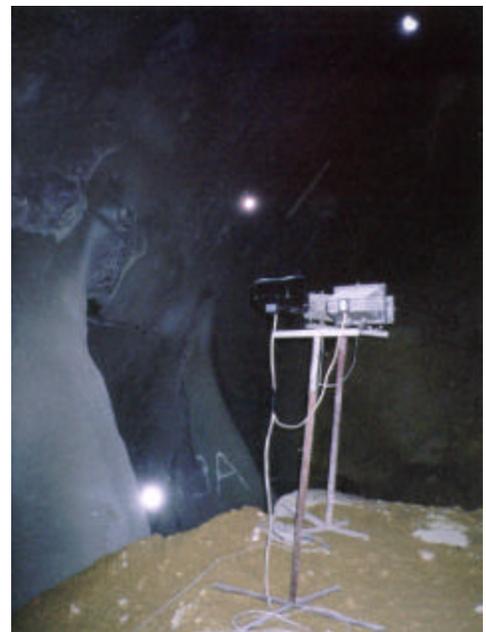
Figure 34. Spalled shotcrete at sets.

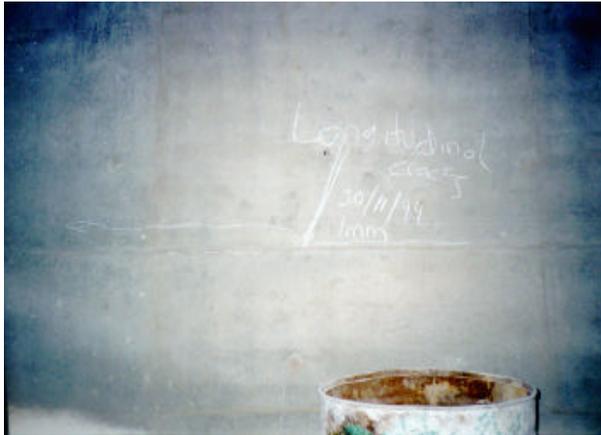
5. One-millimeter-wide longitudinal and radial cracks were observed in the structurally complete reinforced-concrete liner (Figures 35 and 36).
6. Cracking of the reinforced-concrete utility box beams was also noted (Figures 37 and 38).

Figure 35. Longitudinal cracking of concrete liner

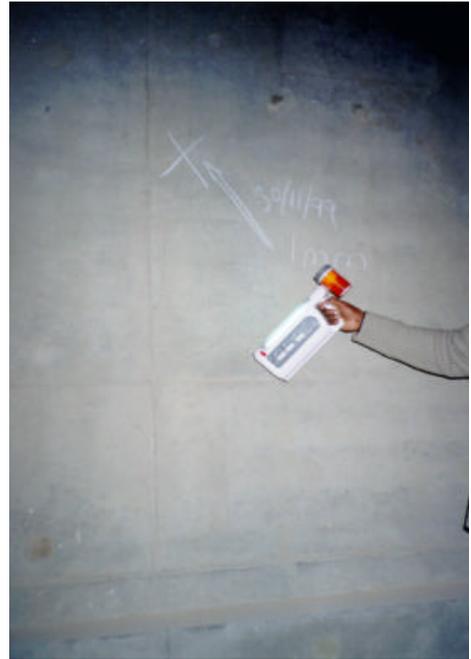
Figure 36. Radial cracking of concrete liner

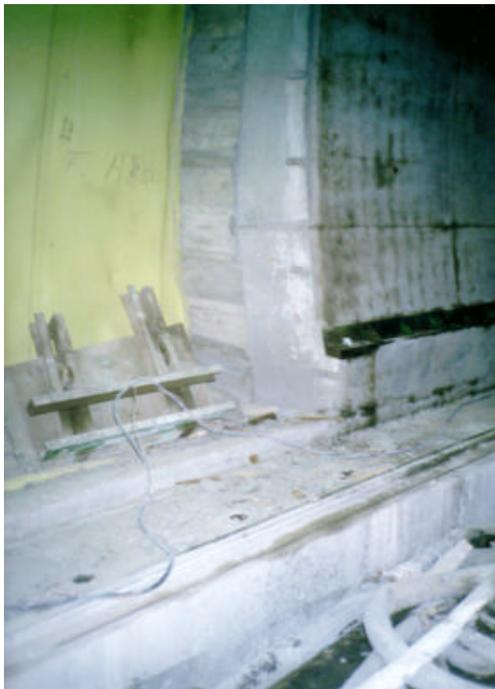
Figure 37. Utility box beam cracking.

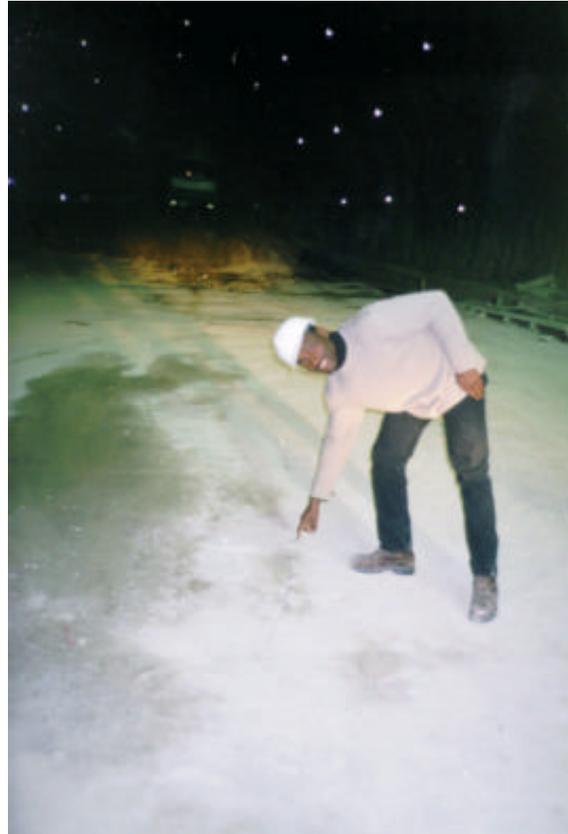
9. Longitudinal cracking along a segment above the tunnel invert, near the collapsed face, was noted (Figure 39). It was reported by the consultant that the invert had heaved upwards as much as 1 m.

Figure 39. Longitudinal cracking above invert.
