Postearthquake Reconnaissance Report on Transportation Infrastructure Impact of the February 27, 2010, Offshore Maule Earthquake in Chile

PUBLICATION NO. FHWA-HRT-11-030

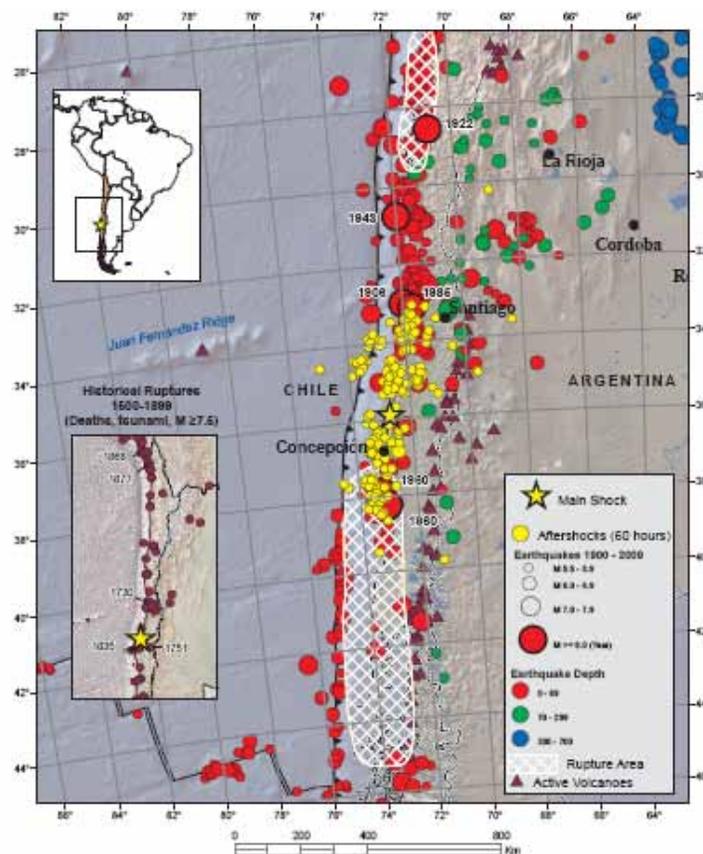
Figure 4. Map. Historic seismicity for Chile.⁽¹⁾

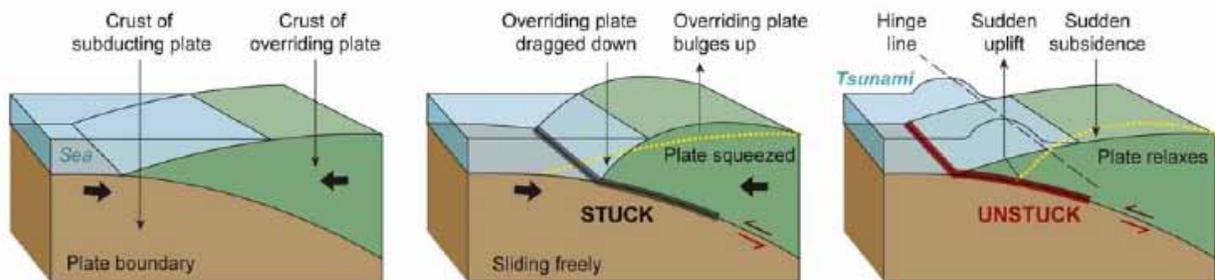
Figure 5. Illustration. Conceptual diagram of a subduction zone earthquake.^(2,4)

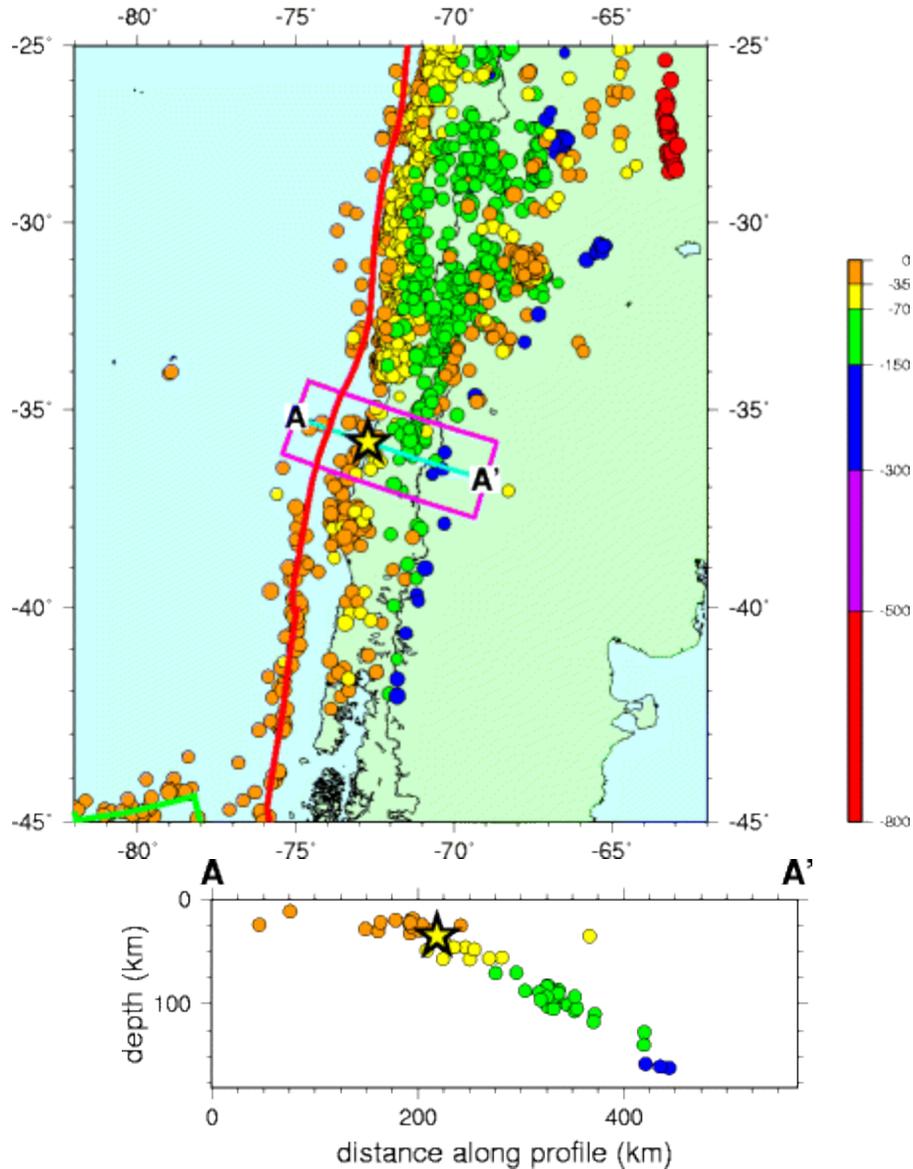
Another key aspect of this type of earthquake is the tendency of such an event to produce many strong aftershocks as the plates adjust to the sudden change in stresses following rupture. The aftershocks themselves can produce a significant hazard to the structures and facilities damaged by the main shock, as well as to the people within or near the partially damaged structures. Figure 4 and figure 6 show maps illustrating the number and distribution of aftershocks, some of which approached M7.0. The cross section of the aftershock locations as a function of depth and distance in figure 6 illustrates the location of the rupture surface. The hypocenter of the main shock is marked with a star.

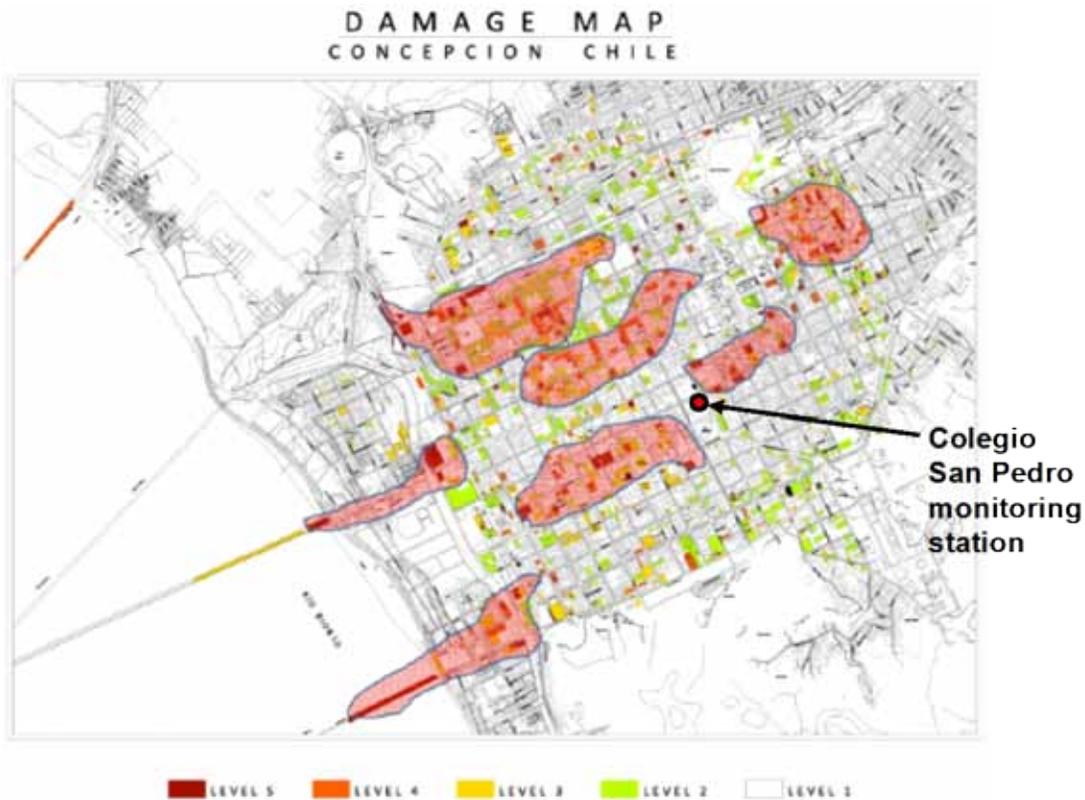
Figure 21. Map. Damaged sections in downtown Concepción.⁽²⁾

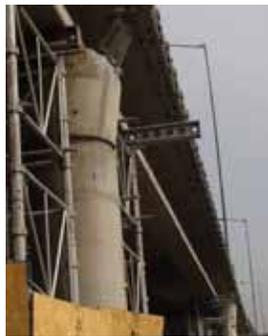
Figure 23. Photo. Damage to eastbound Independencia bridge.

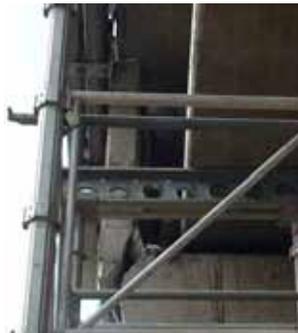
Figure 24. Photo. Curtain wall at east abutment of eastbound Independencia bridge.

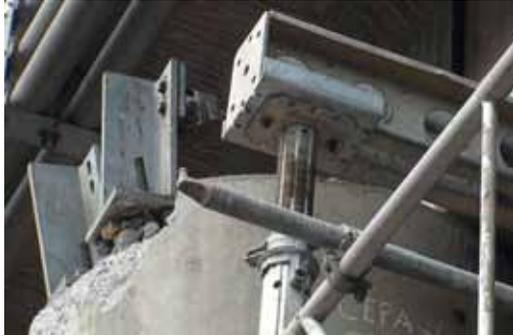
Figure 25. Photo. Damage to steel stoppers on eastbound Independencia bridge.

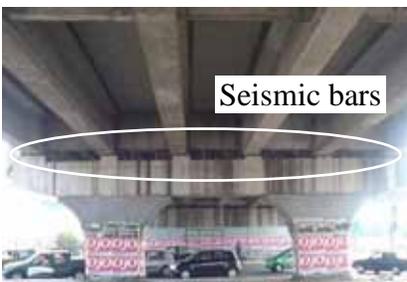
Figure 27. Photo. Typical flared wall pier of westbound Independencia bridge.

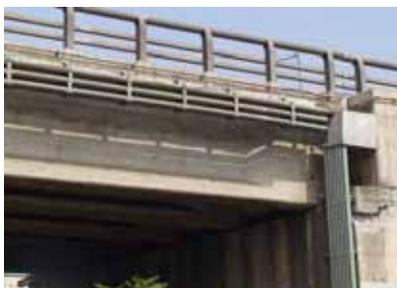
Figure 29. Photo. Shear key damage at abutment of westbound Independencia bridge.

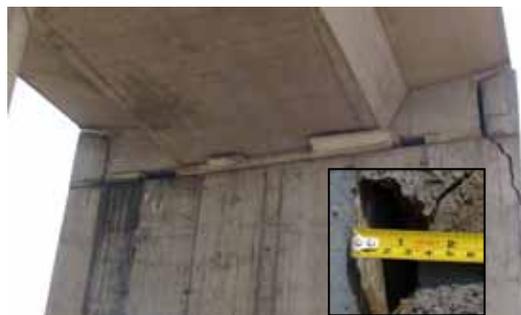
Figure 33. Photo. Shear key damage at entrance ramp abutment.

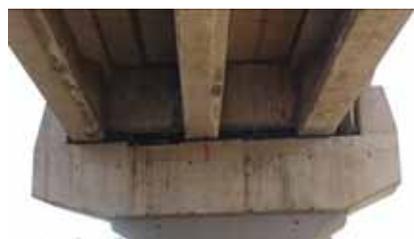
Figure 34. Photo. Flared wall pier of exit ramp from westbound Independencia bridge.

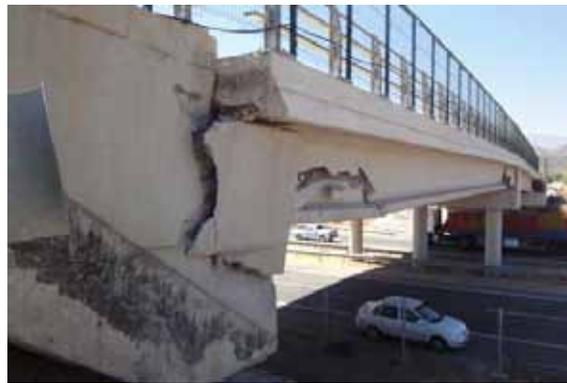
Figure 36. Photo. Curtain wall shear failure at abutment of Chada bridge.

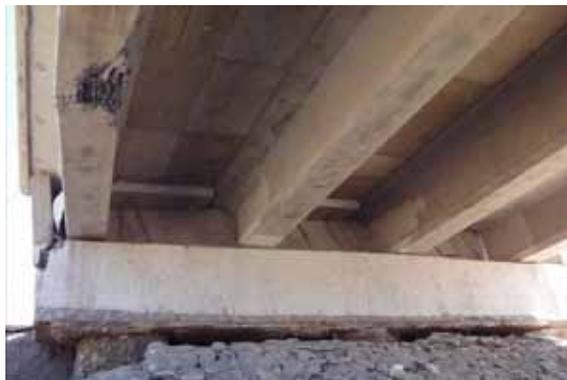
Figure 37. Photo. Bottom flange damage to Chada bridge.

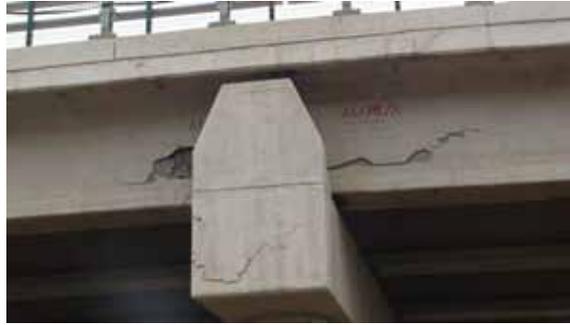
Figure 38. Photo. Curtain wall damage at bent of Chada bridge.

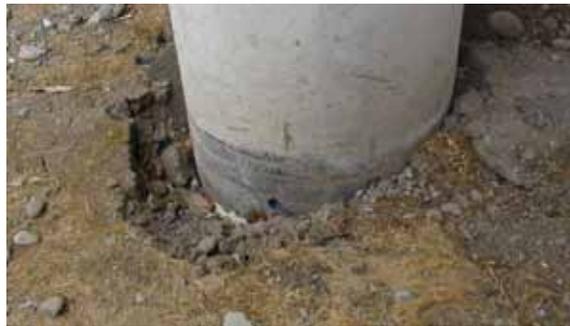
Figure 39. Photo. Soil separation from column of Chada bridge.

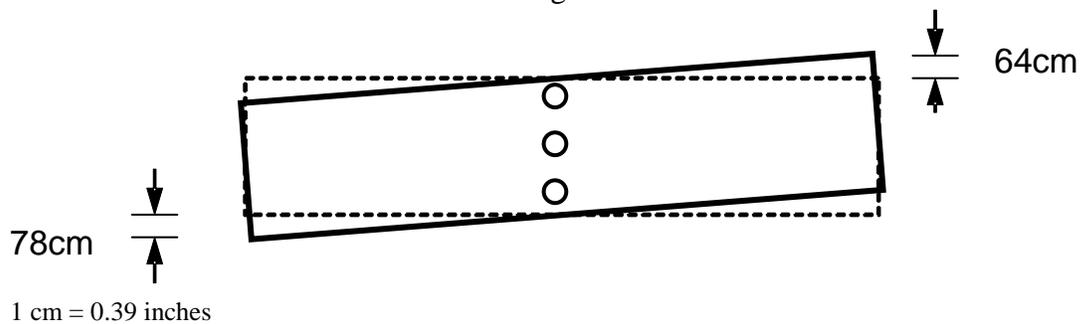
Figure 40. Illustration. Plan view of superstructure rotation of Chada bridge.

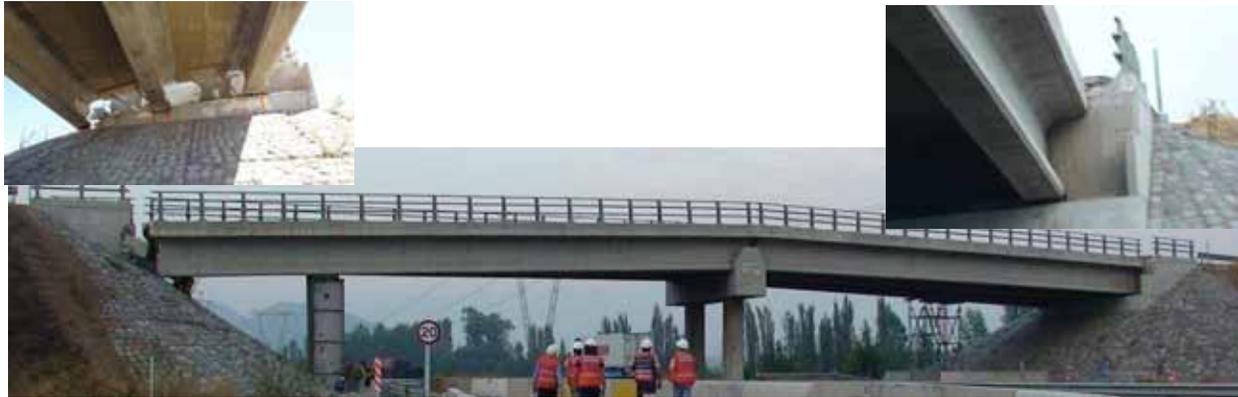
Figure 41. Photo. Las Mercedes bridge and girder unseating at abutments.

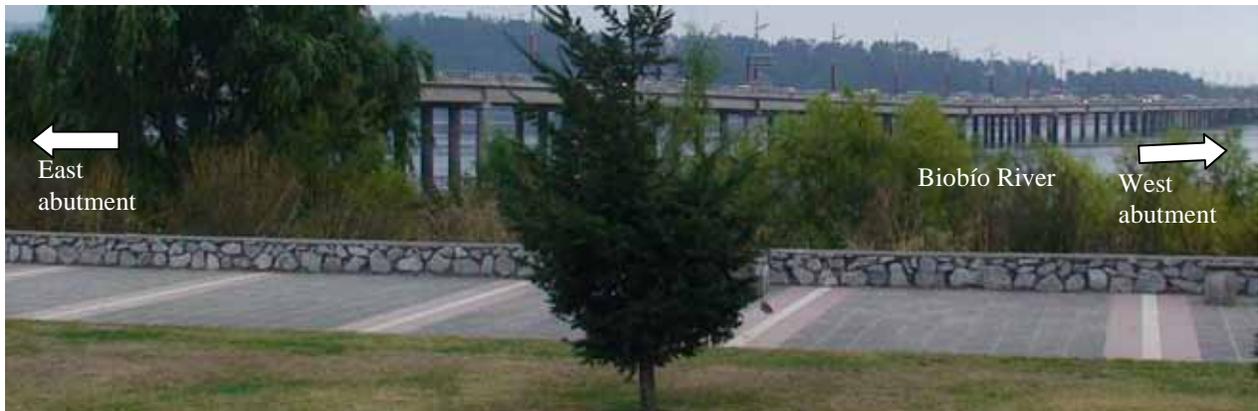
Figure 42. Photo. Llacolen bridge looking south-southwest.

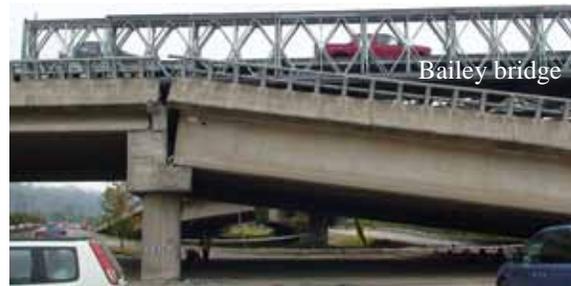
Figure 43. Photo. Unseated simply supported span in eastern approach to Llacolen bridge.

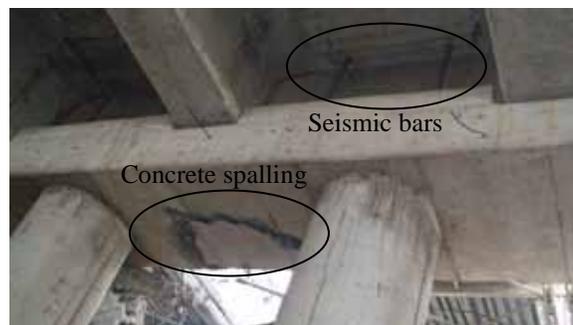
Figure 45. Photo. Concrete spalling beneath cap beam of eastern approach to Llacolen bridge.

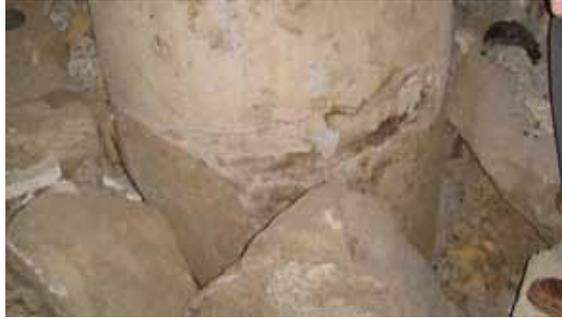
Figure 46. Photo. Flexural cracks at the level of rip rap on eastern approach to Llacolen bridge.

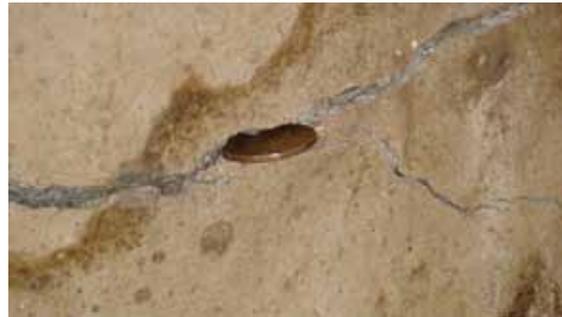
Figure 47. Photo. Close-up view of cracks at the level of rip rap on eastern approach to Llacolen bridge.

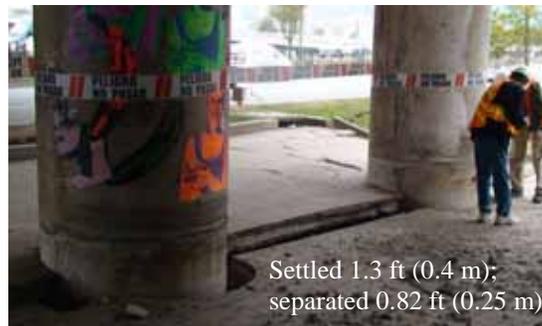
Figure 48. Photo. Ground settlement and lateral movement of eastern approach to Llacolen bridge.

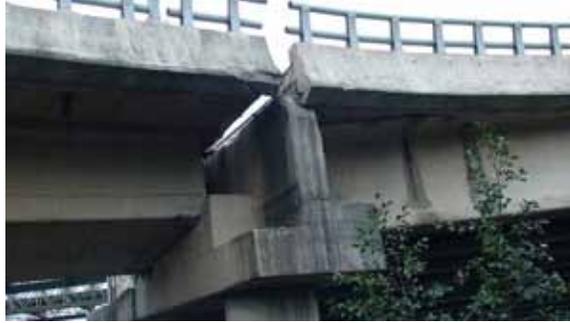
Figure 49. Photo. Exterior face of westbound ramp to Llacolen bridge at the river end.

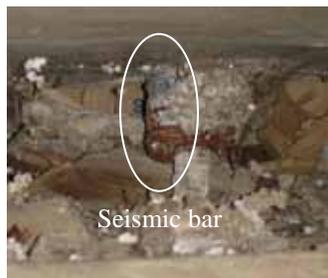
Figure 52. Photo. Seismic bar condition on westbound ramp to Llacolen bridge.

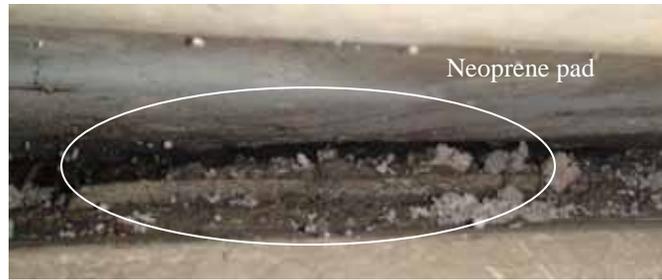
Figure 53. Photo. Neoprene pad degradation on westbound ramp to Llacolen bridge.

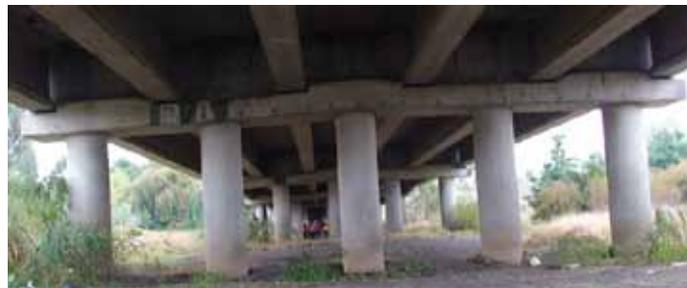
Figure 54. Photo. Columns with soil marks indicating ground settlement at west end of Llacolen bridge.

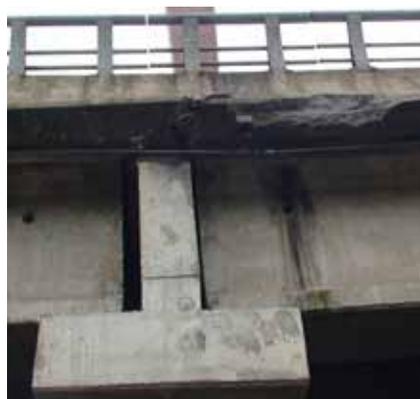
Figure 56. Photo. Spalling in deck slab at west end of Llacolen bridge.

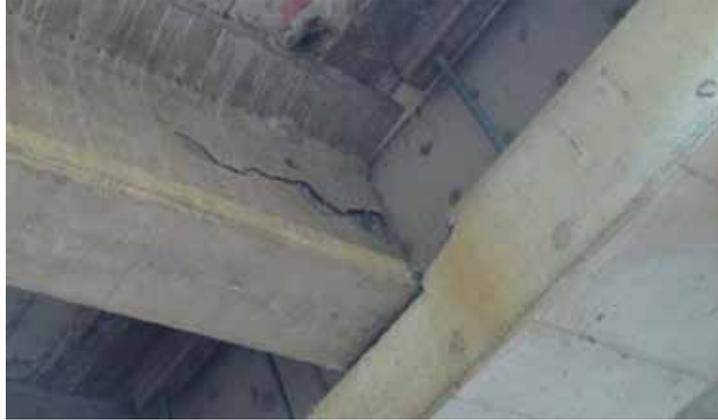
Figure 57. Photo. Horizontal crack in web of end girders at west end of Llacolen bridge.

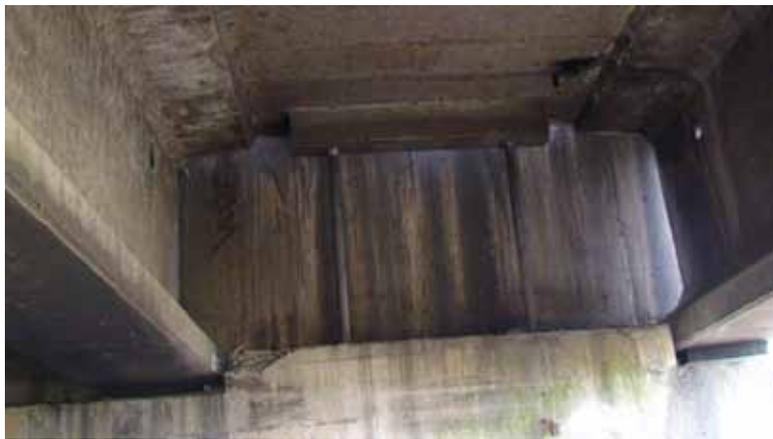
Figure 58. Photo. Spalling of shear key at southwest abutment of Llacolen bridge.

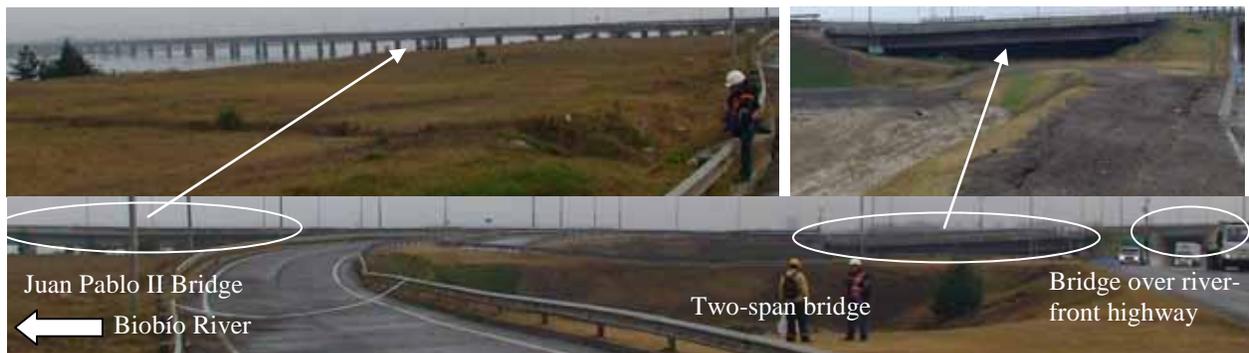
Figure 59. Photo. Approaches to Juan Pablo II bridge.

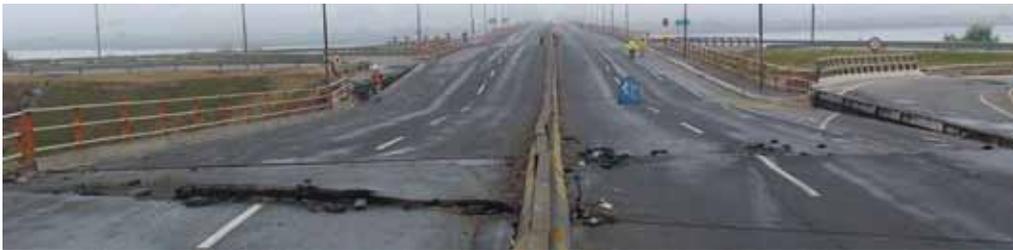
Figure 60. Photo. Southwest view of northern approach to Juan Pablo II bridge, facing Biobío River.

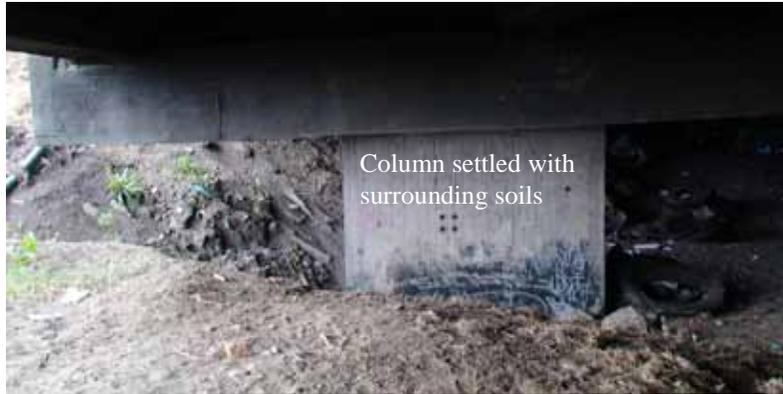
Figure 63. Photo. Column settlement under approach to Juan Pablo II bridge (cracks on far side).

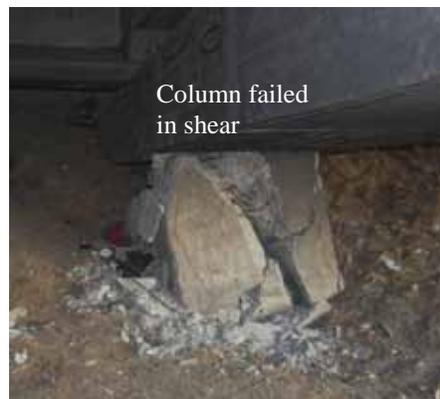
Figure 64. Photo. Reduced column height due to shear failure under approach to Juan Pablo II bridge.

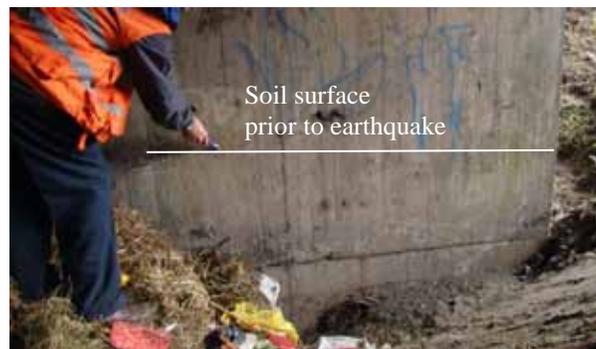
Figure 65. Photo. Soil surface on far side of undamaged column under approach to Juan Pablo II bridge.

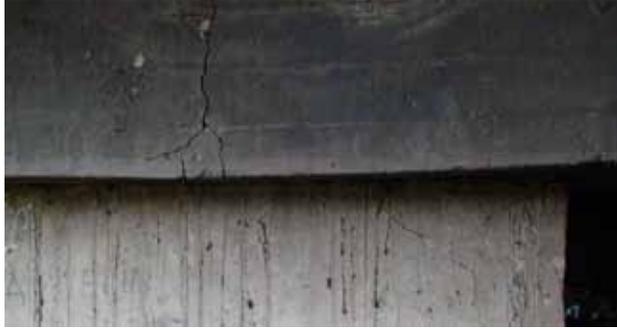
Figure 66. Photo. Cracks on far side of undamaged column under approach to Juan Pablo II bridge.

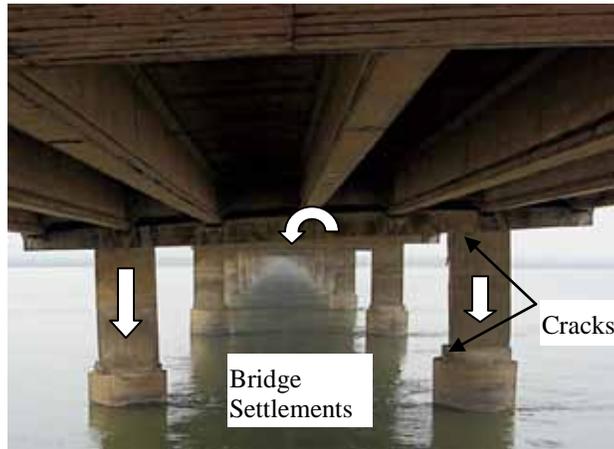
Figure 67. Photo. Differential settlement underneath first span over water at northern end of Juan Pablo II bridge.

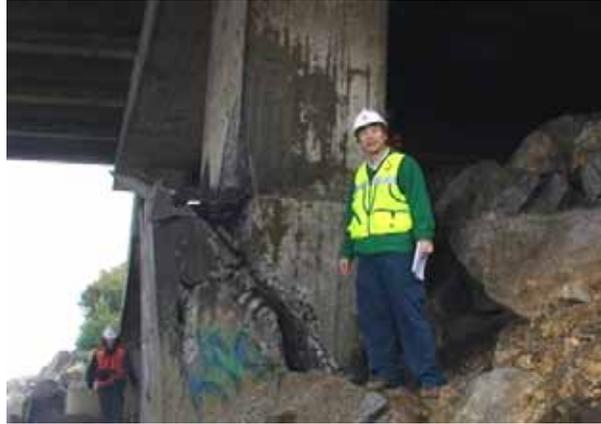
Figure 68. Photo. Shear failure in upstream column at northern end of Juan Pablo II bridge.

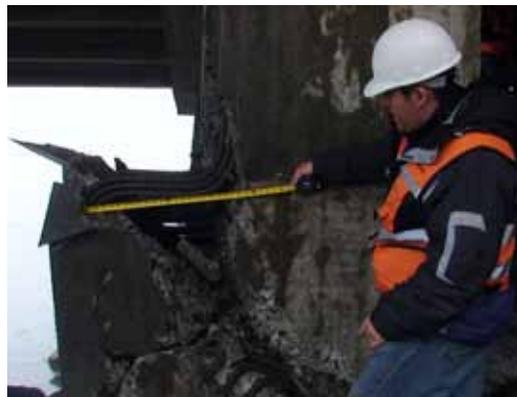
Figure 69. Photo. Front face of failure plane at northern end of Juan Pablo II bridge.

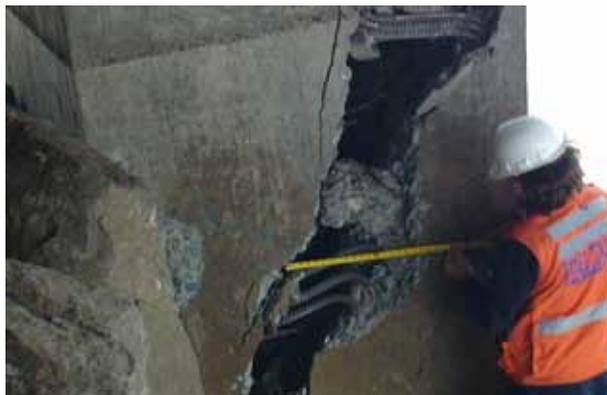
Figure 70. Photo. Back face of failure plane at northern end of Juan Pablo II bridge.

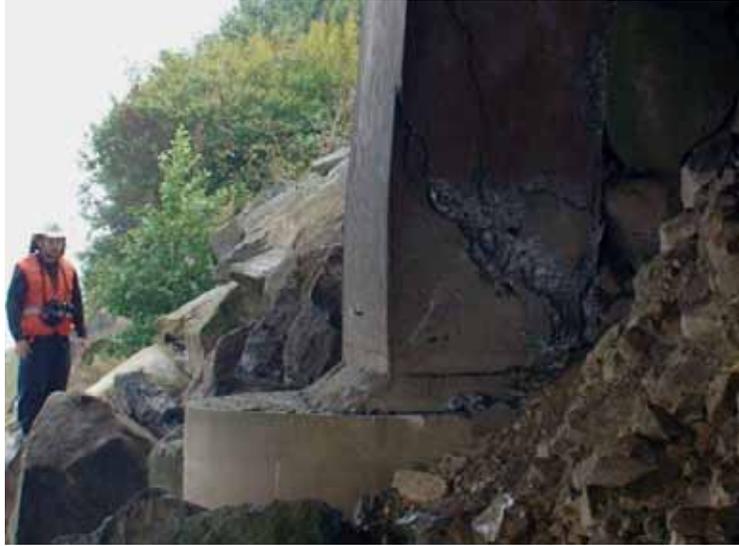
Figure 71. Photo. Shear failure in downstream column at northern end of Juan Pablo II bridge.

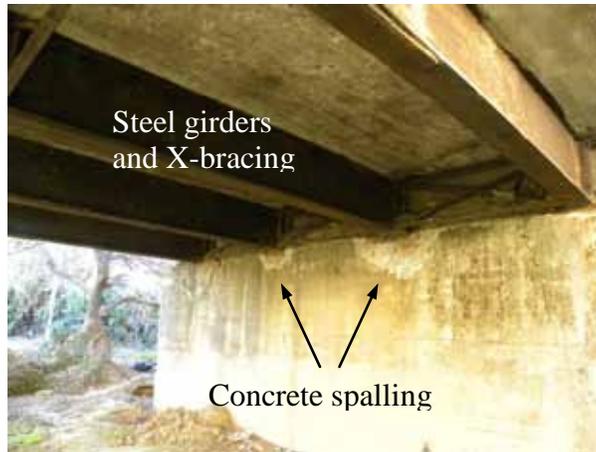
Figure 78. Photo. Abutment damage beneath west Ramadillas bridge.

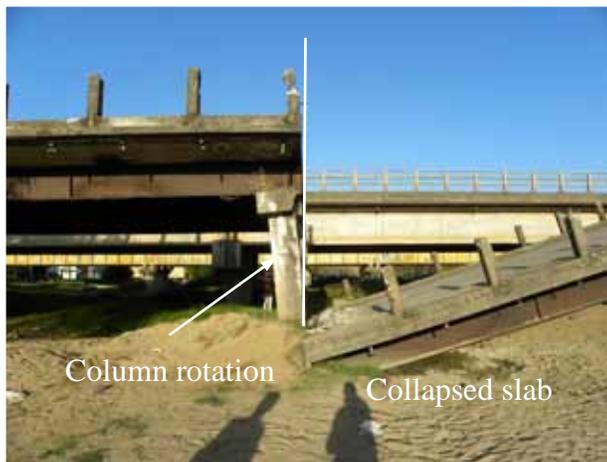
Figure 79. Photo. Pier rotation in collapsed span of west Ramadillas bridge.

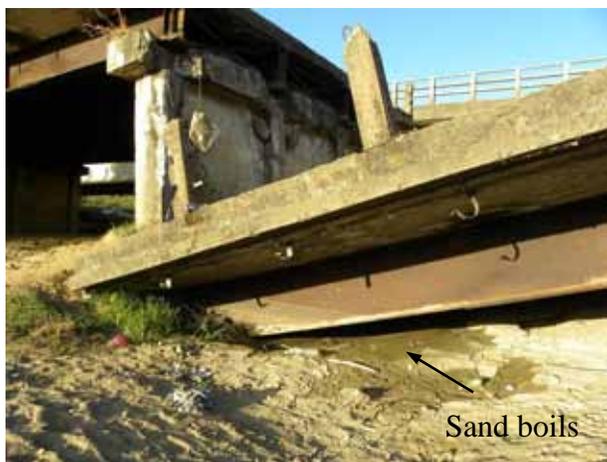
Figure 80. Photo. Sand boils near collapsed span in west Ramadillas bridge.

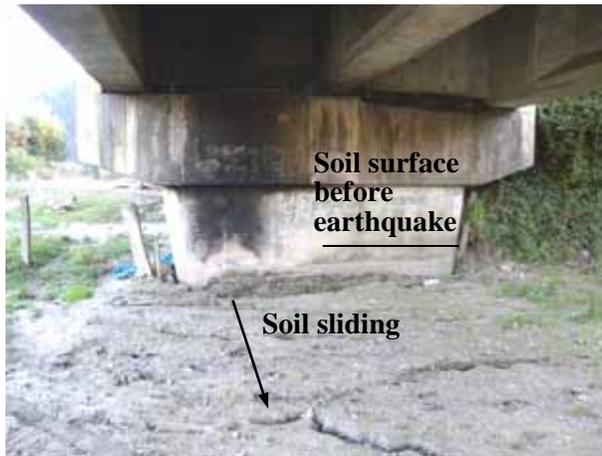
Figure 81. Photo. Settlement at south abutment under east Ramadillas bridge.

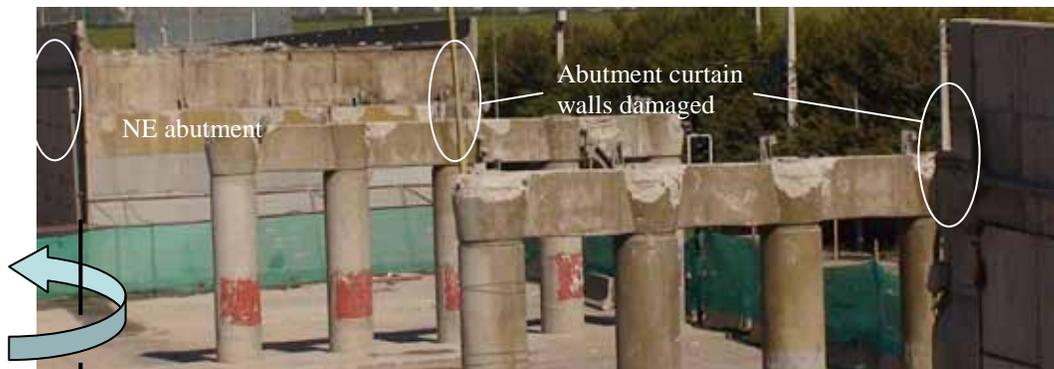
Figure 89. Photo. Miraflores bridge after removal of superstructure.

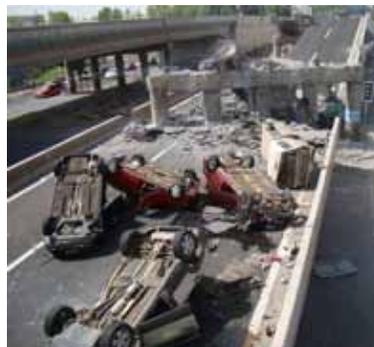
At the Lo Echevers bridge site, two parallel bridges had spans of 91.3, 119.1, and 91.3 ft (27.84, 36.32, and 27.84 m). As shown in figure 92 and figure 93, the southwest-bound bridge suffered minor damage while the northeast-bound bridge collapsed. The bridges did not have end diaphragms and appeared to have had an S-shaped superelevation. Each three-span precast prestressed girder bridge had five discontinuous girders and a continuous deck slab. The abutments and two intermediate piers were skewed approximately 33 degrees. Each girder was supported on a neoprene pad and a concrete pedestal at both ends. The girders were restrained by a pair of steel stoppers with 0.4- and 2-inch (10- and 50-mm) gaps for vertical and horizontal motions. Details of the steel stoppers are shown in figure 26.

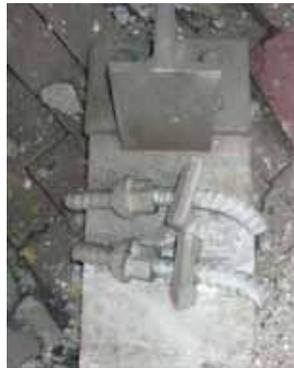
Figure 94. Photo. Failure of a steel stopper on Lo Echevers bridge.

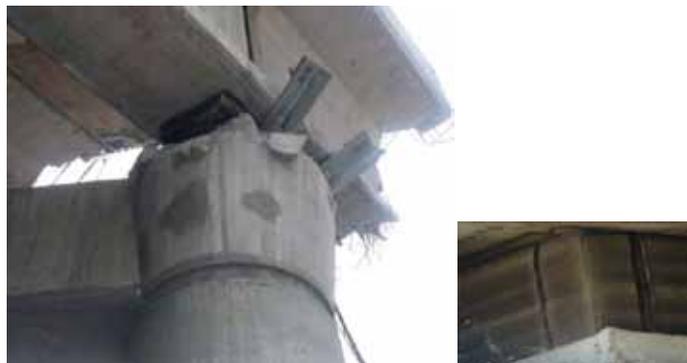
Figure 95. Photo. Displaced elastomeric bearing on Lo Echevers bridge.

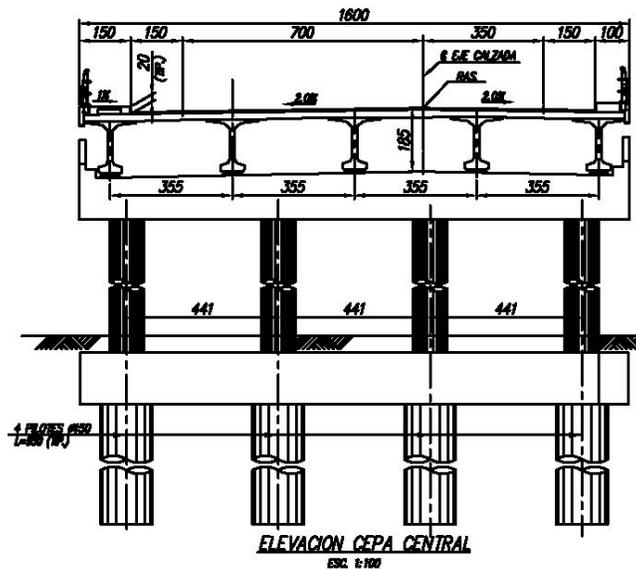
Figure 96. Illustration. Intermediate bent details for Romero bridge.

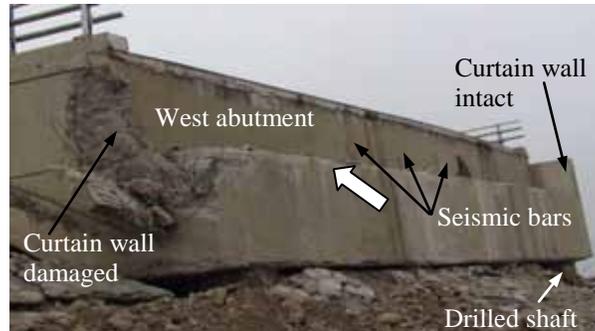
Figure 98. Photo. Seismic bars at west abutment of Romero bridge.

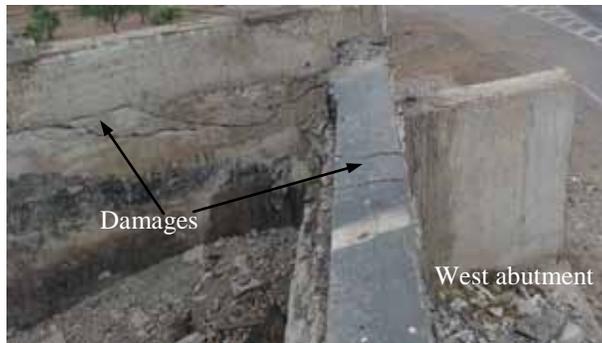
Figure 101. Photo. Back wall and wing wall damage at west abutment of Romero bridge.

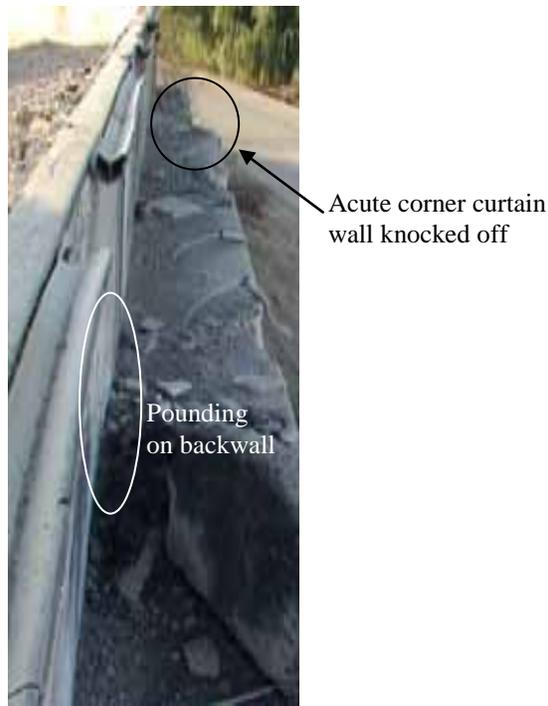
Figure 104. Photo. Damage at north abutment of Route 5 overcrossing at Hospital.

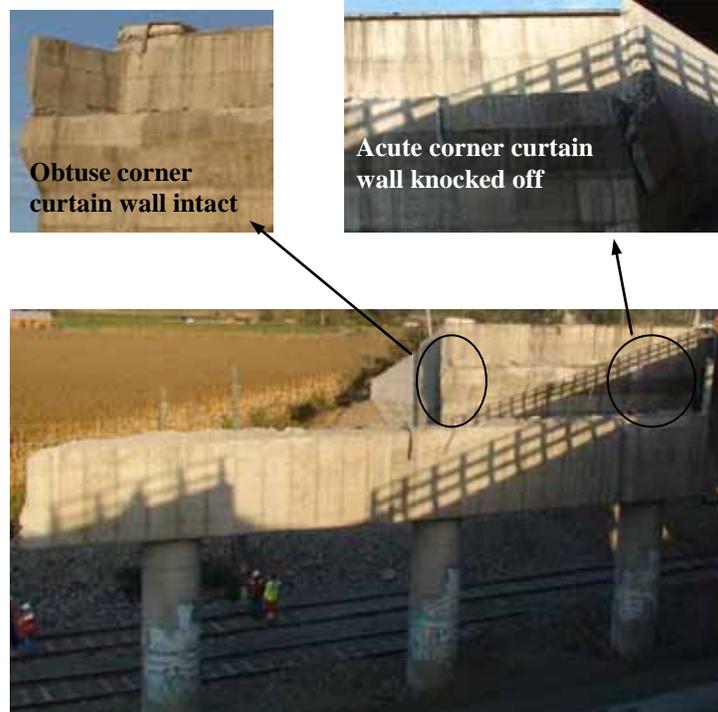
Figure 105. Photo. Damage at south abutment of Route 5 overcrossing at Hospital.

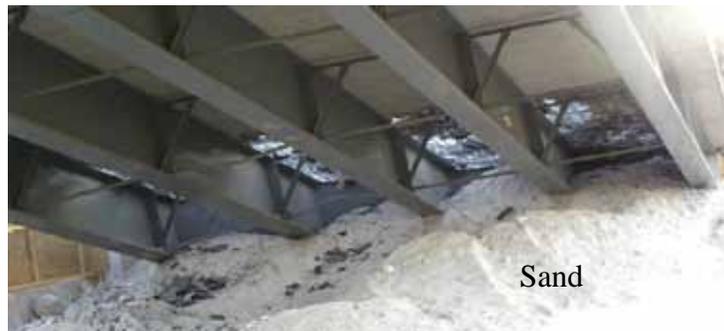
Figure 111. Photo. West span of Quilicura railway overcrossing lowered onto sandbank.

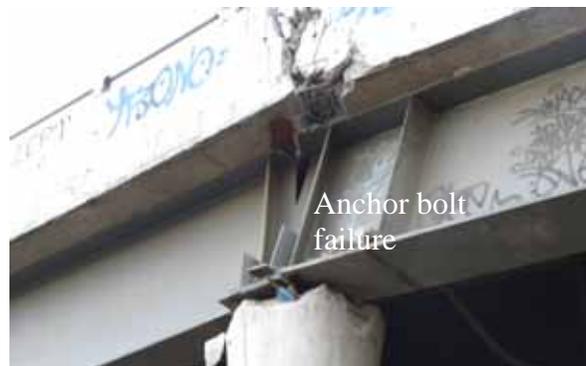
Figure 112. Photo. Damage to anchor bolts on Quilicura railway overcrossing.

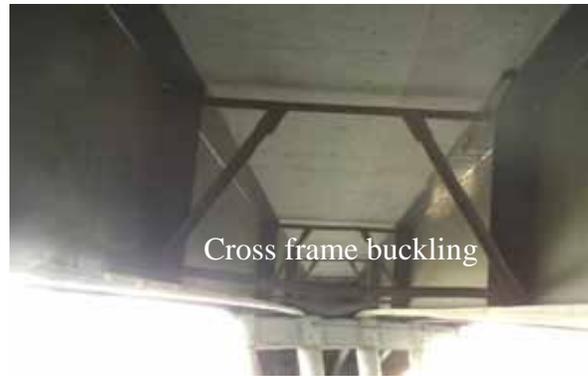
Figure 113. Photo. Damage to cross frame on Quilicura railway overcrossing.

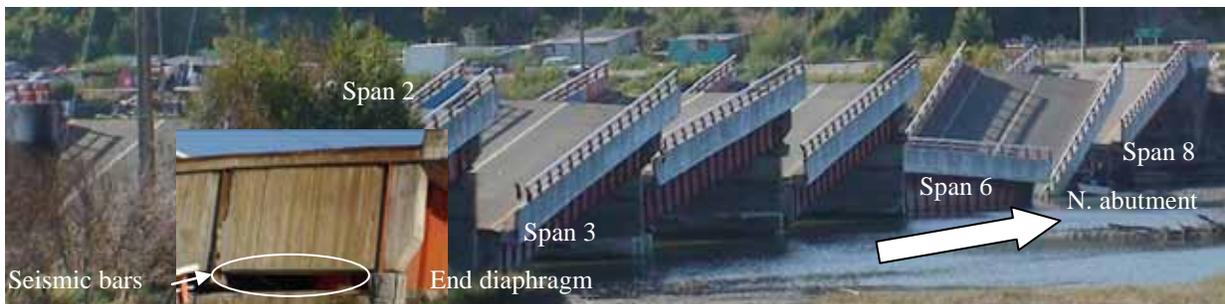
Figure 114. Photo. Unseating at southern ends of each span of Tubul bridge.

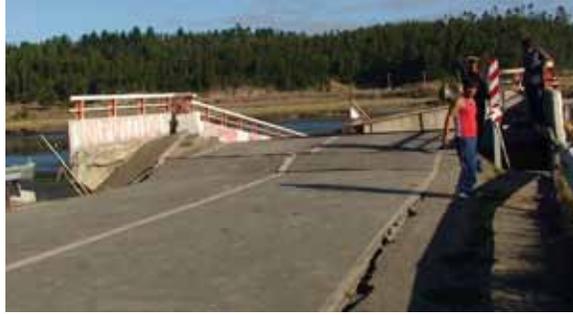
Figure 116. Photo. Buckling of pavement at north abutment of Tubul bridge.

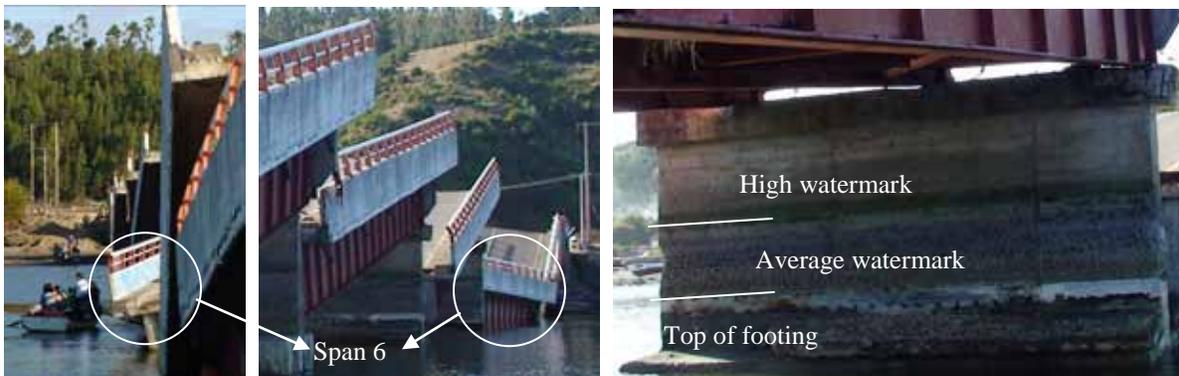
Figure 117. Photo. Span 6 of Tubul bridge, unseated at north end during an aftershock.

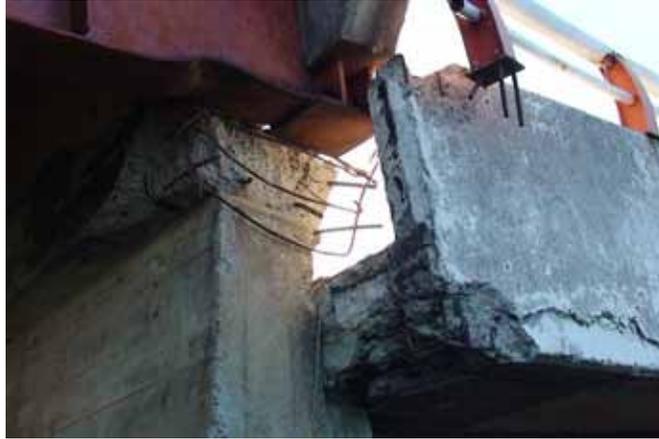
Figure 118. Photo. Bottom flange buckling and concrete spalling on Tubul bridge.

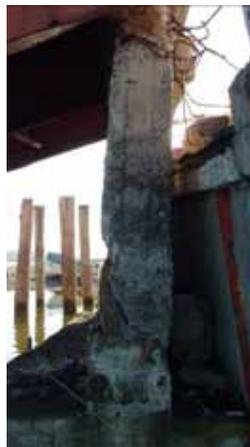
Figure 119. Photo. Shear crack in Tubul bridge.

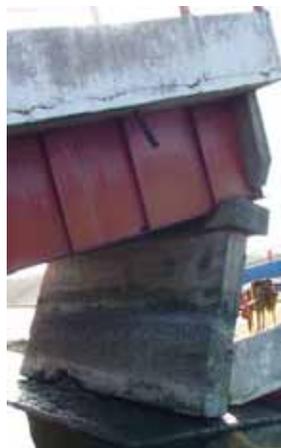
Figure 120. Photo. Tilting wall pier on Tubul bridge.

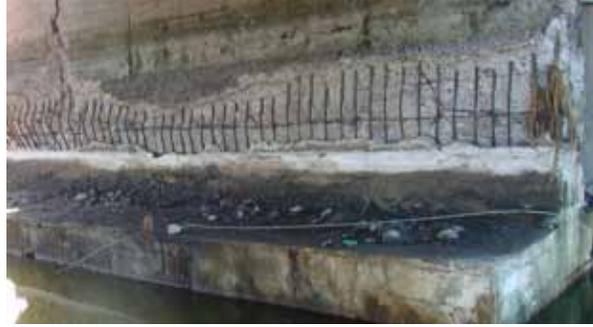
Figure 121. Photo. Spalling due to shear action and vertical crack in Tubul bridge.

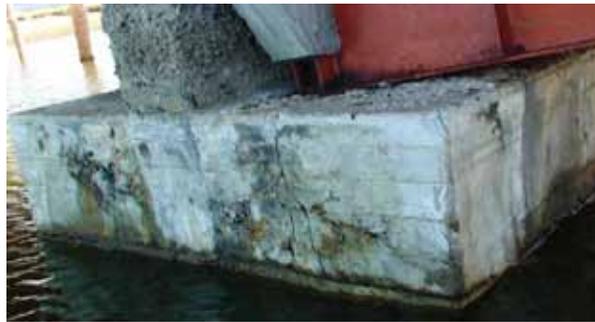
Figure 122. Photo. Crack in footing of Tubul bridge.

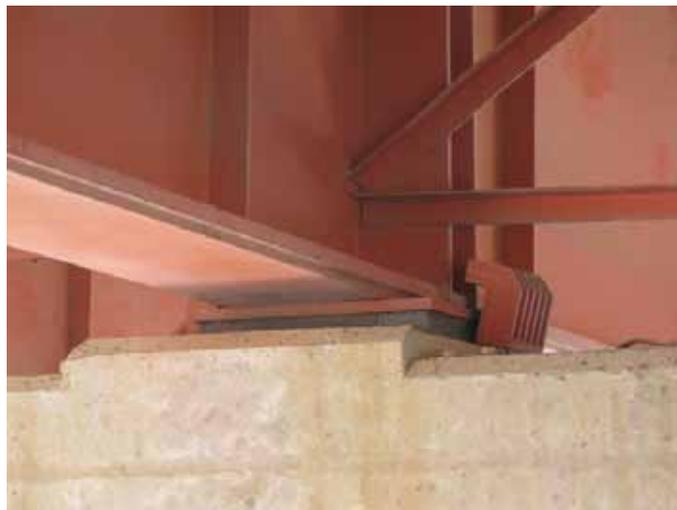
Figure 124. Photo. Elastomeric pad and stopper over bent on Cardenal Raúl Silva Henríquez bridge.

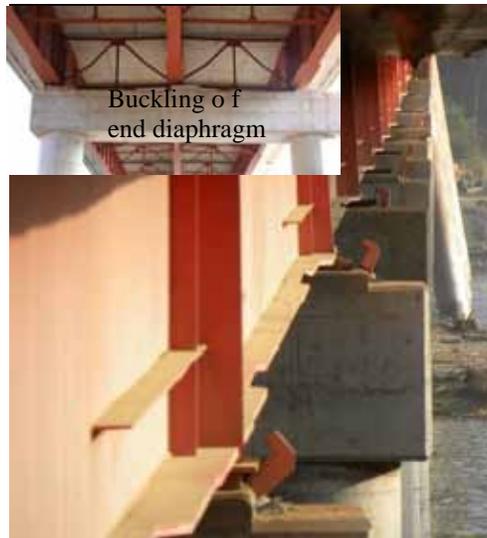
Figure 125. Photo. Girder offset and cross frame buckling on Cardenal Raúl Silva Henríquez bridge.

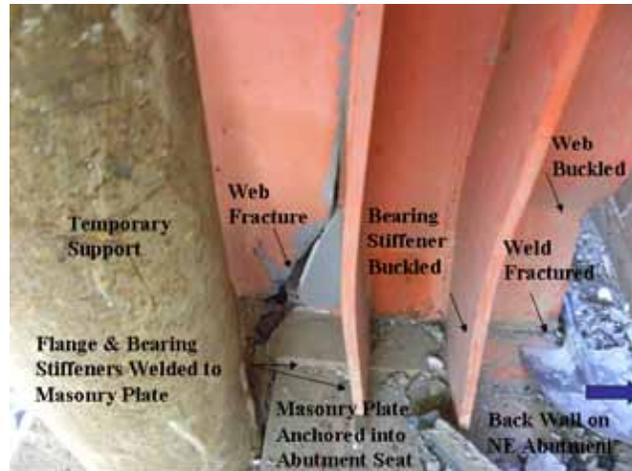
Figure 127. Photo. Girder damage at northeast abutment of Cardenal Raúl Silva Henríquez bridge.

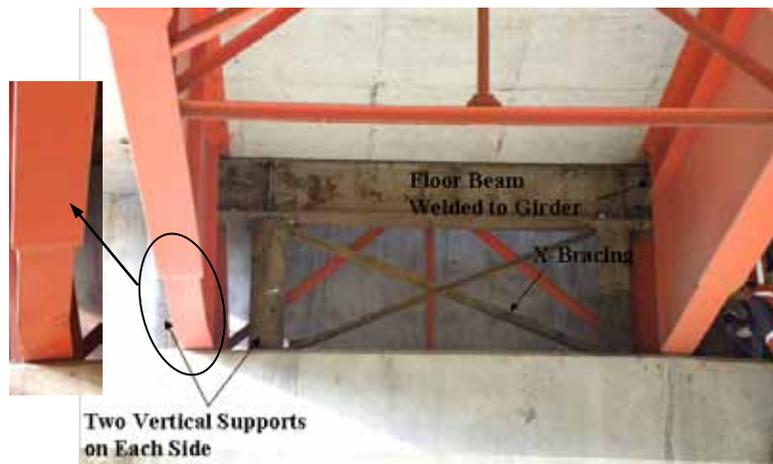
Figure 128. Photo. Temporary repair at northeast abutment of Cardenal Raúl Silva Henríquez bridge

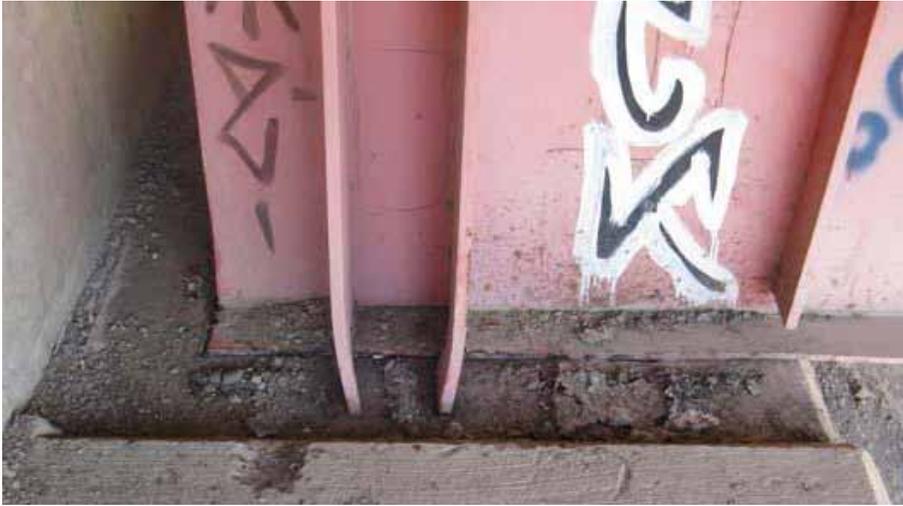
Although the details are similar, the damage to the girders at the southwest abutment was not as severe as at the northeast abutment and was limited to the buckling of the bearing stiffeners. The reason for this difference is probably that the fillet welds connecting the girder flanges and bearing stiffeners to the masonry plates failed during the earthquake and large longitudinal loads were not attracted to this abutment (see figure 132 through figure 134).

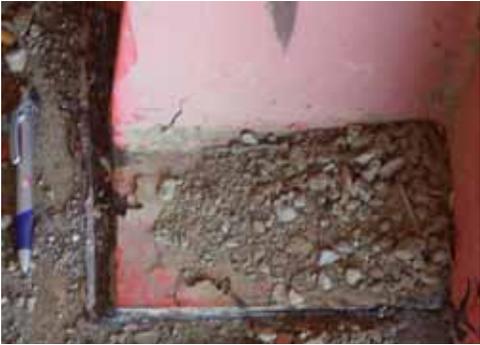
Figure 132. Photo. Fillet weld fractures at the girder-to-abutment connection on the Cardinal Raúl Silva Henríquez bridge.

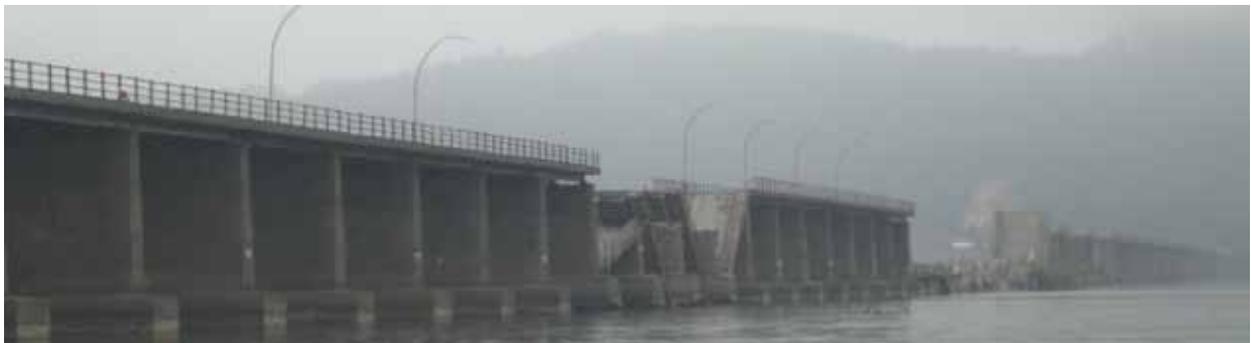
Figure 135. Photo. Collapsed spans in Biobío River bridge.

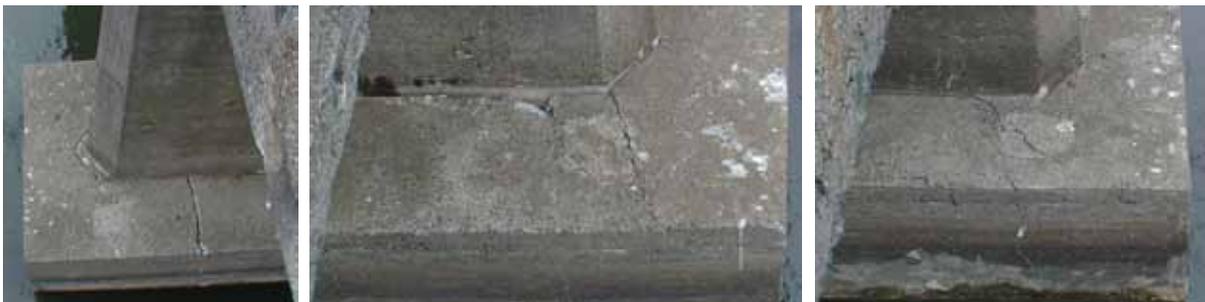
Figure 139. Photo. Cracks in pile caps of Biobío River bridge.

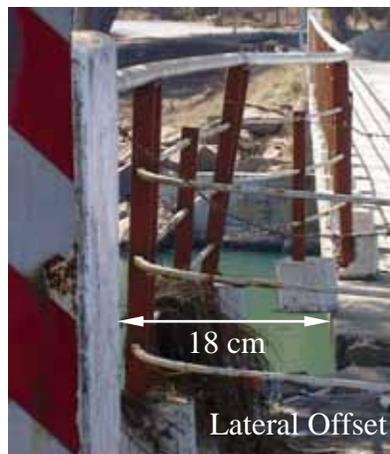
Figure 144. Photo. Offset in handrail on south abutment of Pichibudis bridge.

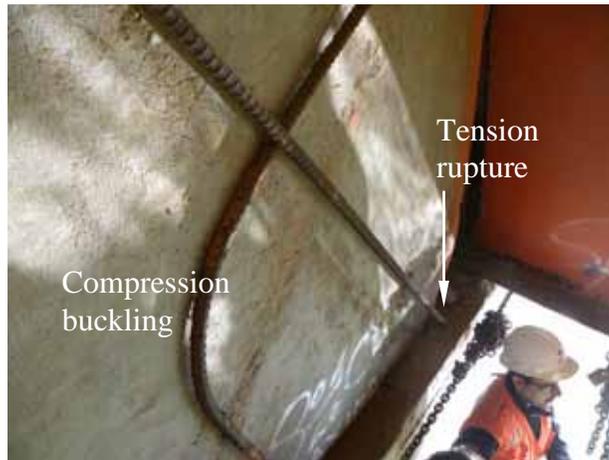
Figure 145. Photo. X-braces damage in south abutment of Pichibudis bridge.

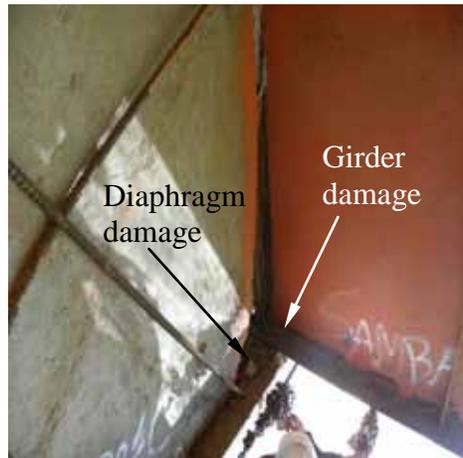
Figure 146. Photo. Diaphragm crushing in south abutment of Pichibudis bridge.
