Postearthquake Reconnaissance Report on Transportation Infrastructure Impact of the February 27, 2010, Offshore Maule Earthquake in Chile

PUBLICATION NO. FHWA-HRT-11-030

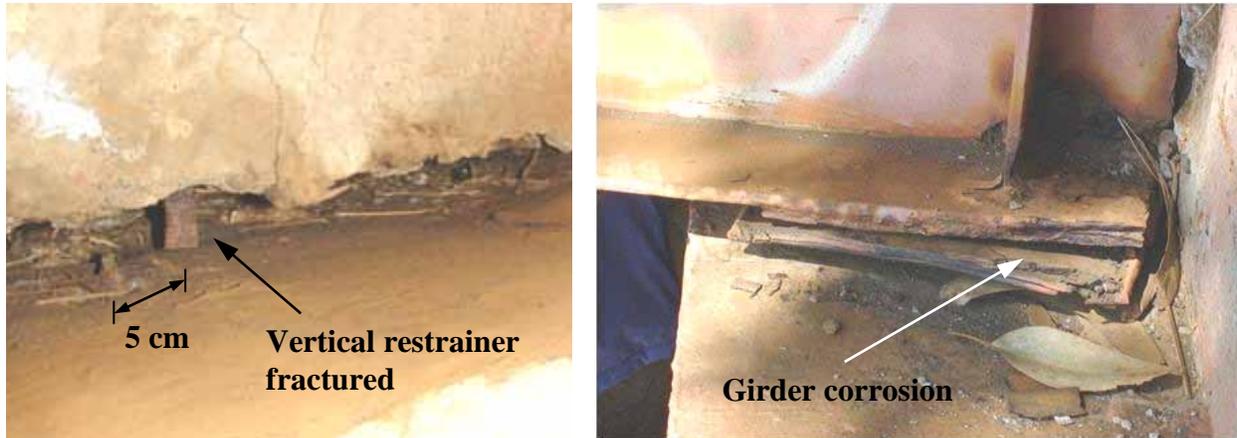
Figure 147. Photo. Damage on south abutment due to corrosion in Pichibudis bridge.

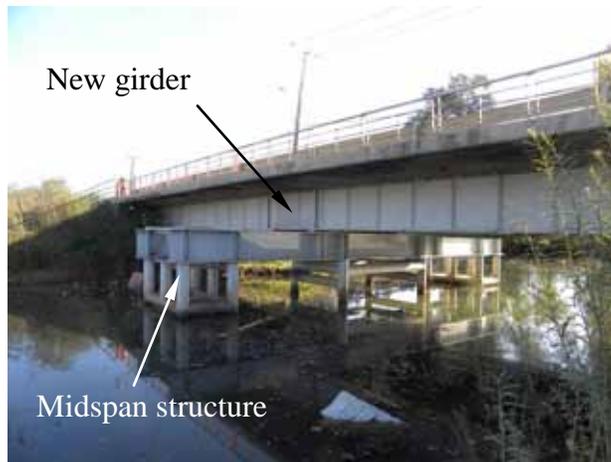
Figure 149. Photo. Side view of El Bar bridge.

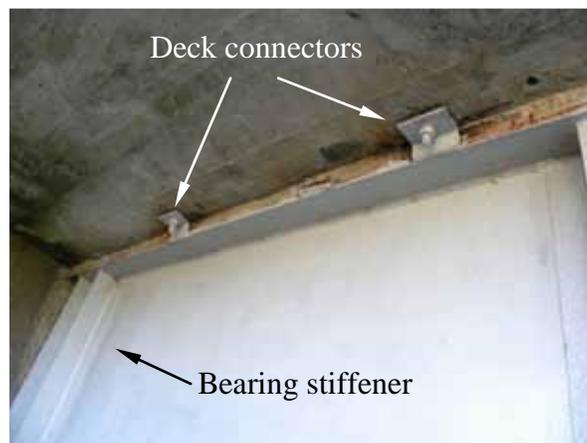
Figure 151. Photo. Retrofit deck connections on El Bar bridge.

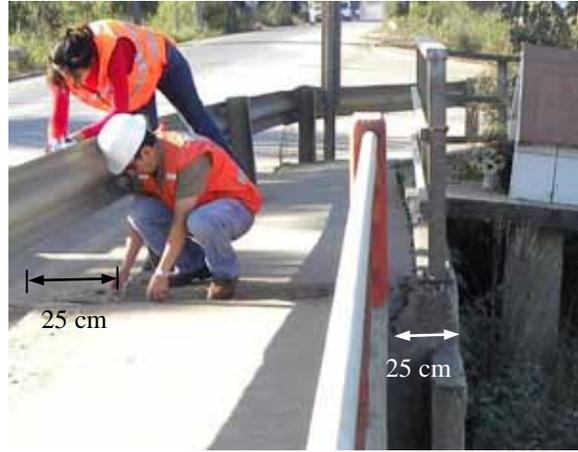
anchored to the abutment seat using vertical restraining bars (seismic bars). Earthquake damage observed at this support included large deformations in the rebar of the X-brace system (tension yielding and compression buckling), lateral deformation of the seismic restrainers, and concrete crushing of the original abutment back wall (see figure 154 and figure 155).

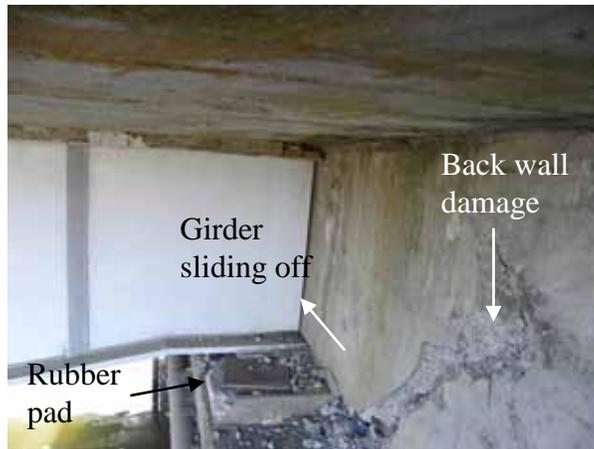
Figure 153. Photo. Damage at south abutment of El Bar bridge.

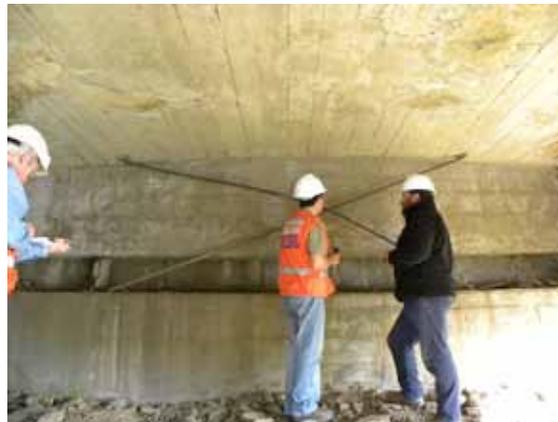
Figure 154. Photo. Damage to rebar X-brace system on north abutment of El Bar bridge.

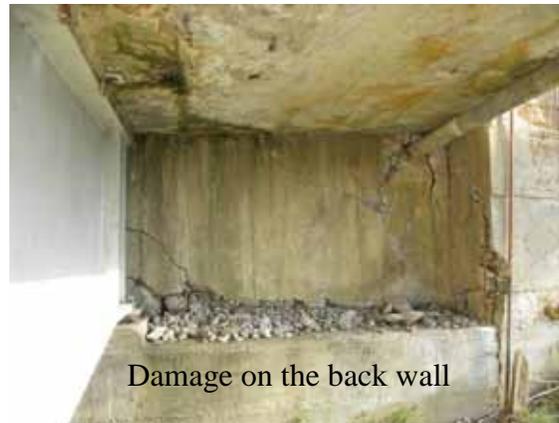
Figure 155. Photo. Damage to north abutment back wall of El Bar bridge.

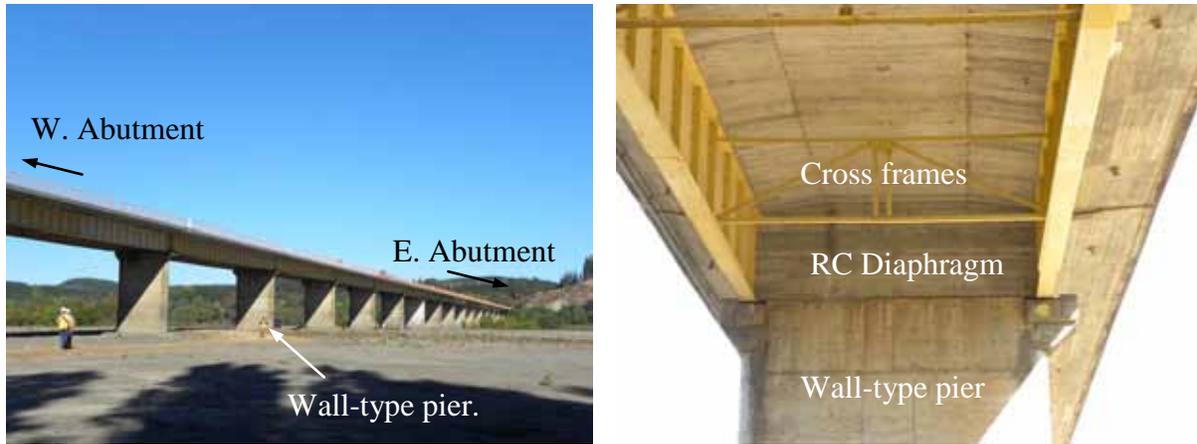
Figure 157. Photo. Side view and superstructure details for Itata River bridge.

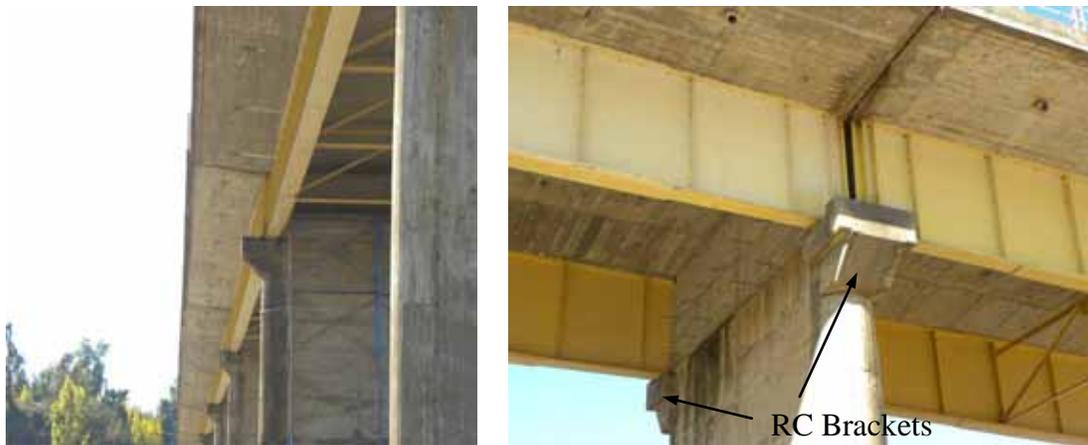
Figure 158. Photo. Girder supports at each pier of Itata River bridge.

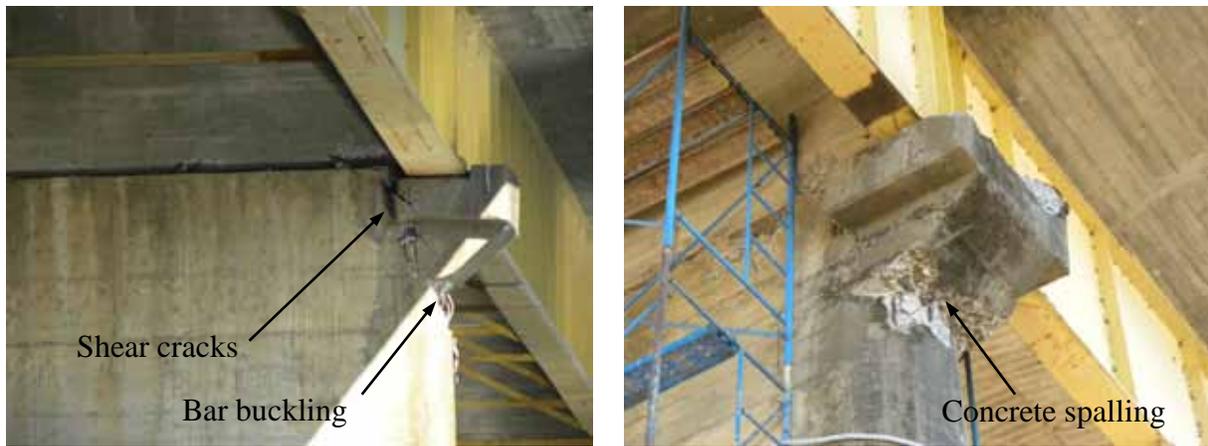
Figure 159. Photo. Damage to girder supports of Itata River bridge.

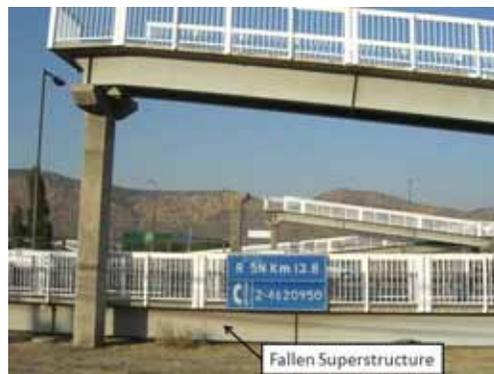
Figure 160. Photo. Damaged Route 5 pedestrian bridge.

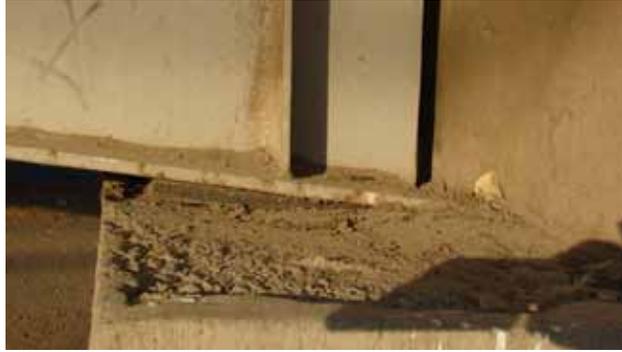
Figure 161. Photo. Steel girder on neoprene pad at abutment of Route 5 pedestrian bridge.

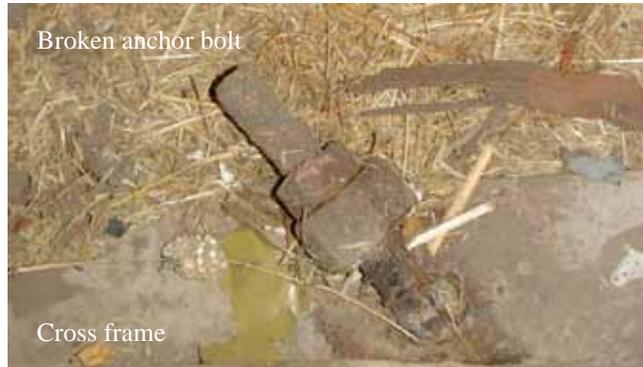
Figure 163. Photo. Anchor bolt failure (shear and pull out) on Route 5 pedestrian bridge.

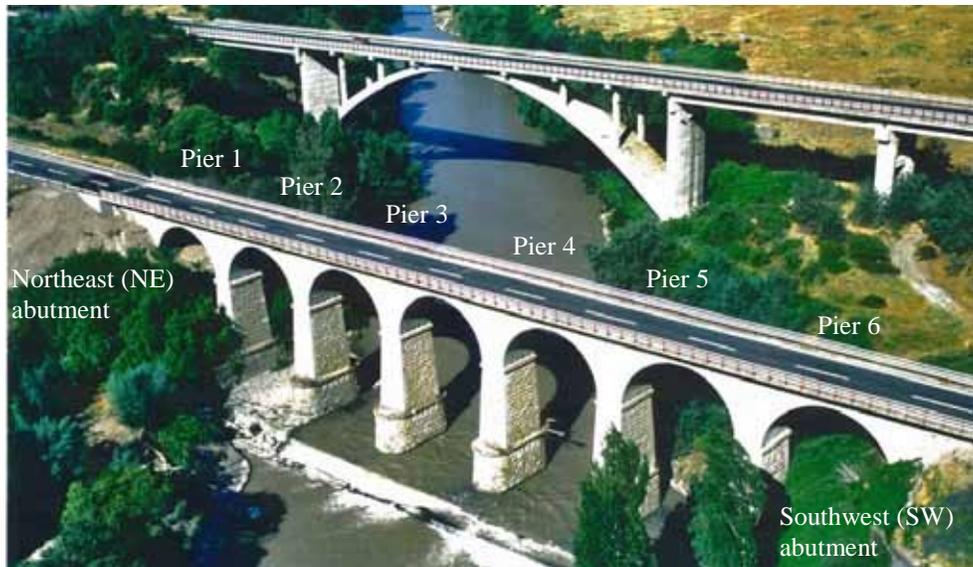
Figure 164. Illustration. Highway bridges crossing Claro River before earthquake.

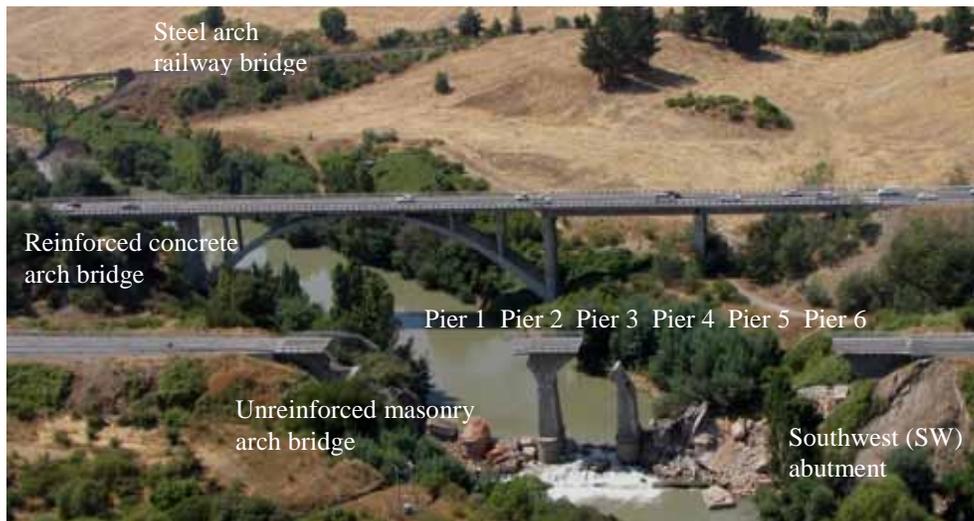
Figure 165. Photo. Collapse of masonry arch bridge at Claro River.

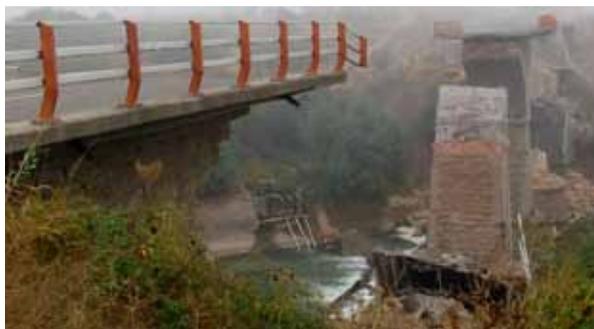
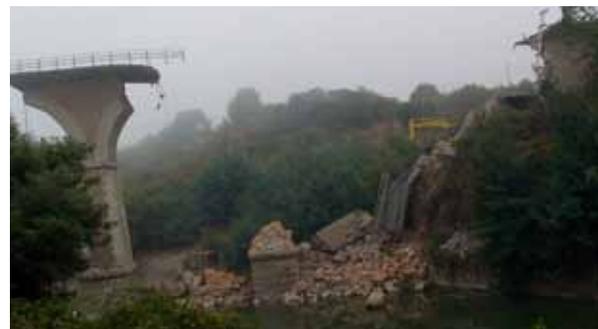
Figure 166. Photo. Close-up view of collapsed bridge at Claro River.

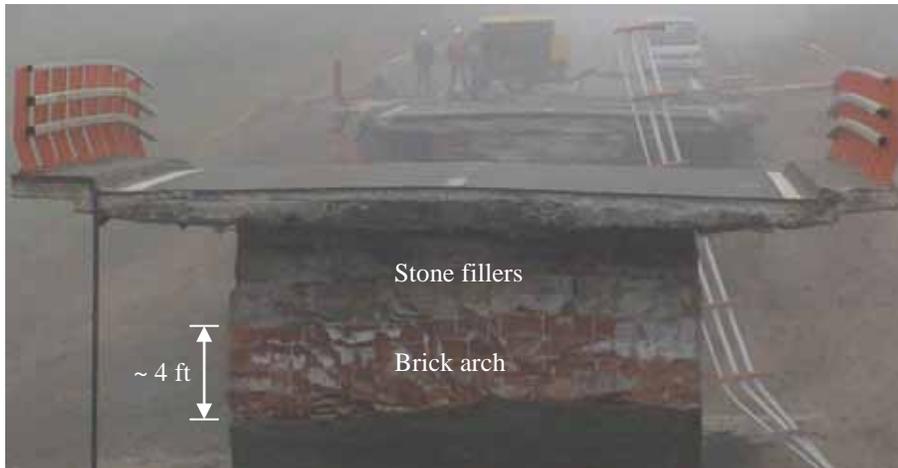
Figure 167 through figure 169 show details of various components of the bridge. The deck slab was approximately 8 to 10 inches (203 to 254 mm) thick, and the arch crown was approximately 4 ft (1.2 m) thick. The ribs and piers were constructed from solid brick with some stone fill above the brick ribs, as shown in figure 167 and figure 168, and faced with stone blocks or plastered with cement to give the appearance of stonework. Close inspection of the piers found some cracks between the bricks and stone facades, possibly due to shaking, but, in general, the masonry was in excellent condition. The foundations of the bridge were most likely made of stone blocks and seemed to have experienced little or no damage during the earthquake (see figure 169).

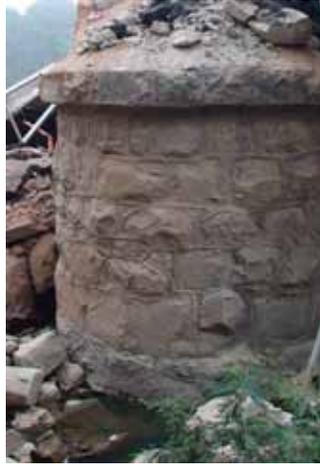
Figure 169. Photo. Foundation of Claro River bridge.

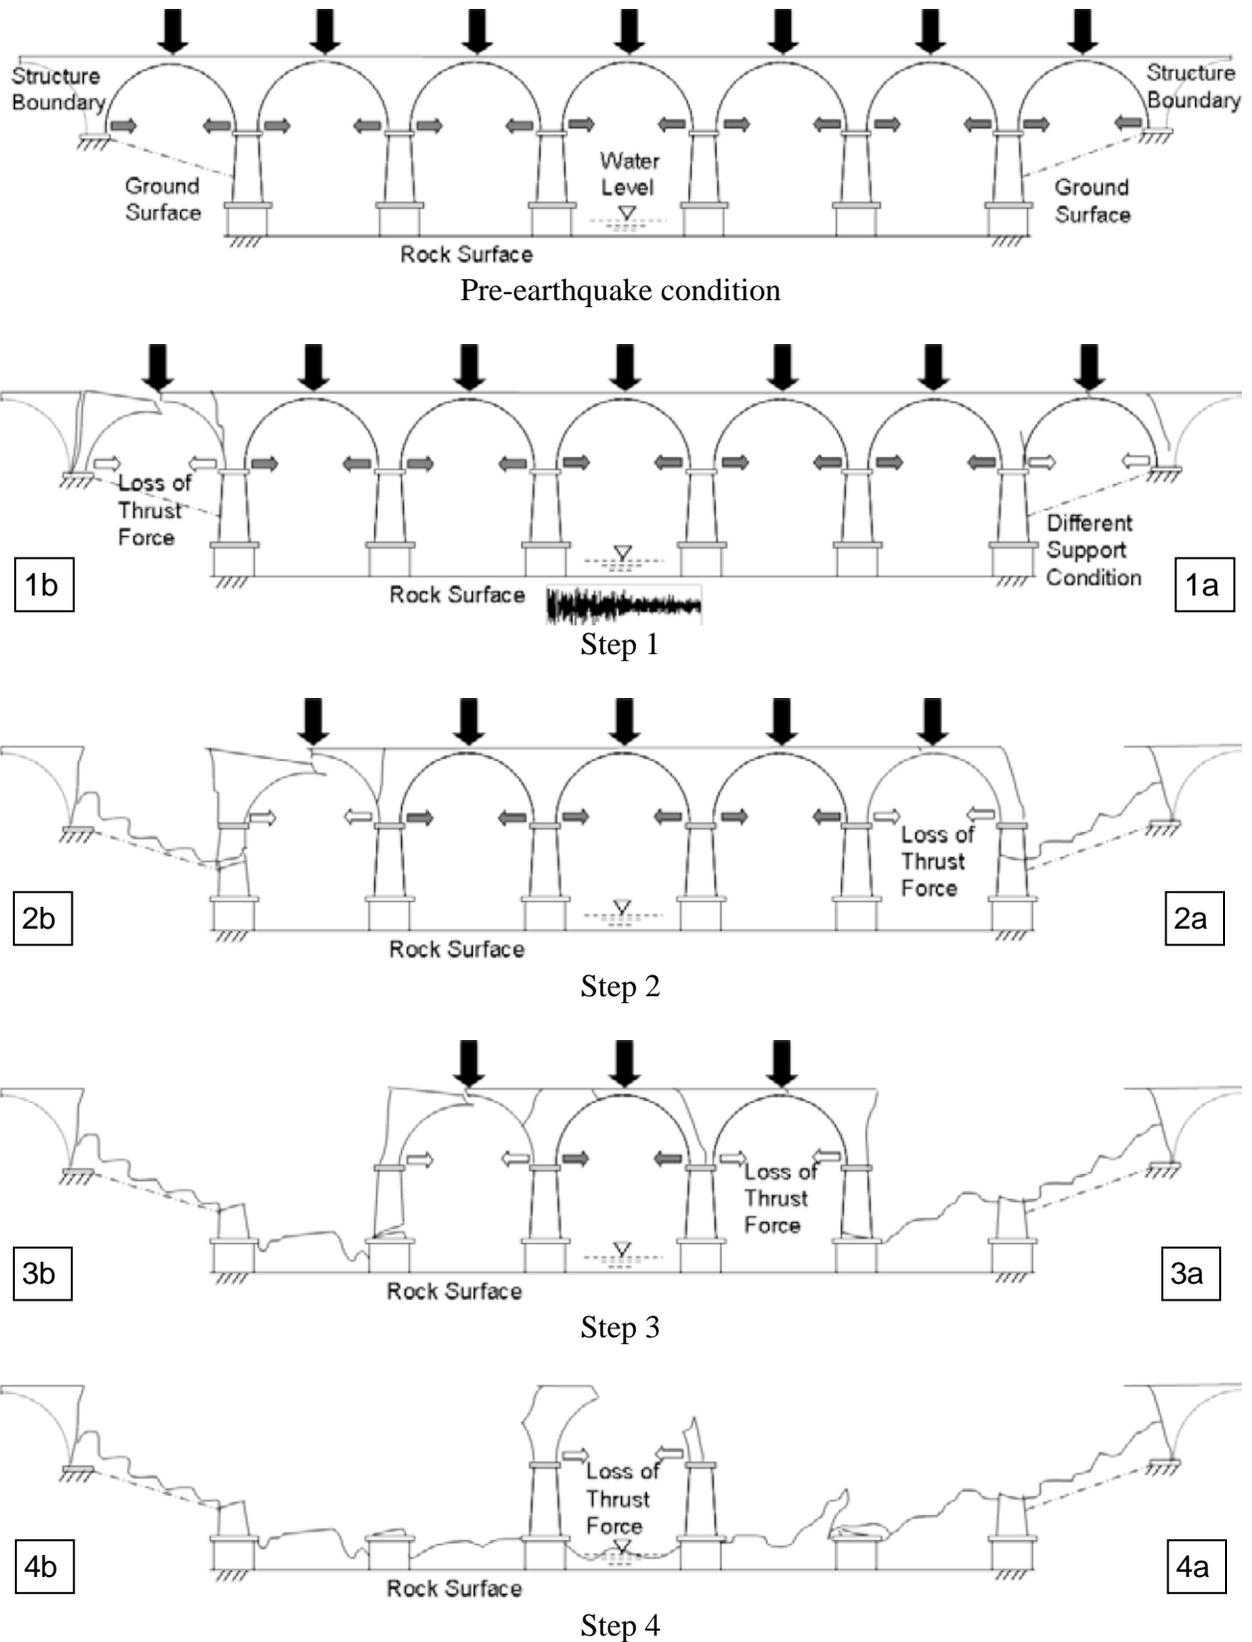
Figure 170. Illustration. Scenario for the progressive collapse of Claro River bridge.

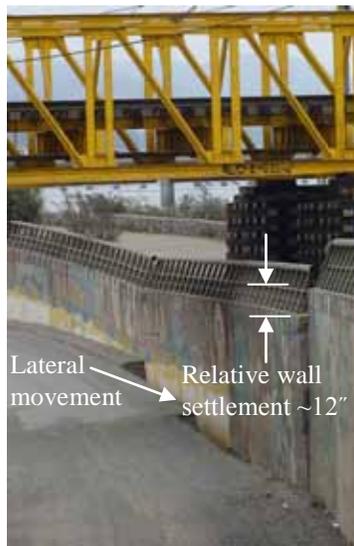
Figure 178. Photo. Settlement behind retaining wall on Chepe railroad bridge.

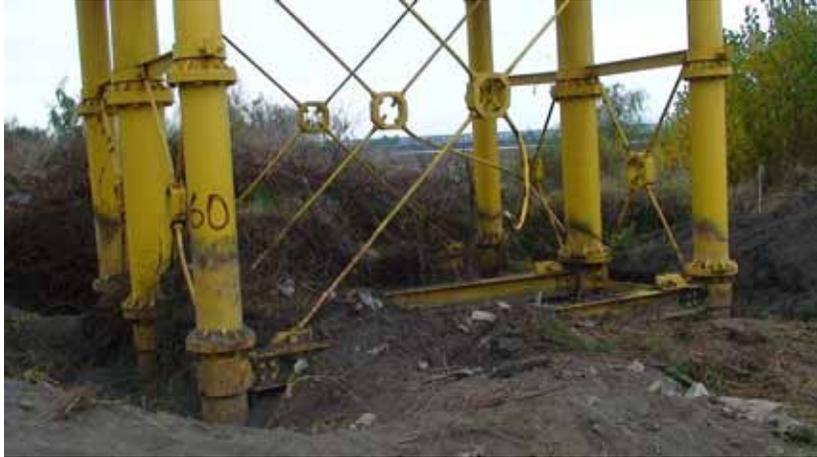
Figure 179. Photo. Ruptured cross bracing at south end of Chepe railroad bridge.

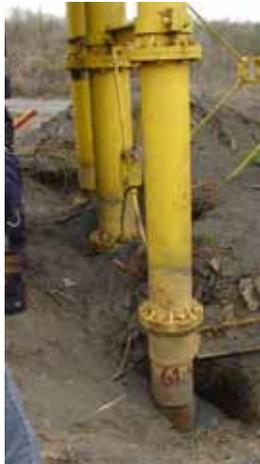
Figure 180. Photo. Fractured steel piles at south end of Chepe railroad bridge.

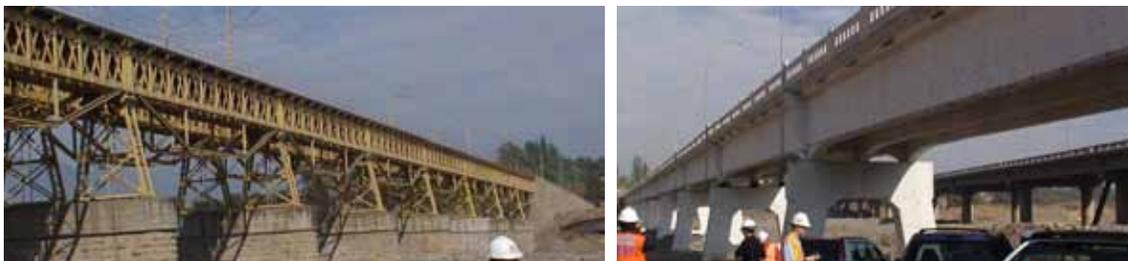
Figure 181. Photo. Three parallel bridges crossing Maipú River south of Santiago.

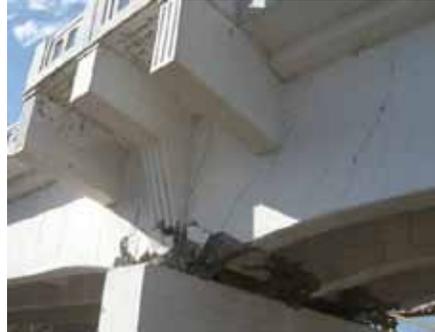
Figure 182. Photo. Crushing of haunches at pier 3 of Maipú River bridge.

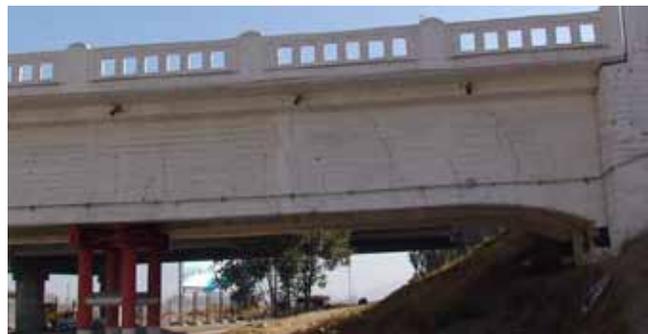
Figure 183. Photo. Shear cracks at span 1 of Maipú River bridge.

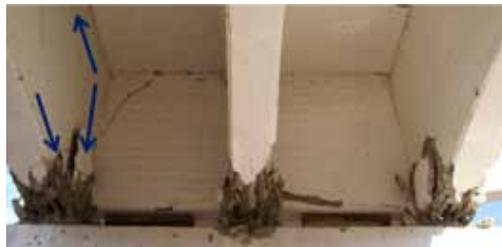
Figure 184. Photo. Longitudinal and vertical seismic forces in haunches at pier 3 of Maipú River bridge.

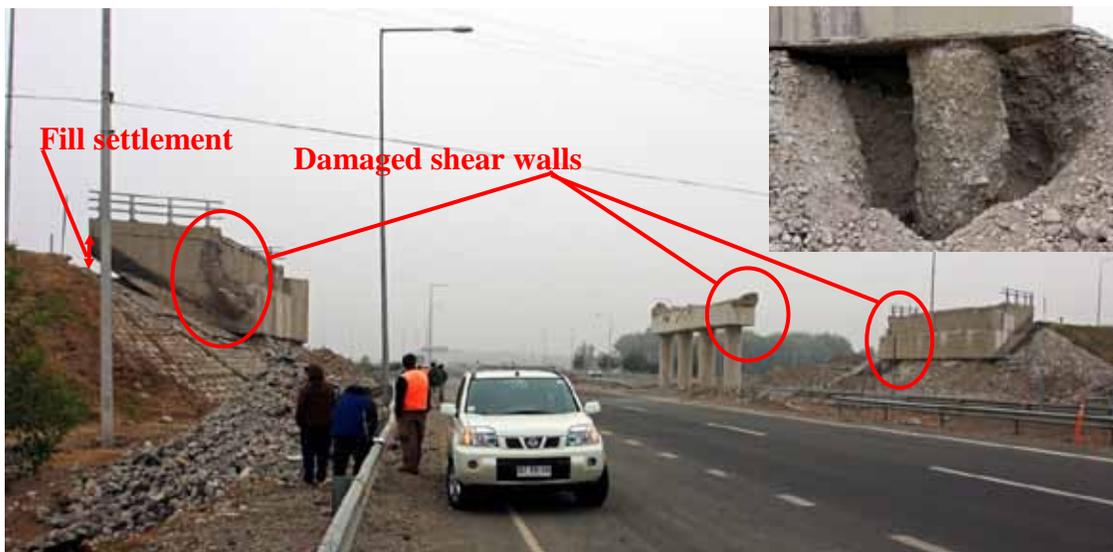
Figure 185. Photo. Damage at Romero bridge and shaft foundation supporting abutment (collapsed superstructure removed).

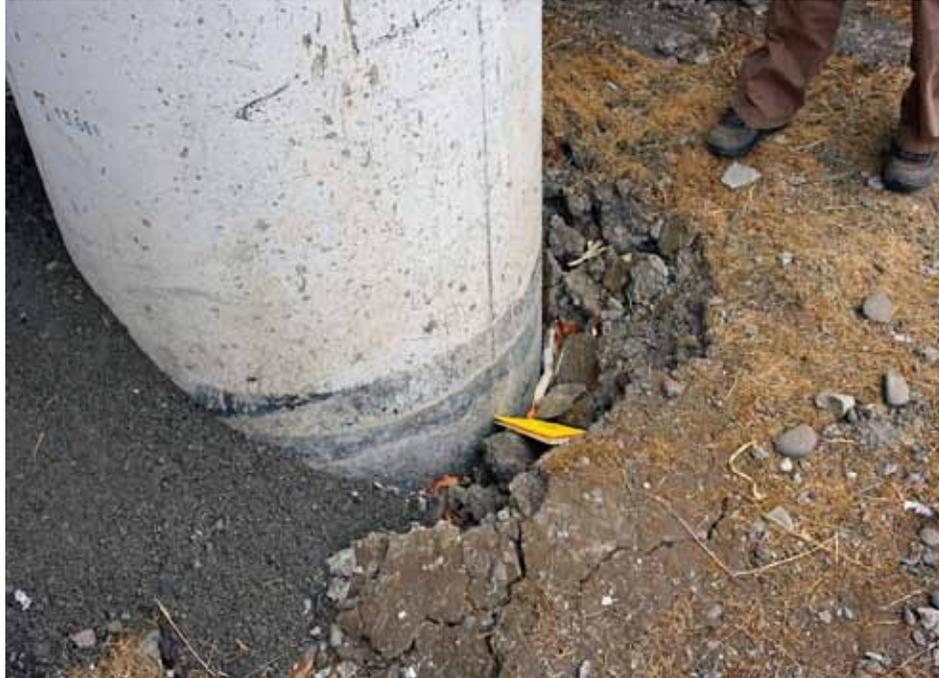
Figure 186. Photo. Interior pier of Chada structure with 5.8- to 7.8-inch (150- to 200-mm) gap in soil transverse to bridge centerline.

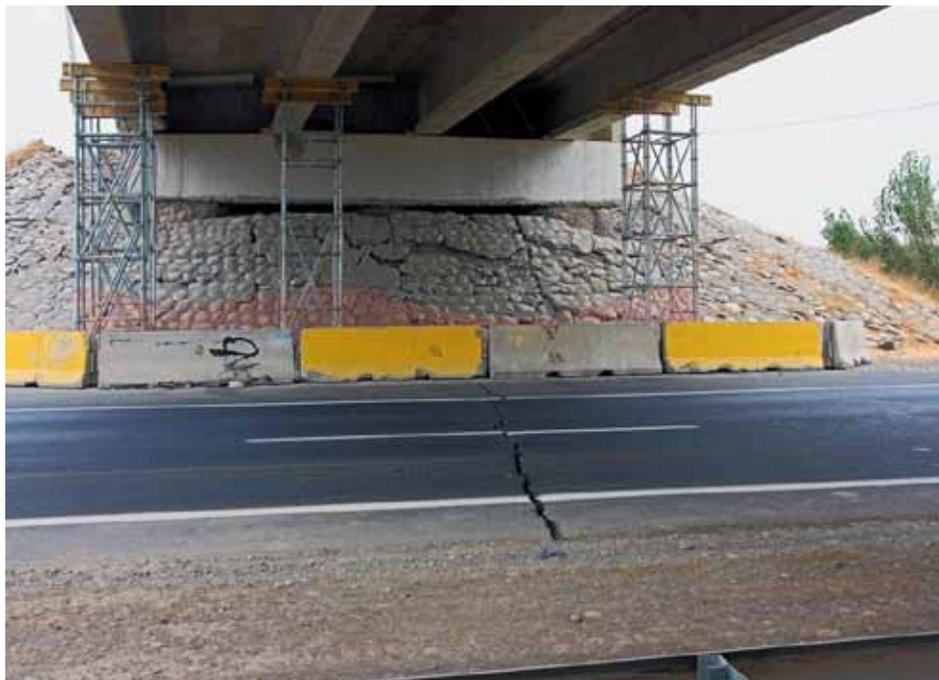
Figure 187. Photo. East abutment of Chada structure showing large pavement crack directly below bridge centerline.

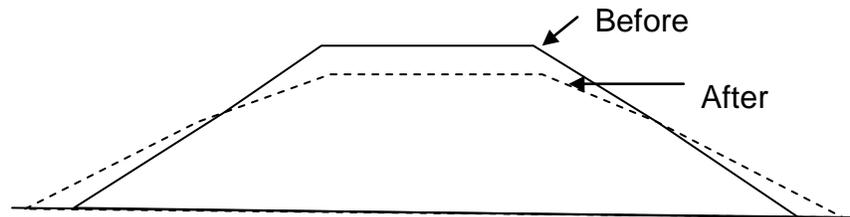
Figure 188. Illustration. Fill slumping observed for bridge sites 7 and 8.

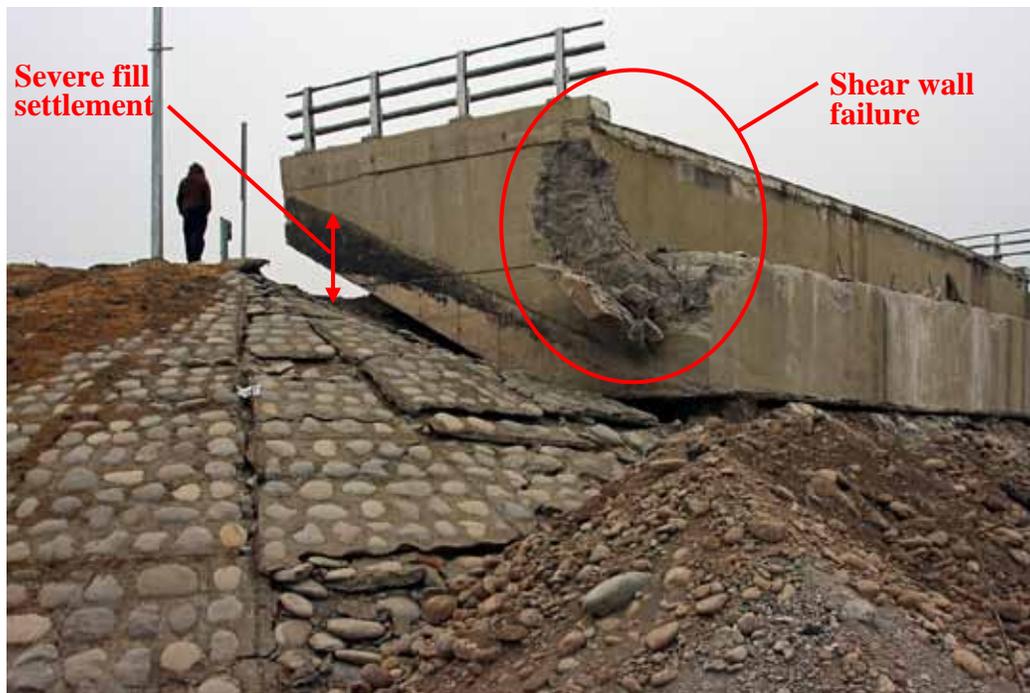
Figure 189. Photo. Fill slumping observed at Romero bridge.

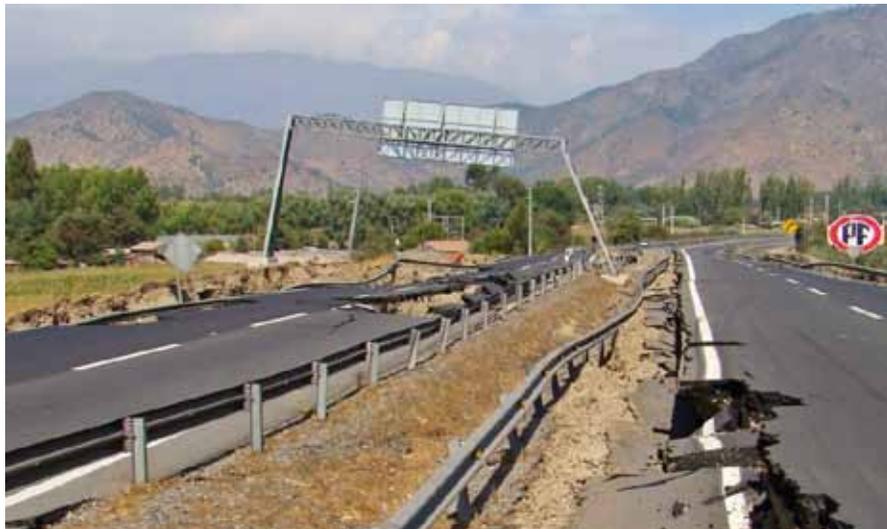
Figure 190. Photo. View of roadway fill failure from abutment of Route 5 railway crossing at Hospital.

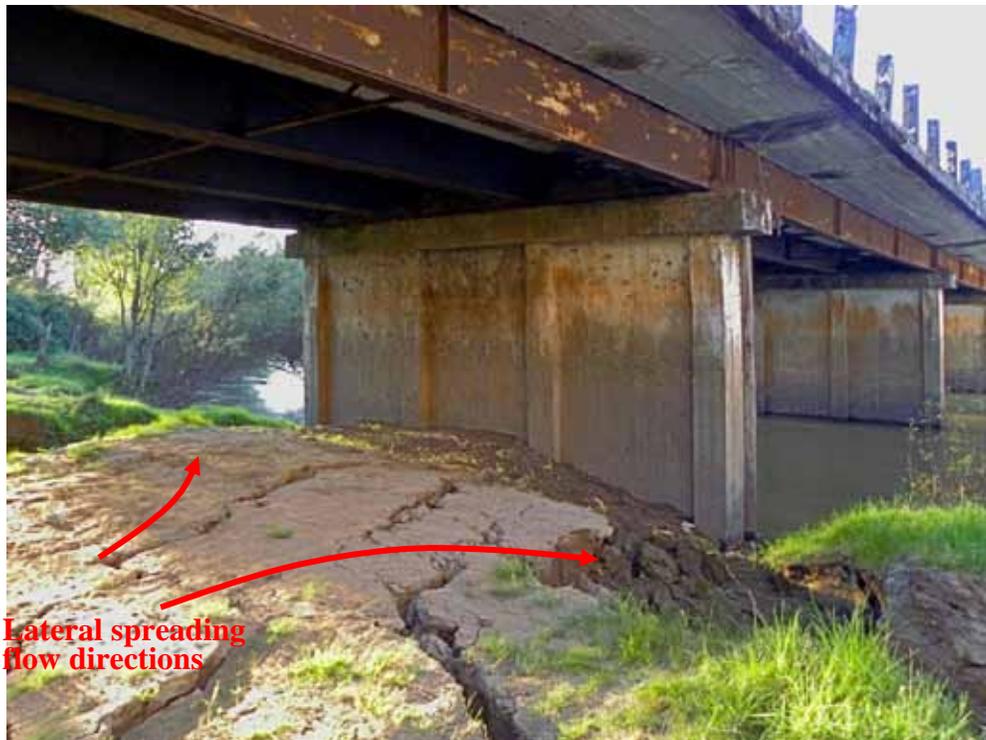
Figure 194. Photo. Lateral spreading and ground failure at old Ramadillas bridge.

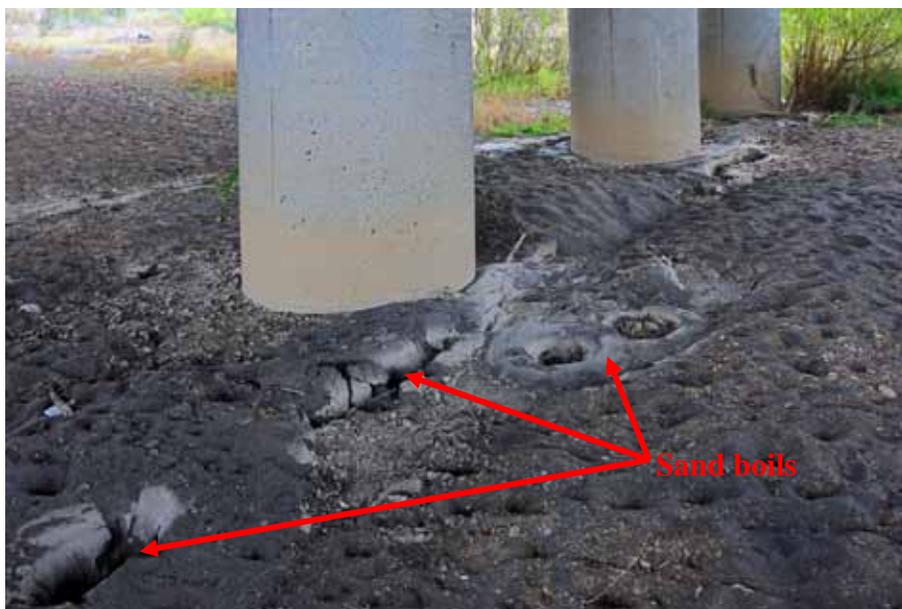
Figure 195. Photo. Sand boils at southwest end of Llacolen bridge.

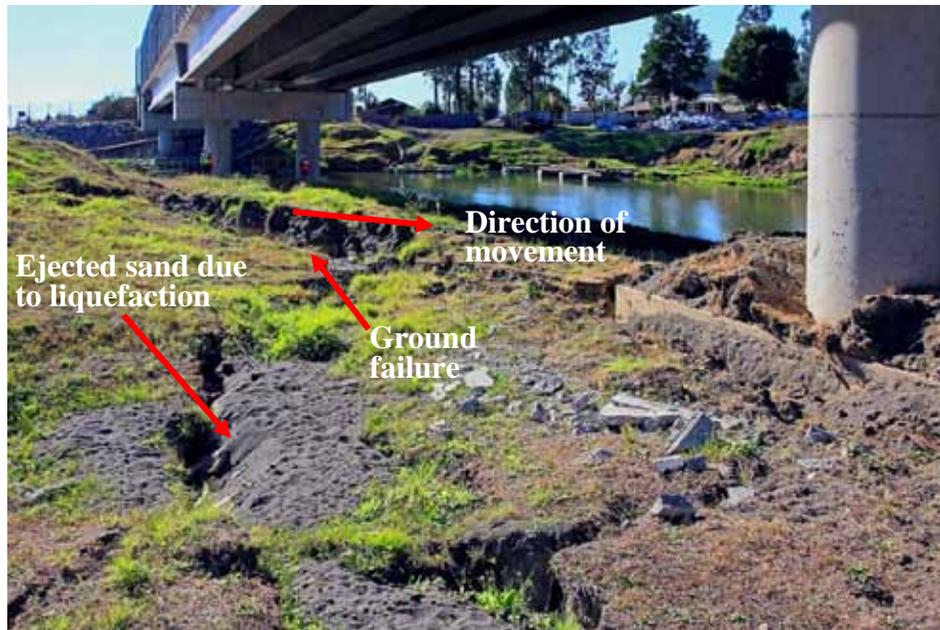
Figure 196. Photo. Ejected sand due to liquefaction and ground failure at La Mochita bridge.

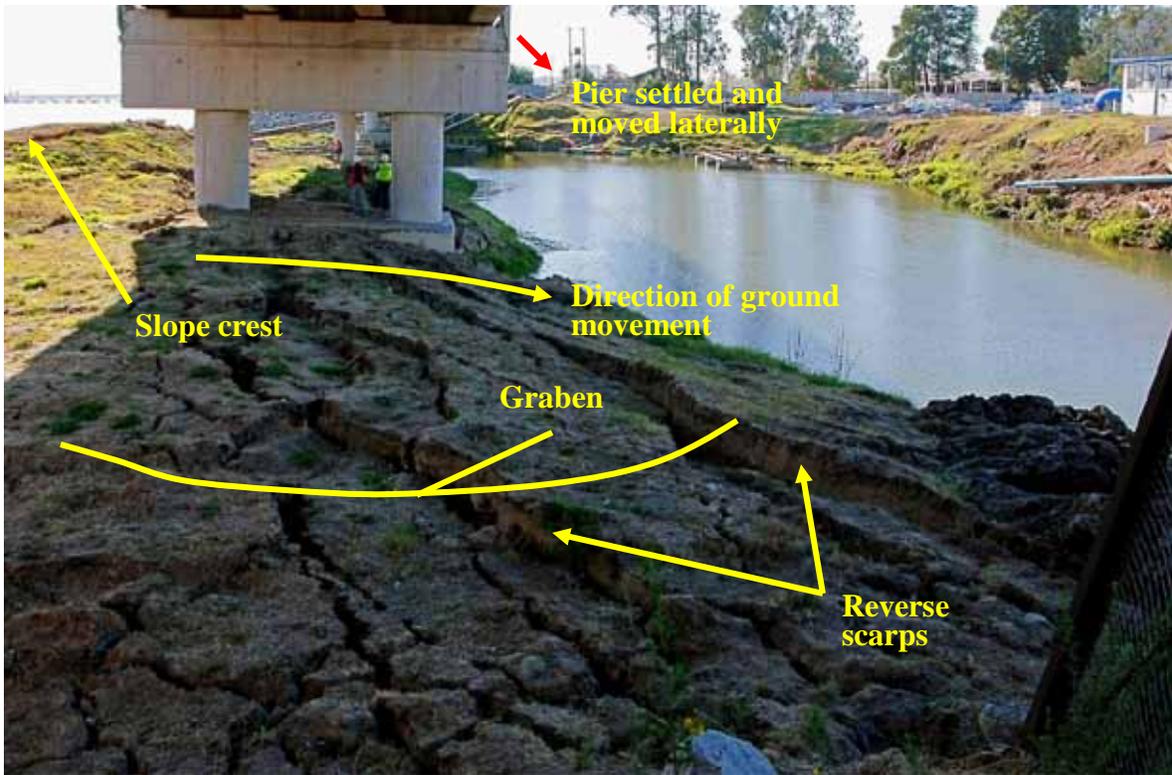
Figure 197. Photo. Severe ground failure at La Mochita bridge.

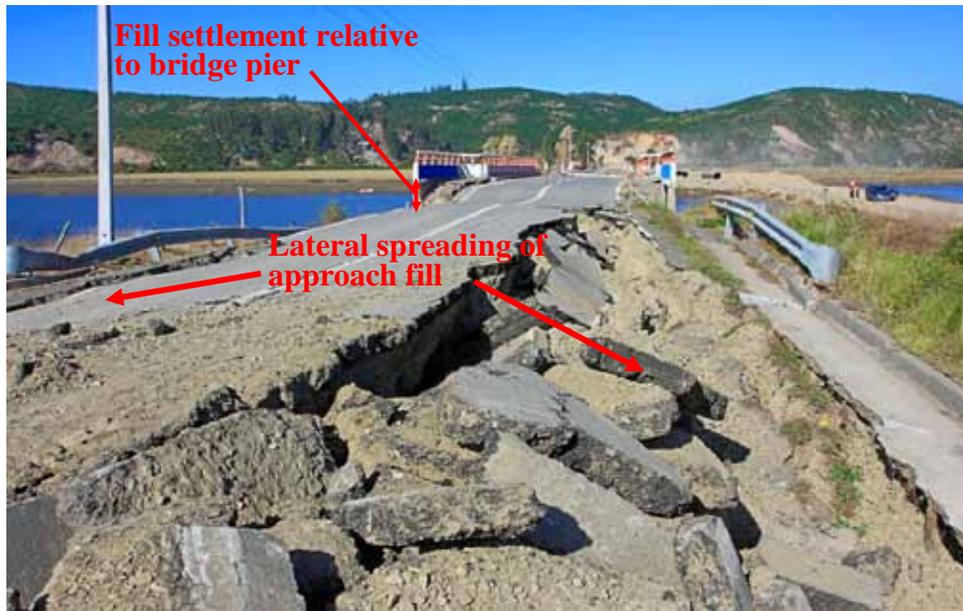
Figure 198. Photo. Lateral spreading and ground failure at Raqui 2 bridge.

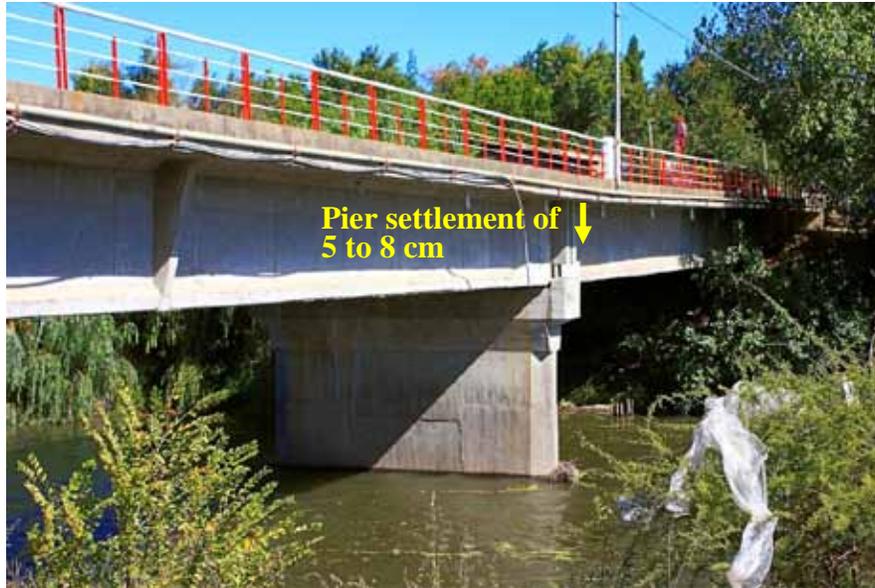
Figure 199 shows an example in which a center pier in the middle of the river settled (about 1.9 to 3.1 inches (50 to 80 mm)), but, because of the water in the river, no specific evidence of liquefaction could be observed. It is likely that liquefaction is the cause of this kind of effect on the bridge, although it is also likely that the liquefied layer is not extensive because the amount of deformation in the foundation is relatively small.

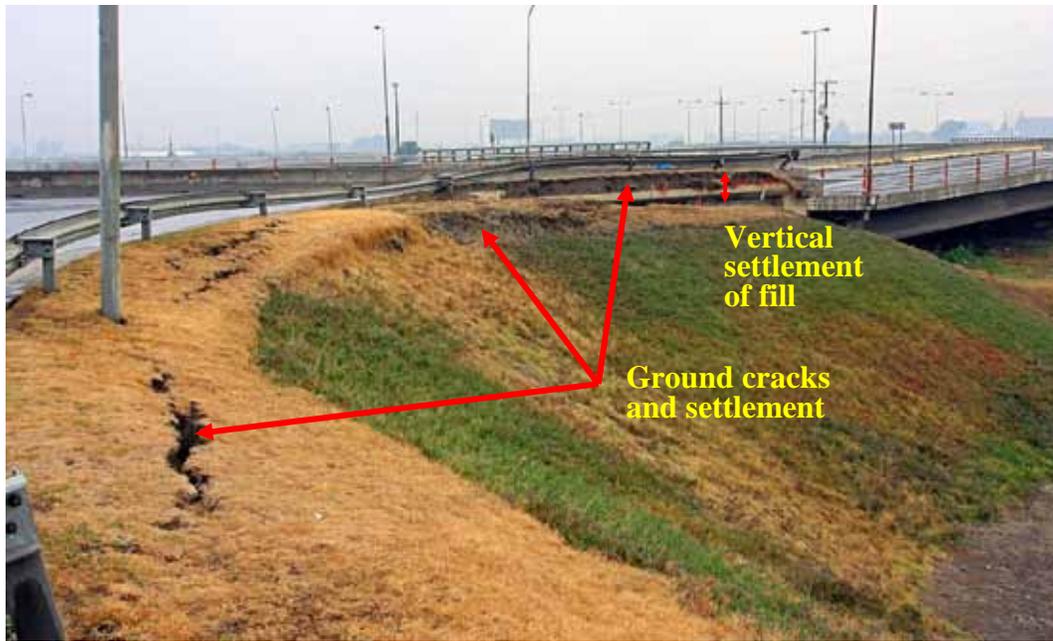
Figure 200. Photo. Ramps at Juan Pablo II bridge where existing ground was improved with DDC.

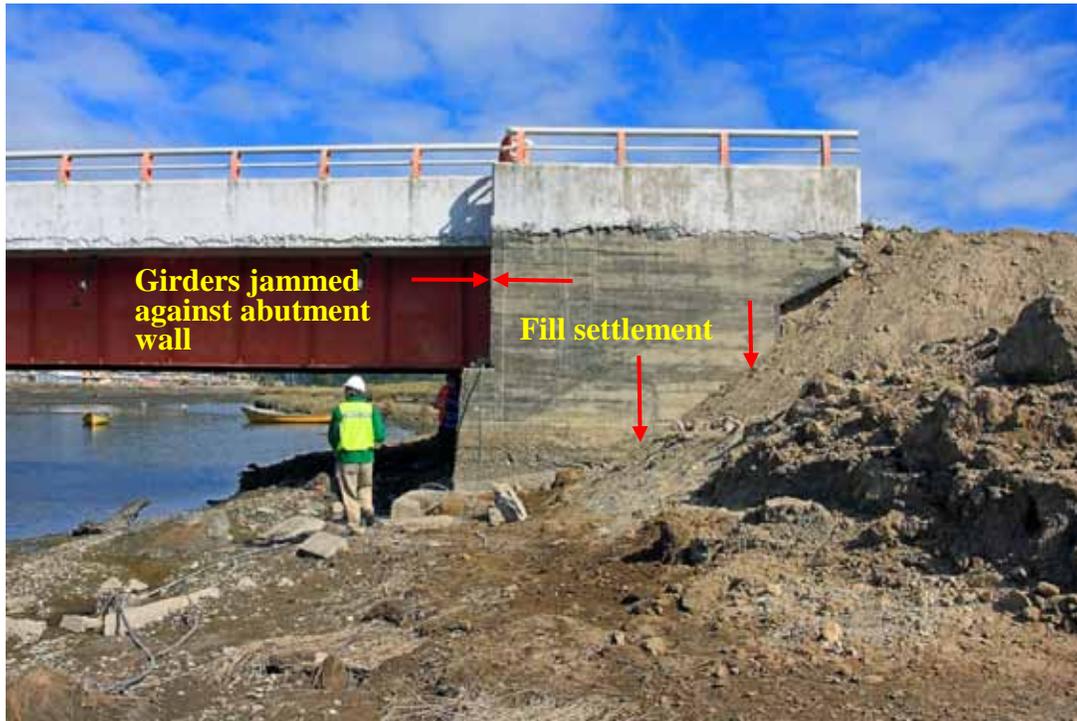
Figure 205. Photo. Abutment fill settlement at northwest abutment of Raqui 1 bridge.

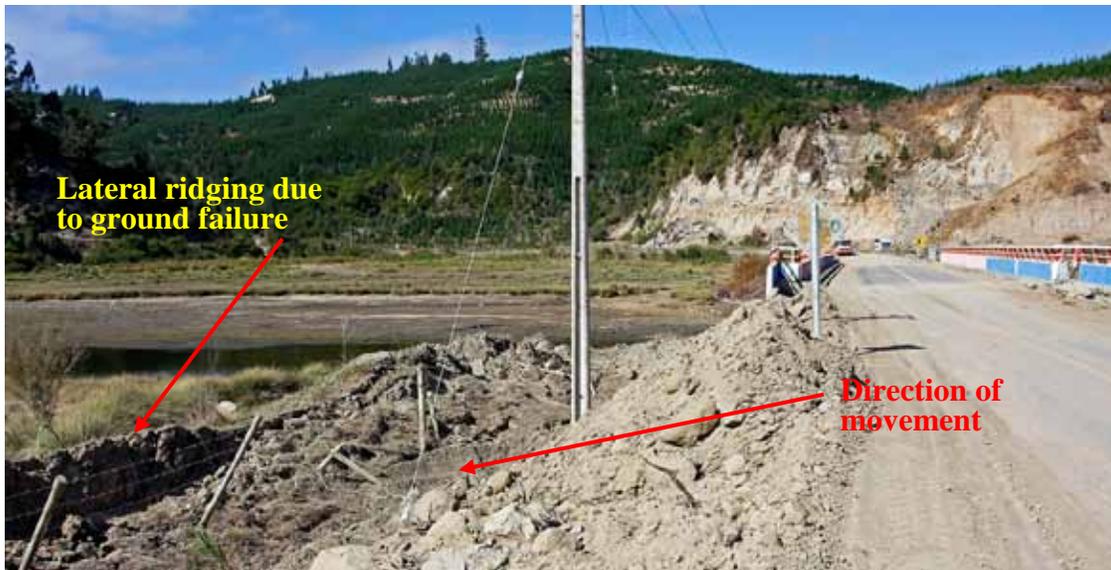
Figure 208. Photo. Evidence of ground failure perpendicular to roadway centerline at northwest approach of Raqui 1 bridge.

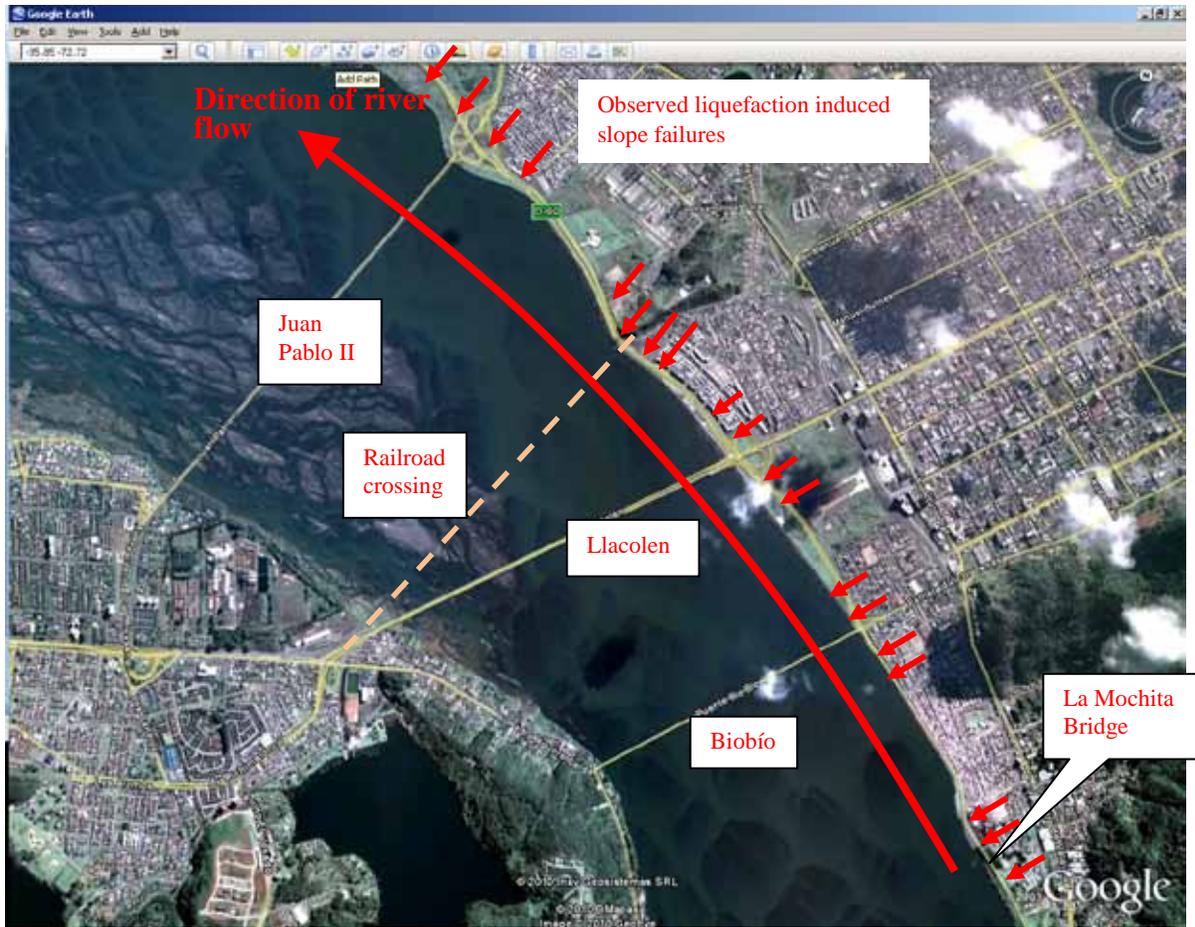
© Google, Inav/Geosistemas SRL, DMapas, and GeoEye

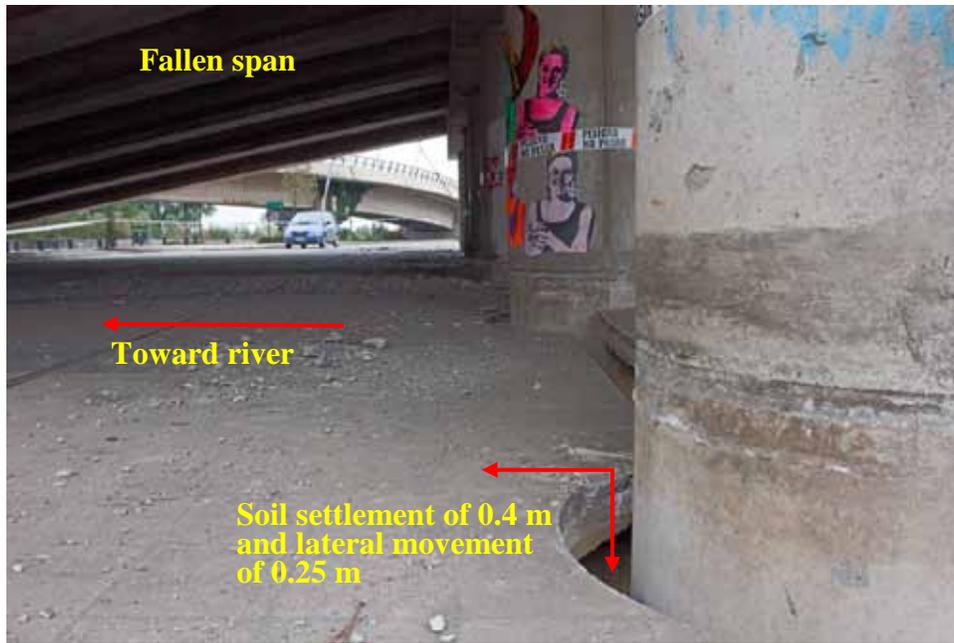
Figure 213. Photo. Settlement and lateral ground movement of interior pier at northeast end of Llacolen bridge.

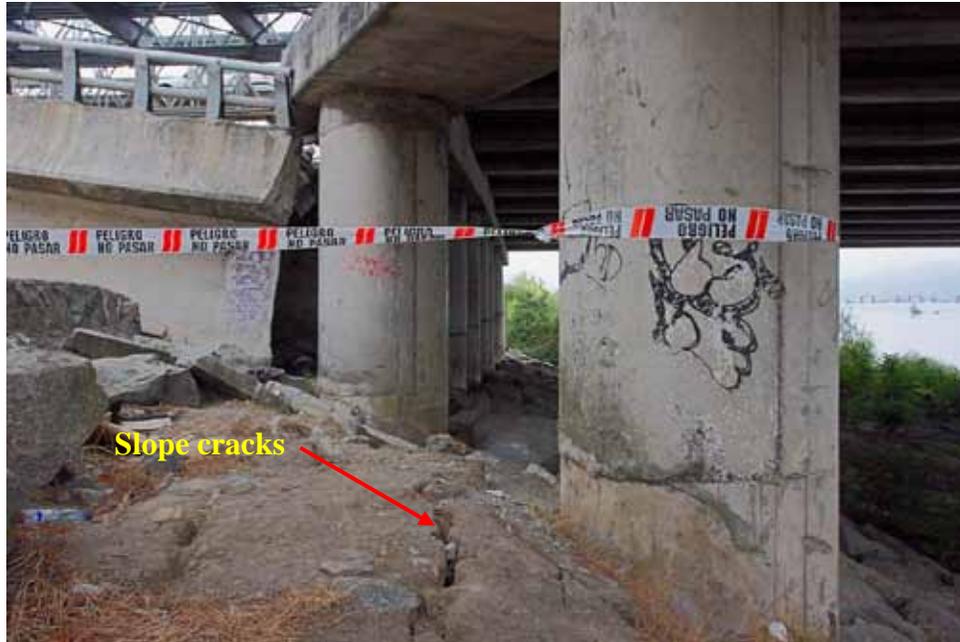
Figure 214. Photo. Lateral ground and foundation movement at interior pier and fallen span at northeast end of Llacolen bridge.
