Postearthquake Reconnaissance Report on Transportation Infrastructure Impact of the February 27, 2010, Offshore Maule Earthquake in Chile

PUBLICATION NO. FHWA-HRT-11-030

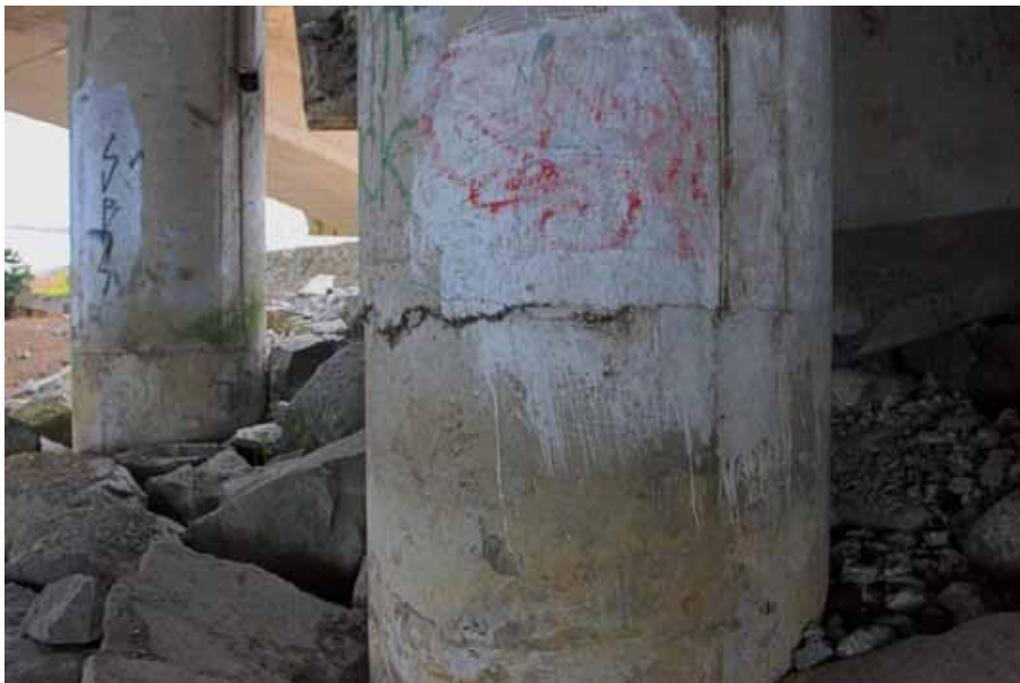
Figure 215. Photo. Close-up of cracked column at northeast end of Llacolen bridge.

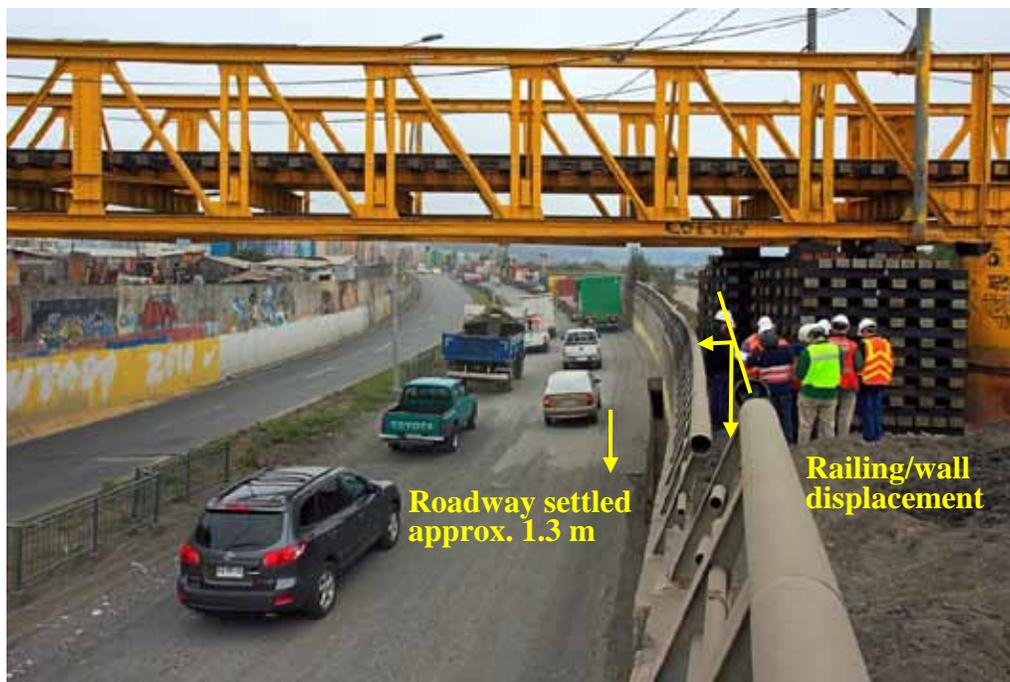
Figure 216. Photo. Wall settlement due to slope movement and instability caused by liquefaction at northwest end of Chepe railroad bridge.

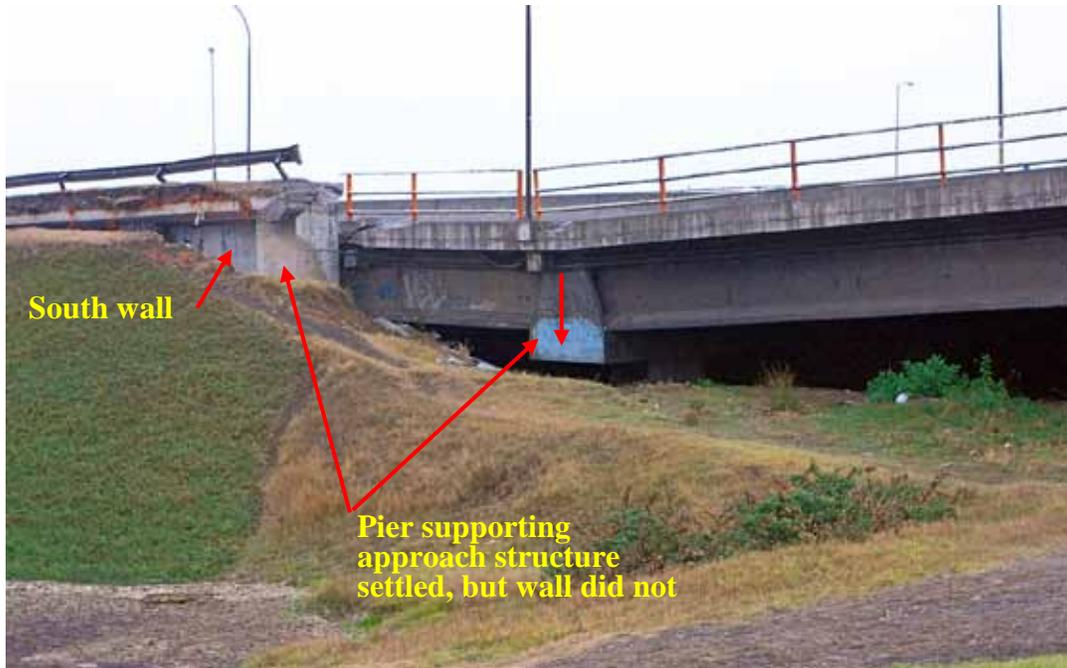
Figure 217. Photo. Settlement of approach structure for Juan Pablo II bridge.

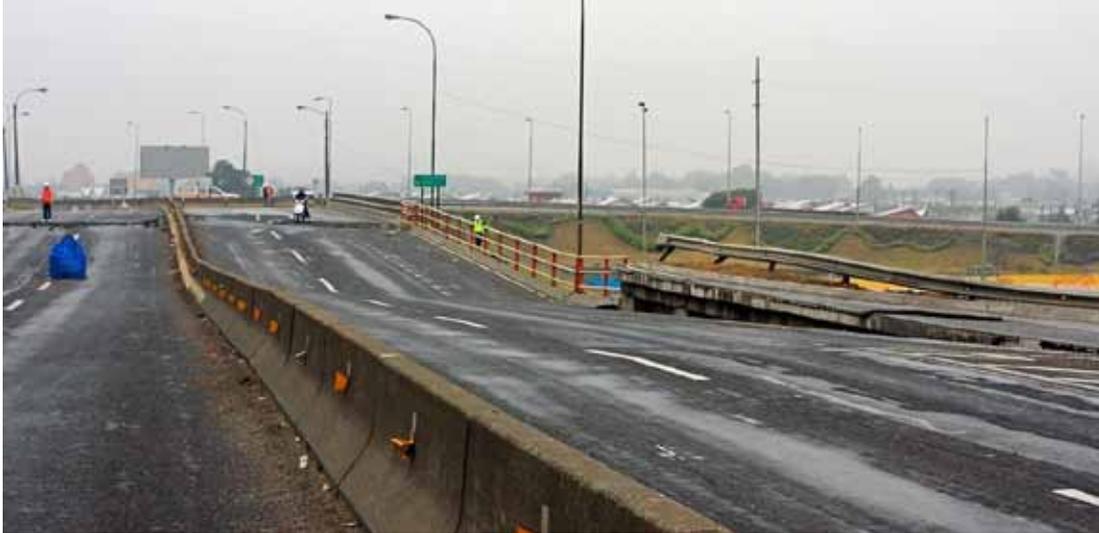
Figure 219. Photo. Roadway settlement due to settlement of approach structure pier foundations for Juan Pablo II bridge.

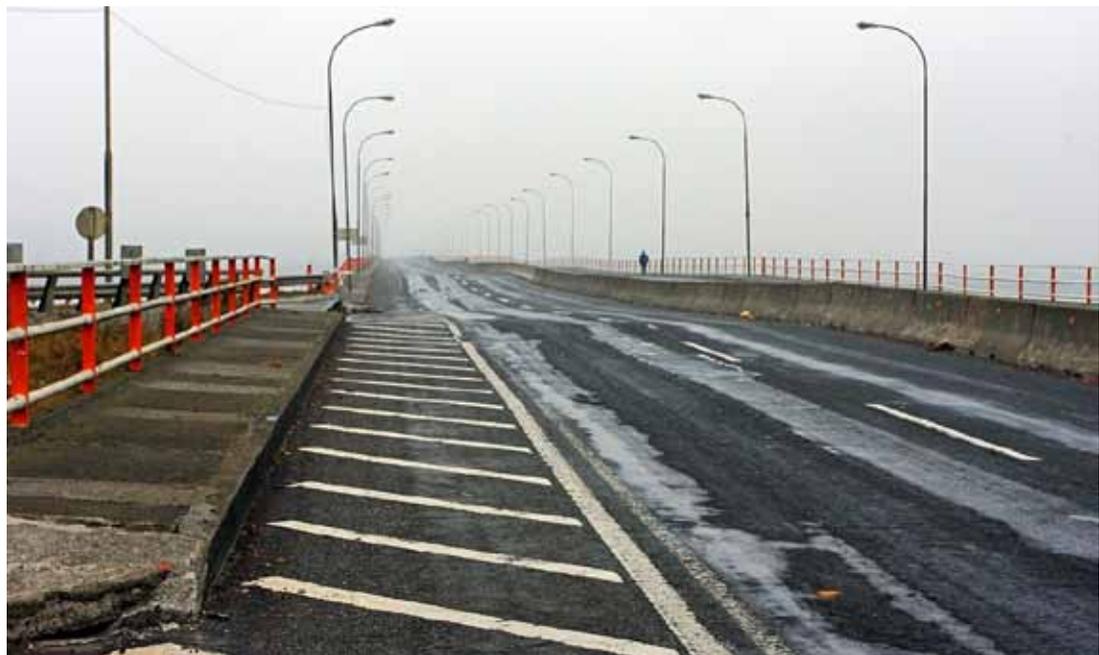
Figure 220. Photo. Roadway settlement due to settlement of mainline pier foundations for Juan Pablo II Bridge.

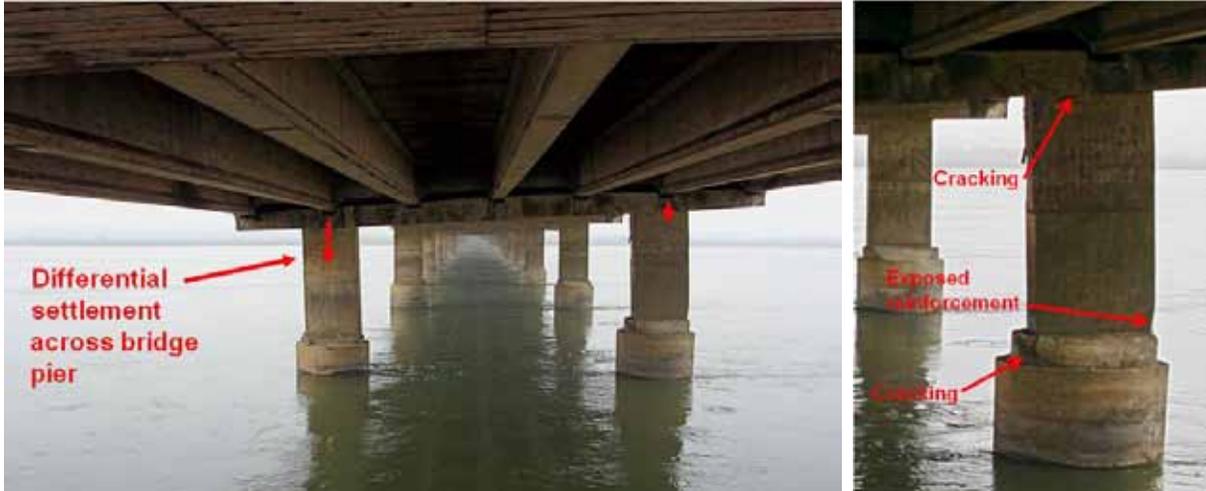
Figure 221. Photo. Liquefaction-induced differential settlement of mainline pier foundations supporting Juan Pablo II bridge.

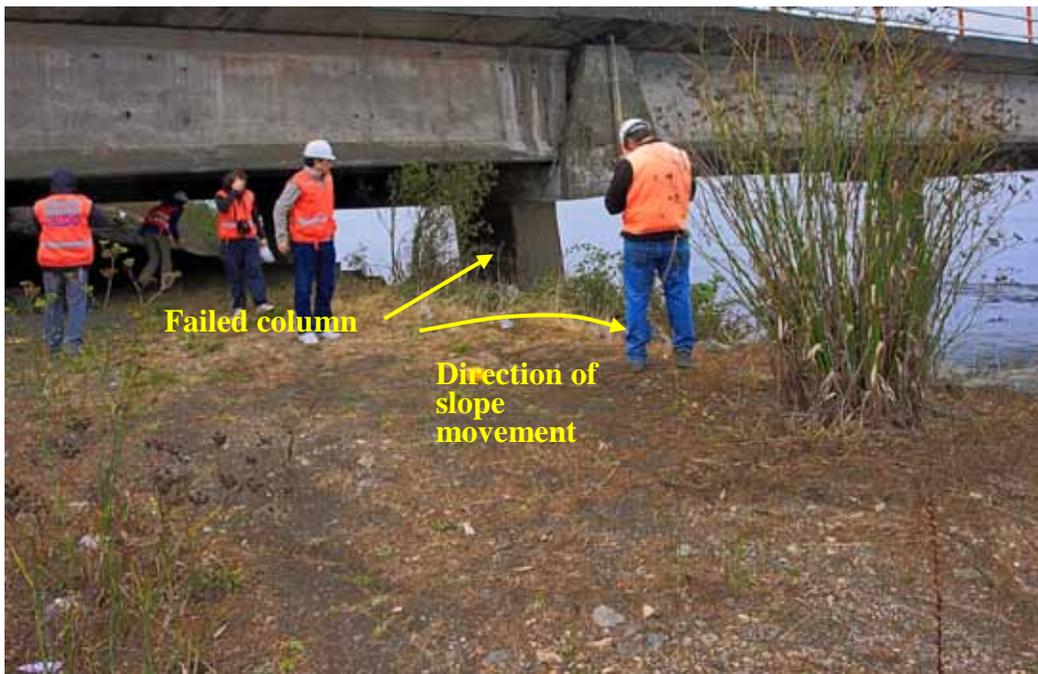
Figure 222. Photo. Damage to pier columns for mainline Juan Pablo II bridge.

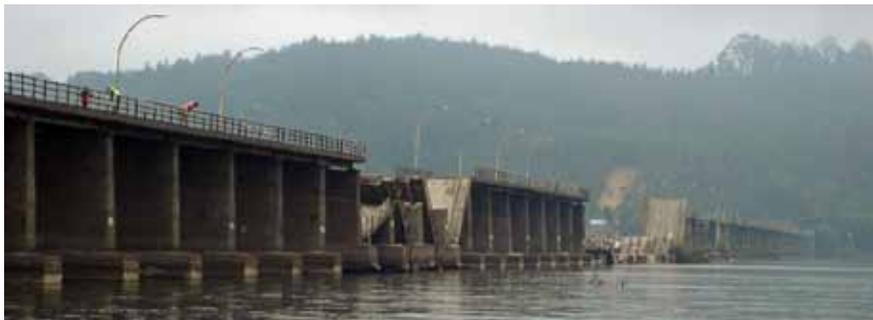
Figure 223. Photo. View of collapsed spans from northeast river bank of Biobío River.

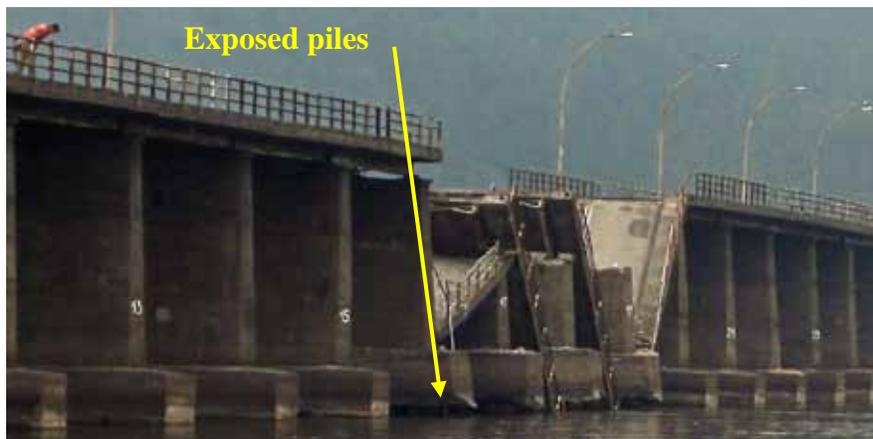
Figure 224. Photo. Close-up of old Biobío River bridge showing exposed pile foundations.

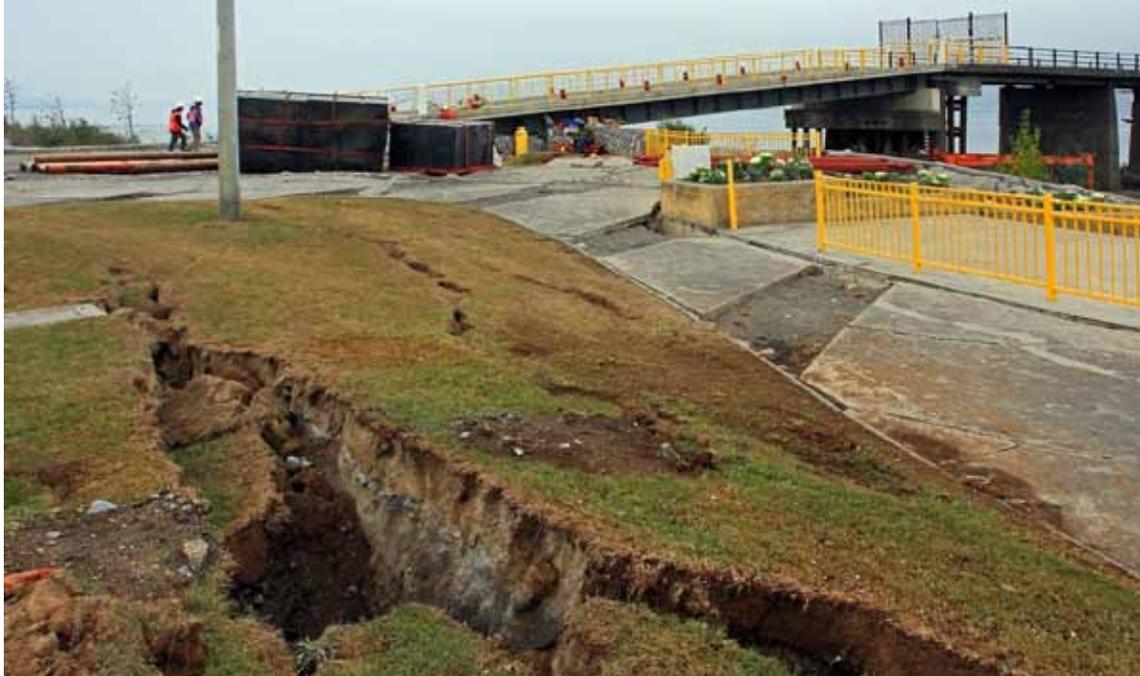
Figure 225. Photo. Ground failure near northeast abutment of old Biobío River bridge.

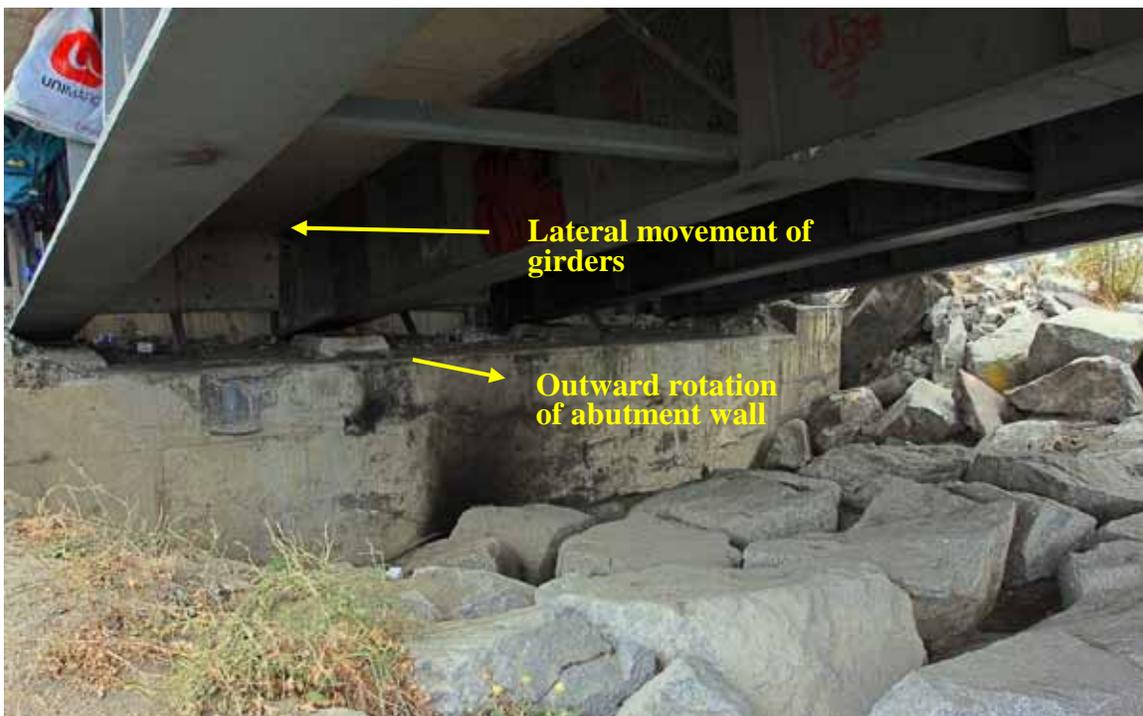
Figure 226. Photo. Tilting of northeast abutment pier wall of old Biobío River bridge.

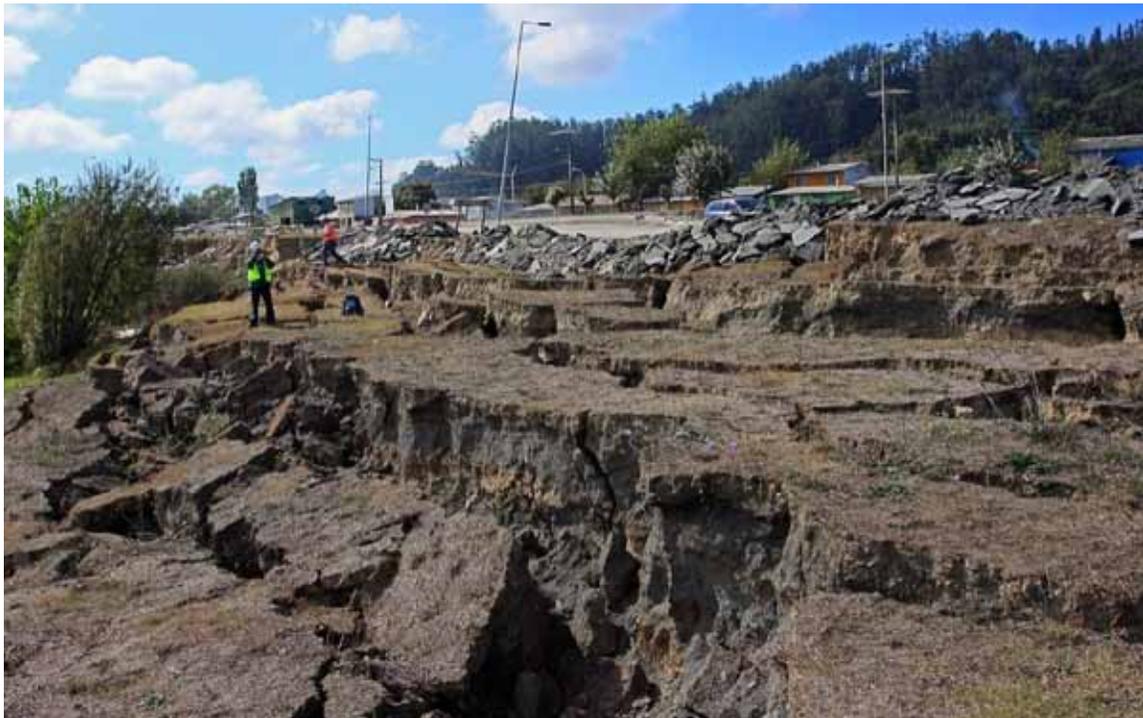
Figure 227. Photo. Ground failure of north approach fill for La Mochita bridge.

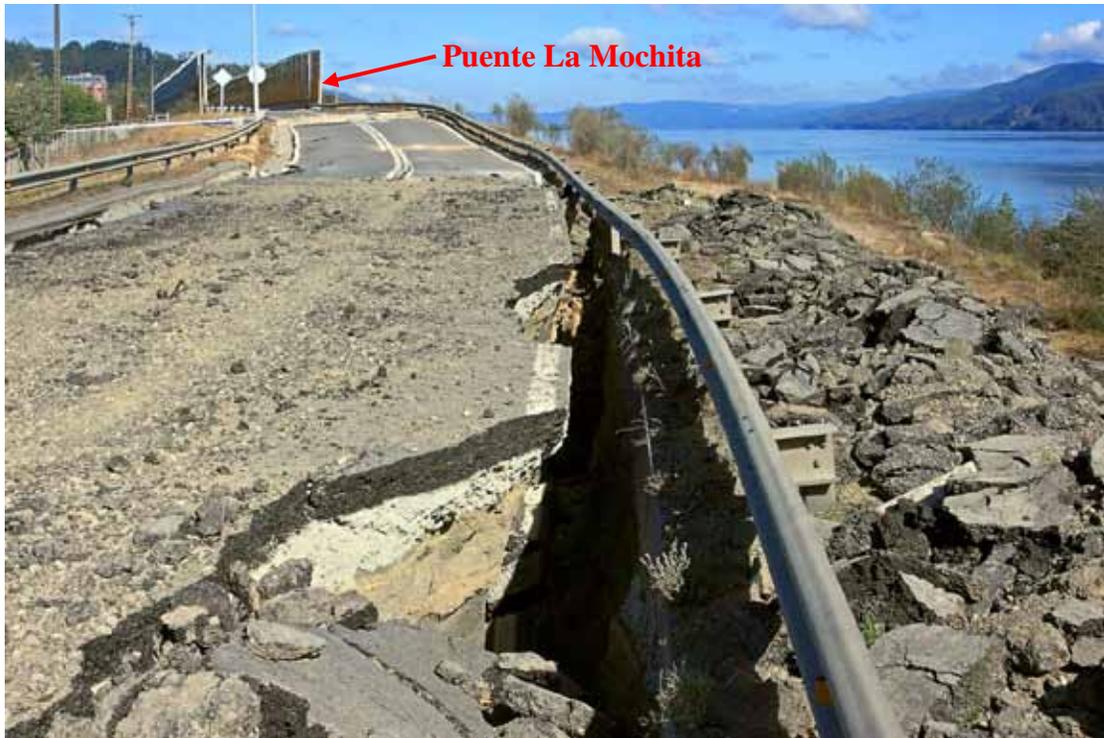
Figure 228. Photo. La Mochita bridge north approach fill liquefaction-induced ground failure.

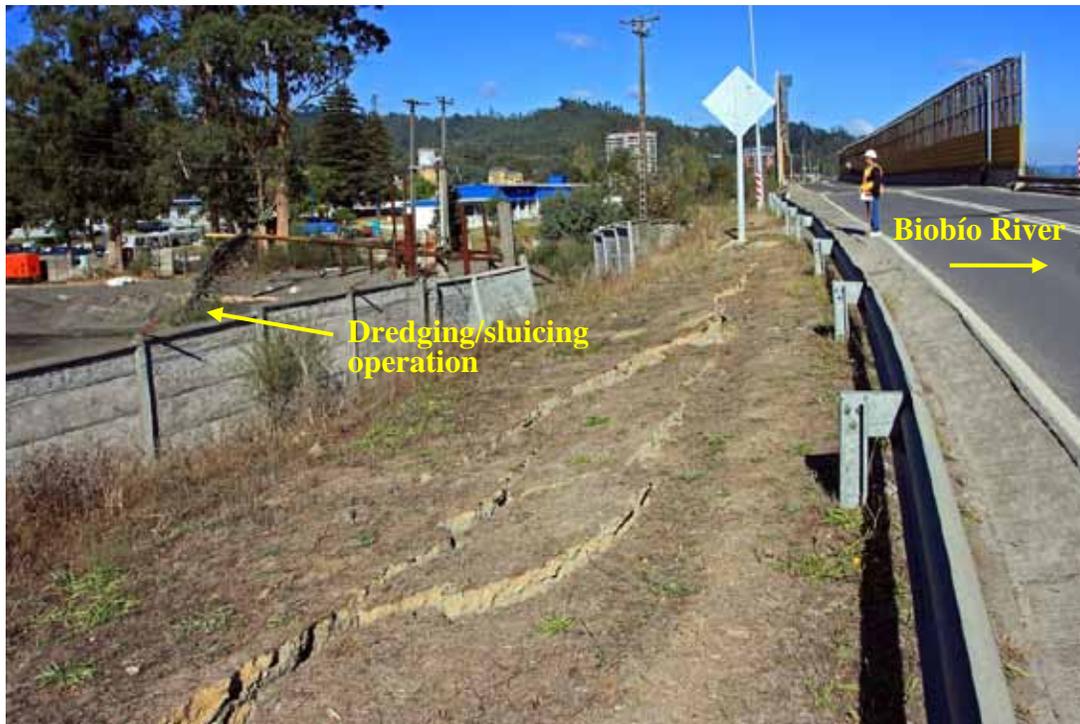
Figure 229. Photo. La Mochita bridge north approach fill and edge of dredging pit.

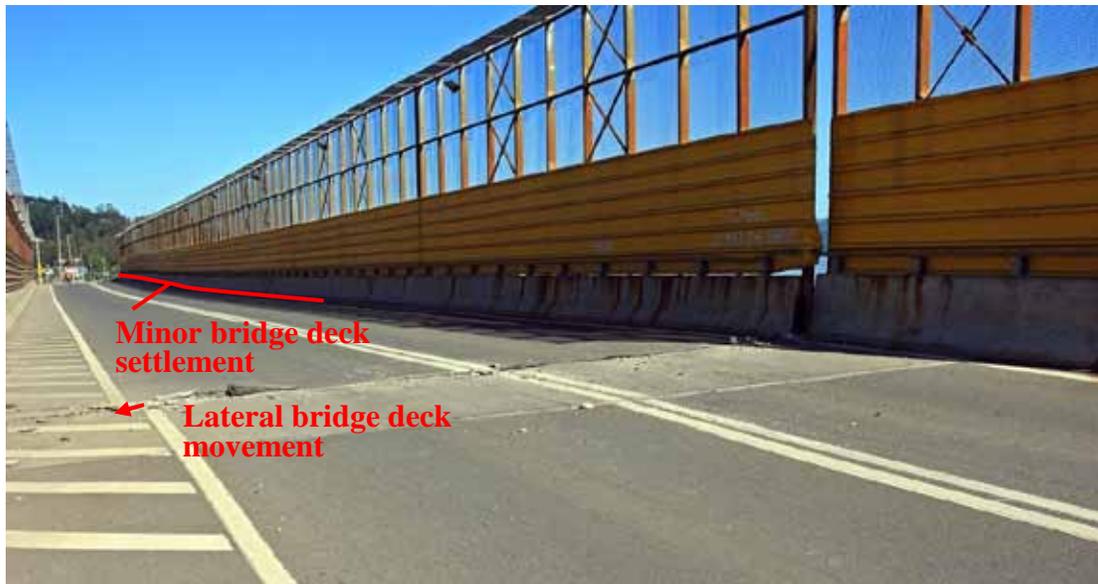
Figure 230. Photo. La Mochita bridge deck and girder lateral movement.

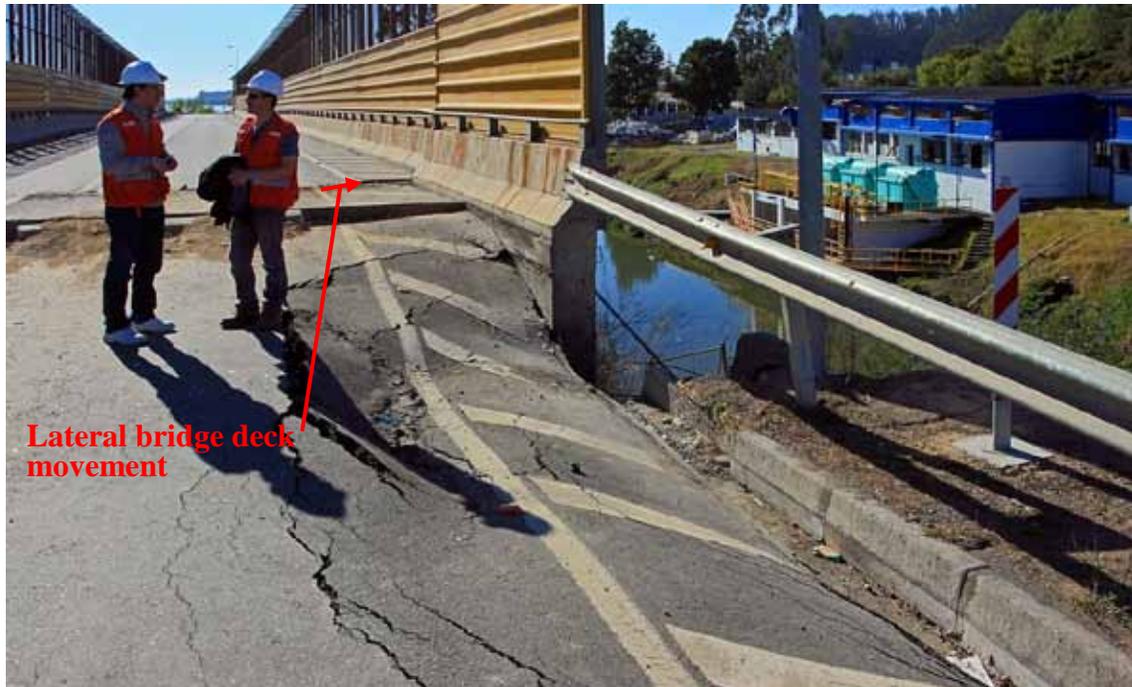
Lateral bridge deck movement

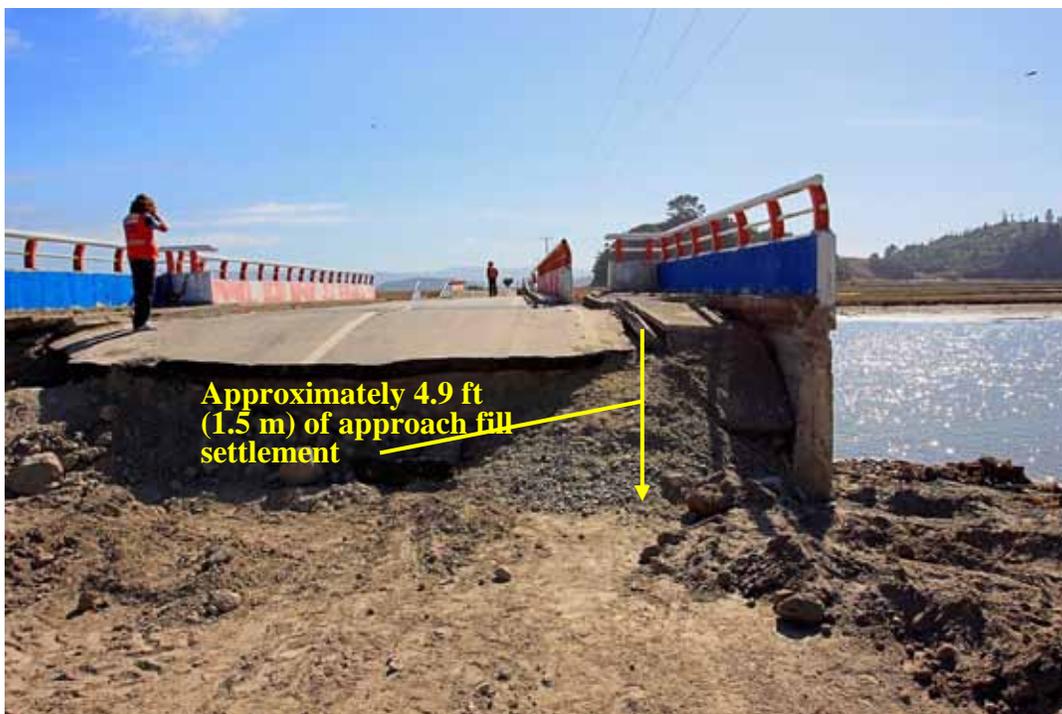
Figure 233. Photo. Southeast approach fill damage at Raqui 2 bridge.

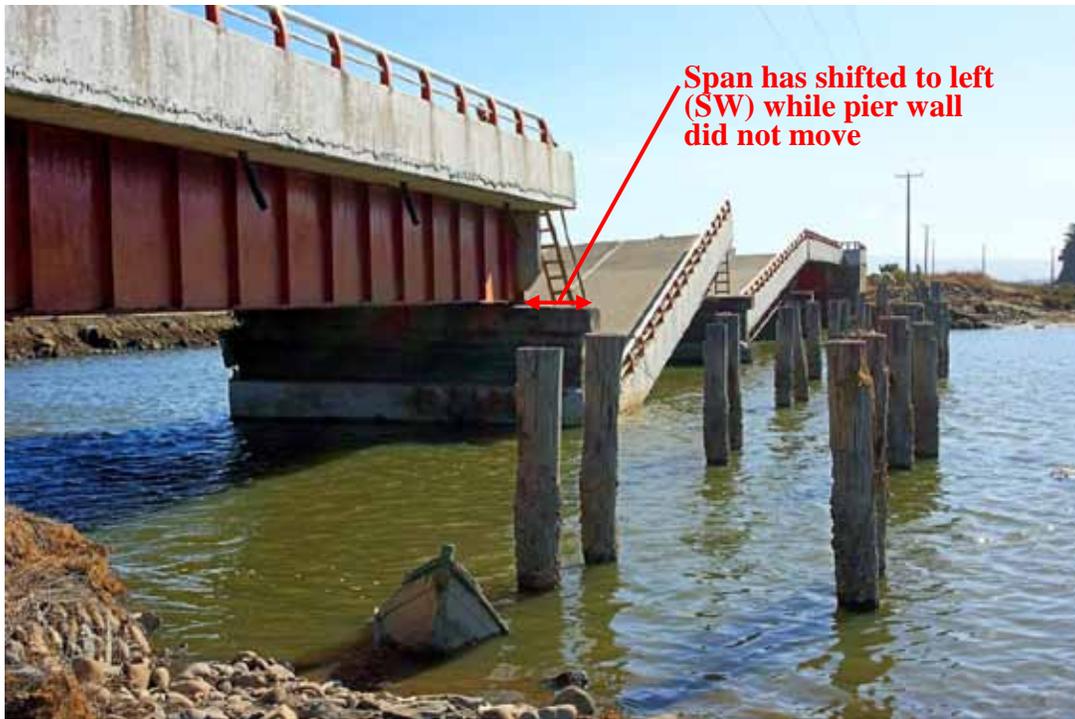
Span has shifted to left (SW) while pier wall did not move

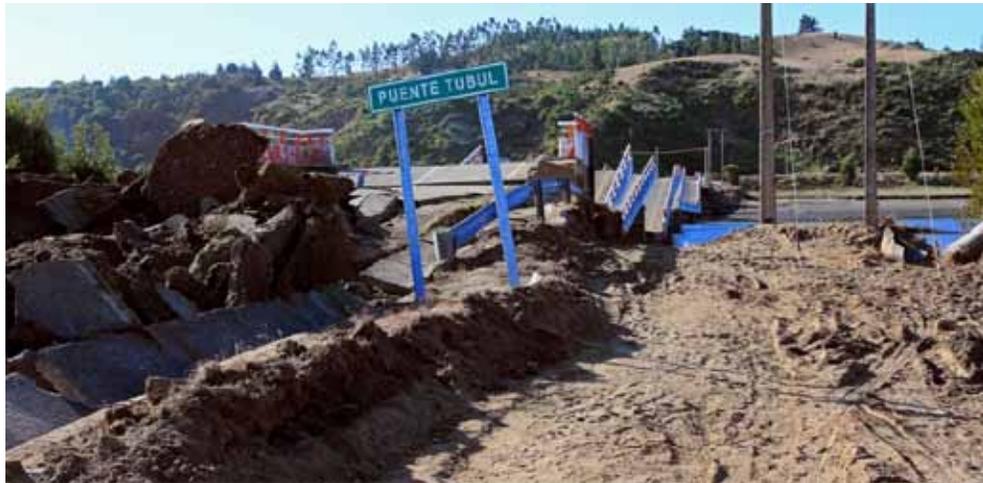
Figure 236. Photo. South approach fill damage and collapsed spans at Tubul Bridge.

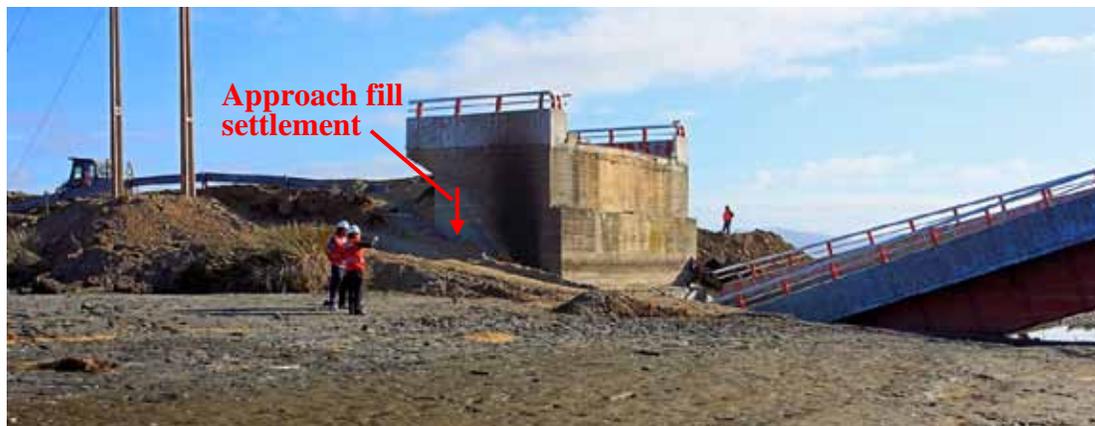
Figure 237. Photo. Settlement of fill beside the south abutment of Tubul bridge.

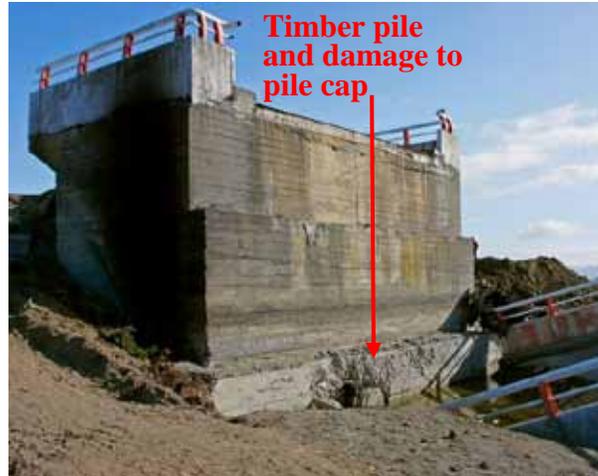
Figure 238. Photo. Overview of damage to south abutment of Tubul bridge.

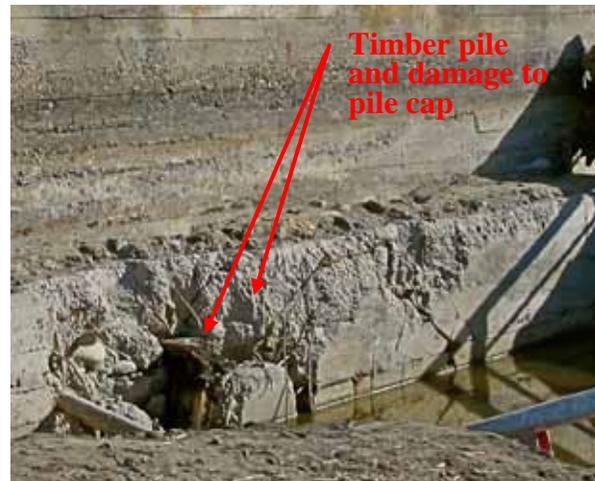
Figure 239. Photo. Close-up of exposed pile and pile cap damage on south abutment of Tubul bridge.

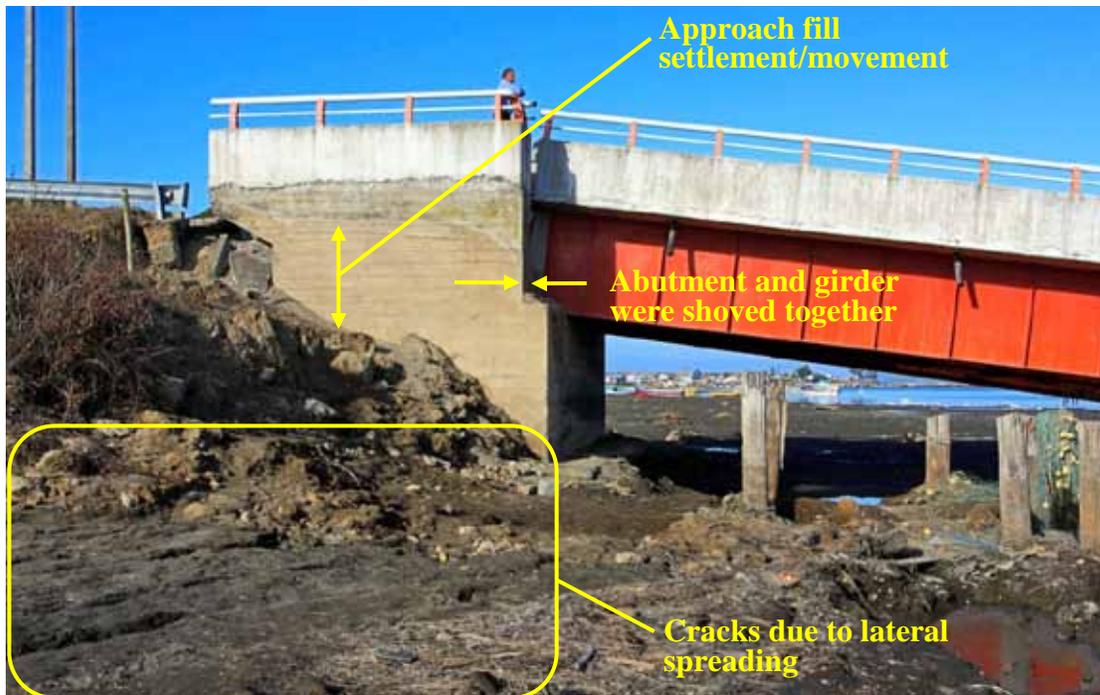
Figure 240. Photo. Overview of Tubul bridge north abutment.

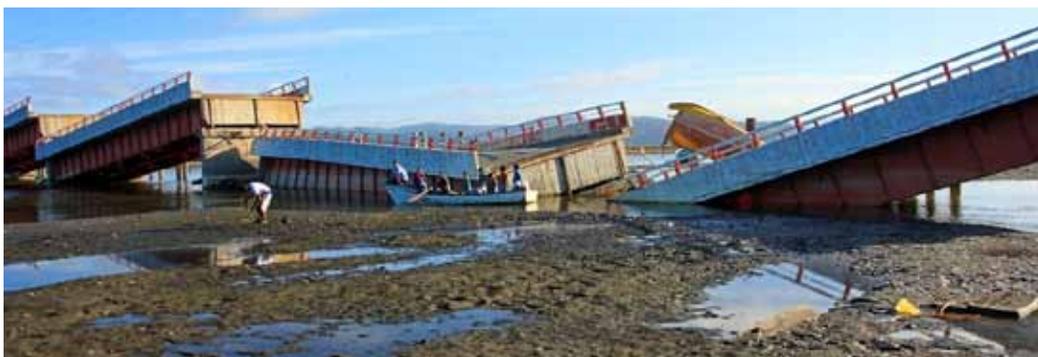
Figure 241. Photo. Tubul bridge collapsed spans and substructure.

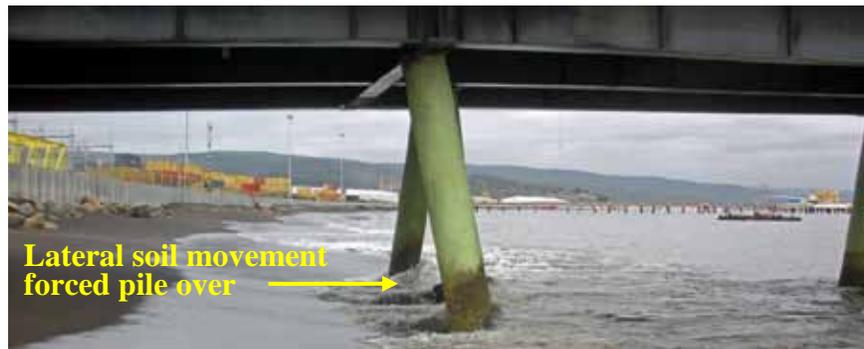
Figure 242. Photo. Puerto de Coronel Muelle foundation displacement and bending.

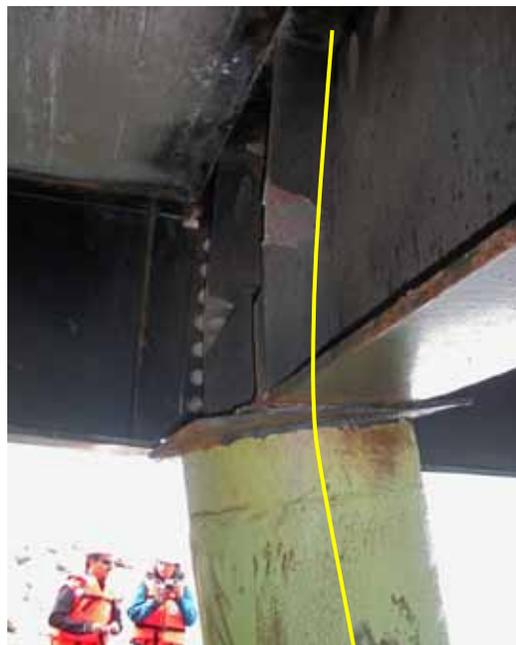
Figure 243. Photo. Close-up of Puerto de Coronel Muelle foundation displacement and bending.

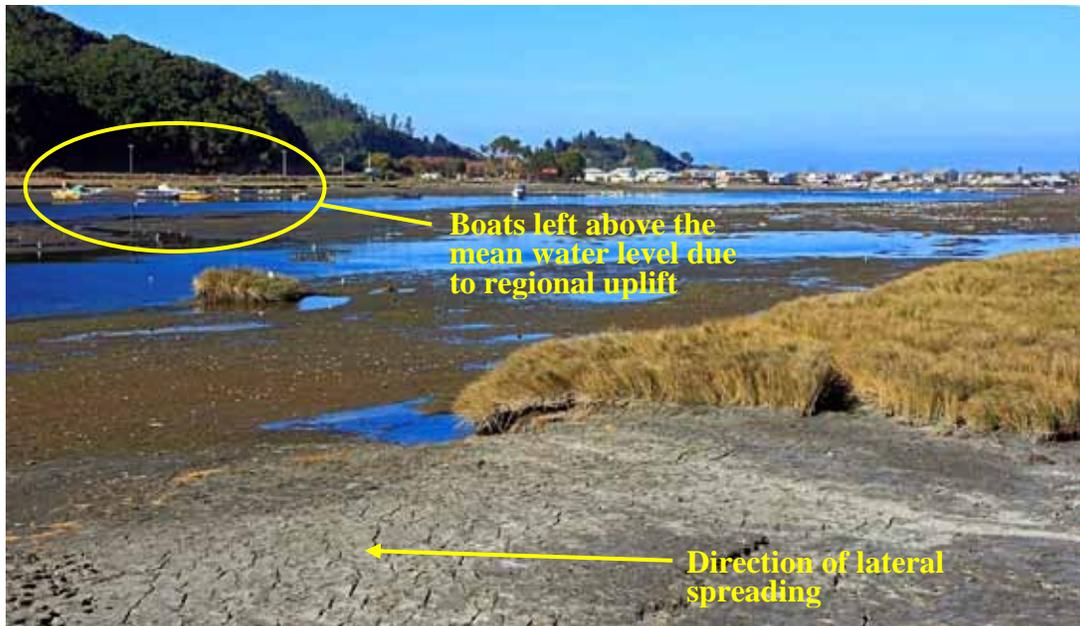
Figure 244. Photo. View northeast from Tubul bridge south abutment showing areas left dry and boats left above the new mean water level.

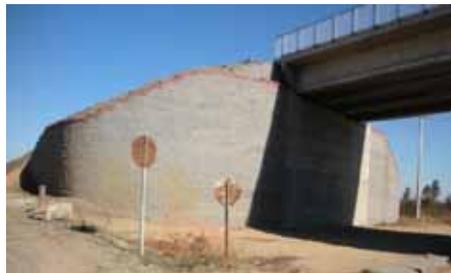
Figure 260. Photo. Retaining wall at Muros Talca (SW).

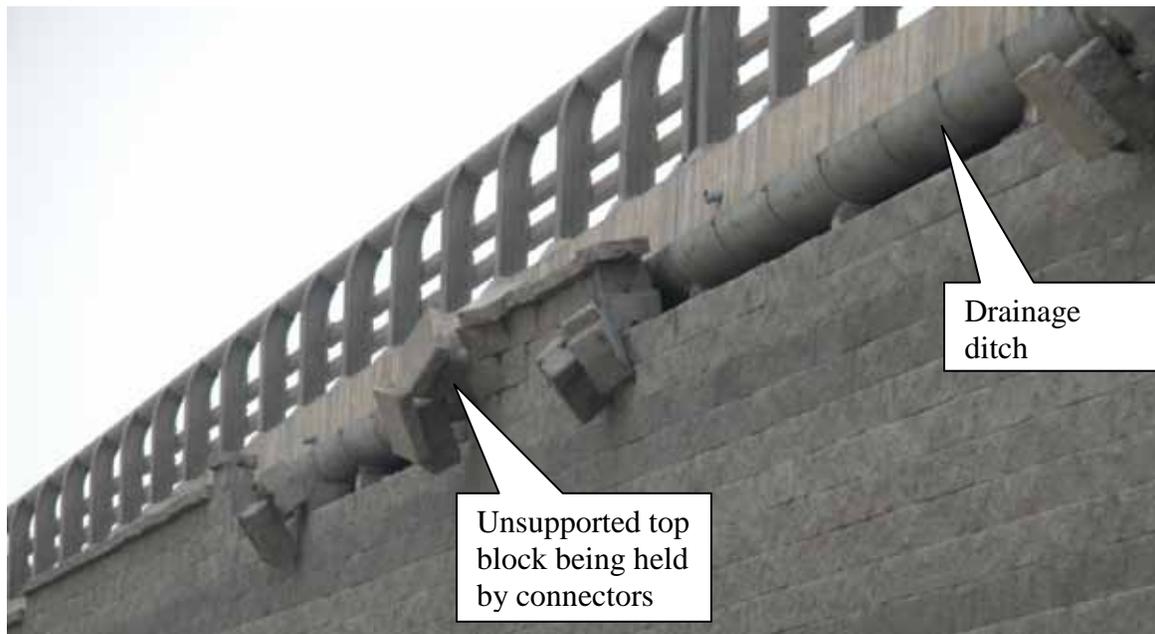
Figure 261. Photo. Toppling of coping at Américo Vespucio/Independencia.

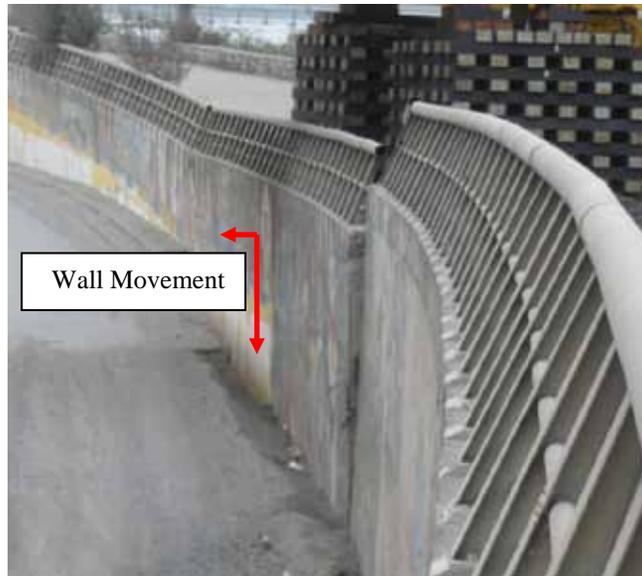
Figure 262. Photo. Wall movement near Chepe railroad bridge due to lateral spreading and settlement.

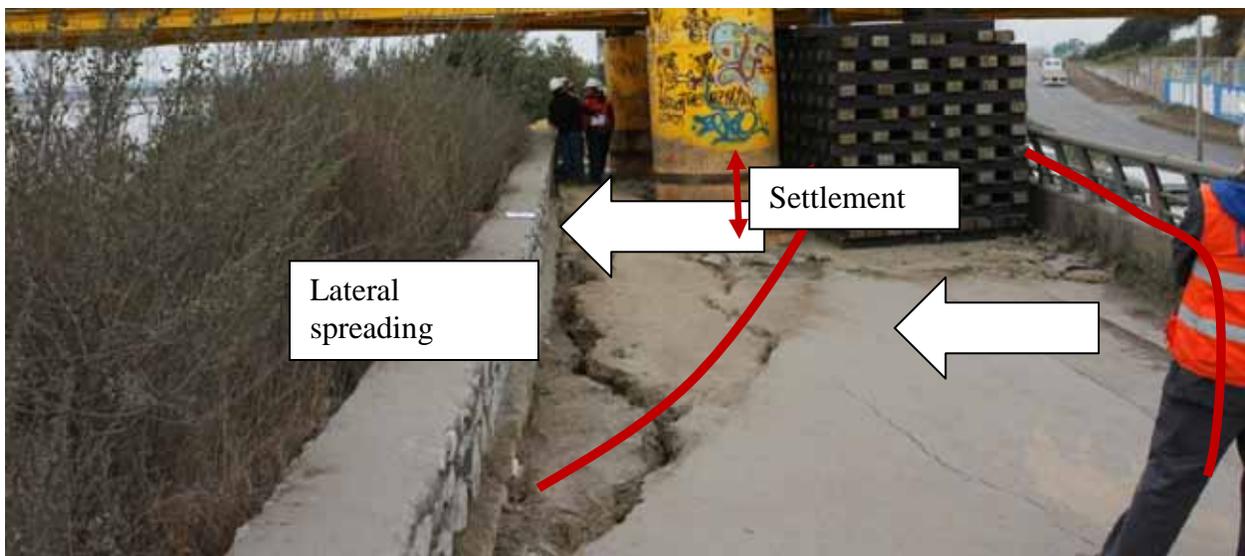
Figure 263. Photo. Wall settlement and rotation due to lateral spreading and settlement.

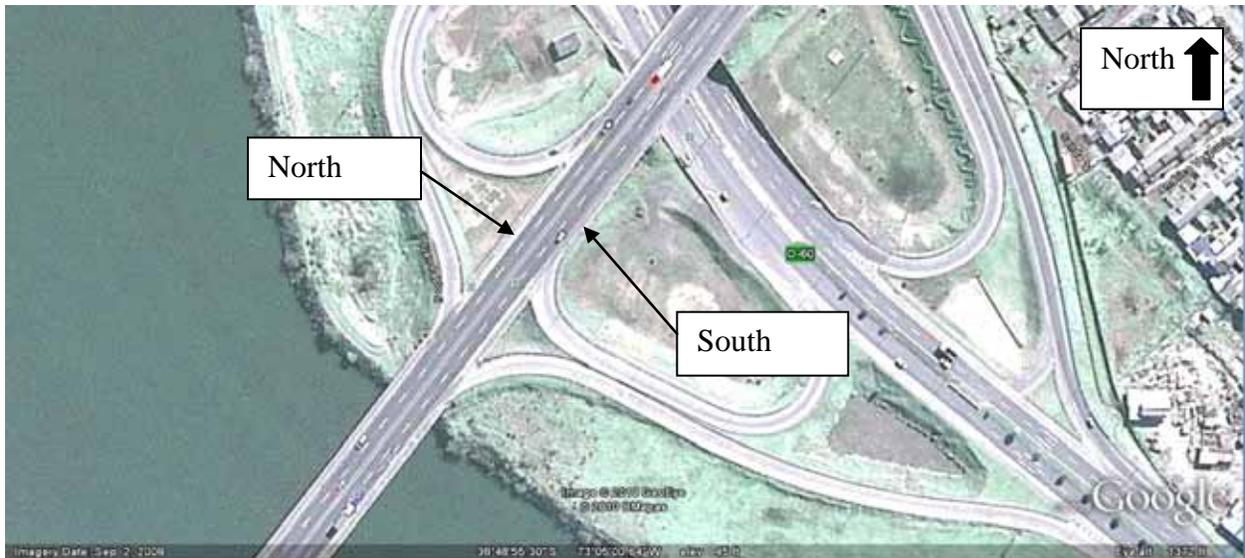
© Google, GeoEye, and DMaps

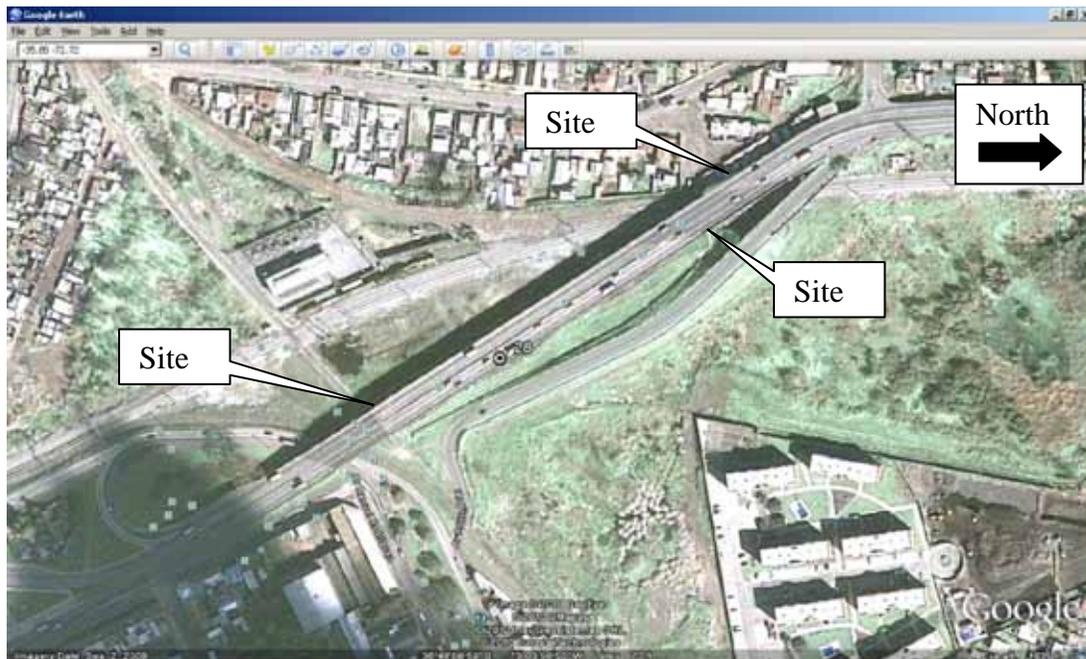
© Google, GeoEye, DMapas, Inav/Geosistemas SRL, and Europa Technologies

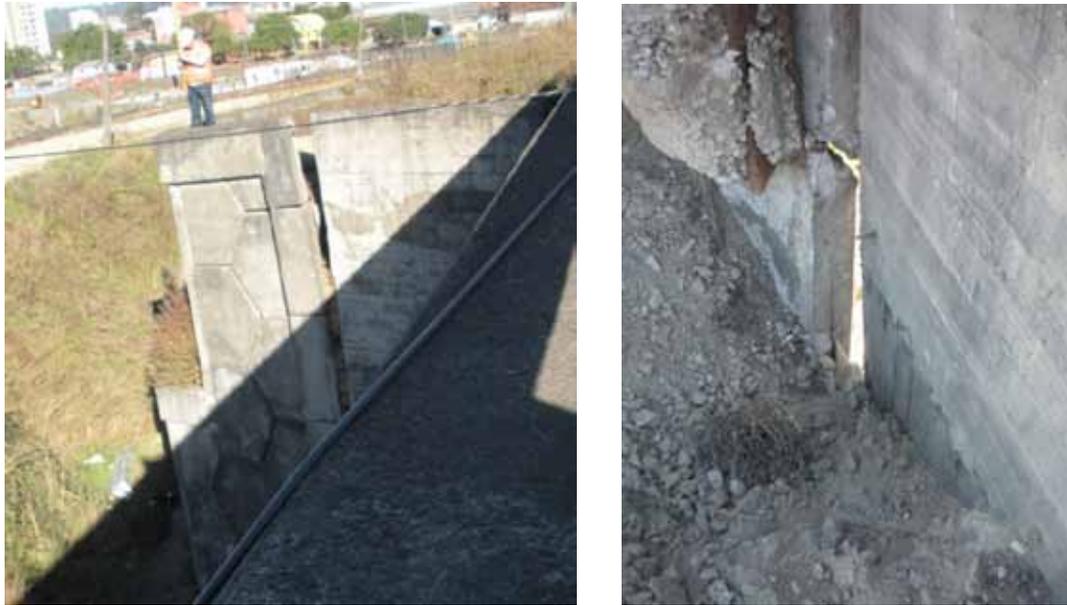
Figure 267. Photo. Tiered wall corner tilting outward at wall site 28A.

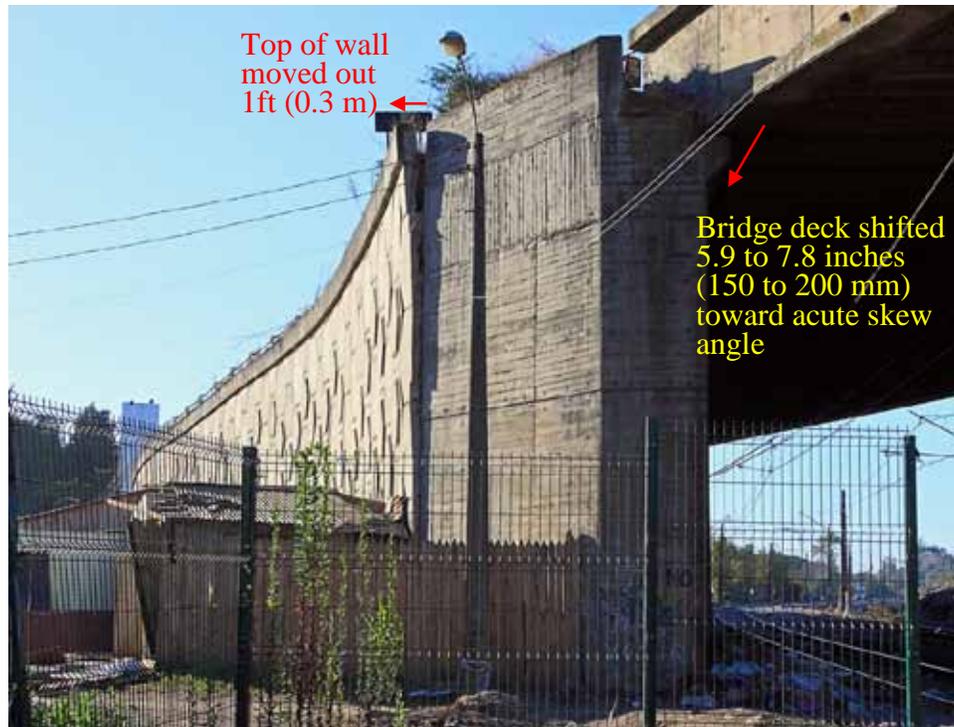
Figure 268. Photo. Wall corner tilting outward at wall site 28B.

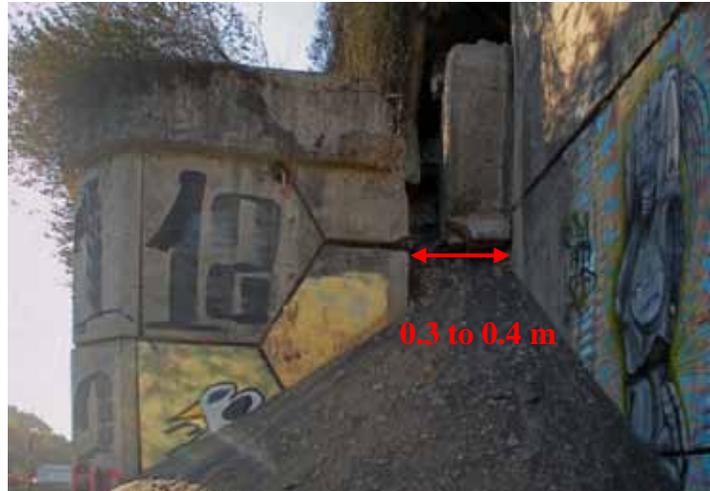
Figure 269. Photo. Lateral movement of lower wall top at wall site 28C.

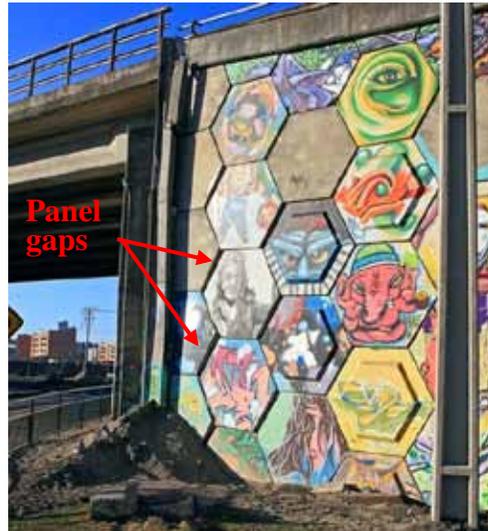
Figure 272. Photo. Differential settlement at wall site 28C.
