Postearthquake Reconnaissance Report on Transportation Infrastructure Impact of the February 27, 2010, Offshore Maule Earthquake in Chile

PUBLICATION NO. FHWA-HRT-11-030

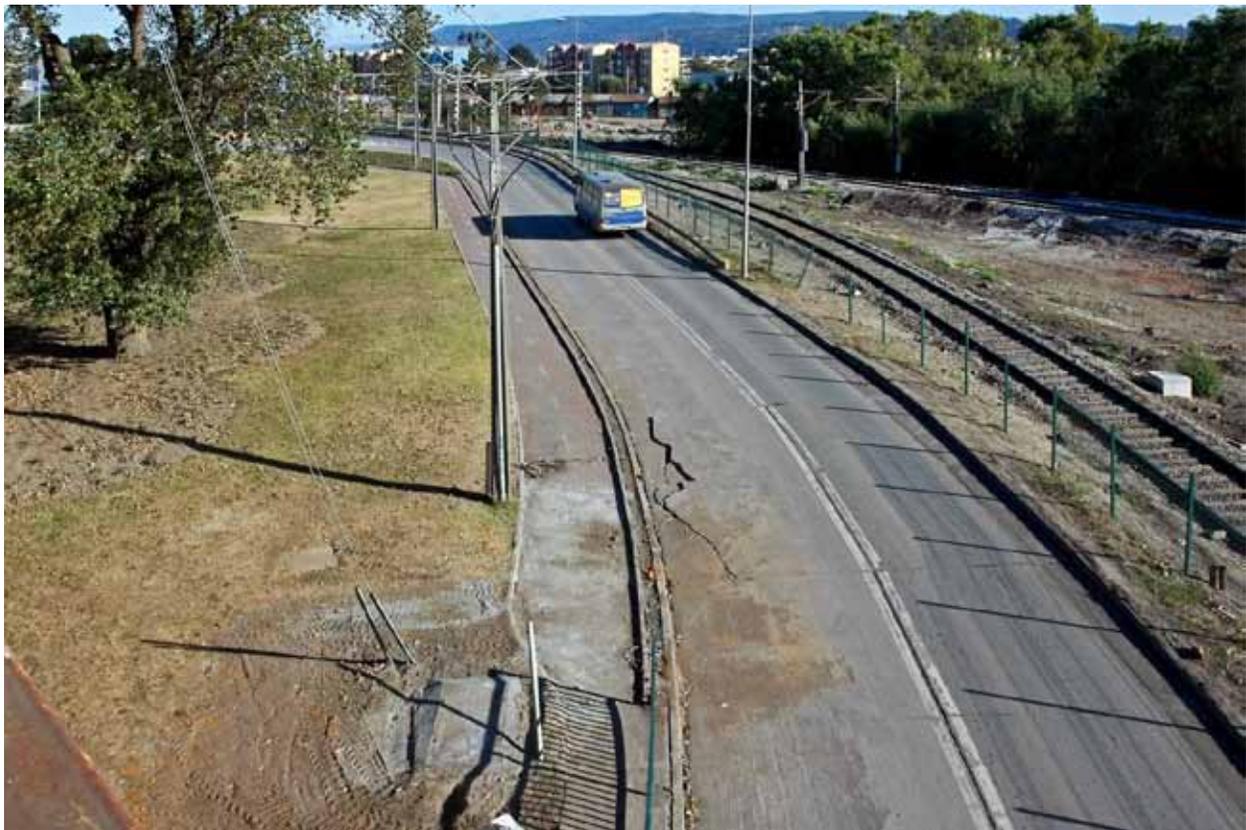
Figure 273. Photo. Possible liquefaction features near wall site 28C.

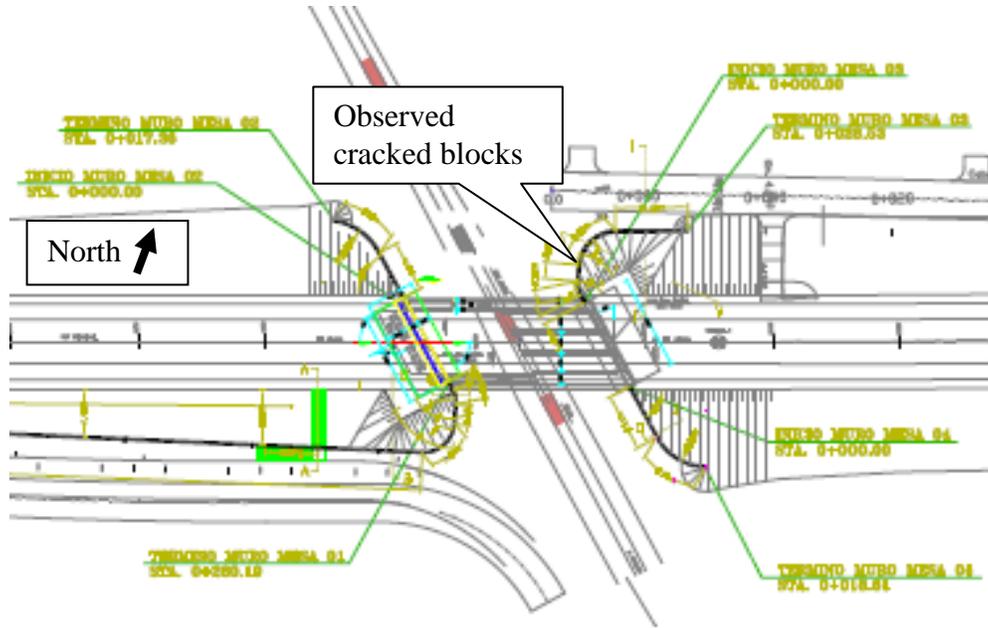
Figure 274. Illustration. Plan view of wall at Muros Talca.

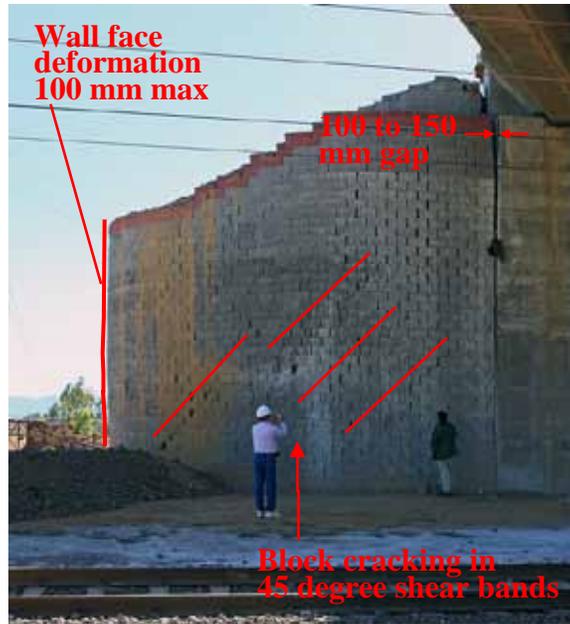
Figure 276. Photo. Wall with cracked block pattern at Muros Talca.

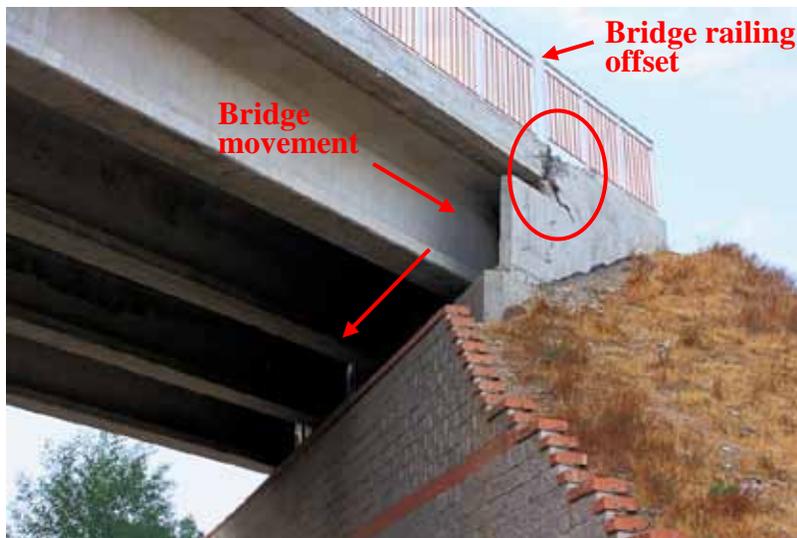
Figure 277. Photo. Bridge supported on footing on top of block-faced geogrid wall at Estribo Francisco Mostazal.

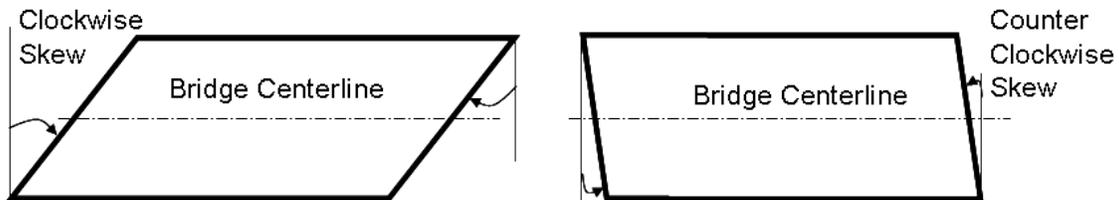
Figure 278. Illustration. Notations on skew direction.

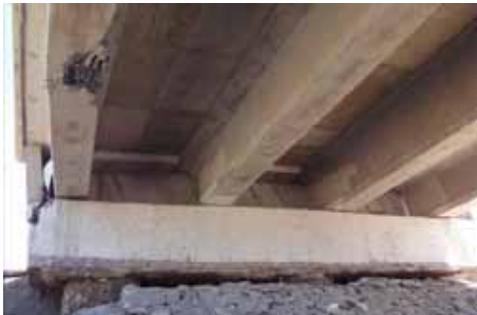
Figure 281. Photo. Exterior girder damage at Chada bridge, no diaphragms.

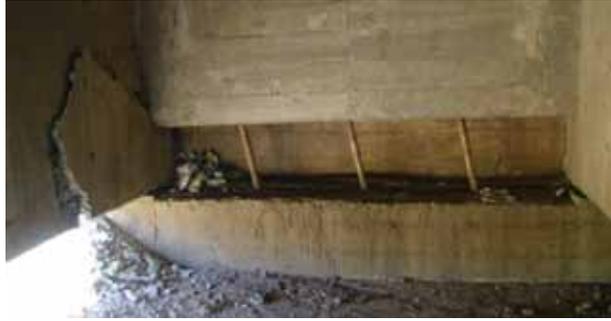
Figure 282. Photo. Exterior girder damage at San Nicolás bridge, partial diaphragms.

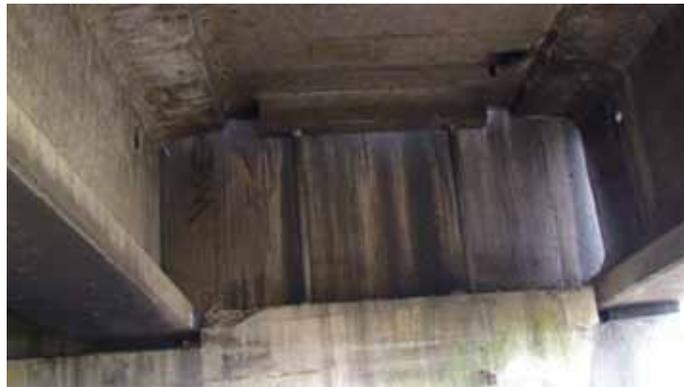
Figure 283. Photo. Exterior girder damage at west abutment of Llacolen bridge, concrete teeth.

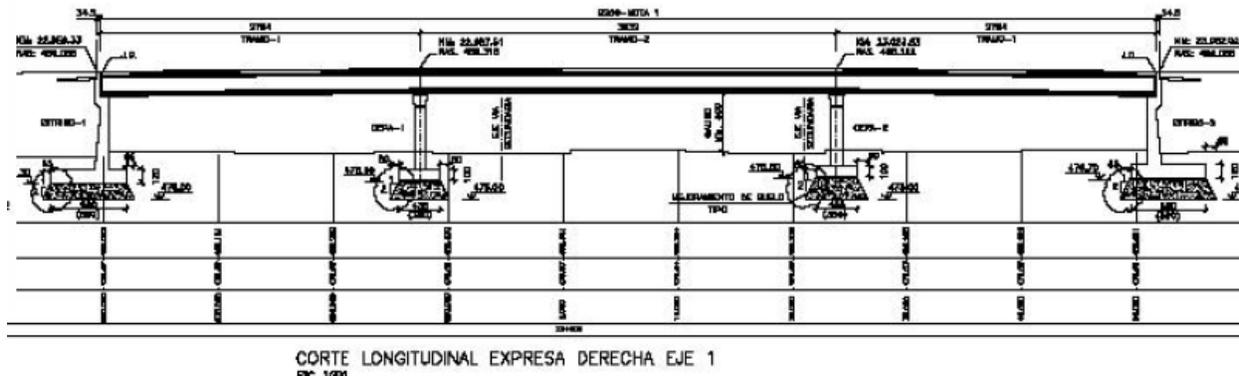
Figure 287. Illustration. As-built bridge plan for site 2.

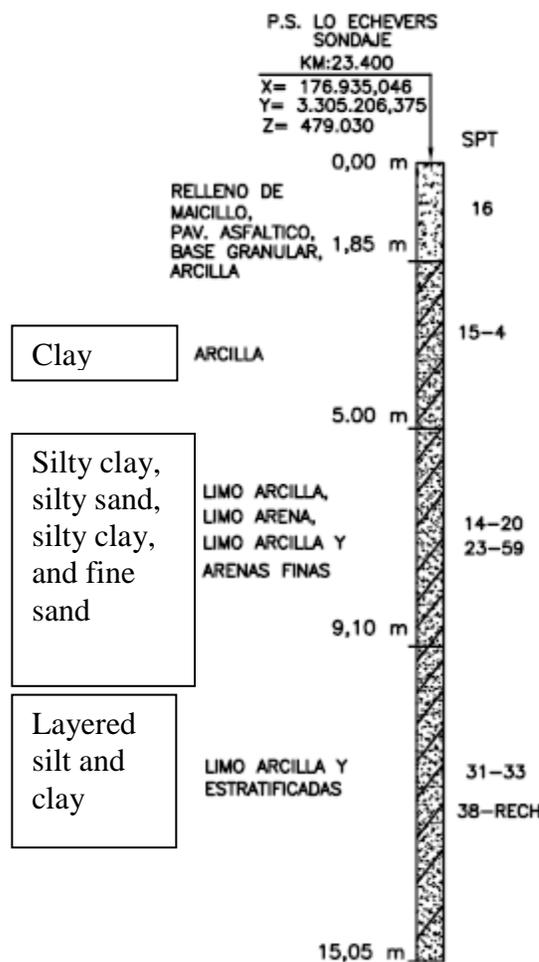
Figure 288. Illustration. As-built bridge profile for site 2 showing footing foundations.
