# Field Testing of an Ultra-High Performance Concrete Overlay

PUBLICATION NO. FHWA-HRT-17-096

SEPTEMBER 2017

Constructed in 1960s, the Laporte Road (County Road L) bridge over Mud Creek is a three-span reinforced concrete slab bridge located in Brandon, IA, approximately 35 mi (56.3 km) northwest of Cedar Rapids. A photo of the bridge is shown in figure 14. The bridge was originally designed using H20-44 loading, and although it has low average daily traffic (ADT), it carries large trucks with agricultural loads. The bridge is supported at the ends by reinforced concrete abutments that were cast over steel H-piles. The abutment-to-abutment length of the bridge is 100 ft (30.5 m). The width of the bridge is 28 ft (8.53 m) and services two lanes of traffic.

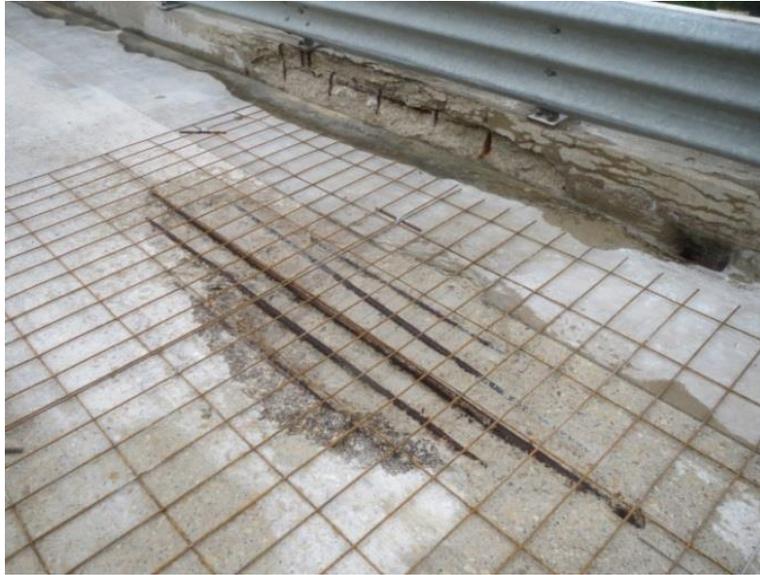
The bridge deck was beginning to exhibit delaminations and spalling along the northern (low elevation) curblin and at each end at the expansion joints. It is likely that the deterioration was related to chloride laden water ingress into the concrete and past the strip seal expansion joints, leading to reinforcement corrosion and freeze-thaw cycle-related distress. This deterioration had progressed to the point where maintenance actions were necessary. A UHPC overlay solution

**Figure 16. Photo. Distressed region observed on the westbound lane over the pier 1 prior to installing the UHPC overlay.**

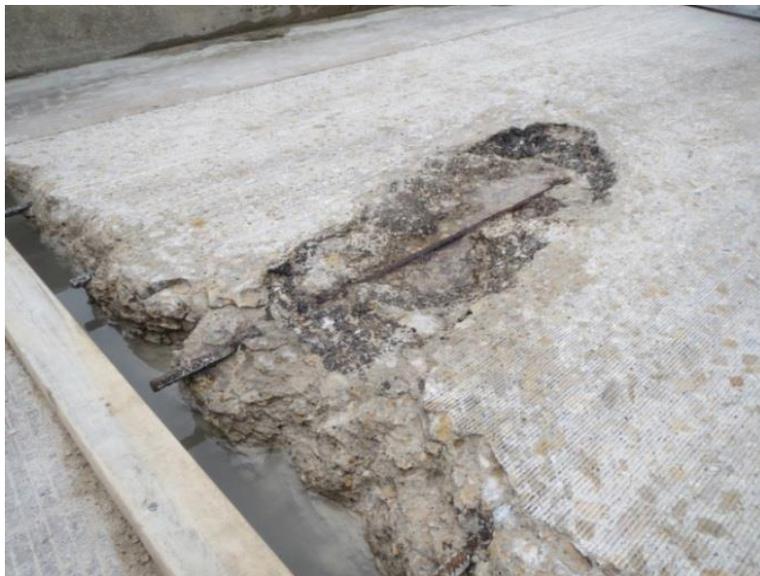
**Figure 17. Photo. Distressed region observed on the westbound lane near west abutment prior to installing the UHPC overlay.**

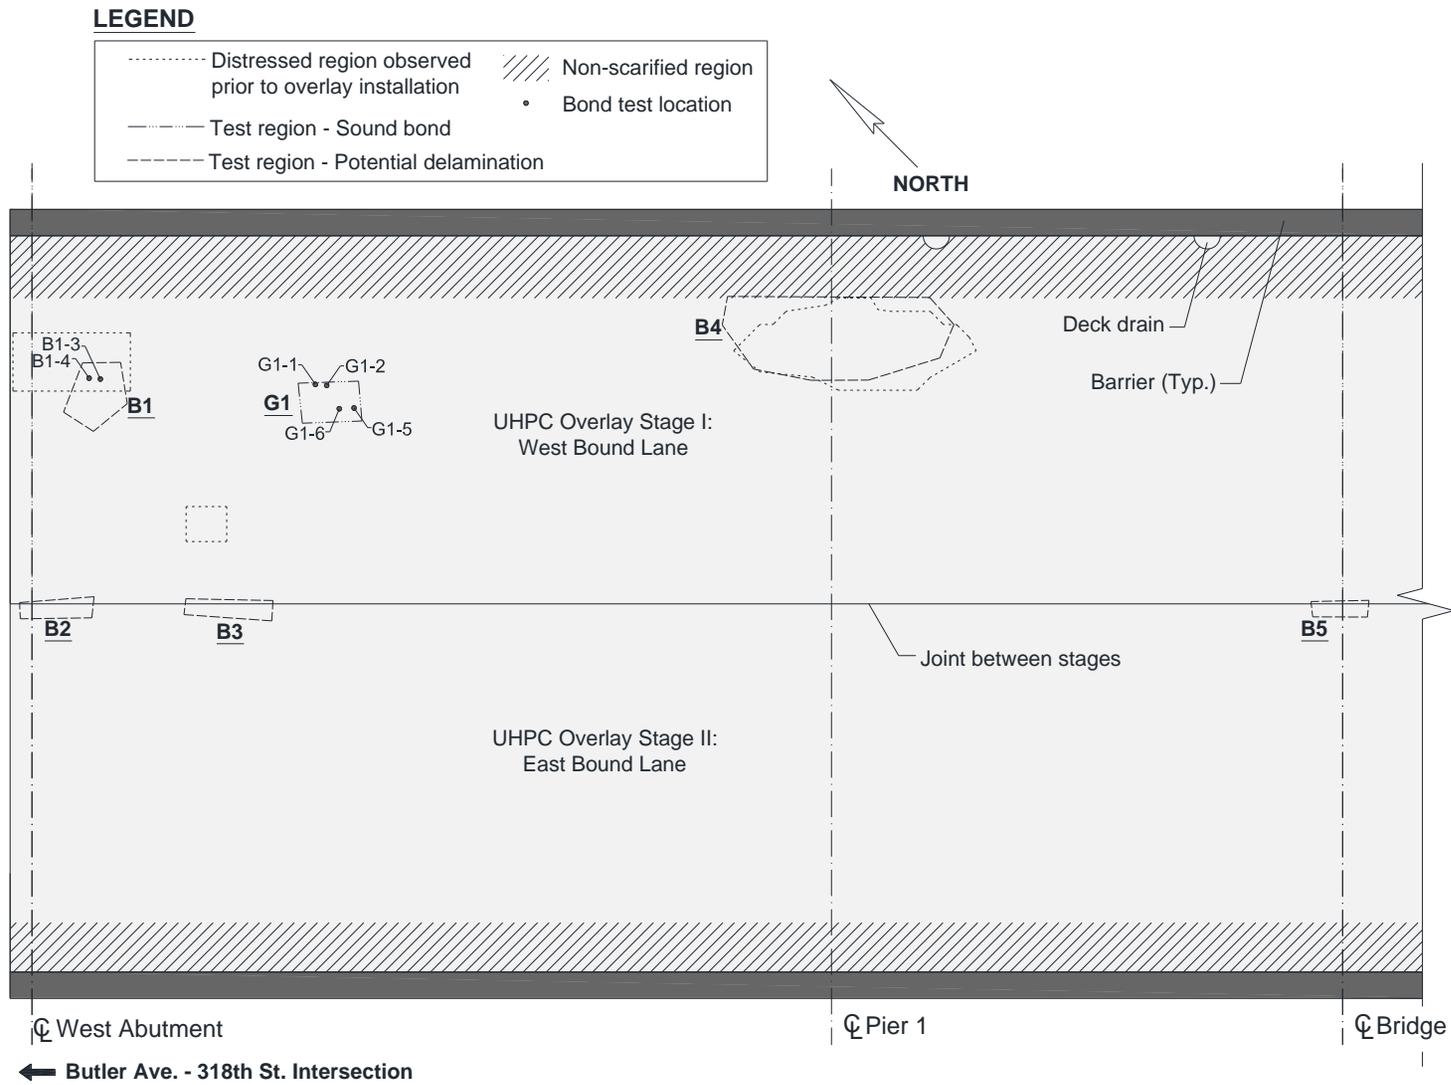
Once onsite, the bridge deck was inspected using a chain drag to identify regions of potential delamination. These regions were marked on the deck and recorded using a global positioning satellite (GPS)-based mobile mapping unit. This data was mapped on the aforementioned CAD drawing of the Laporte Road bridge. A total of eight potential delamination regions were found. Of these eight regions, two were selected for bond testing; one on the west-bound lane and one on the east-bound lane. Three regions exhibiting intact bond between the UHPC overlay and the underlying concrete deck were also selected for bond testing; one on the westbound lane and two on the eastbound lane. The eastbound lane locations included regions with and without scarification prior to the overlay installation.

Figure 22 and figure 23 present the observations, inspection findings, and test locations on the western and eastern sides of the bridge, respectively. Moreover, table 4 lists the findings from the onsite chain drag and details related to each region of interest. Regions of good apparent bond are denoted with a “G,” and regions of potential delamination are denoted with a “B.” Regions of potential delamination were found near the boundaries of the overlay construction stage (i.e., at the longitudinal construction joint or near the approaches) or in close proximity to the distressed regions observed prior to installing the overlay.

Figure 22. Illustration. Schematic of observations, inspection findings, and test locations on the western side of the bridge.

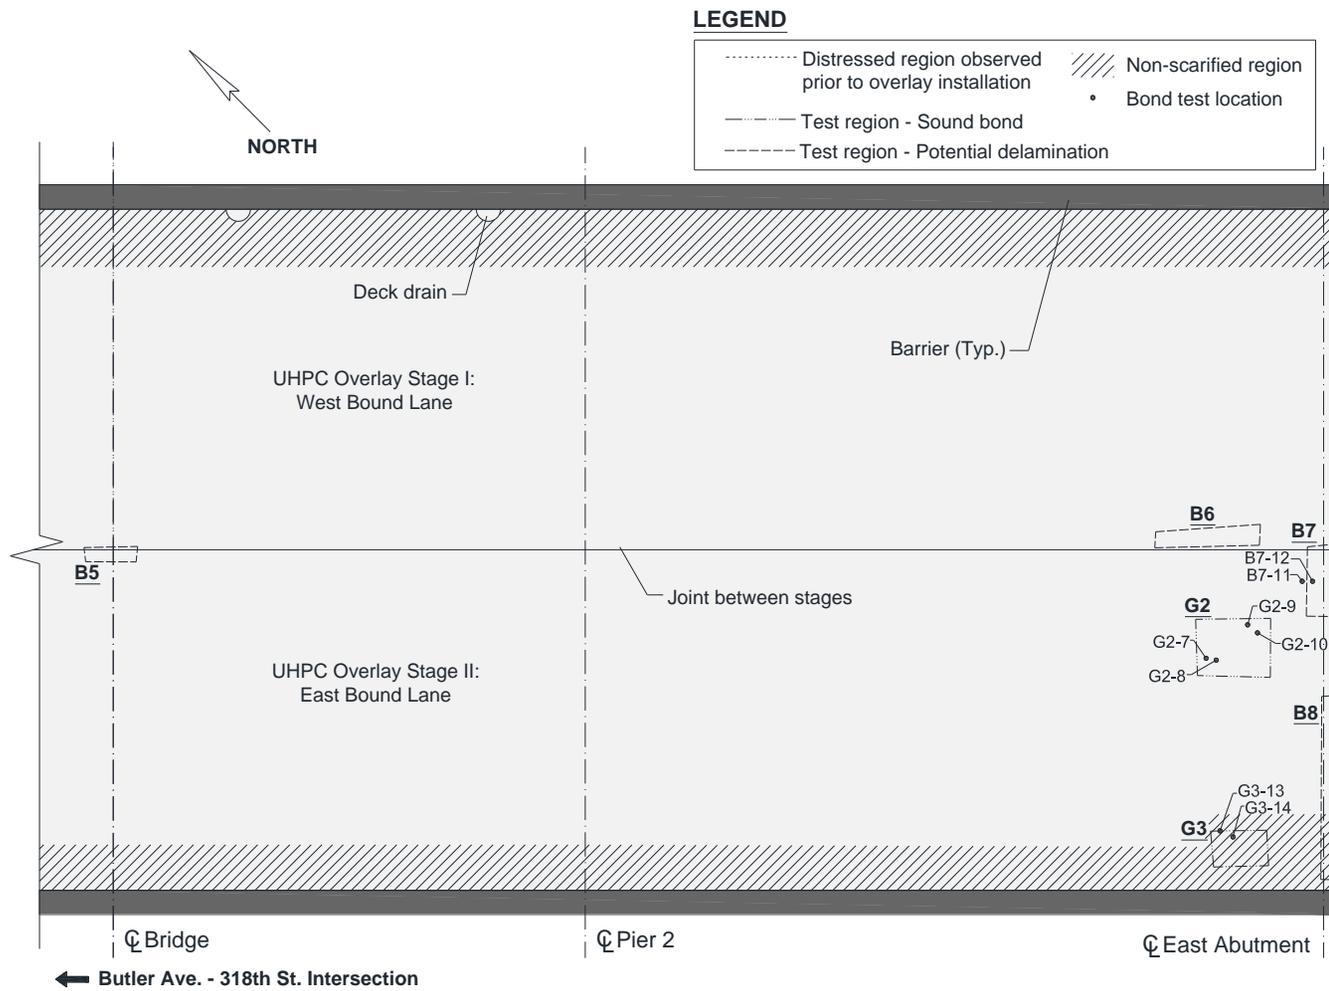
**Figure 23. Illustration. Schematic of observations, inspection findings, and test locations on the eastern side of the bridge.**

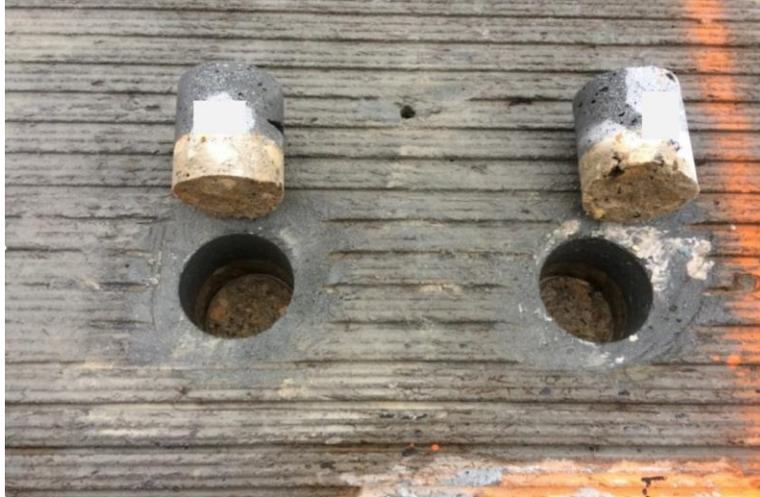
**Figure 28. Photo. Two test samples after failure in the substrate concrete.**

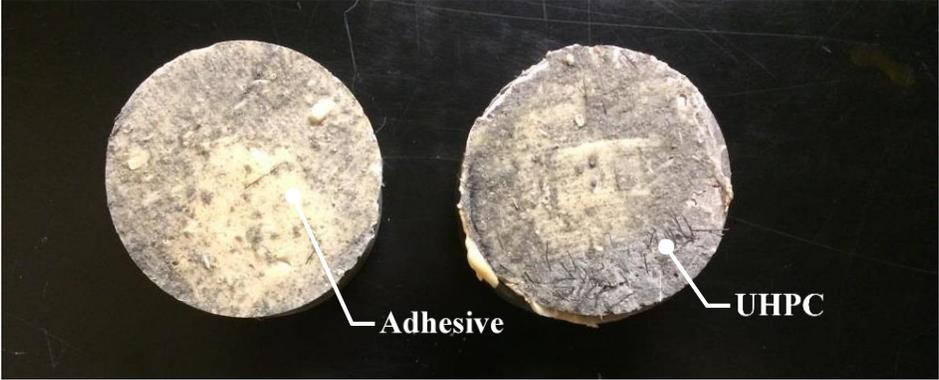
Specimens failing in Mode 4 were subsequently removed from the test location by applying a prying action to the sample using a hand tool. In each case, the prying action resulted in fracture of the substrate concrete. Figure 30 and Figure 31 show a representative sample (G2-9) from the G1 and G2 test locations. The bond between the UHPC overlay and the substrate concrete appears intact.

**Figure 30. Photo. Test disc removed from samples from G1 and G2 locations.**

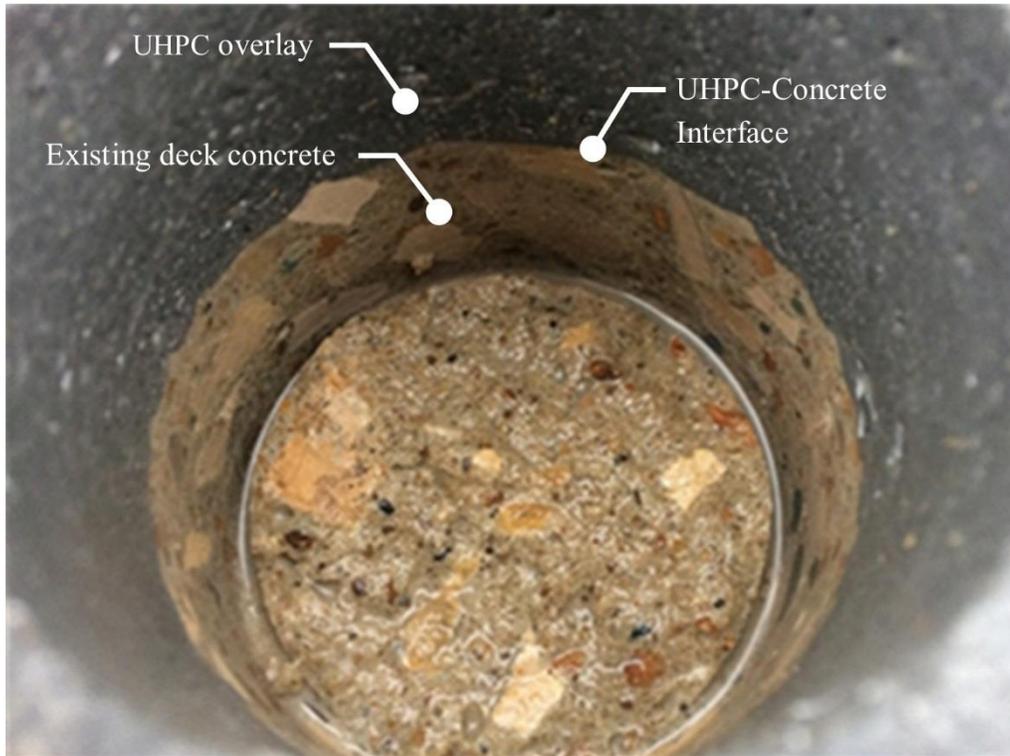
Figure 32 shows the core location from which sample G2-9 was removed. As expected, apparent damage or delamination in the deck concrete or at the UHPC-concrete interface was not present.

**Figure 32. Photo. Core location for specimen G2-9.**

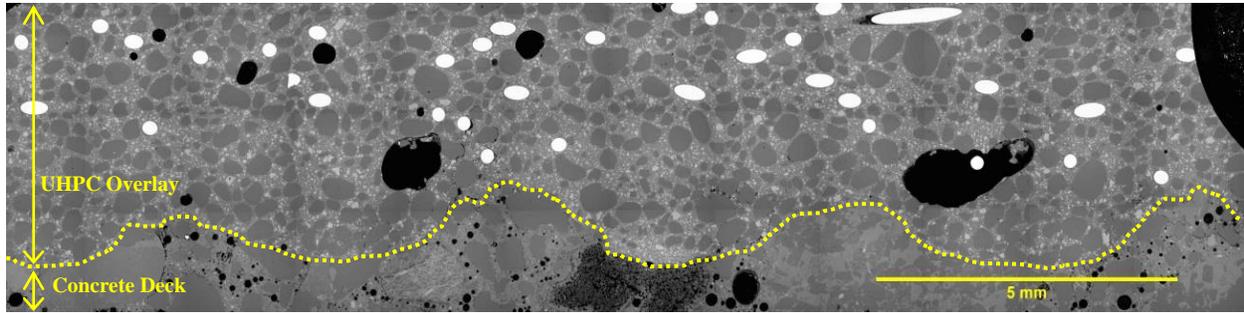
The General map shown in figure 33 displays a sound interface with close physical contact between hydrated phase of UHPC and the existing concrete deck substrate. This observation is justified by the absence of a gap dividing the paste from the concrete substrate and the presence of hydrated cement products—most likely calcium silicate hydrated (C-S-H) and portlandite—on the interface. The high degree of direct contact between the UHPC overlay and the concrete substrates justifies the relatively high tensile stresses sustained during bond strength testing and the absence of failure at the interface. However, this direct contact between hydrated products of the UHPC overlay and the concrete substrate was locally disrupted by the presence of entrapped air, (shown in figure 34) or poor consolidation or accumulation of debris, which is shown in figure 35. The presence of these features near the UHPC-concrete interface was marginal and did not compromise the overall bond performance.

**Figure 33. Electron Microscope Image. General map of the UHPC-concrete interface for specimen G2-8.**

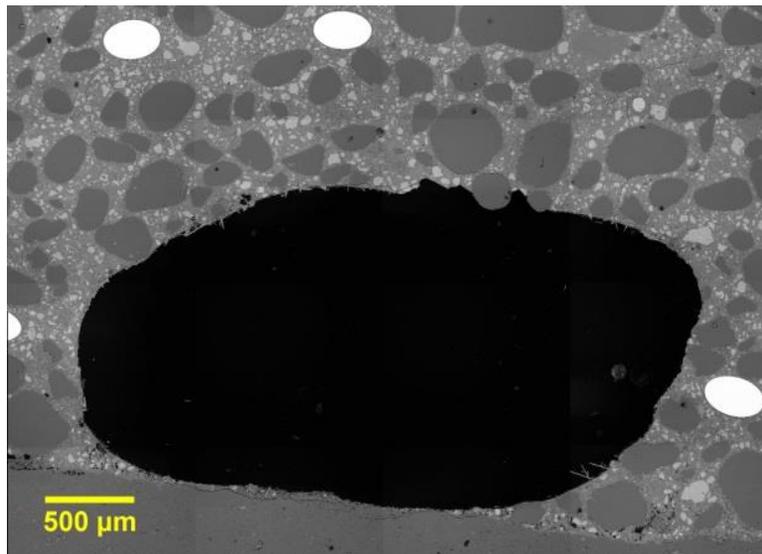
**Figure 34. Electron Microscope Image. BSE image of a void between the UHPC overlay and the substrate concrete.**

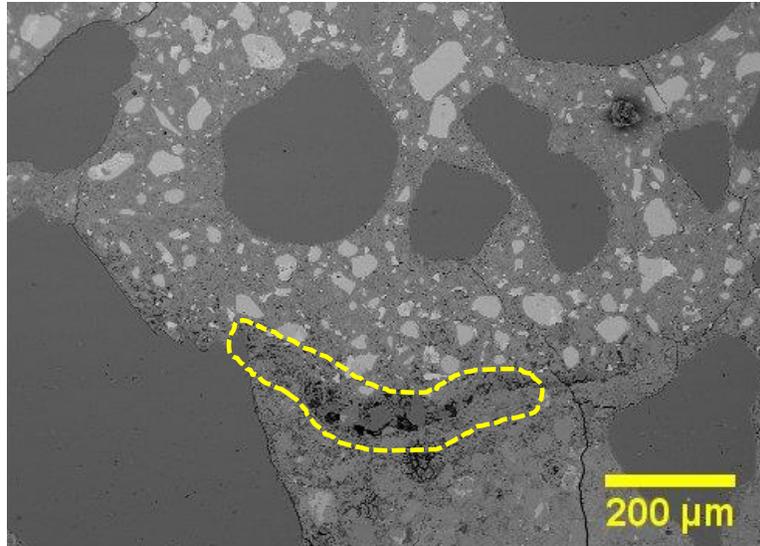
**Figure 35. Electron Microscope Image. BSE image of poor consolidation or debris accumulation at the interface.**

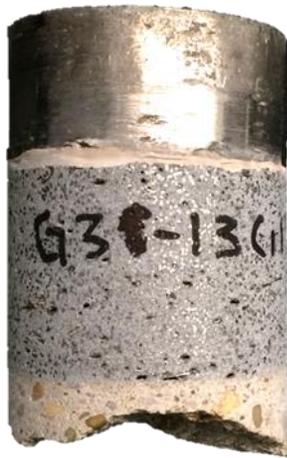
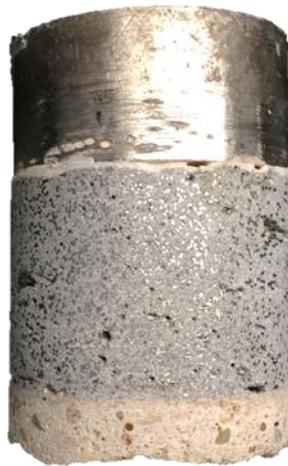
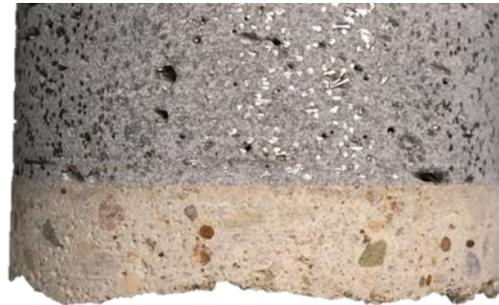
**Figure 37. Photos. Specimen G3-13 after testing.**

Specimens tested from region G3, which represented an apparent region of good bond without scarification prior to placement of the UHPC overlay, all failed in the concrete substrate (Mode 1). Peak stresses recorded prior to failure were between 344.6 psi (2.37 MPa) and 474.6 psi (3.27 MPa). Figure 37 shows a representative sample (G3-13) from the G3 test location. The bond between the UHPC overlay and the substrate concrete appears intact. Further, the difference in the UHPC-concrete interface texture can be observed when comparing the photos in Figure 31-C and Figure 37-C. Figure 38 shows the core location from which sample G3-13 was removed. As expected, apparent damage or delamination in the deck concrete or at the UHPC-concrete interface was not present.

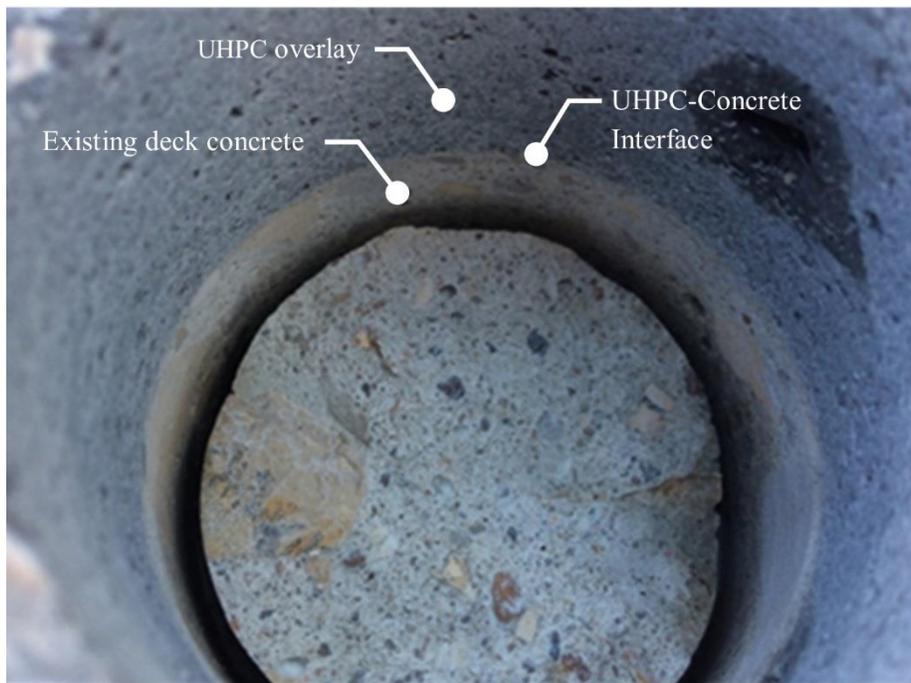
**Figure 38. Photo. Core location for specimen G3-13.**

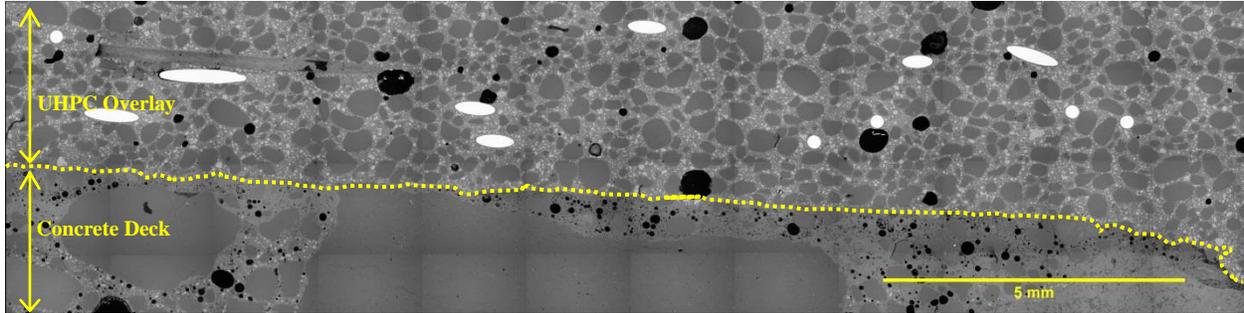
The UHPC-concrete substrate interface of the G3-14 specimen had characteristics similar to those identified on the G2-8 sample. As shown in figure 39, the width of the UHPC paste adjacent to the concrete surface free of steel fibers varied between 0.024 in (0.6 mm) and 0.1 in (2.6 mm). This band was also characterized by its high degree of contact with the concrete surface. This was also motivated by high content of hydrated products of the UHPC paste in the vicinity of the concrete surface.

**Figure 39. Electron Microscope Image. General map of the UHPC-concrete interface for specimen G3-14.**

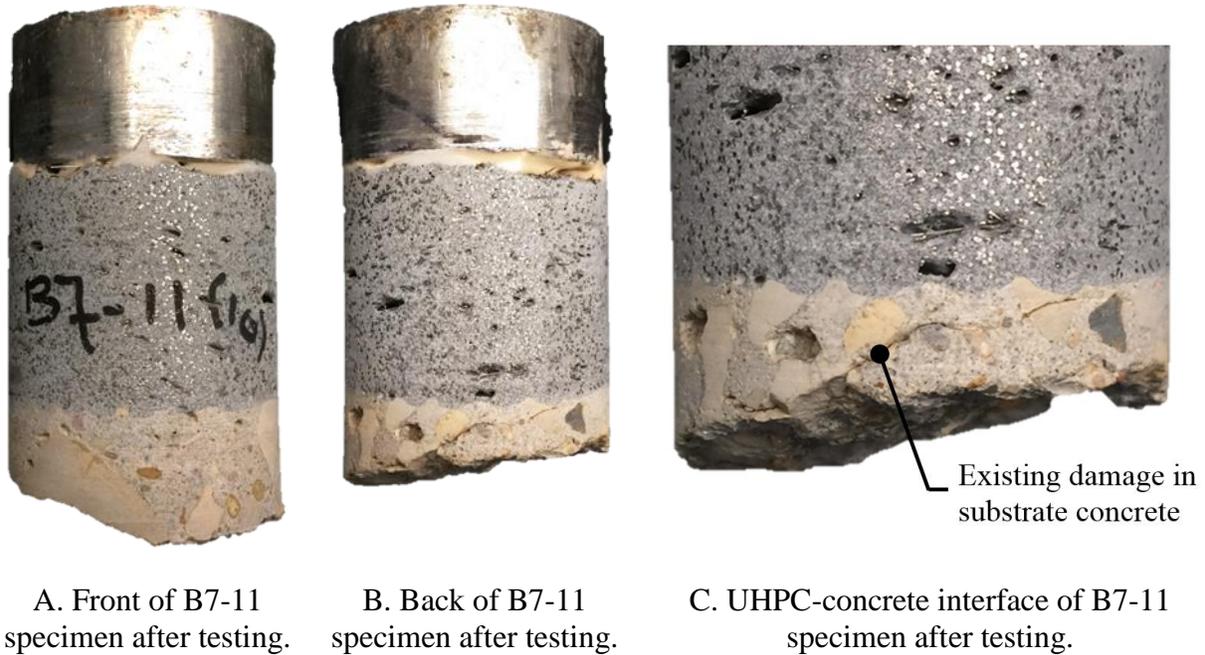
Specimens tested from regions B1 and B7, which represented regions of potential delamination with scarification prior to placement of the UHPC overlay, all failed in the concrete substrate (Mode 1). Peak stresses recorded prior to failure were between 0 psi (0 MPa) and 114 psi (0.79 MPa), which were relatively low compared with other regions. Two of the four samples (B1-3 and B7-12) were loose after completing the coring procedure. These two samples were removed without applying load (i.e., they were loose after completing the particle coring). Further examination of the four test samples and their respective core locations indicated that pre-existing delamination was present in the conventional concrete deck. Figure 41 shows a representative sample (B7-11) from the B1 and B7 test locations. Although the bond between the UHPC overlay and the substrate concrete appears intact, pre-existing damage can be observed within the concrete substrate layer.

**Figure 41. Photos. Specimen B7-11 after testing.**

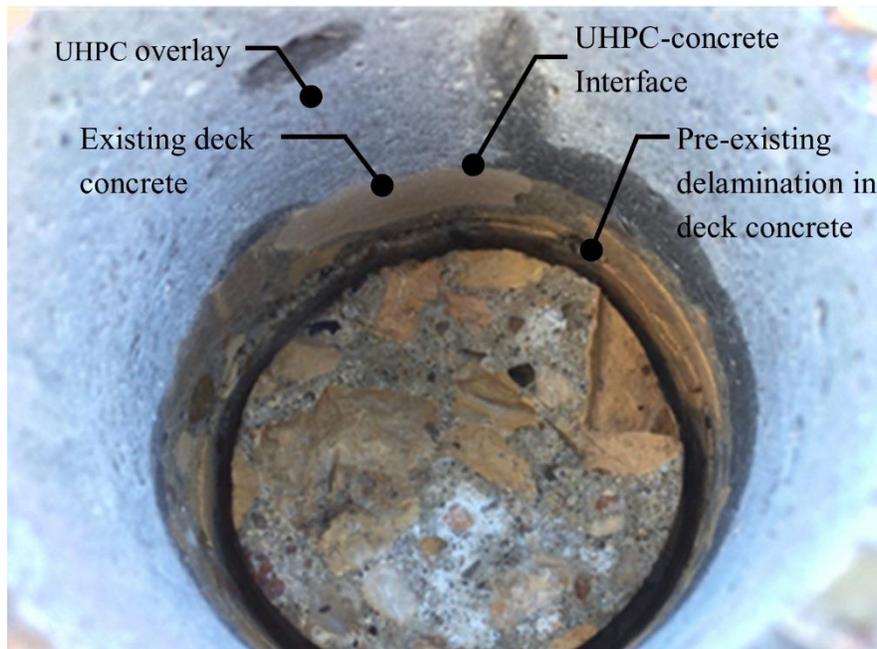
This can be most clearly observed in figure 42, which shows the core location from which sample B7-11 was removed. A horizontal crack plane can be observed within the concrete deck layer approximately 0.5 in (12 mm) below the UHPC-concrete interface. Further, it is evident that when sample B7-11 failed, failure was initiated from this existing crack plane.

**Figure 42. Photo. Core location for specimen B7-11.**

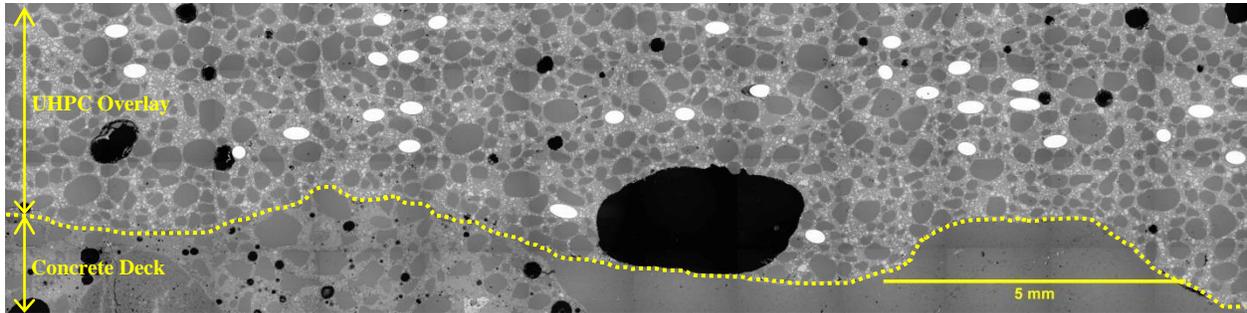
The microstructural analysis of specimen B7-12 also revealed a dense interface dominated by the presence of hydrated products, as in the previous two samples. In this case, the width of the UHPC band without steel fibers ranged from 0.024 in (0.6 mm) to 0.12 in (3.0 mm). The typical valley-hill topography was observed on the concrete surface as illustrated in figure 43. Additionally, as in the case of the G2-8 specimen, entrapped air and accumulated debris were visualized disrupting the contact between UHPC hydrated products and concrete surface. However, the extent of this disruption was limited, and it was not expected to have a deleterious effect on the overall bond strength of the system.

**Figure 43. Electron Microscope Image. General map of the UHPC-concrete interface for specimen B7-12.**
