Cable-Stay Strand Residual Strength Related to Security Threats

PUBLICATION NO. FHWA-HRT-17-109

JANUARY 2018

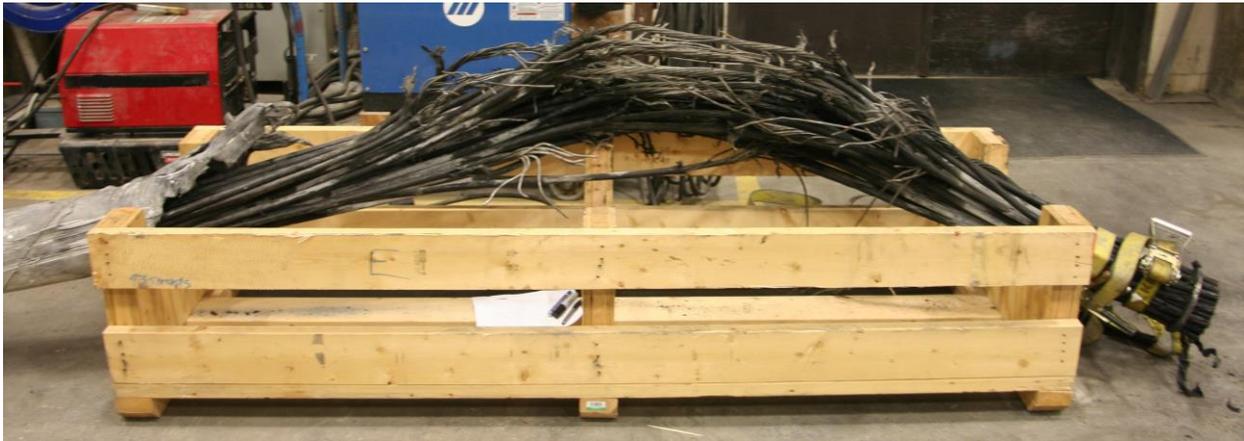
Figure 1. Photo. Bundle subjected to a blast charge.

Four bundles subjected to blast were used in this project. Each bundle size (43-strand and 109-strand) was tested at two different standoff distances. Three of the bundles were no longer intact after the blast event; thus, only boxes of individual strands were received. Though the last bundle did remain intact, as pictured in figure 1, it was significantly deformed, and numerous wires were severed.

The photo of bundle E in figure 1 shows that, after the blast event, the strands are certainly left in a residual bent or kinked shape. One of the primary questions to be explored is, Does this additional cold working from the strand being bent, along with birdcaging, affect the residual strength of the strand? To answer this question, the deformations (curvature and diameter of the strand) of each strand were measured. To characterize curvature, a jig was fabricated to consistently measure the lateral and vertical deformation of the strand relative to a fixed plane along a 24-inch-long chord distance. As illustrated in figure 17, two aluminum angles, spaced with an out-to-out distance of 24 inches, were attached to a piece of plywood. A bent strand was laid on the plywood and put into contact with these two angles. In each blast test, a charge was placed near the center of the bundle along its length, around the outermost surface of a protection device encasing the strand bundle. Thus, assuming the maximum damage was most likely aligned with the charge position, the center of each individual strand was aligned to the middle of the 24-inch-chord distance. In the plane of the plywood, the lateral deformation was measured as the distance normal to the 24-inch chord to the strand (depicted in the plan view of figure 17). The vertical deformation was measured as the distance from the plywood to the center of the strand (depicted in the elevation view of figure 17).

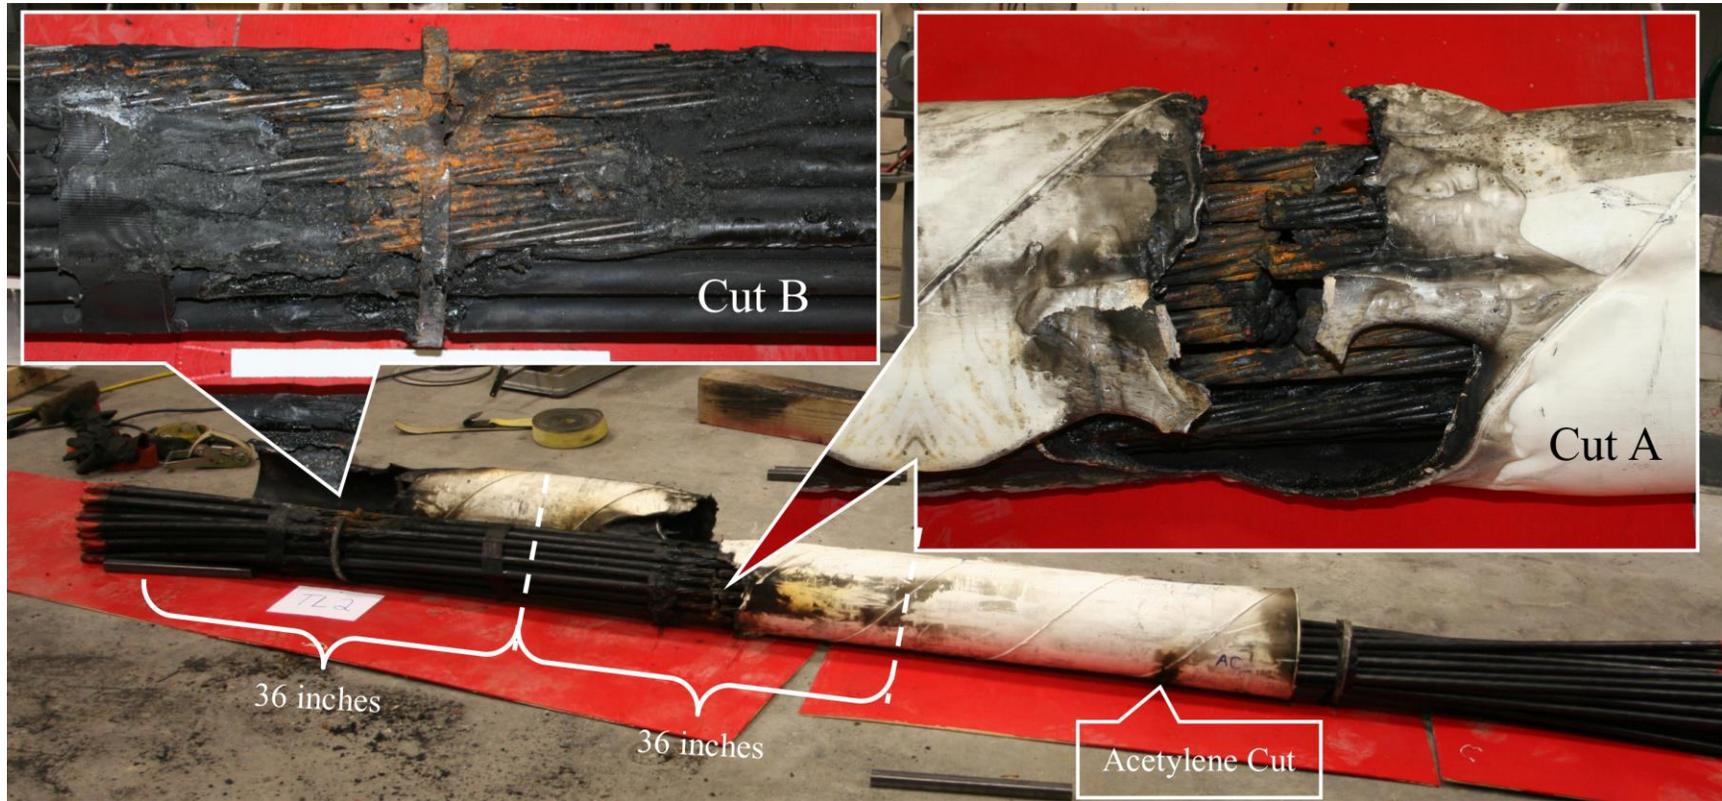
Figure 2. Photo. Bundle subjected to thermal lance tests.

One 43-strand bundle that had three different thermal-cutting tests applied to it was delivered. Two tests were performed with a thermal lance and one with an oxyacetylene torch. The notion behind the qualification test was to see how much damage could be done in a set amount of time. Very little damage was caused by the oxyacetylene torch; thus, only the thermal lance cuts were of interest. Figure 2 shows a picture of the bundle with closeups of the two individual thermal lance cuts, labeled “Cut A” and “Cut B.”

Figure 5 and figure 6 present similar maps of severed and damaged wires for cut B. The extents of cut and damaged wires were much less for this cut, particularly as evident in figure 6. As shown in figure 2, cut B happened to coincide with the location of a bundle retaining plate, and this greatly impeded the thermal lance operator's ability to compromise the bundle. The same data on cut and damaged wires are replicated with histograms in figure 7 and figure 8, respectively, for cut A and cut B.

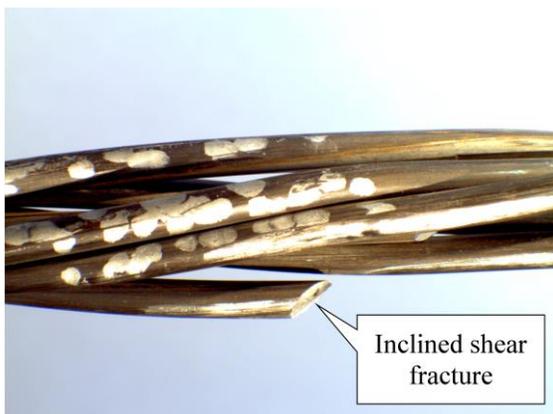
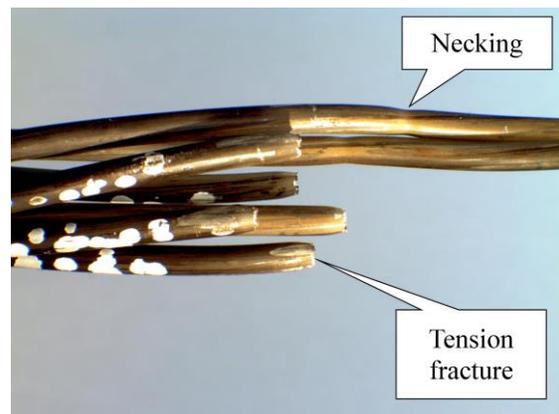
Figure 22. Photo. Shear failure of virgin 2. Figure 23. Photo. Tension failure of virgin 4.

Of the 16 tests on virgin strands, 3 failed in shear within the grips. Figure 22 shows a typical shear failure of a wire from the virgin 2 specimen with the characteristic inclined fracture plane. Shear failures in or at the grips may artificially reduce the strength of the strands, and thus these results were not part of statistical calculations or plotted in any figures shown. The desired fracture pattern is a tension failure that is normal to the applied stress; figure 23 shows a tension failure of five wires in virgin 4, and the remaining two intact wires are noticeably necked.

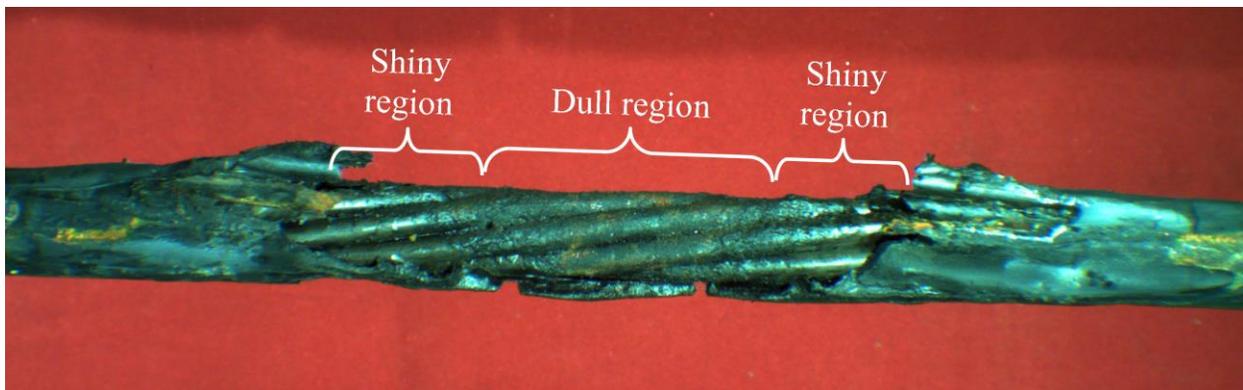
Figure 27. Photo. Untested strand B23 with burned HDPE and grease.

Depending on the thermal cycle applied to strands, microstructural changes might have occurred in the steel wires. These microstructural changes could affect the residual tensile strength in the steel wires. The thermal lance qualification tests did not employ thermocouples to measure magnitude or duration of temperature. However, prior to conducting the tension tests, a visual inspection of the strand (relative to other strands) might provide a qualitative measure of the maximum temperature reached in a steel wire. All strands were originally greased and sheathed, and it is recognized that these coatings will change under sufficiently high heat. The HDPE cover on the majority of the strands selected from the thermal lance test groups was melted. It was also noticed that the grease was either partially or completely burned away from some of the selected strands. Figure 27 shows a picture of the untested B23 strand, considered representative, which shows the HDPE has burned away for a few inches, and the dull appearance at the center of the strand indicates that the grease was possibly burned away on the outer wires. The shinier appearance near the melted HDPE indicates intact grease on the outer wires. After the strands were tested in tension, it was easier to observe the condition of the HDPE and grease both on the outer six wires and around the king wire. Using the information describing the condition of the HDPE and grease might help provide a qualitative measure of the temperature the strand may have experienced.

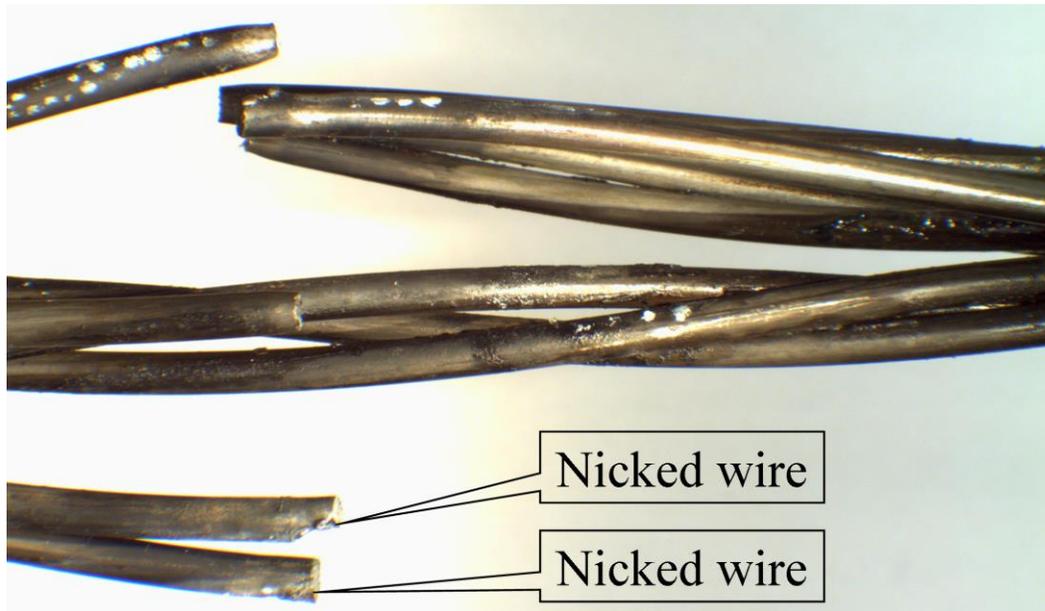
Figure 28. Photo. Fracture of A35.

Table 4 footnotes add important commentary to explain posttest observations not known a priori. First, according to the map of damaged wires presented in figure 4, the only strand with seven wires intact with damage was A35; this strand was originally documented as having one wire damaged. Visual examination of the fractured strand after testing (shown in figure 28) clearly shows that fractures on two wires initiated from nicks on each wire from the thermal lance. This indicates that the damage mapping presented in figure 3 through figure 6 is subject to some error, as melted HDPE and/or burned grease may have masked damage to wires, though this damage became more apparent after pressure washing to remove grease before testing. Similarly, strand A34 had no reportable damage, but posttest inspection did reveal one nick on a wire. Note, also, that during the dismantling of the bundle, wires in strands A32 and A43 received nicks from the reciprocating saw blade during the cutting operation to remove the melted HDPE cover. The nicks on wires in strand A32 did not appear to affect the residual capacity test results. However, the nicks on wires in strand A43 did appear to affect the residual capacity test results. A posttest view after the tension test on strand B12 is shown in figure 29, and no obvious nicks are visible around the fracture. However, a slag ball fused to one wire coincided with a fracture in one wire, but since two other wires simultaneously fractured, the low strength was likely the result of microstructural changes due to excessive heat, not necessarily the fused slag ball.

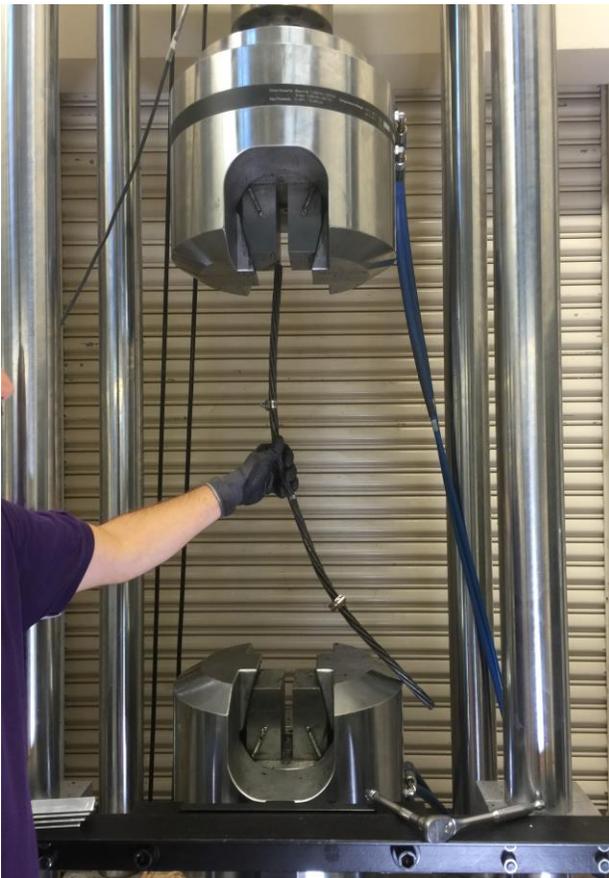
Figure 32. Photo. Strand D38 before installation.

The strands recovered after the blast tests were obviously quite deformed, evident from the lateral deformation data presented in the Documentation chapter. The photo in figure 32 shows a view of the D38 strand before installation into the lower or upper grips of the tension test frame. This view shows the extreme bent shape of the strand. To grip the bottom portion of such a bent strand required a strong effort to bend it straight. This same strand is depicted in figure 20 once it was completely installed. The strong efforts included technicians bending the strand by hand and hitting the strand with a dead-blow hammer. Evidence that the installation stresses imposed were elastic was observed when the strand would spring back to its original bent shape after being removed from the grips. When installing birdcaged strands, the dead-blow hammer impacts tended to walk the birdcage up or down the strand or sometimes exacerbate its diameter slightly, but this was necessary to get the strand installed. Figure 33 shows strand G2 installed in the test machine. Strand G2 represented a test sample with one of the largest birdcage diameters.
