# NCHRP Report 350 Test 3-11 of the Strong Wood Post Thrie Beam Guardrail

PUBLICATION NO. FHWA-RD-99-061

DECEMBER 1999

6. Performing Organization Code	
7. Author(s) C. Eugene Buth and Wanda L. Menges		8. Performing Organization Report No. 404211-11	
9. Performing Organization Name and Address Texas Transportation Institute The Texas A&M University System College Station, Texas 77843-3135		10. Work Unit No. (TRAIS)

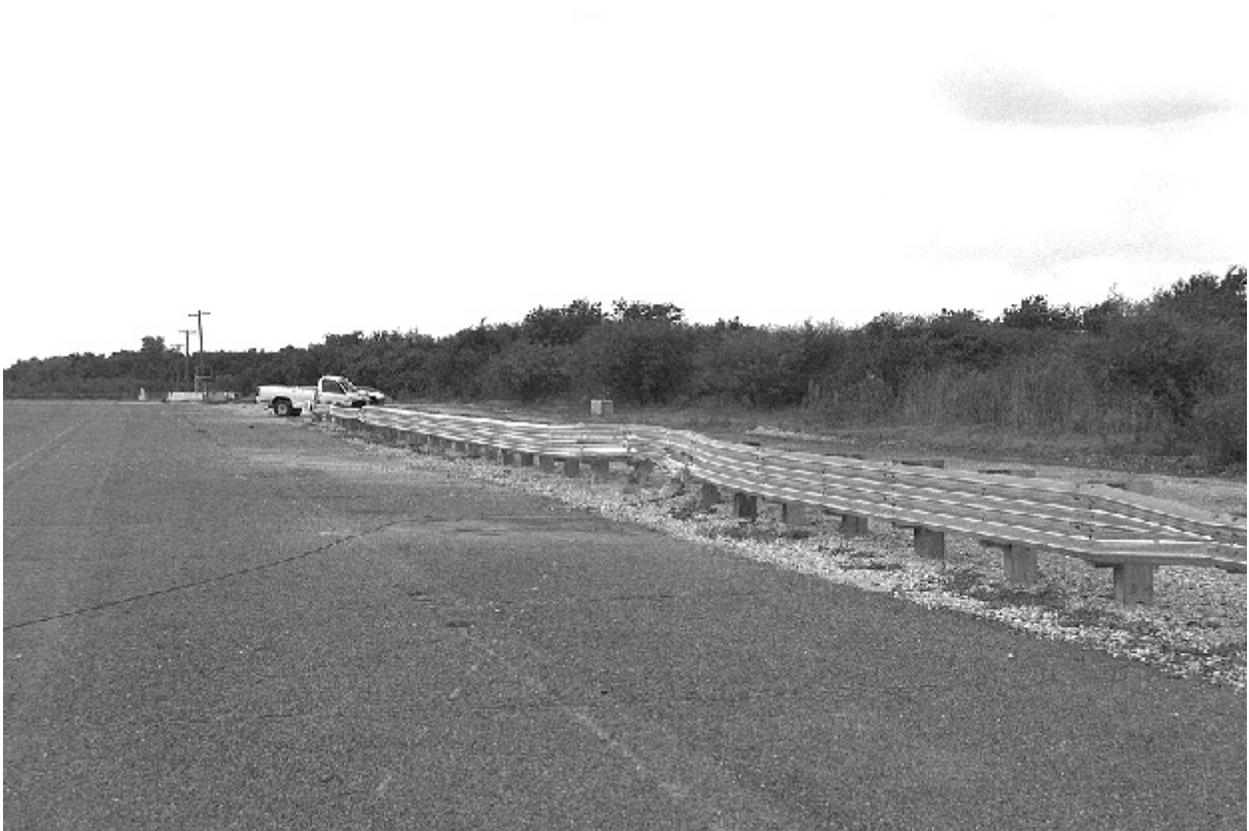
Figure 8. After-impact trajectory for test 404211-11.

Damage to the strong wood post three beam guardrail is shown in figures 8 and 9. Post 17 fractured just below ground level and post 18 split along the longitudinal axis. As shown in figure 10, the bolts pulled out of the rail element at posts 17 and 18. The ET-2000 end terminal on the downstream end was disturbed as were posts 6 through 14. Posts 15 through 20 were pushed back with a maximum displacement of 110 mm at post 16. Maximum dynamic deflection of the guardrail was 676 mm and the maximum permanent deformation was 390 mm between posts 16 and 17. Total length of contact during the initial impact was 6.3 m. The vehicle contacted the installation again at post 40 and rode off the end (post 43).

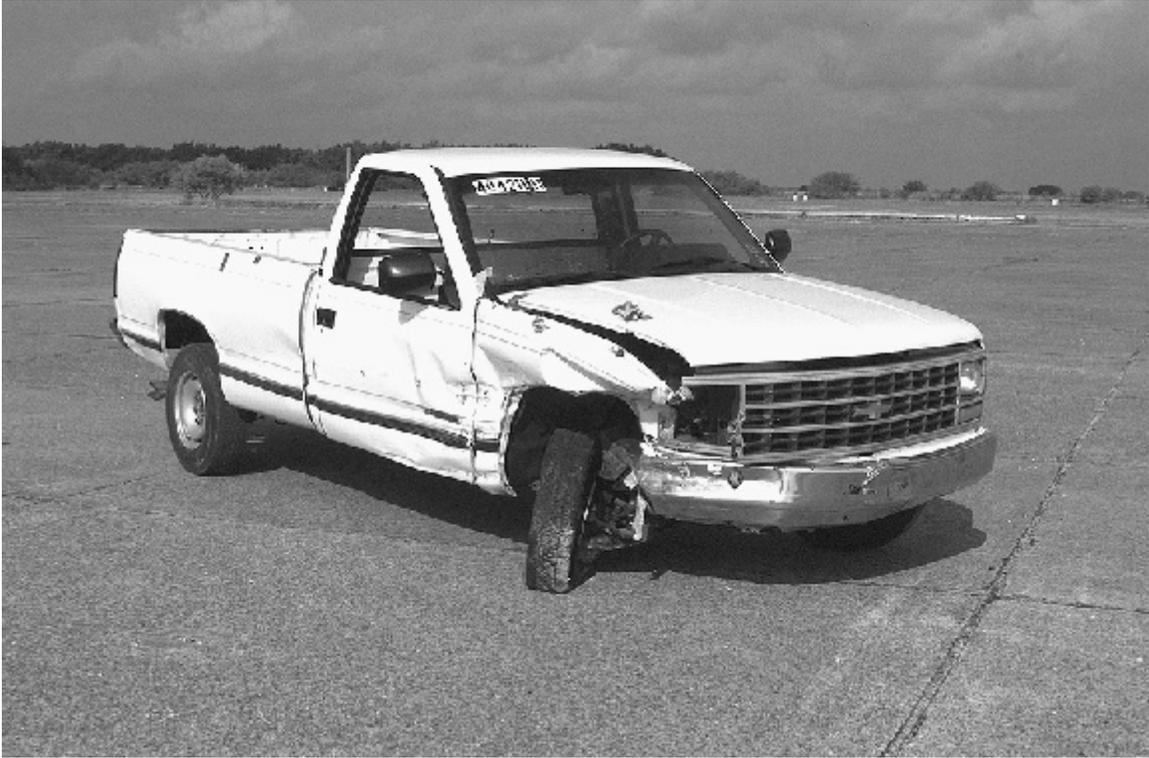
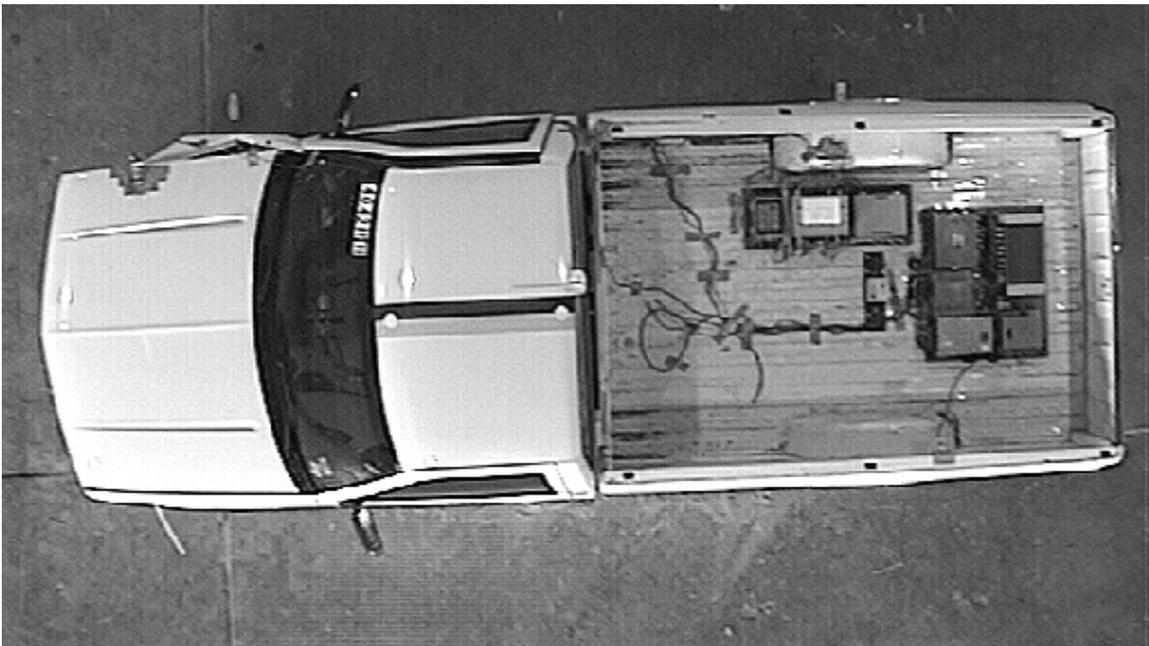
Figure 11. Vehicle after test 404211-11.

The bumper, hood, grill, fan, radiator, right front tire and wheel, right door, right front and rear quarter panels, and left door were damaged and the windshield was shattered as shown in figure 11. Structural damage included the right upper and lower A-arms, right spindle and rod ends, stabilizer bar, right front frame, firewall, and floor pan. Maximum exterior crush to the vehicle was 470 mm at the right front corner of the bumper. Maximum occupant compartment deformation was 30 mm (32% reduction of space) in the center floor pan area under the instrument panel. The interior of the vehicle is shown in figure 12. Exterior crush measurements and occupant compartment measurements are shown in tables 2 and 3.
