# NCHRP Report 350 Test 4-11 of the New York Two-Rail Curbless Bridge Railing

PUBLICATION NO. FHWA-RD-99-076

DECEMBER 1999

6. Performing Organization Code	
7. Author(s) C. Eugene Buth, William F. Williams, Wanda L. Menges, and Sandra K. Schoeneman				8. Performing Organization Report No. Report No. 404531-2

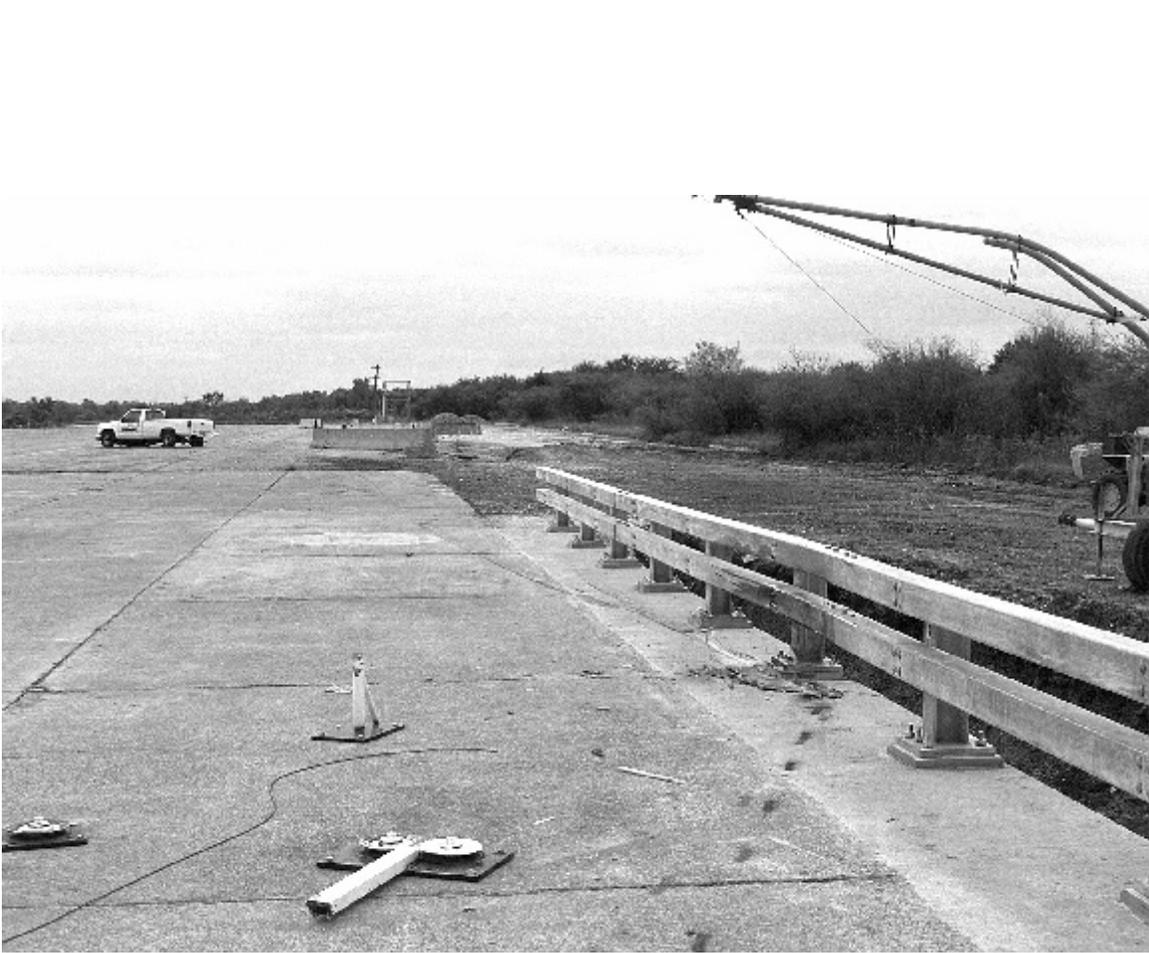
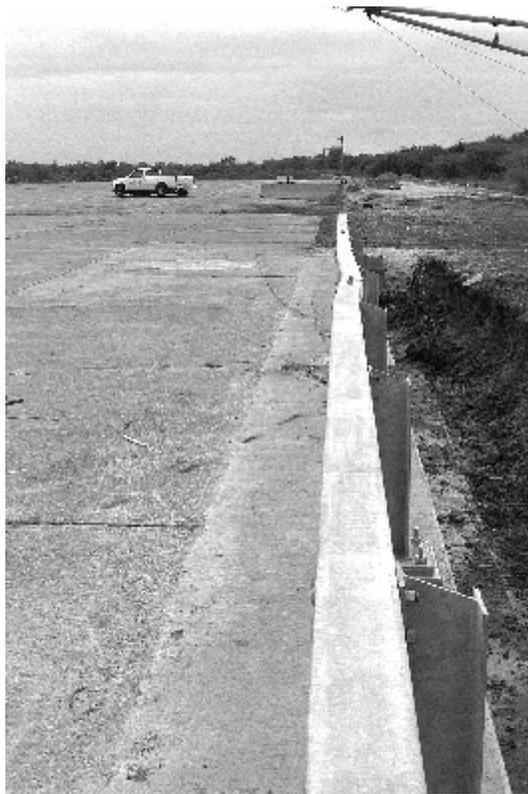
Figure 7. After-impact trajectory for test 404531-2.

Intrusion into adjacent traffic lanes occurred as the vehicle came to rest 12.2 m toward traffic.

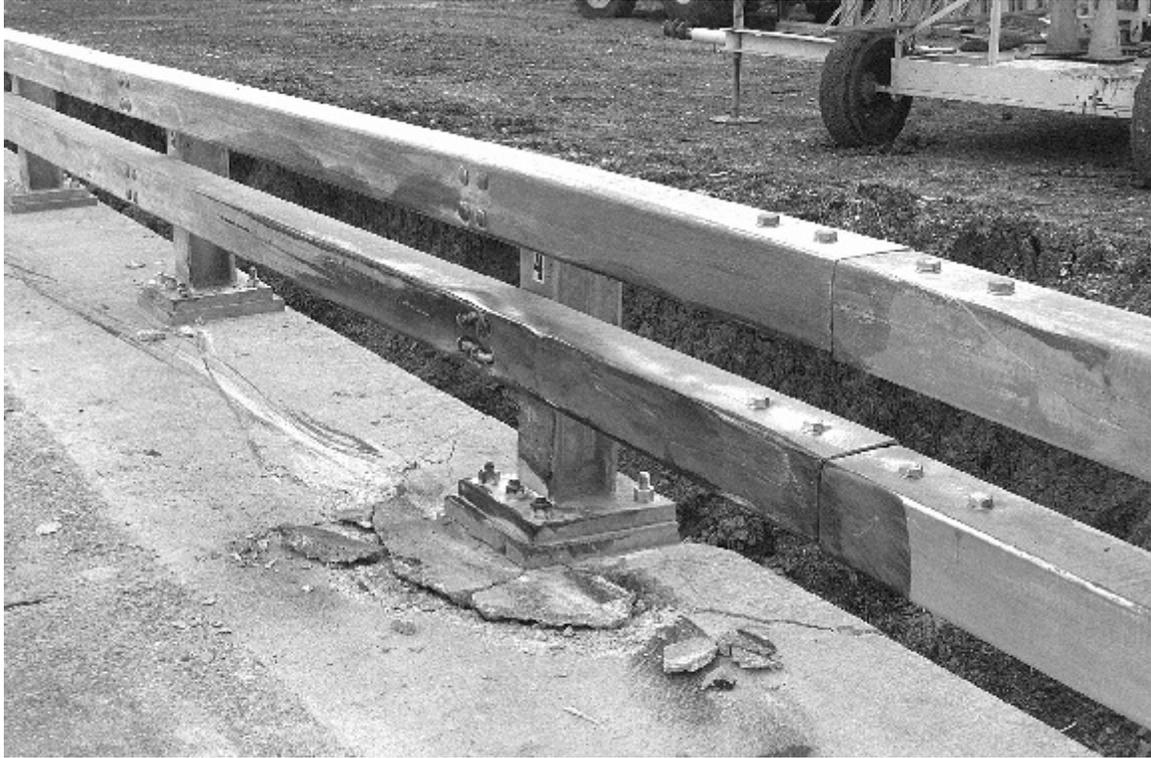
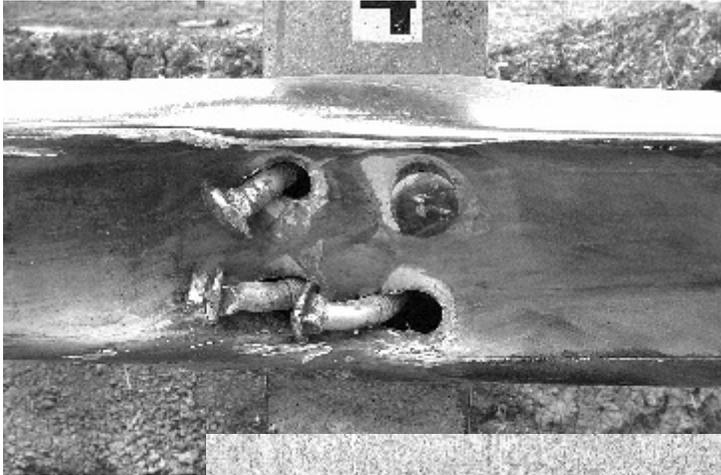
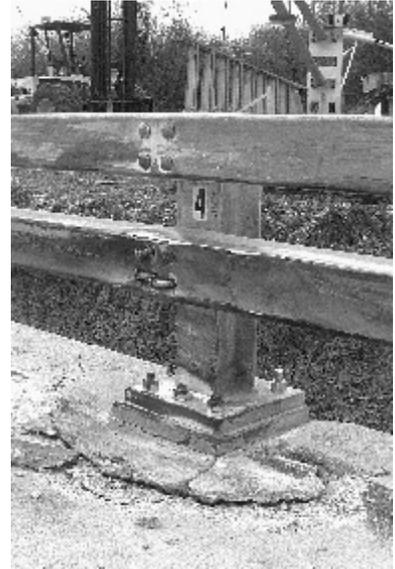
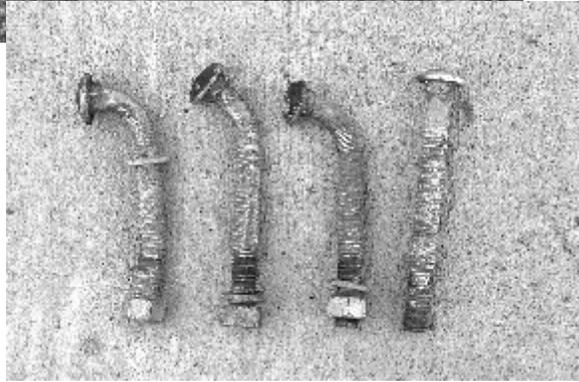
Figure 8. Damage to rail at post 4 after test 404531-2.

Damage to the New York Two-Rail Curbless Bridge Railing is shown in figures 7 through 9. Tire marks extended 225 mm behind the rail element at impact and tire marks were on the edges of the front and rear flange on the impact side of post 4, on the front face of the post and on the front anchor bolts. The tubular element in the vicinity of post 4 was partially flattened and the four bolts connecting the lower element were partially pulled out and deformed (see figure 8). Numerous cracks in the concrete deck surrounded post 4 and part of the concrete deck was broken away. After removal of the broken concrete around post 4, the exposed reinforcement did not show any signs of damage (see figure 9). At post 5, tire marks were on the front flange on the impact side of the post and extended 200 mm behind the rail element. Total length of vehicle contact with the rail elements was 3.3 m.

Damage to the concrete deck at one post location was extensive and would require major repairs. It is recommended that the post-to-deck connection be reviewed with the objective of reducing structural damage to the deck.

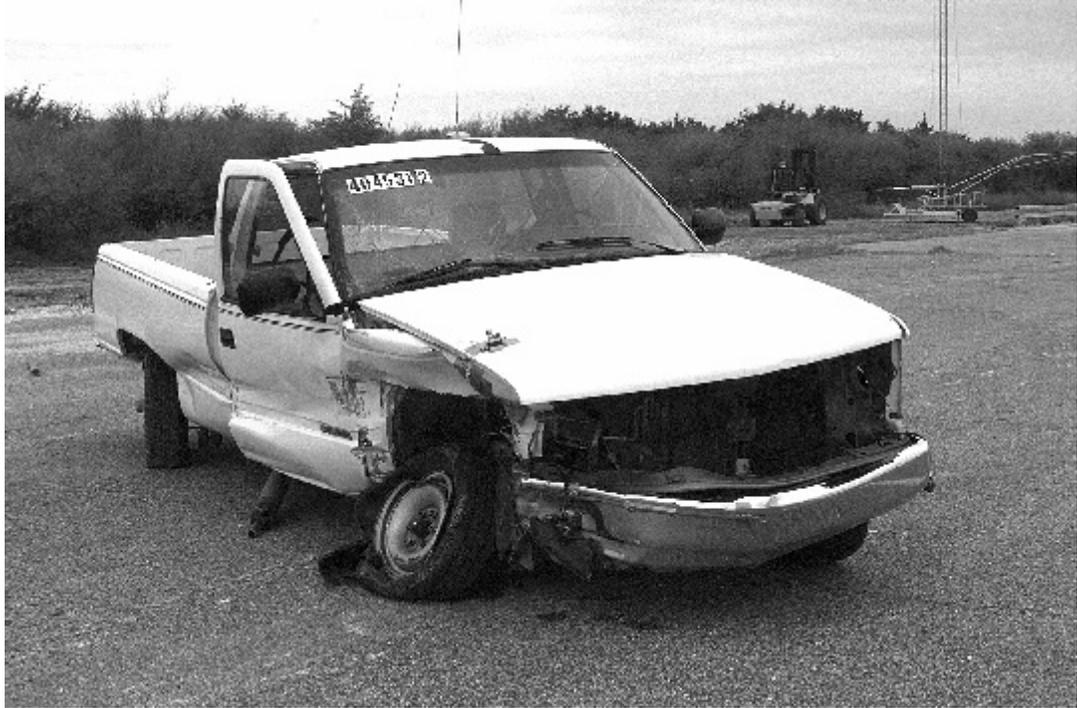
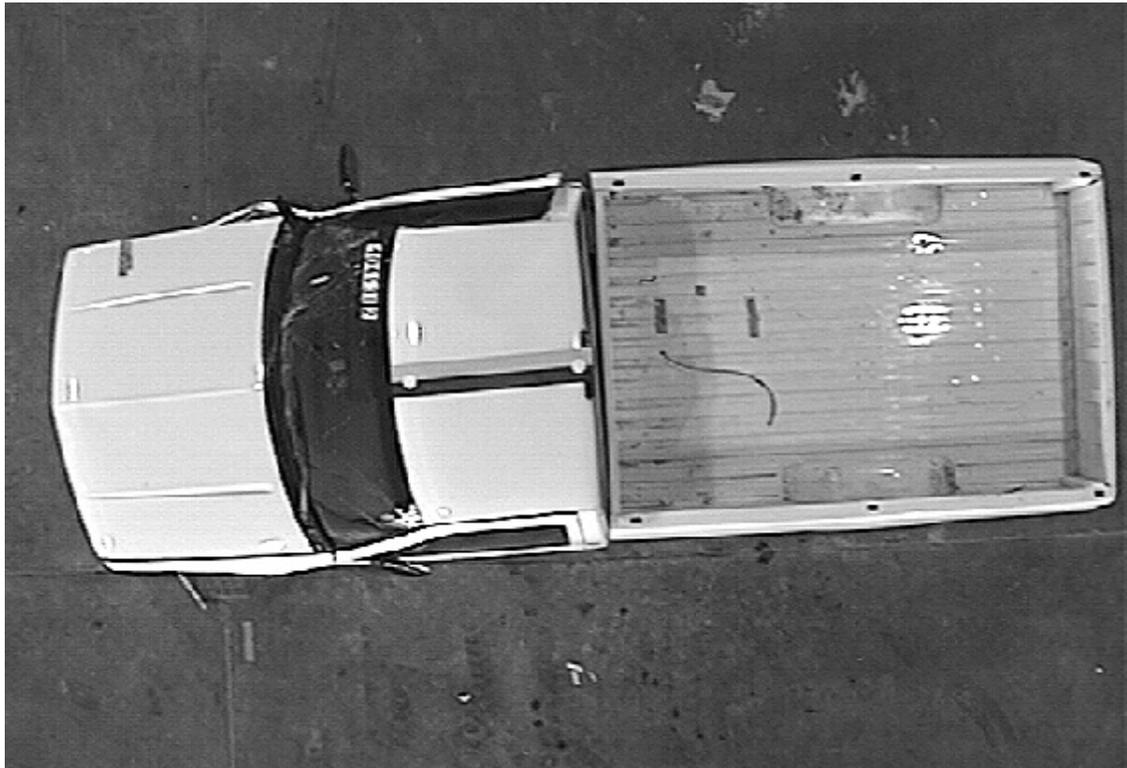
Figure 10. Vehicle after test 404531-2.

The vehicle sustained structural damage on the front right and the right side. The sway bar, tie rod, right front upper and lower A-arms, upper ball joint, right A-post, drive shaft, and transmission housing were all severely damaged. The front right portion of the bumper, hood, grill, fan, radiator, right front tire, and rim were damaged as shown in figure 10. The windshield was shattered and the right door was deformed outward 150 mm. The right front quarter panel and rear bed were dented. The front end of the vehicle shifted 150 mm to the left. At the rear of the vehicle on the right side, the rear tire and rim sustained damage, the rear axle was pushed back, and the rear U-bolts at the leaf springs were broken. The maximum exterior crush to the front bumper was 470 mm on the front and 340 mm on the right side. The floor pan was separated at the seam just above the upward curve (where the occupant's feet normally rest). The opening in the floor pan at the separation was judged to be wide enough to allow an occupant's foot to become jammed into the opening or go through (see lower photo in figure 11). This result was judged to have a potential for causing serious injury to the occupant. Maximum deformation of the occupant compartment was 199 mm (17.6-percent reduction in space) in the floor pan area and maximum reduction of space was 38.8 percent in the center floor pan to instrument panel area. The interior of the vehicle is shown in figure 11. Exterior vehicle crush and occupant compartment measurements are shown in appendix B, tables 3 and 4.

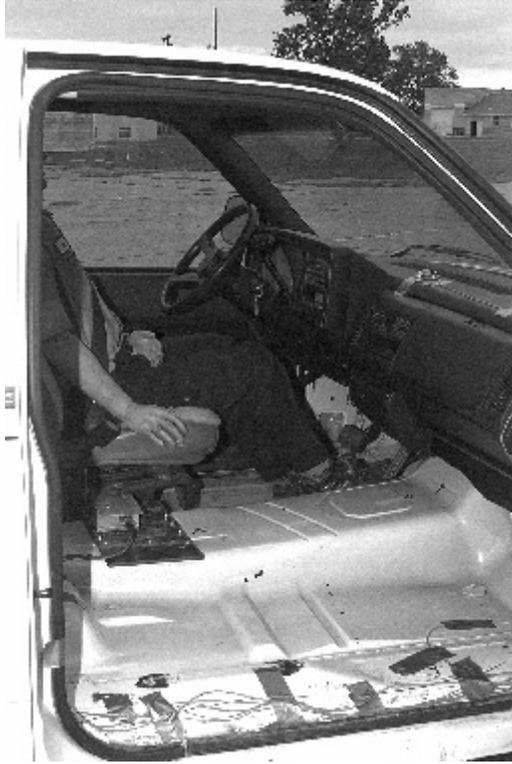
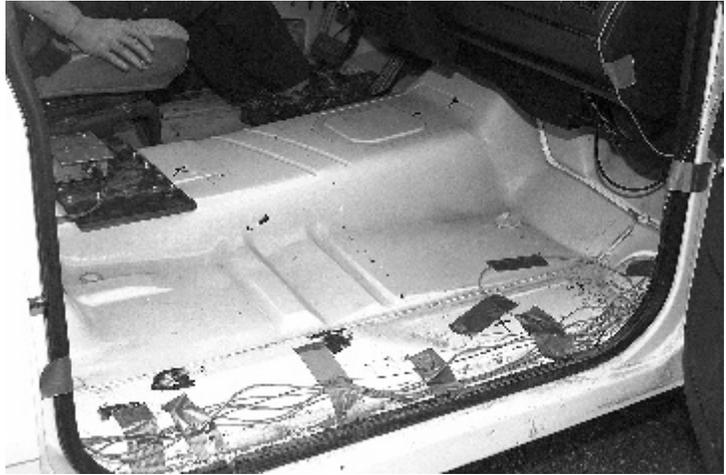
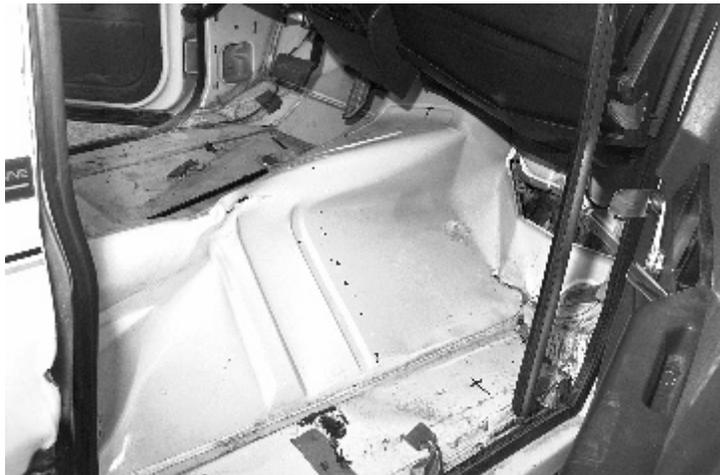
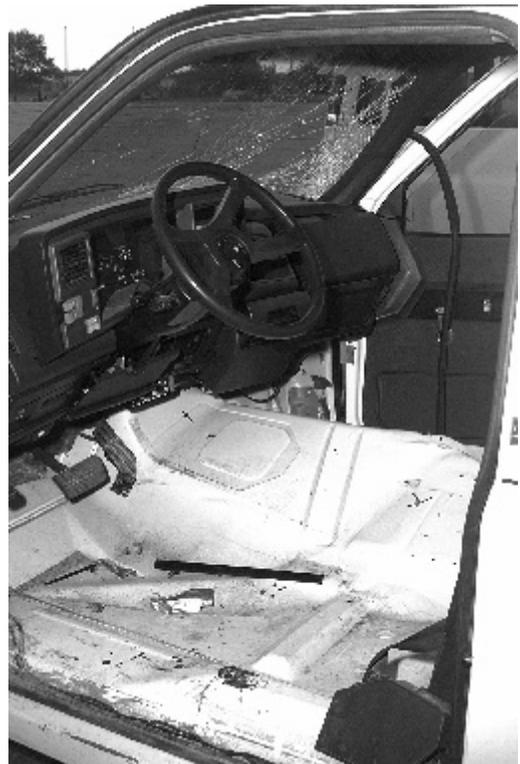
Figure 11. Interior of vehicle for test 404531-2.

No detached elements, fragments, or other debris from the test article were present to penetrate or to show the potential for penetrating the occupant compartment, nor to present undue hazard to others in the area. Maximum deformation of the occupant compartment was 199 mm (17.6-percent reduction in space) in the floor pan area and maximum reduction of space was 38.8 percent in the center floor pan to instrument panel area with separation of the floor pan just above the upward curve (where the occupant's feet normally rest).
