# NCHRP Report 350 Test 4-10 of the New York Two-Rail Curbless Bridge Railing

PUBLICATION NO. FHWA-RD-99-077

DECEMBER 1999

**Federal Highway Administration**

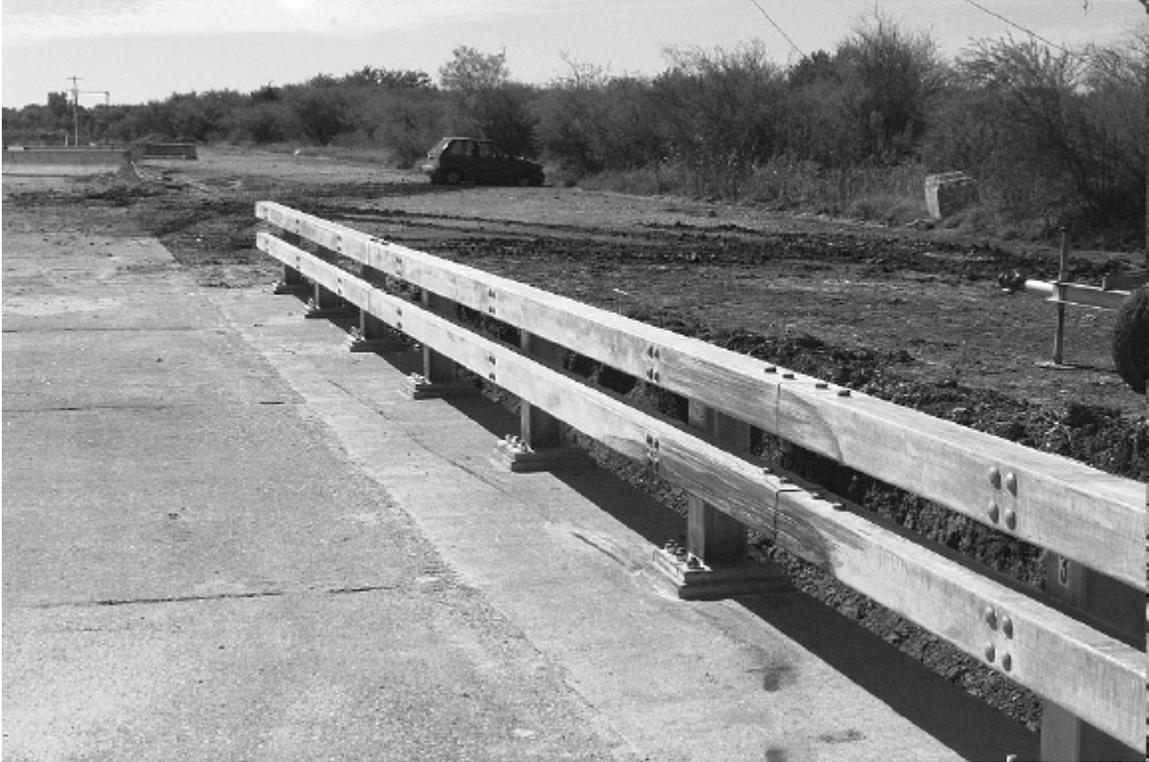
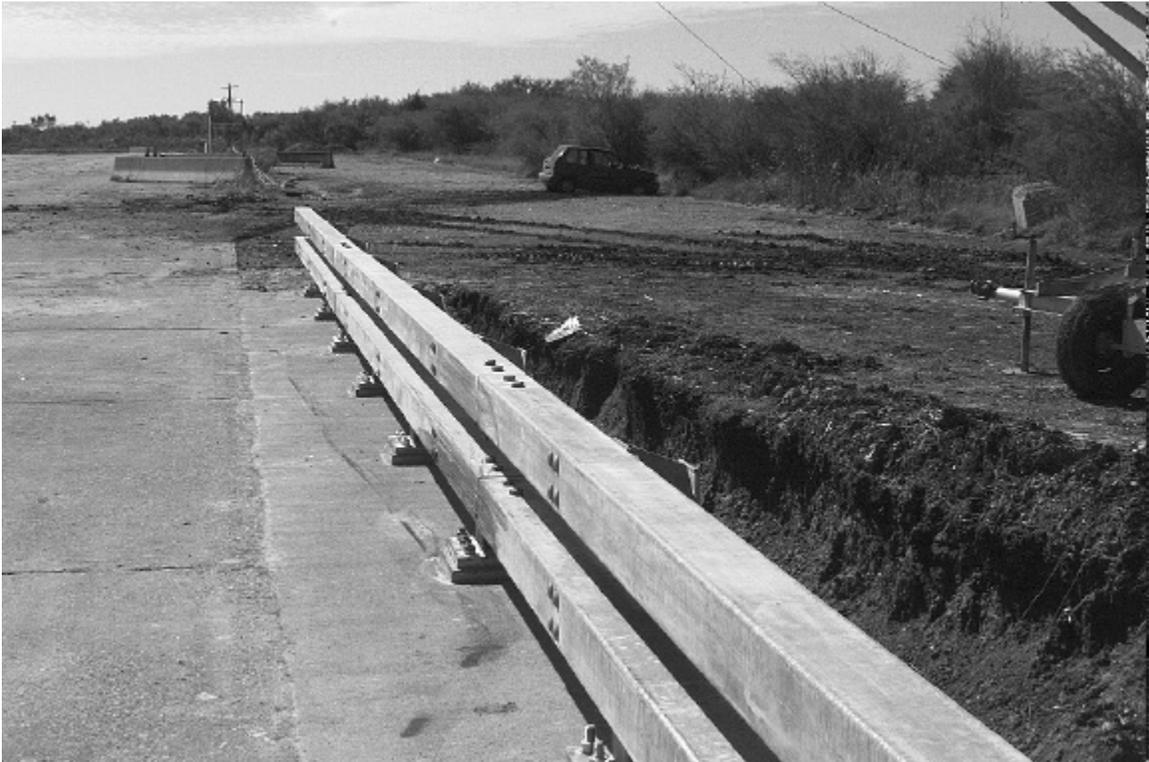
Figure 6. Vehicle trajectory path after test 404531-1.

The vehicle did not intrude into adjacent traffic lanes as it came to rest behind the installation

The exit angle at loss of contact was 0.8 degrees, which was significantly less than 60 percent of the impact angle.

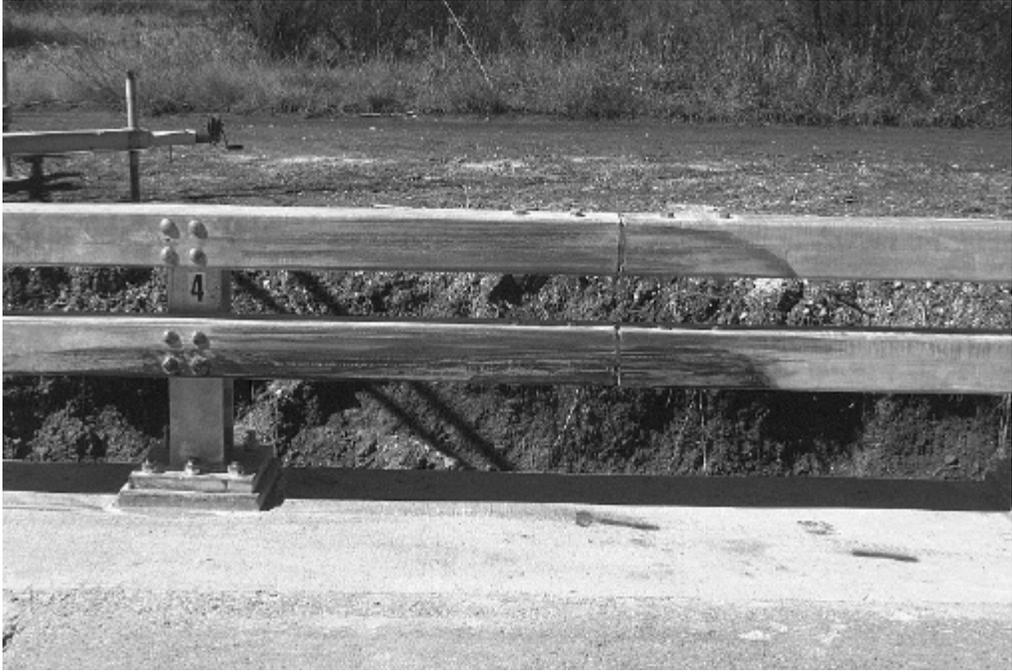
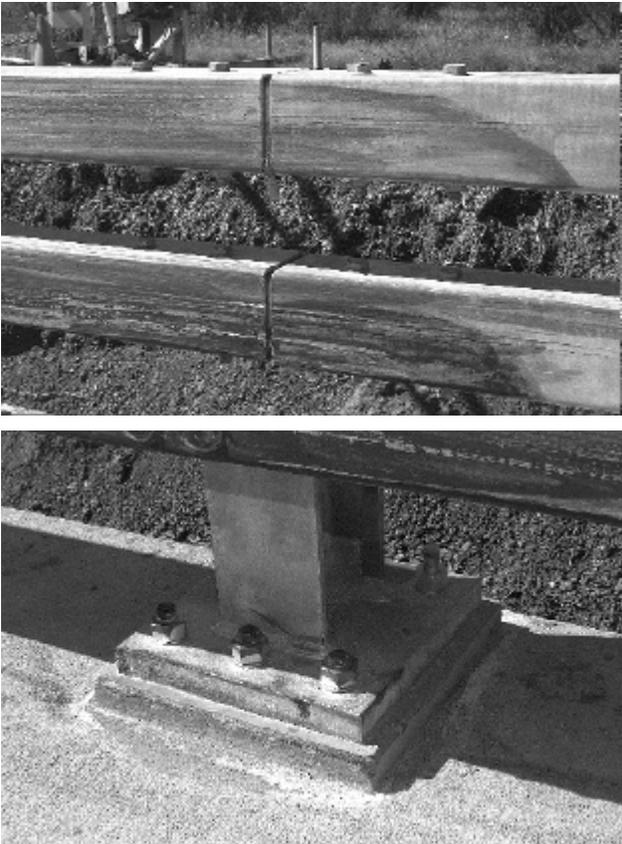
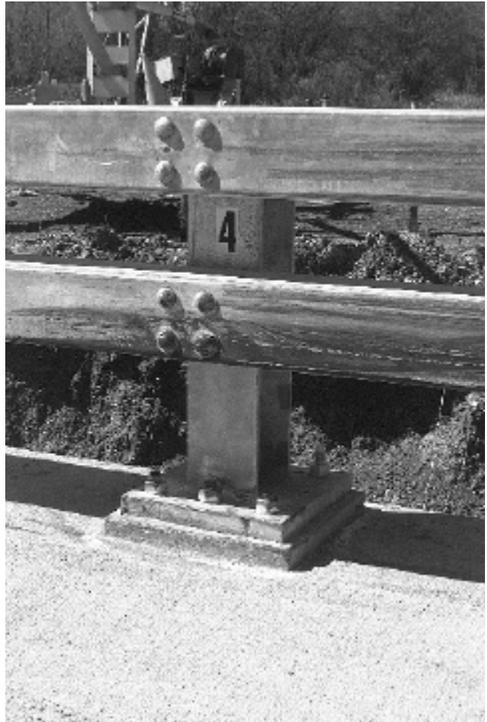
Figure 7. Installation after test 404531-1.

Damage to the New York Two-Rail Curbless Bridge Railing is shown in figures 6 and 7. Tire marks were on the baseplate and nuts at impact. No cracks in the deck were noticed after the test. There was cosmetic damage with no measurable deformation of the rail elements. Total length of vehicle contact with the rail element was 3.0 m.

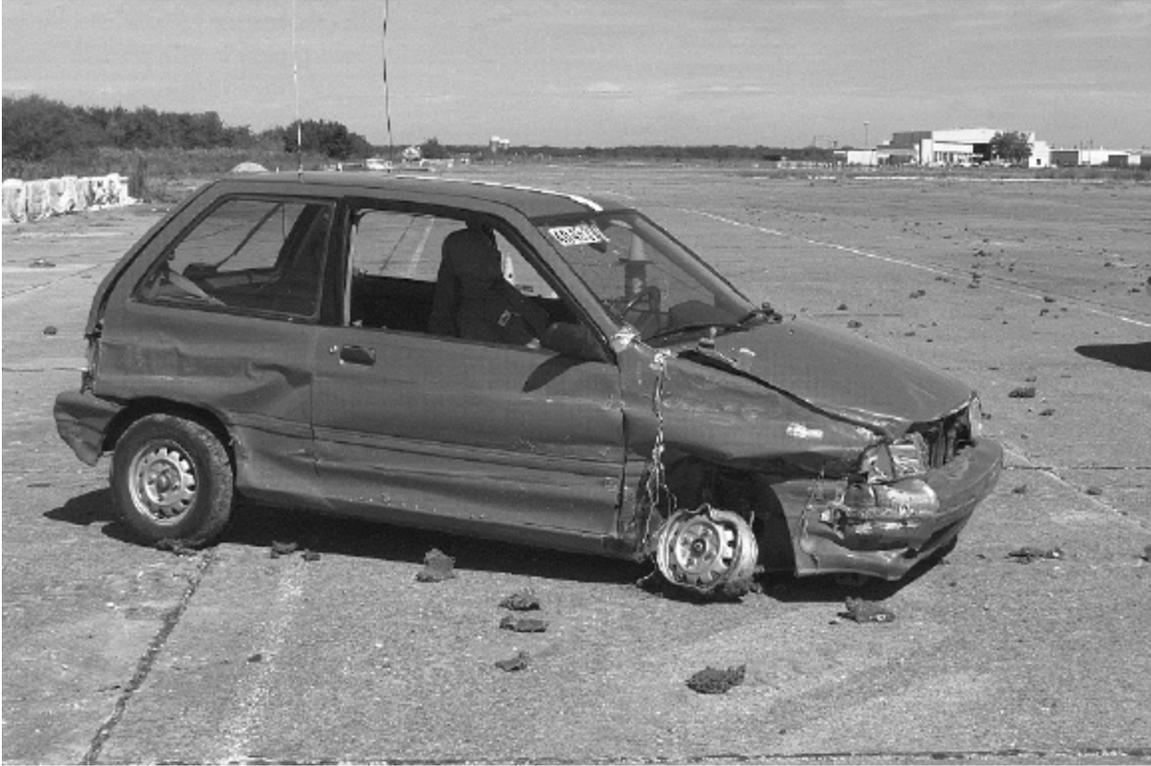
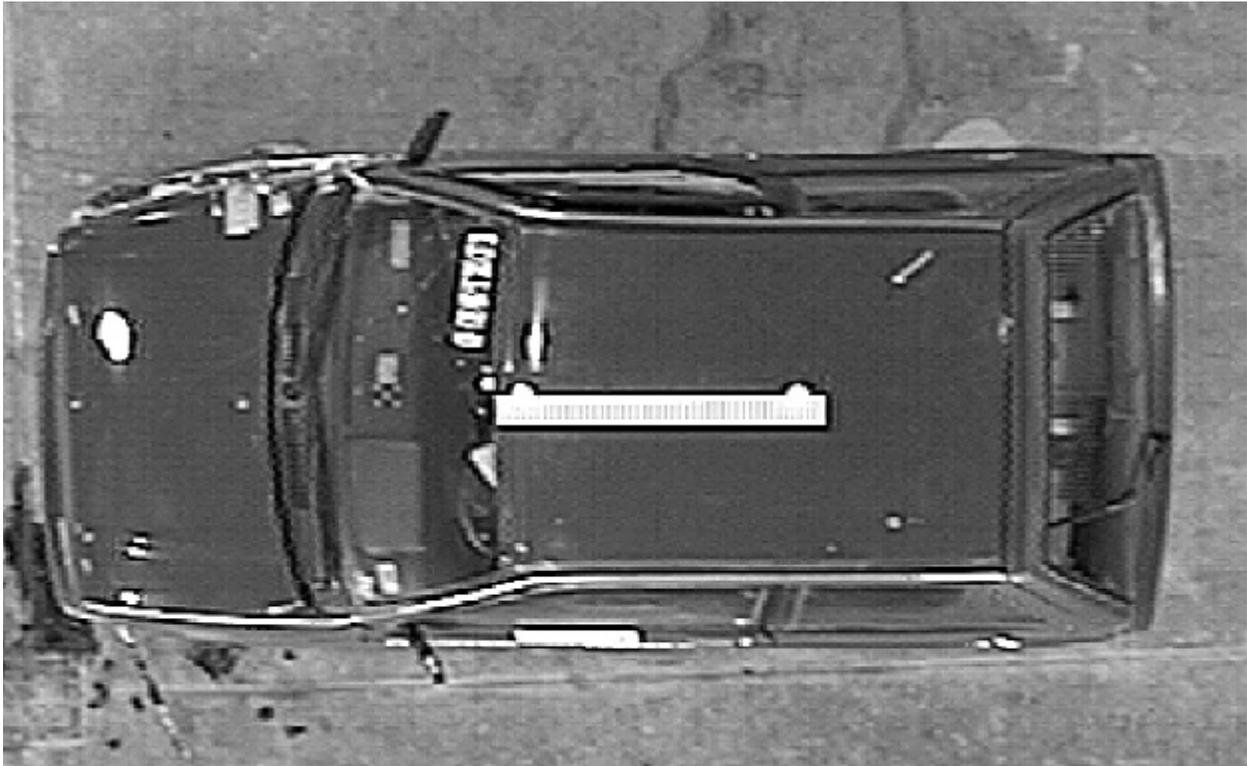
Figure 8. Vehicle after test 404531-1.

The vehicle sustained structural damage on the front right and right side. The sway bar, A-arm, motor support, and right strut and axle were all severely damaged. The front right portion of the bumper, fan, radiator, hood, tire, and wheel were damaged as shown in figure 8. The right front and rear quarter panels and right door were dented. The left front tire also sustained damage. The roof had a slight buckle on the passenger side. The maximum exterior crush was 190 mm, measured near bumper height on the right side. Maximum deformation of the occupant compartment was 15 mm (2-percent reduction in space) in the right firewall area. The door and the floor pan were deformed. The interior of the vehicle is shown in figure 9. Exterior vehicle crush and occupant compartment measurements are shown in appendix B, tables 3 and 4.

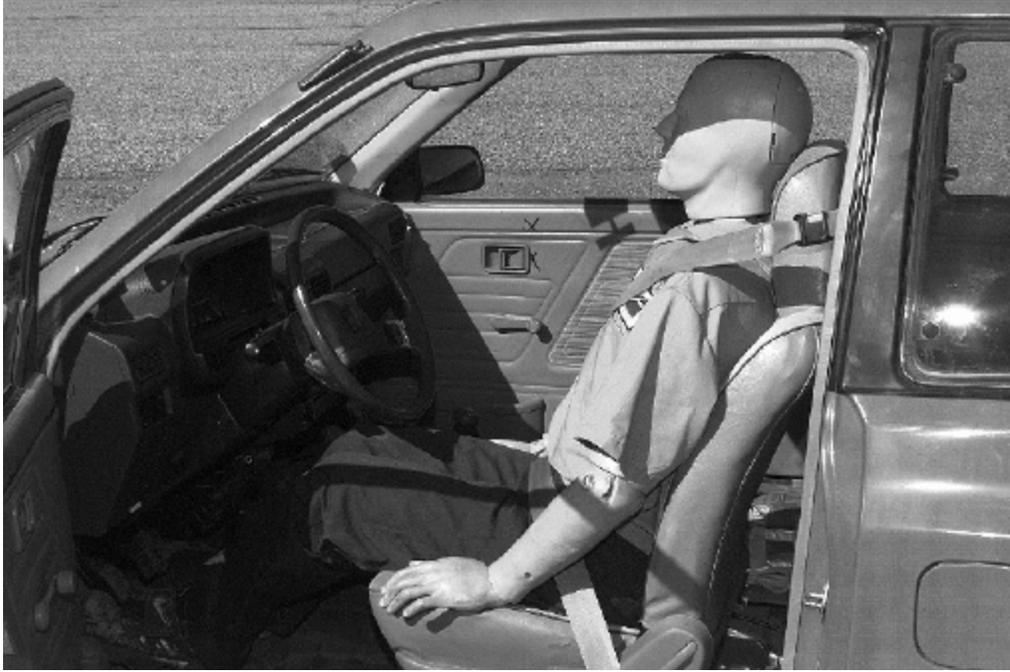
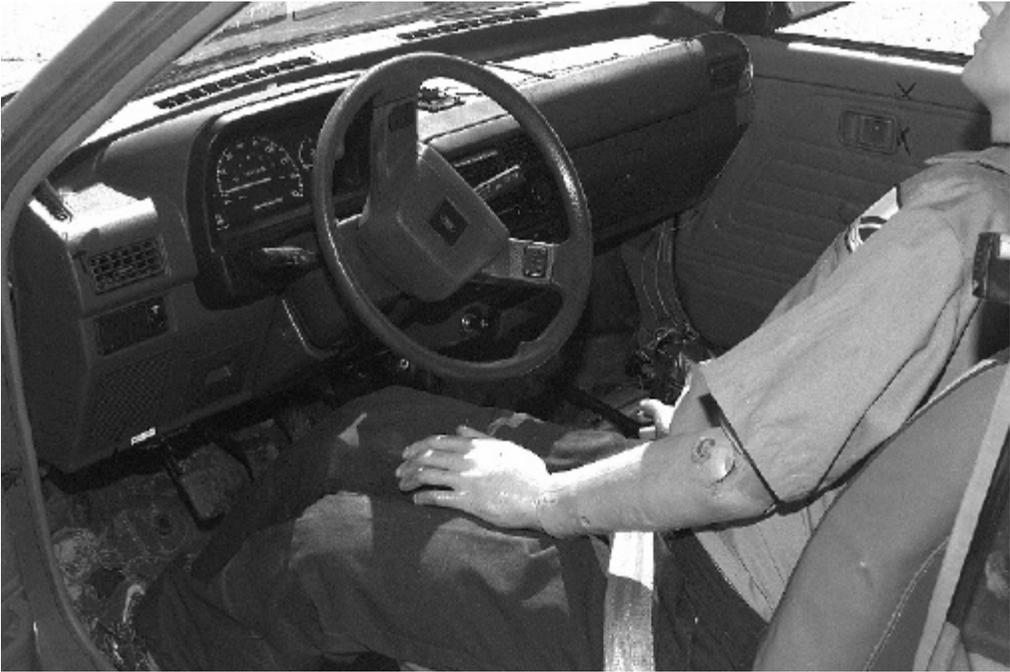
Figure 9. Interior of vehicle for test 404531-1.

No detached elements, fragments, or other debris from the test article were present to penetrate or to show potential for penetrating the occupant compartment. Minimal deformation occurred to the occupant compartment, 15 mm (2% reduction in space) in the right firewall area
