**JOHN W. FISHER AND ASSOCIATES, INC.**  
**ENGINEERING CONSULTANT**

**FHWA Bay Bridge Pile Connection Plate Welding Investigation**  
**By John W. Fisher, PhD, PE**

**Introduction**

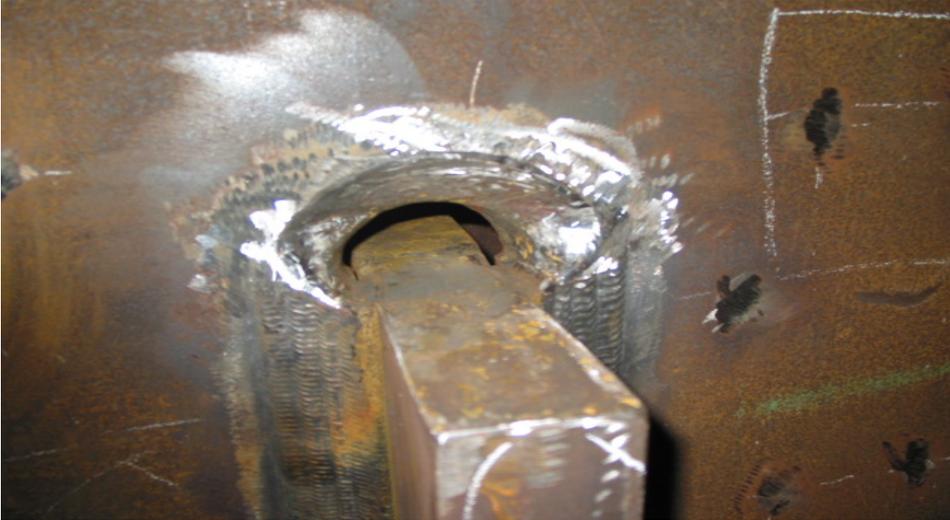
The site visit on April 18, 2005 provided an opportunity to examine a number of PJP welds in various stages of completion in Pier E4W. Characteristic of the conditions observed are provided in the photographs in Figures 1 to 8. Figure 1 shows a partially ground upper opening at Pile 2 plate F where the run off tabs have been removed, the area gouged and ground to shape.

Figure 1 Pile 2 plate F upper opening with runoff tabs removed and surface ground

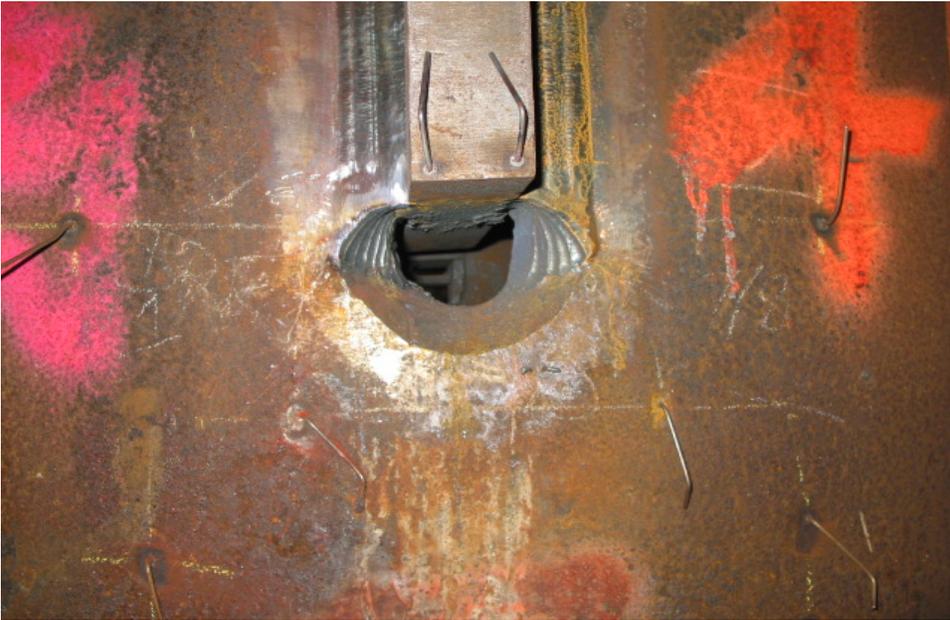
Figure 2 shows the condition at Pile 3 plate C where the run of tabs were removed and the area shaped by torch. No grinding had been carried out as a result of work being stopped on April 7, 2005. At the adjacent plate D as seen in Figures 3 and 4, welding had stopped before the welds between the shear plate and the pile sleeve were completed. A root pass can be seen to have started on the run off tabs and had been completed. The weld bead surface profile was characteristic of a vertical up weld. Figure 4 shows the weld nozzle and the machine equipment attached to the pile sleeve surface with magnets as well as the electrical heat pads.

Figure 2 Pile 3 plate C with weld complete, runoff tabs removed at lower end and arc gouges evident as surface has not been ground

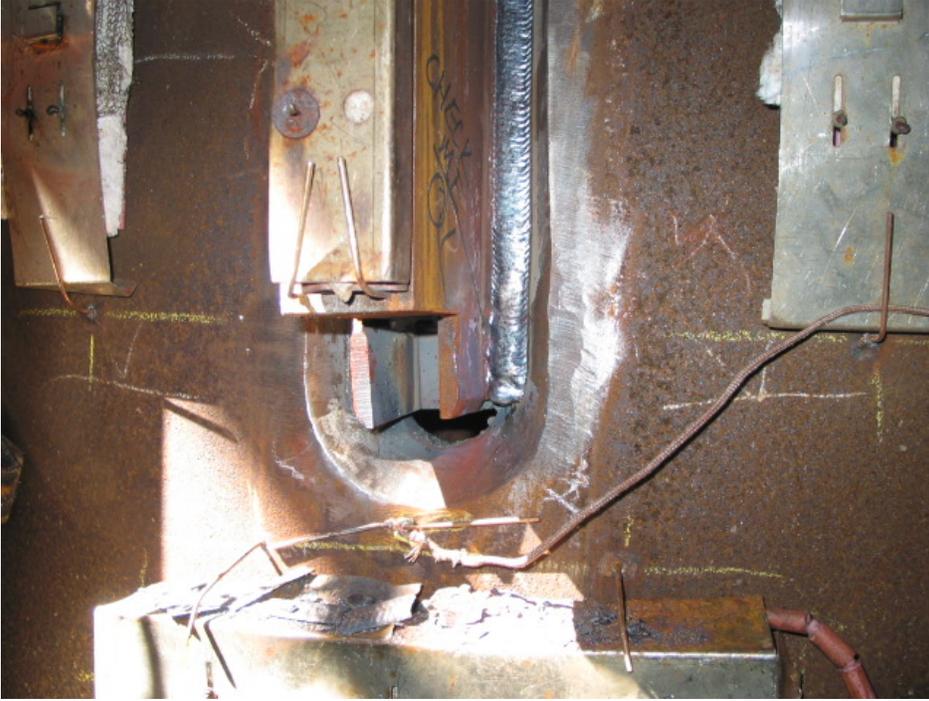
Figure 3 Pile 3 plate D showing runoff tabs and root pass at lower end of connection

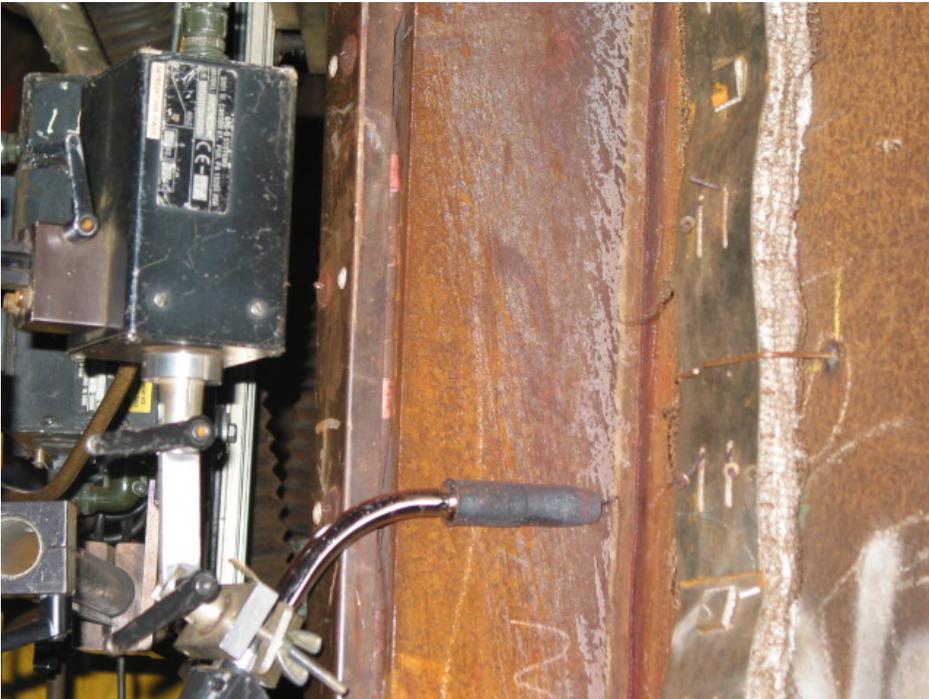
Figure 4 Pile 3 plate D showing welding unit attached to pile sleeve with Buggo unit

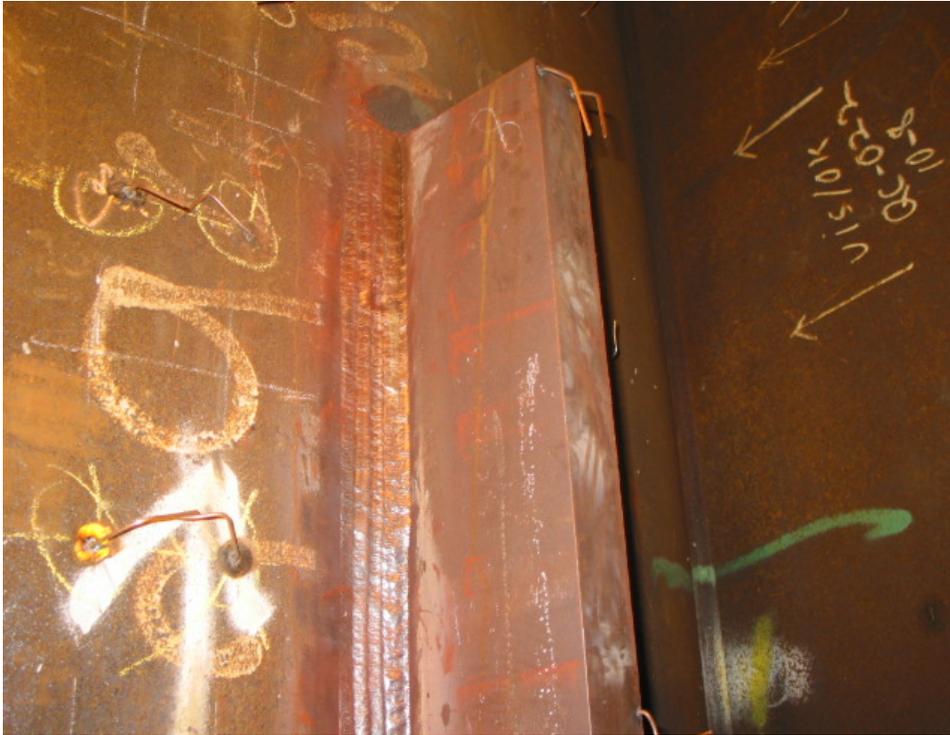
Figures 5 and 6 show the alleged improperly made welds at Pile 3 plate G. Although the run off tabs were removed, and the weld end shaped, neither opening had been cleaned up by grinding. The physical appearance of the weld cap passes were normal and can be seen in both Figures 5 and 6.

Figure 5 Pile 3 plate G showing weld passes near upper end of shear connection plate

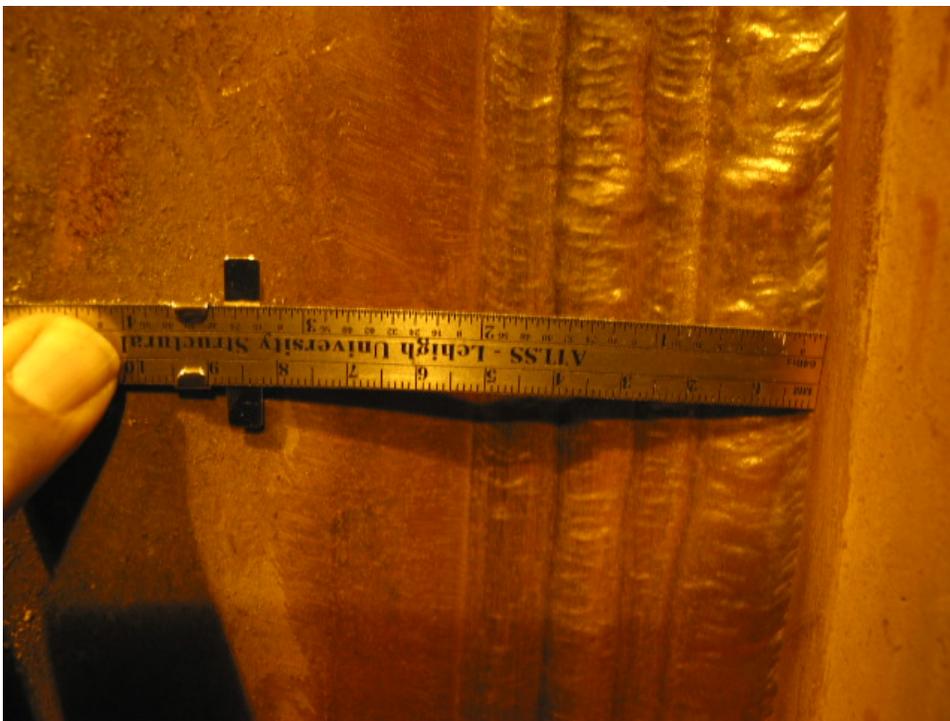
Figure 6 Pile 3 plate G showing weld passes of the cap weld

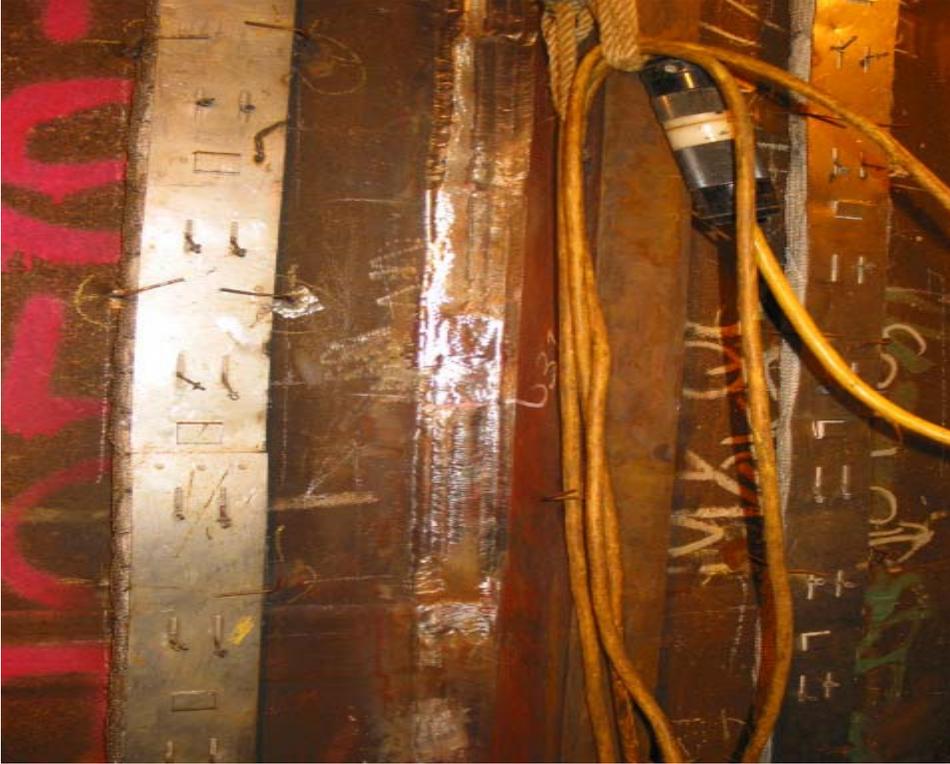
The final location examined was at Pile 5 plate D which was also alleged to be executed in a faulty way. The weld shown in Figures 7 and 8 has regions where weld repair of the cap weld surfaces is apparent. At most other locations the weld run off tabs had been removed and the end access holes reshaped by arc gouging which is seen in Figure 8. During the visit personnel from Mactec carried out a magnetic particle inspection of the upper end which showed a line at the shear plate surface where the end access hole had been shaped by torch. This was subsequently removed by light grinding to remove the geometric ledge at the access hole. It was noted by Mactec personnel that none of the welds at Pier E4W had QC/QA completed.

Figure 7 Pile 5 plate D showing regions of weld repair on the cap weld surface.

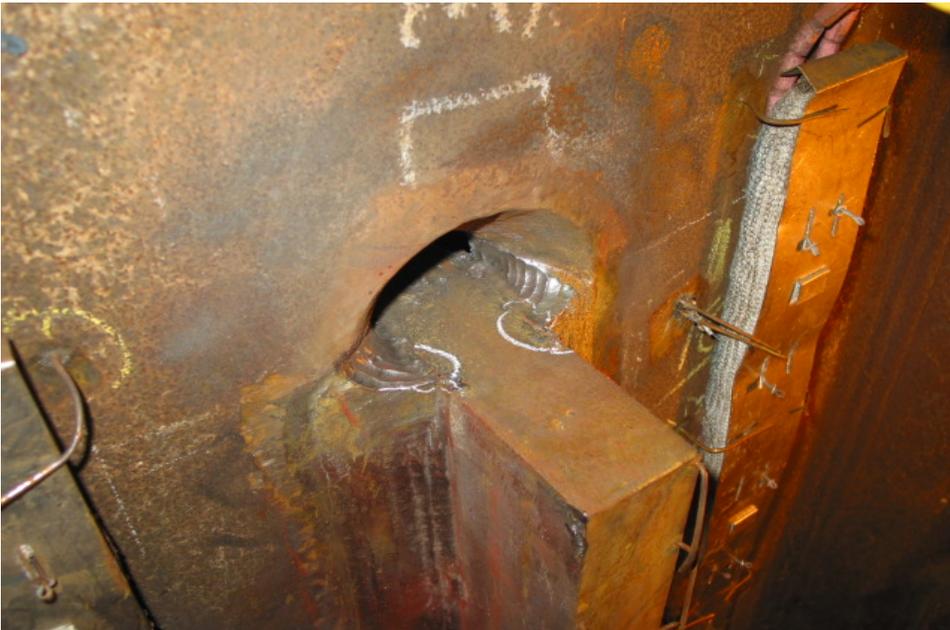
Since most of the top and bottom access holes had the run off tabs removed but the weld ends and adjacent base metal were still in a rough flame cut condition, they would obviously have detectable discontinuities as was observed in Figure 8. Prior to removal of the welds selected for further investigation of weld quality at locations 3G and 5D it was necessary to complete the grinding of the access hole surfaces at those locations before MT examination. After these locations were completed Mayes personnel performed MT testing of 2B, 3G, and 5D. Some additional MT indications were observed and removed by grinding within the project limits.

Figure 8 Pile 5 plate D at upper end showing MP indication at gouge which was removed by grinding. The weld ends have not been finished after runoff tab removal.
