FHWA BAY BRIDGE PILE CONNECTION PLATE WELDING INVESTIGATION REPORT

**San Francisco Oakland Bay Bridge
PILE HEAD at PIER E4W**

WELD SAMPLE REMOVAL PROCEDURE

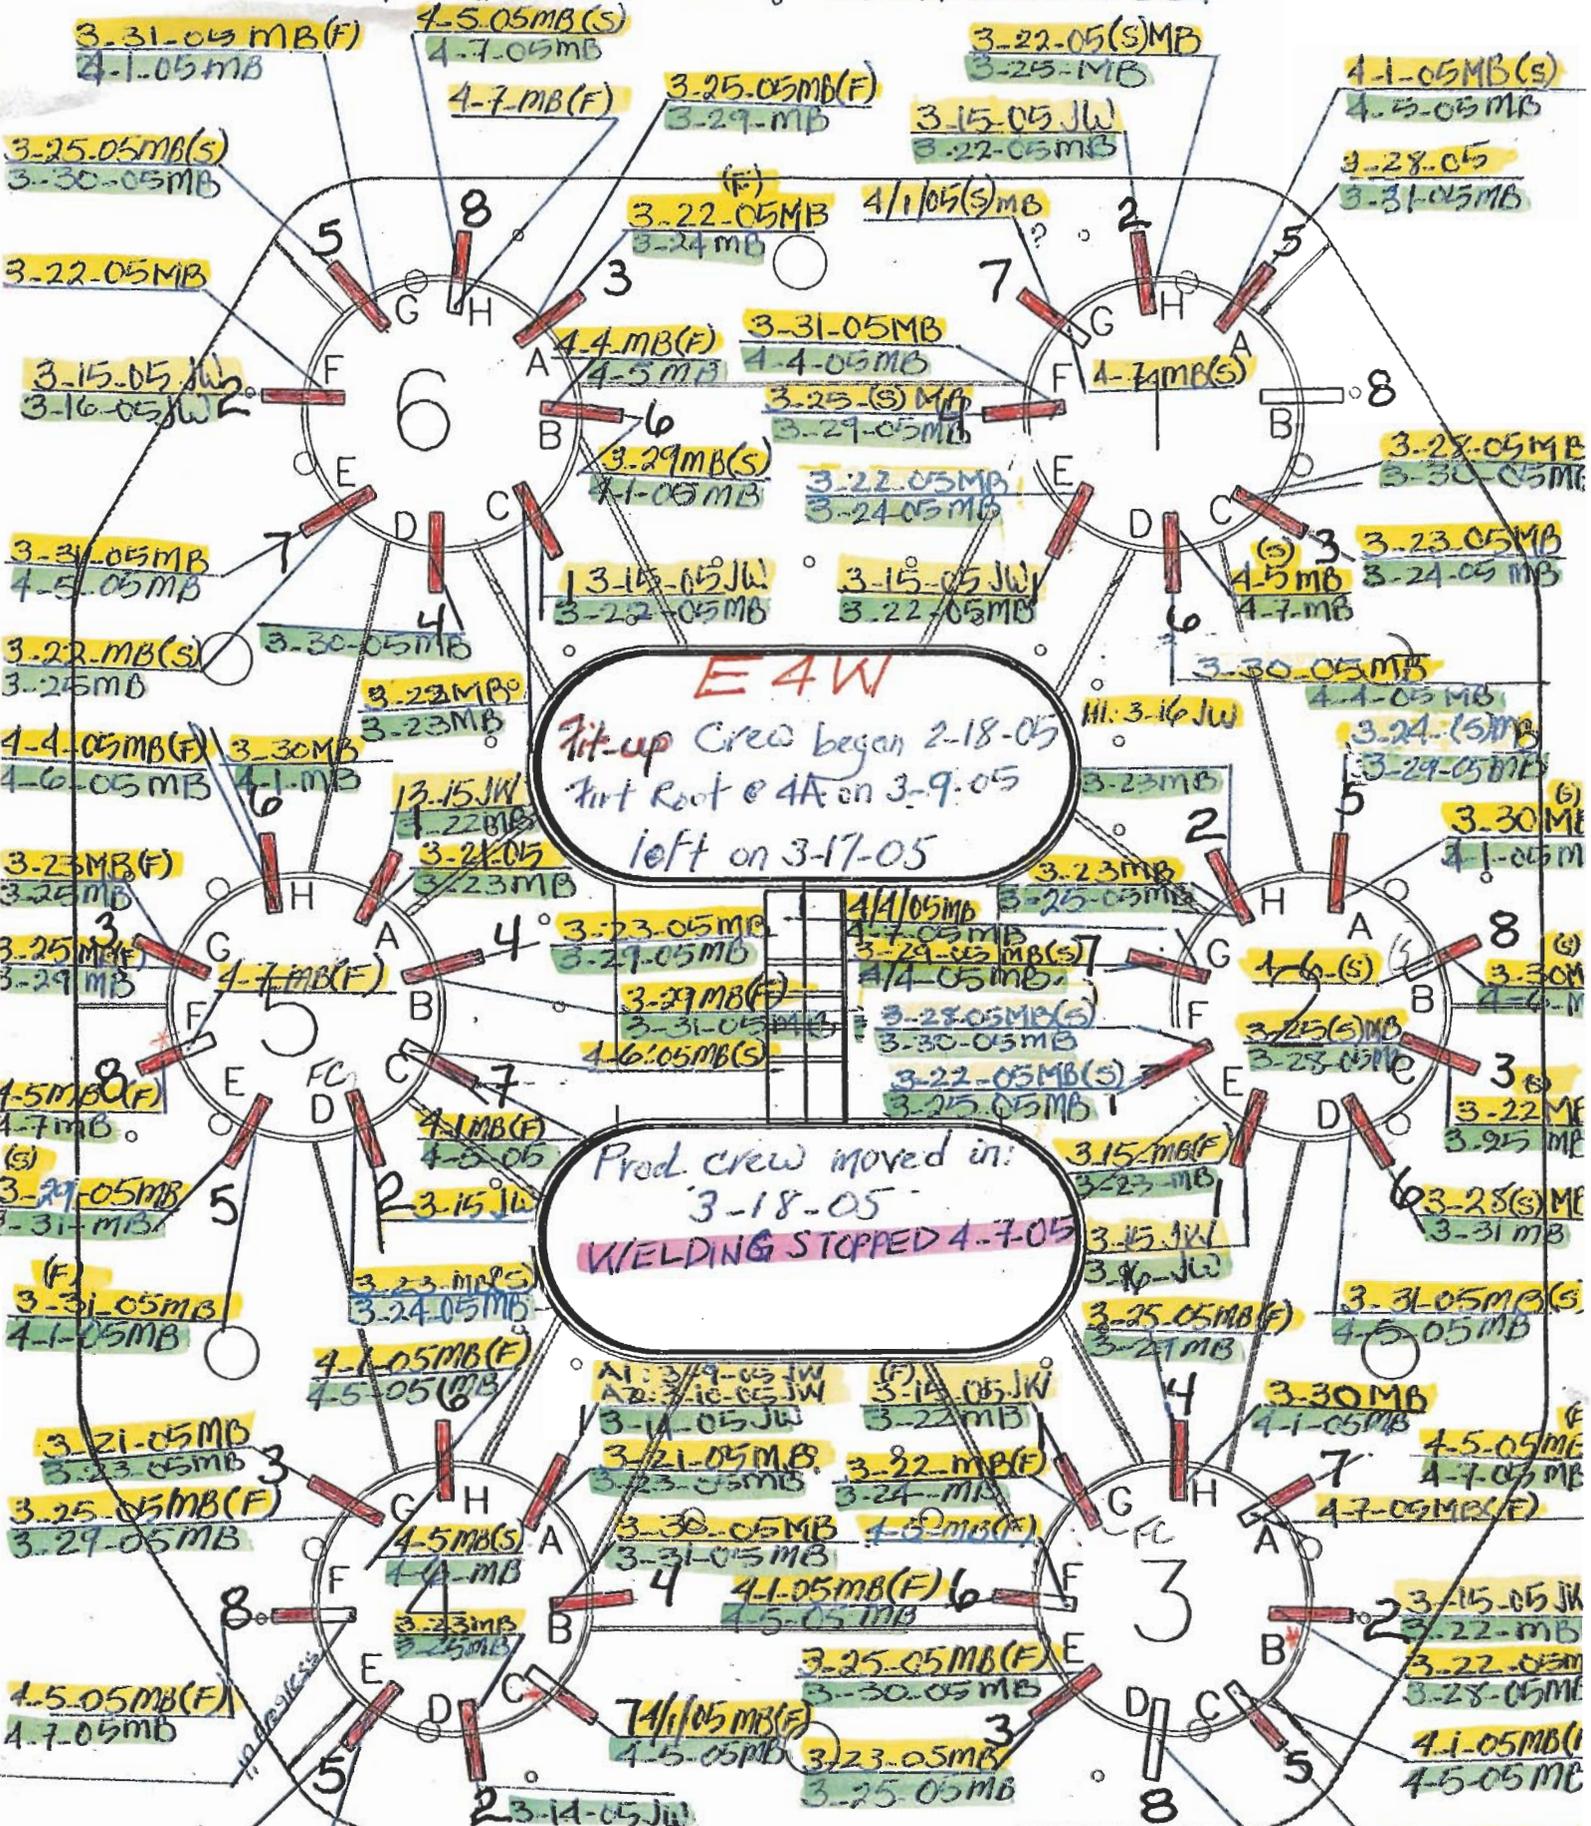
E4W
 Fit-up Crew began 2-18-05
 First Root @ 4A on 3-9-05
 left on 3-17-05

Prod. crew moved in:
 3-18-05
WELDING STOPPED 4-7-05

* J-Groove @ 3B on 2-18-05
 * J-Groove @ 4C on 2-24-05
 * @ 5F1 & F2 on 2-23-05
 1st CW: #316 @ 4G2 - Land side (Fit-up crew)
 2nd CW: #317 @ 6C1 Bot (F.u. crew)
