# SAN FRANCISCO-OAKLAND BAY BRIDGE

## SUMMARY OF WELDING STUDIES

April 2005 – July 2005

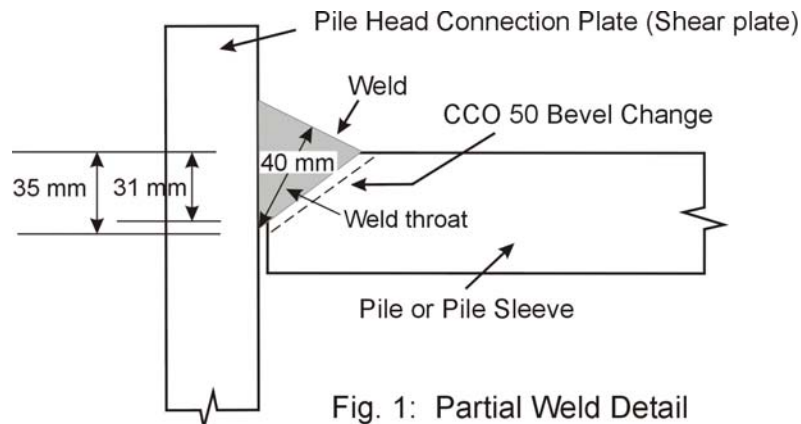
Fig. 1: Partial Weld Detail

The geometry and physical properties of the welds were also assessed. Contract Change Order number 50 increased the overall weld size by enlarging the bevel in the pile and pile sleeve (see Fig. 1). This was done to streamline the inspection process by eliminating Ultrasonic Testing (UT), originally required by the contract as the method for verifying the depth of preparation. The net result of this change is a larger weld than what was originally designed.
