### **3. TEST SESSIONS**

#### **3.1 OVERVIEW OF TEST PROCEDURES**

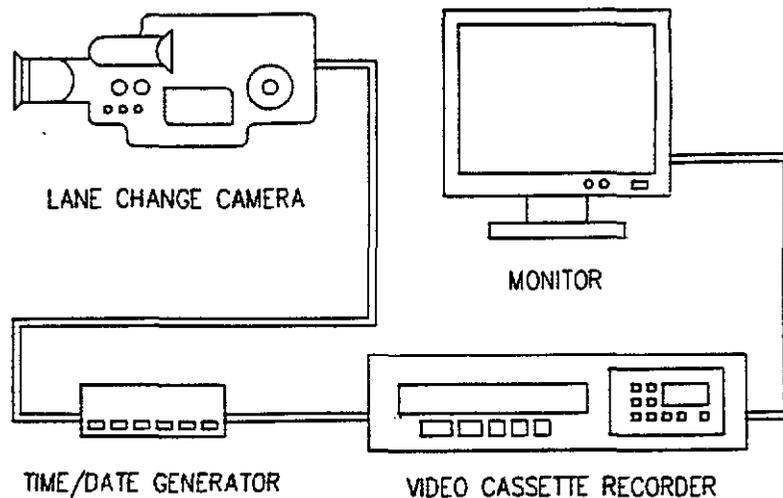
**Figure 21. Correct Configuration of the Lane-Change Camera, Time/Date Generator and VCR**

During the second 48-hour test, the main problem was an incorrect configuration of the lane-change camera and recorder. The camera used for recording lane changes did not

have the capability to imprint time and date on the video. A time/date generator was added in the line between the camera and the VCR to add the time and date to the video image before being recorded. This configuration is shown in Figure 21. During the second test, the VCR and time/date generator were accidentally swapped in the configuration. Thus the time and date was displayed on the local monitor during the test, but was not recorded by the VCR for use during data reduction. Careful use of the VCR's tape time counter and manual time synchronization with the pole camera was required to match vehicles that change lanes with the appropriate vehicles in the ground truth data. This problem did not affect the results of the test.
